## GAS MEMBRANE VALIDATION

| <b>Site Name:</b> Belle Vue | <b>Project Number:</b> 12-123 |
| <b>Company Name:</b> Countryside Properties | <b>Date:</b> 12-10-2022 |
| Ground Gas Risk Assessment: <b>Characteristic Situation 2 / Amber 1</b> | |

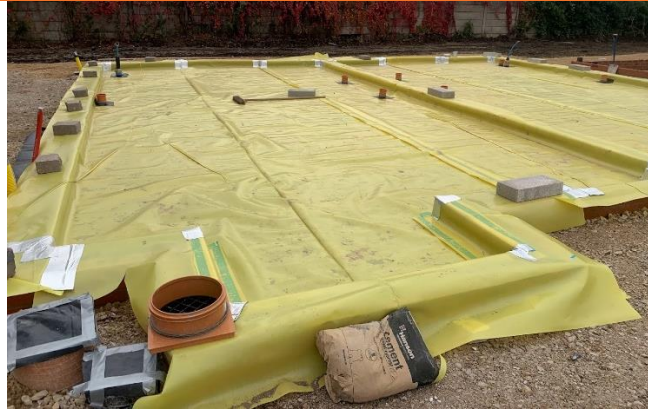
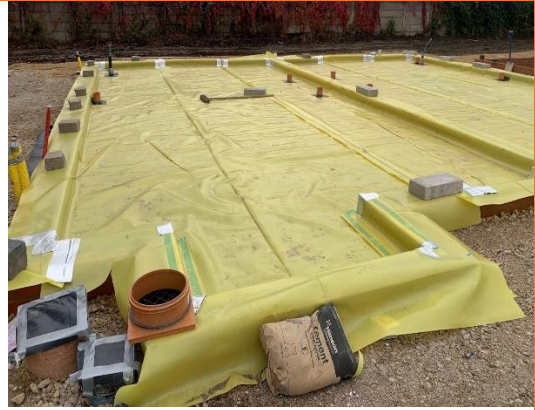
**Plot – 198**

**General Condition of Membrane-Good Condition**

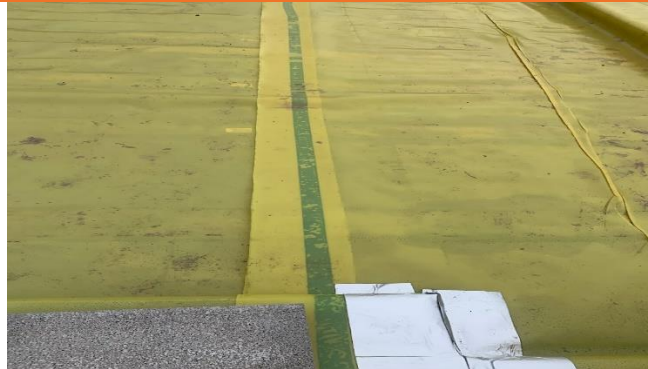
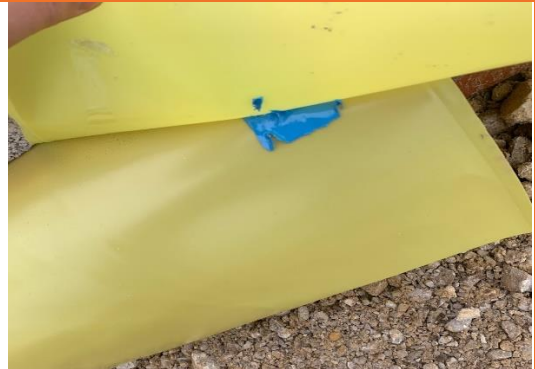
**Verification of Joints and Seals-Good Condition**

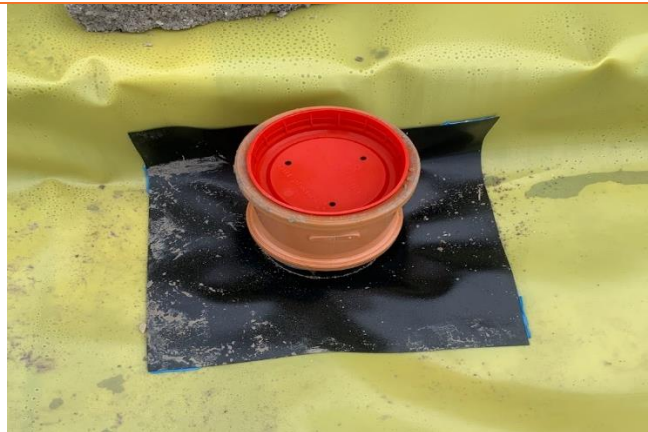
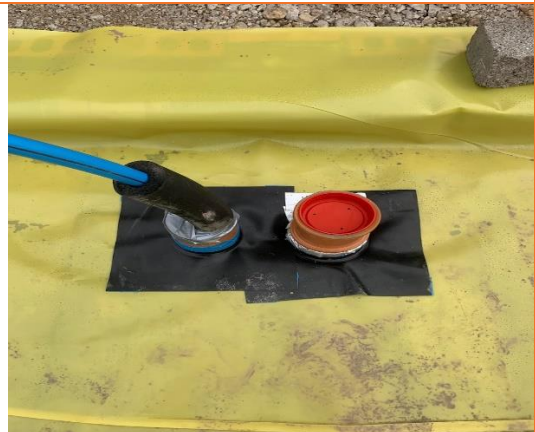
**Verification of Service Penetrations-Good Condition**

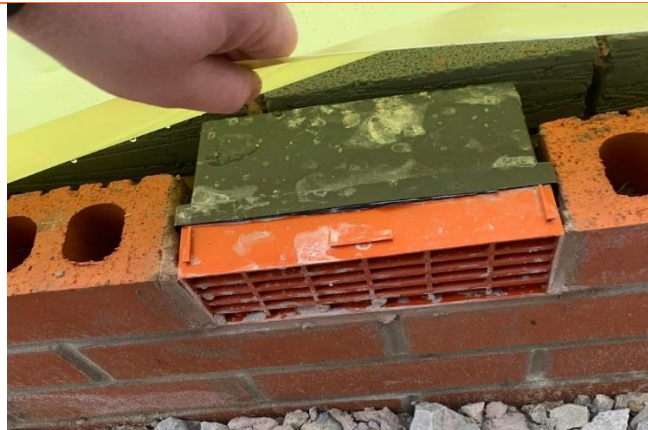
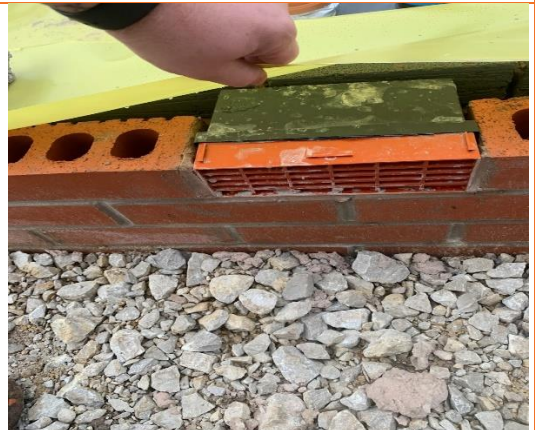
**Verification of Ventilation-Good Condition**

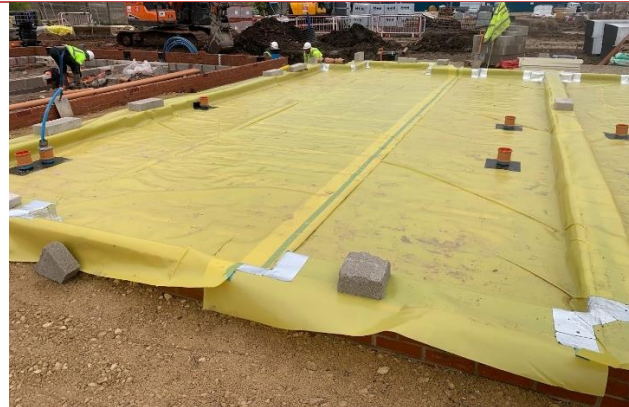
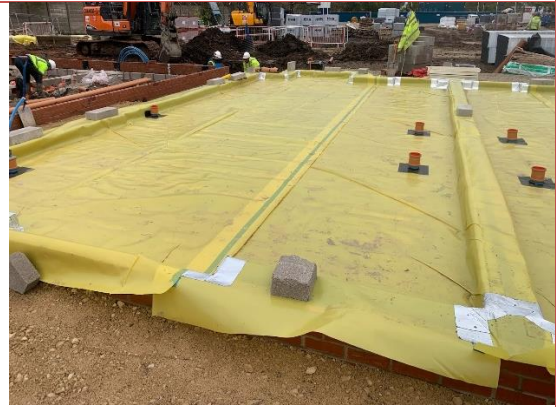
**Plot - 199**

**General Condition of Membrane-Good Condition**

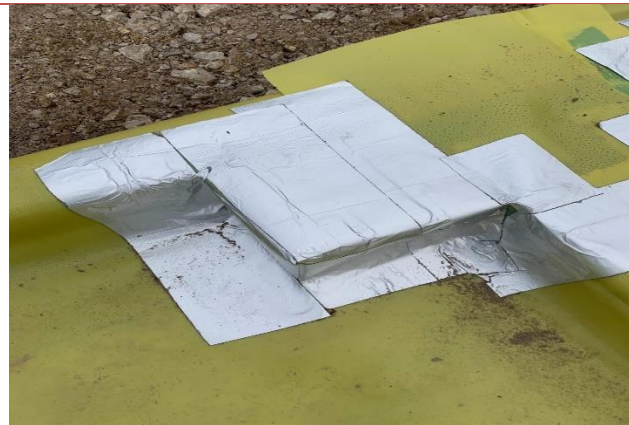
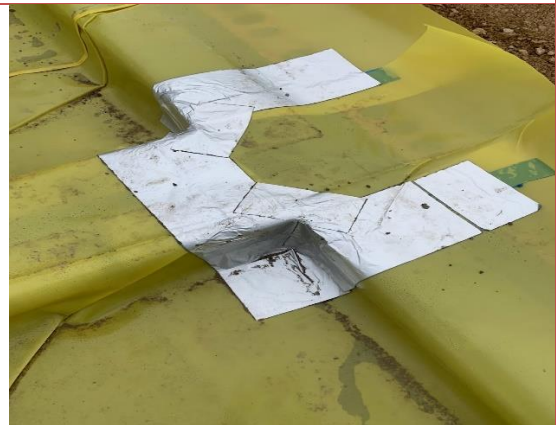
**Verification of Joints and Seals-Good Condition**

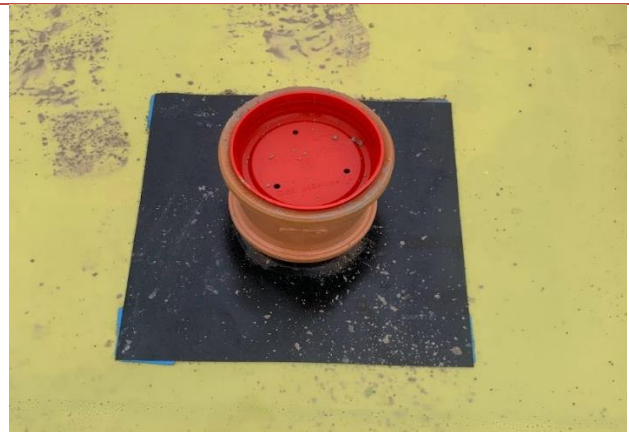
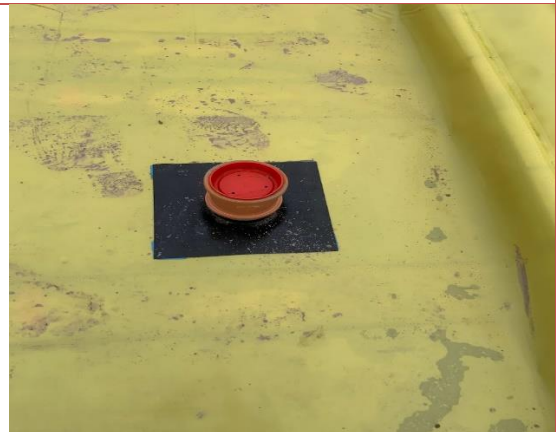
**Verification of Service Penetrations-Good Condition**

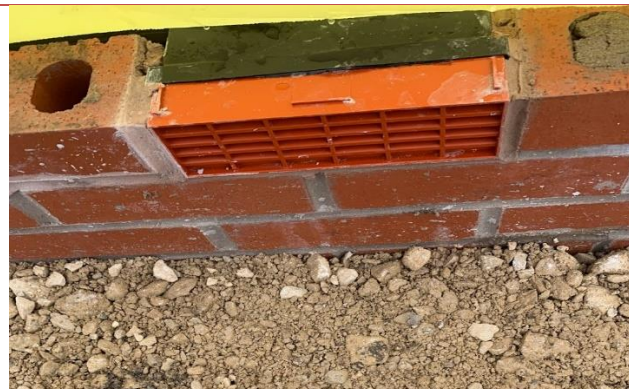
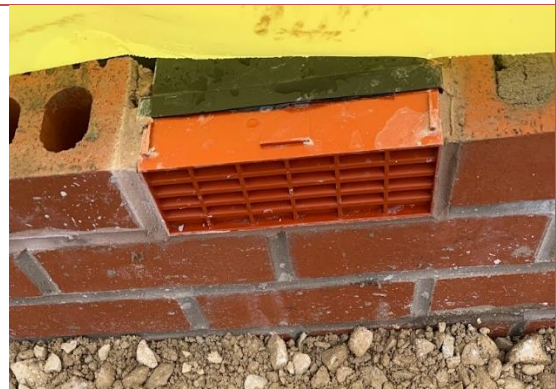
**Verification of Ventilation-Good Condition**
