# Certificate of Re-Occupation

Certificate No.: **RC-20241219083055**

Project No.: **P-57053**

Site: **Kellen Homes Housing Site**

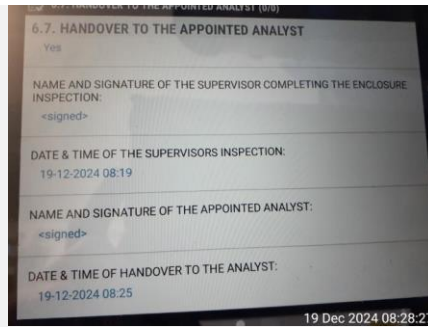
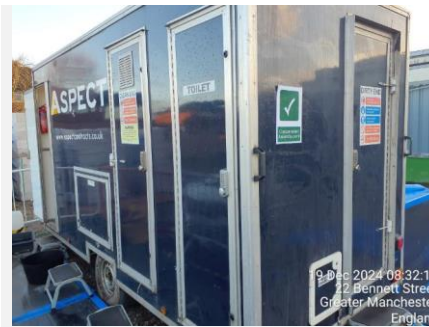
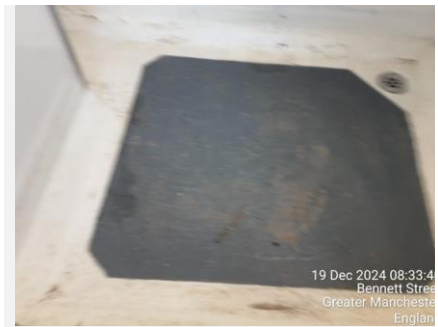
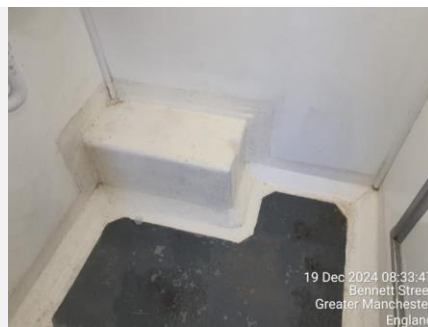
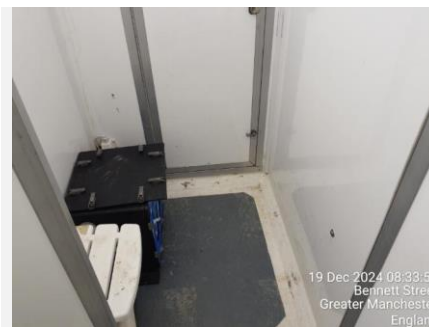
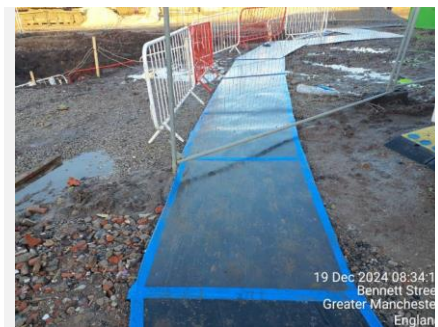
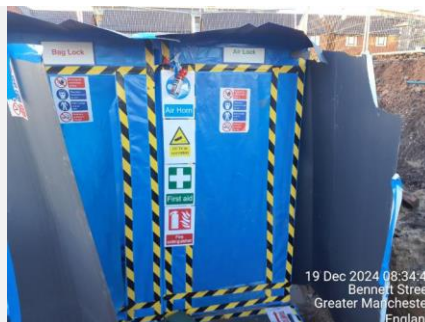
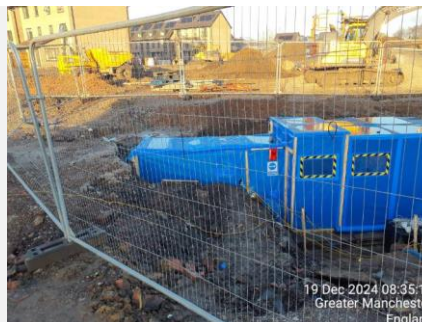
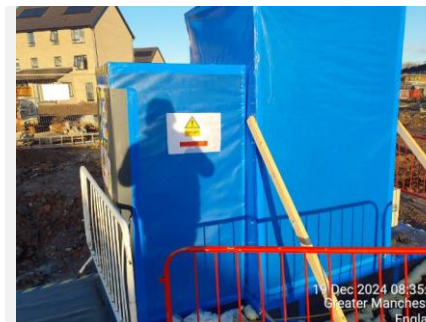
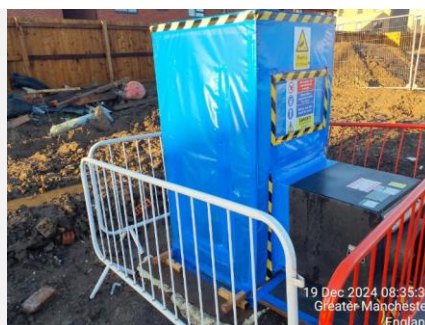
| Comments: | Work area presented to a satisfactory standard by supervisor Brian Hart. | | |

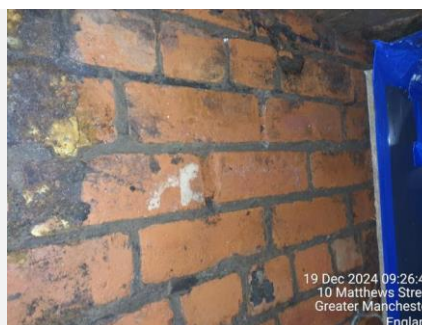
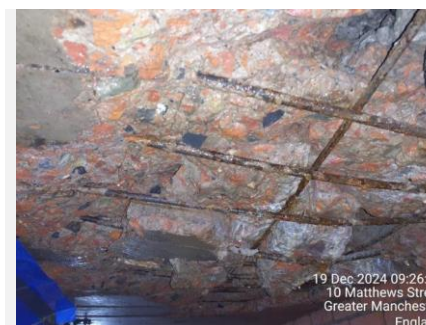
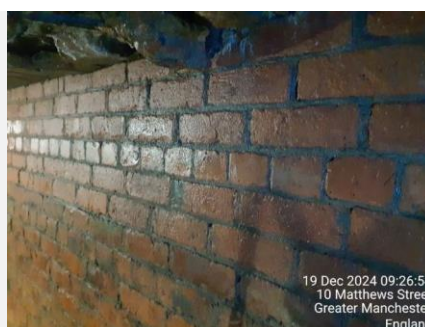
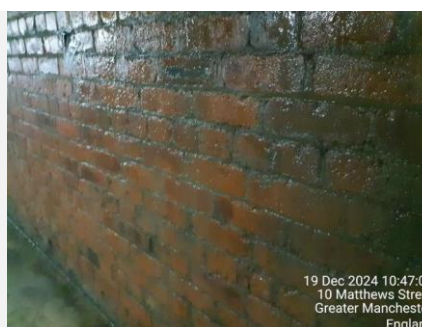
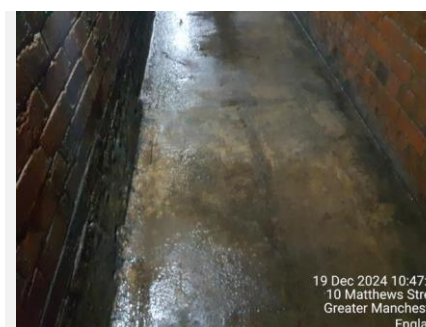
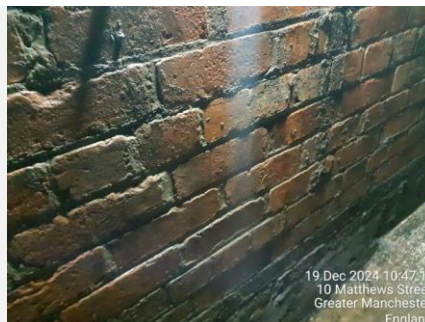
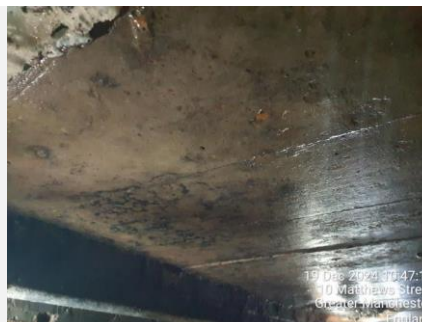
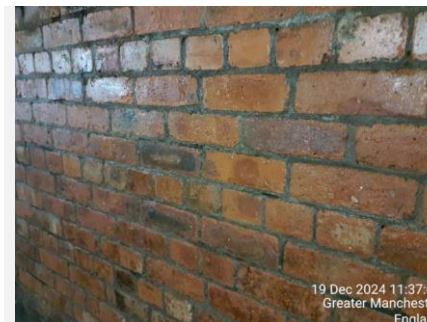
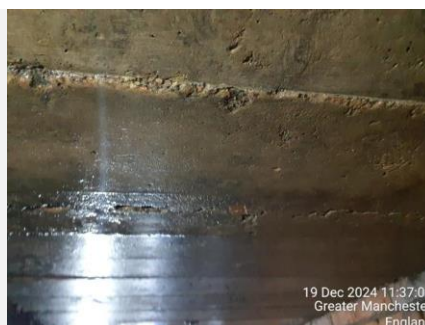
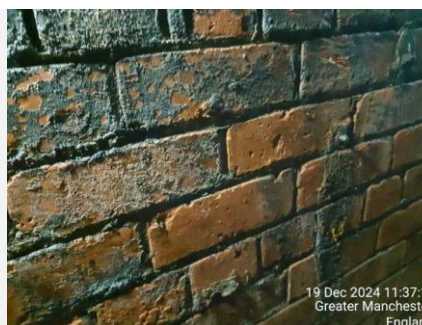
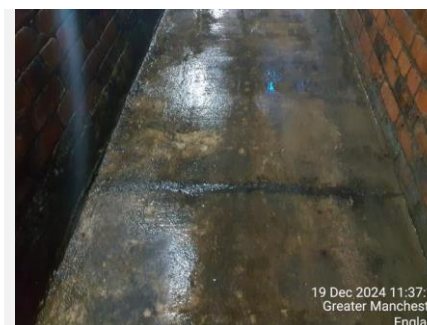
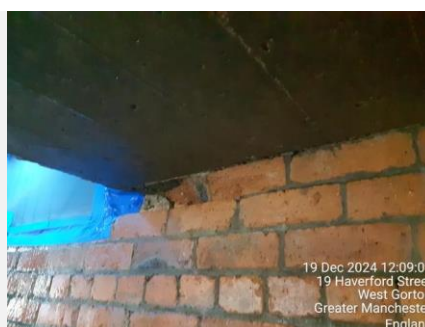
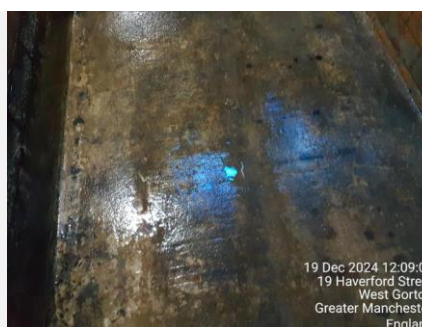
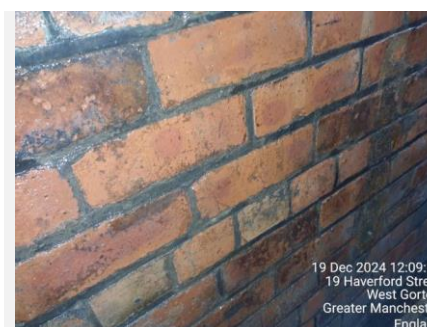
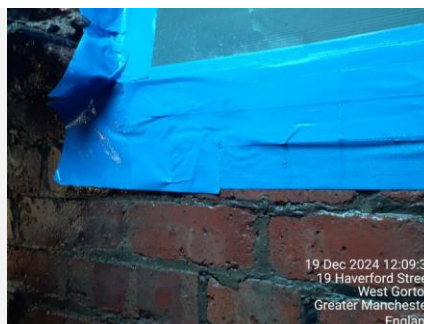
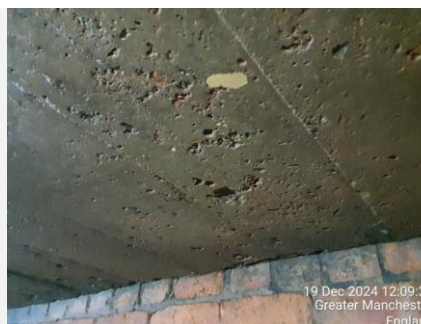
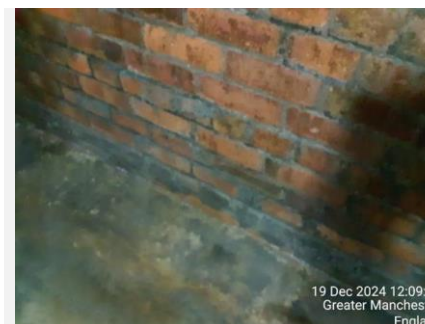
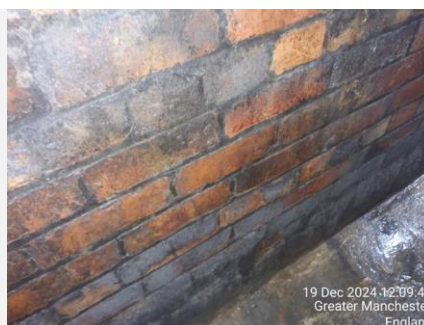
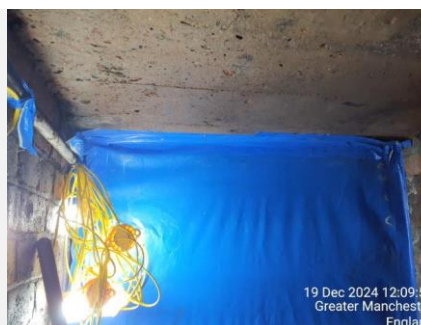
The visual inspection carried out as part of the four stage clearance was passed after some minor amounts of residual dust were cleaned (<10 minutes) whilst present which ultimately led to achieving a satisfactory standard of cleanliness.

All Pipework and brackets cut out and removed from Enclosure.  
All walls, floors and ceiling wire brushed and cleaned as far as reasonably practicable.  
Surfaces very damp due to weather conditions and the Duct being below natural water level. This was dried out as far as reasonably practicable by LARC prior to 4 Stage Clearance.

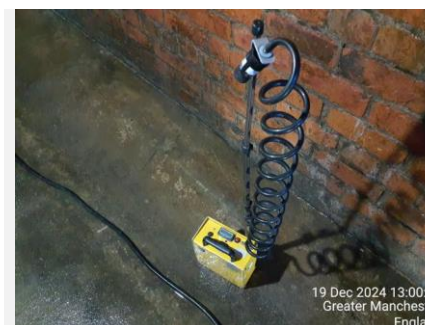
Stage 3 - Sample 001

| Sample no. | Pump no. | Cowl no. | Sample / Test Type | Location / Description | Start time (mins) | Finish time (mins) | Sample time (T) | Initial flow (l/m) | Final flow (l/m) | Average flow (F) (l/m) | Volume (V) (V=T*F) | Fibres (N) | Fields (n) | Limit of quantification (f/m) | Calculated result (f/m) | Reported result (f/m) |
|---|---|---|---|---|---|---|---|---|---|---|---|---|---|---|---|---|
| 001 | SP09 | 09 | Clearance | Floor Duct | 12:46 | 13:27 | 41 | 12.2 | 12.2 | 12.2 | 500 | 6 | 200 | 0.010 | 0.003 | < 0.01 |

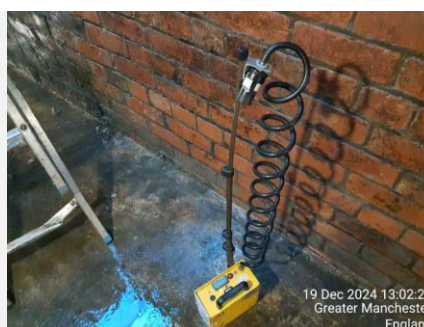
Stage 3 - Sample 002

| Sample no. | Pump no. | Cowl no. | Sample / Test Type | Location / Description | Start time (mins) | Finish time (mins) | Sample time (T) | Initial flow (l/m) | Final flow (l/m) | Average flow (F) (l/m) | Volume (V) (V=T*F) | Fibres (N) | Fields (n) | Limit of quantification (f/m) | Calculated result (f/m) | Reported result (f/m) |
|---|---|---|---|---|---|---|---|---|---|---|---|---|---|---|---|---|
| 002 | SP10 | 10 | Clearance | Floor Duct | 12:47 | 13:27 | 40 | 12.2 | 12.2 | 12.2 | 488 | 3 | 200 | 0.010 | 0.002 | < 0.01 |

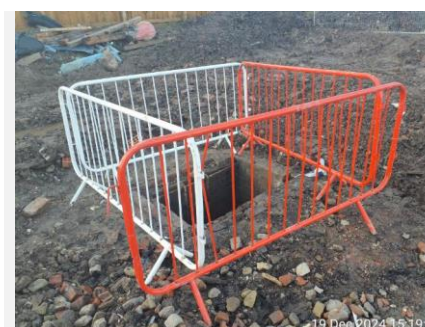
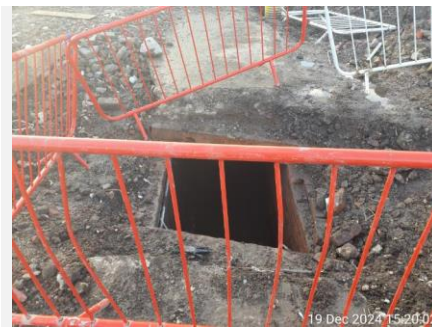
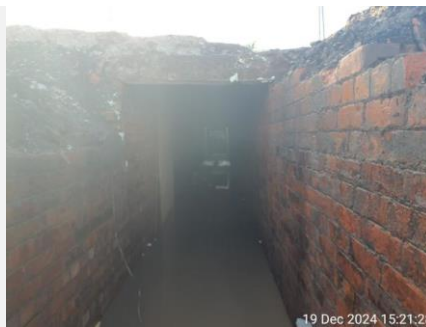
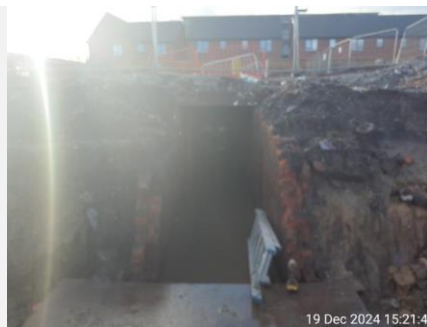
| Comments: | General Debris/Mud to surrounding areas due to the nature of the site. | | |
