## **Verification Completion Report for Ground Gas Protection Systems**

| Project Title | Bennett Street, Manchester |
| GES Report Number | 1838 |
| Plot Numbers | Plots 115-116 |

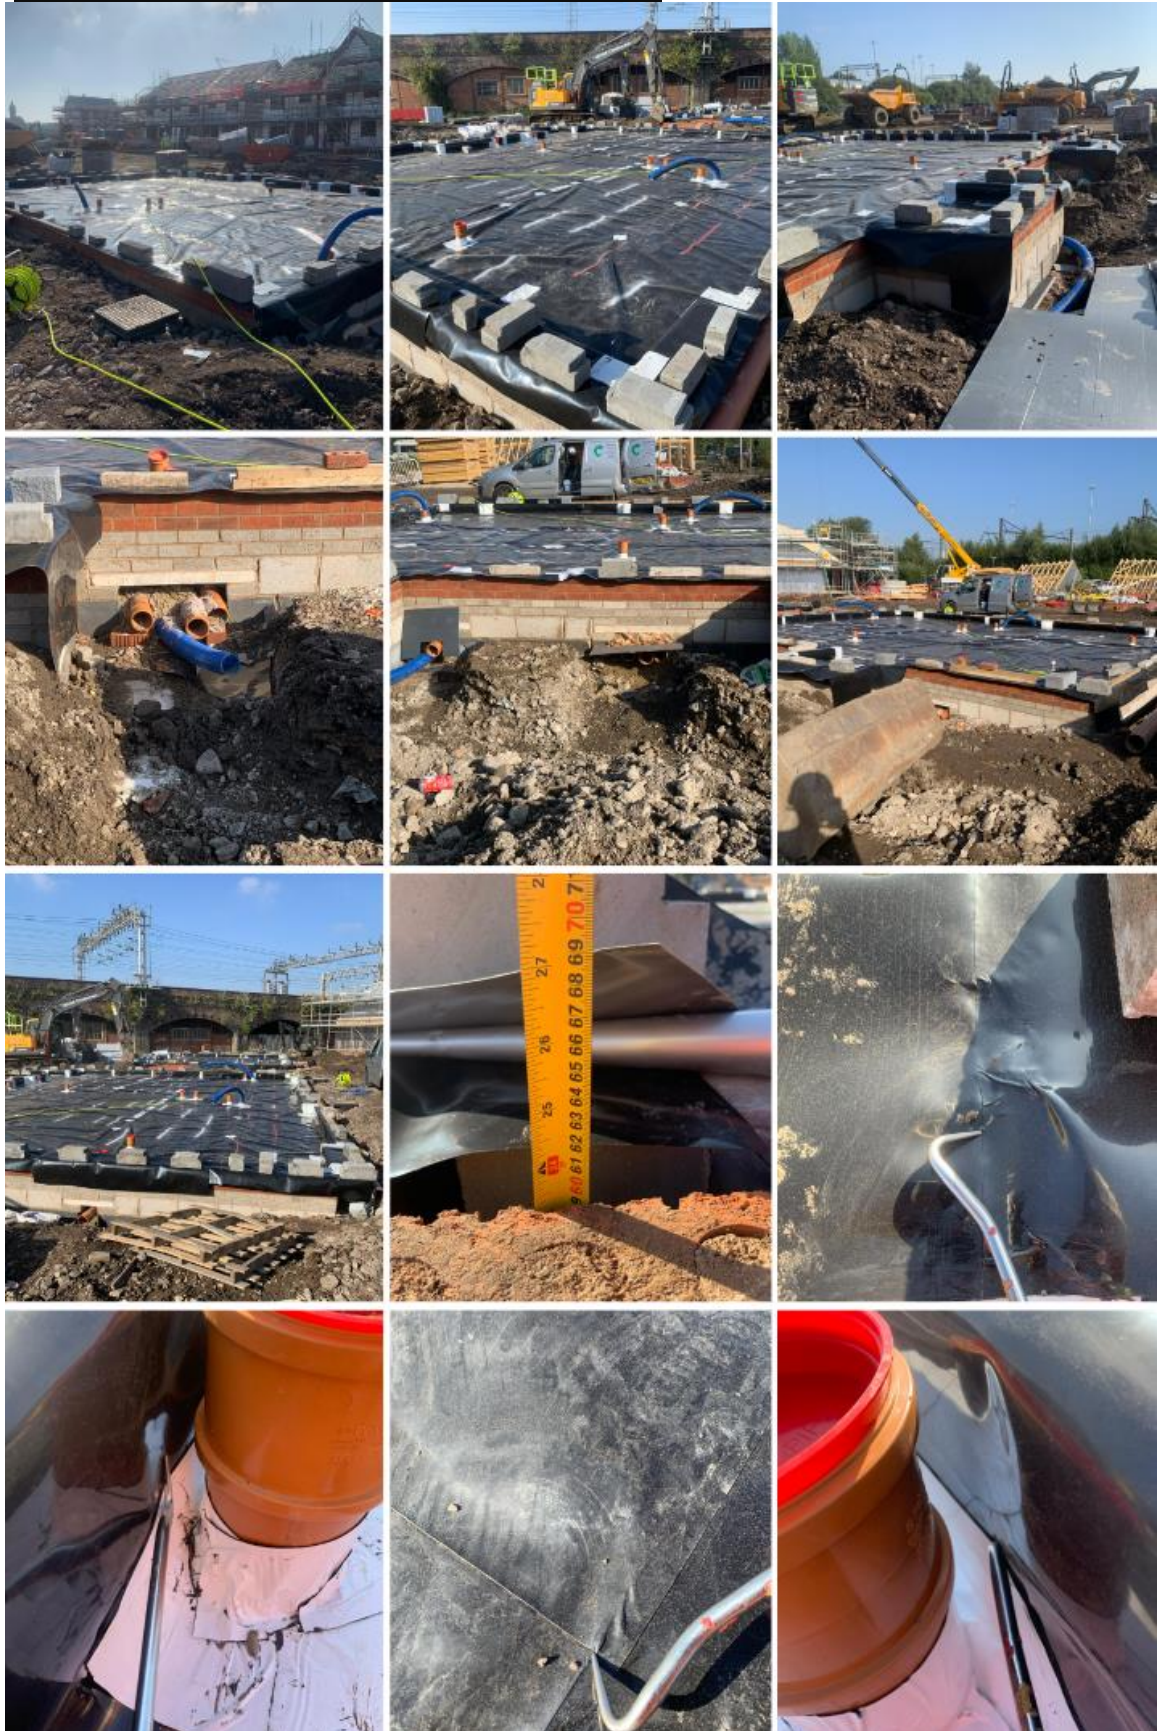
Juta Titan Flex Membrane had been installed on the site and white Detailing Strip was used to detail corners, doorways and pipes.

The corner details were neat and well sealed. I measured and pick tested all corners.

The pipe penetrations / service entries were sealed in situ with white Detailing Strip. All of which were neat and well sealed. I pick tested all pipe penetrations.

The gas membrane joins were fixed together with a combination of hand and machine welds

A few minor faults were found, these were required and passed inspection.

Overall, the membranes have been installed to a very high standard.
