## GAS MEMBRANE VALIDATION – BENNETT STREET

| Project Name: Bennett Street |
| Project Number: 15-974 |
| Plots: 18 & 19 |

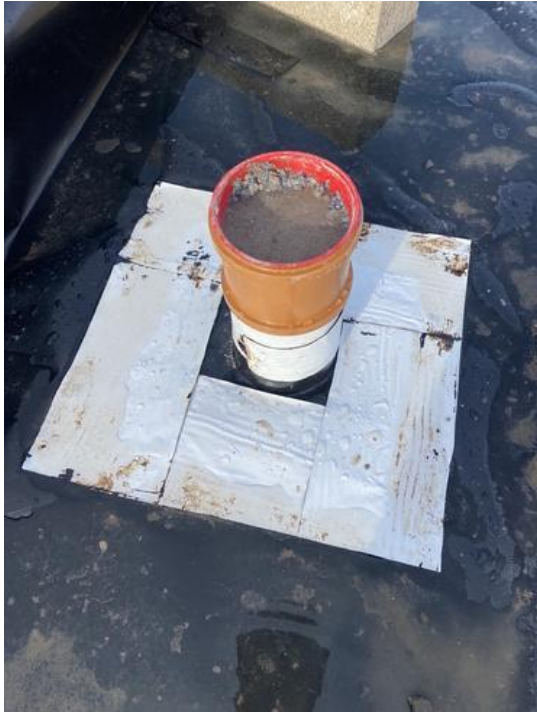
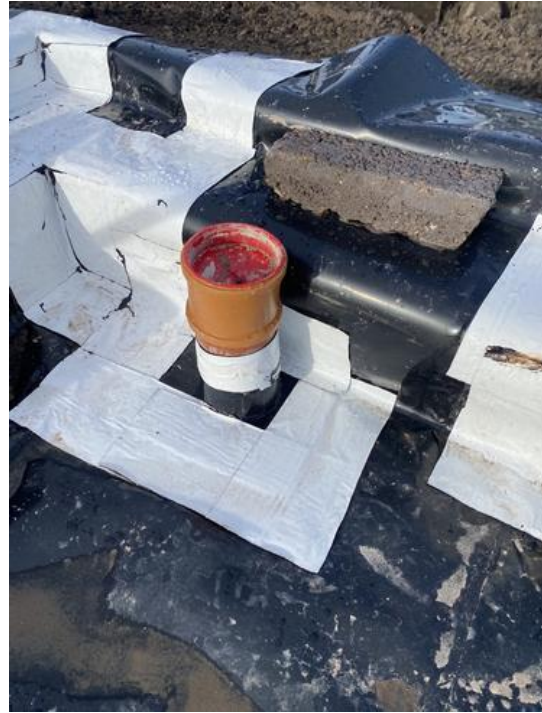
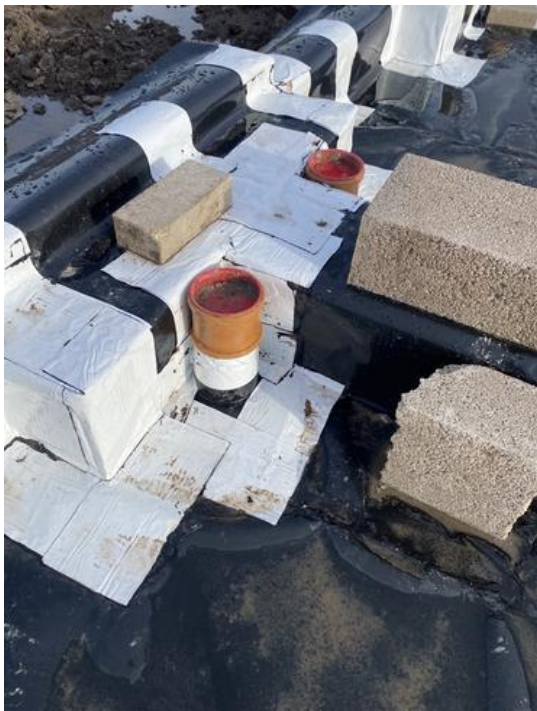
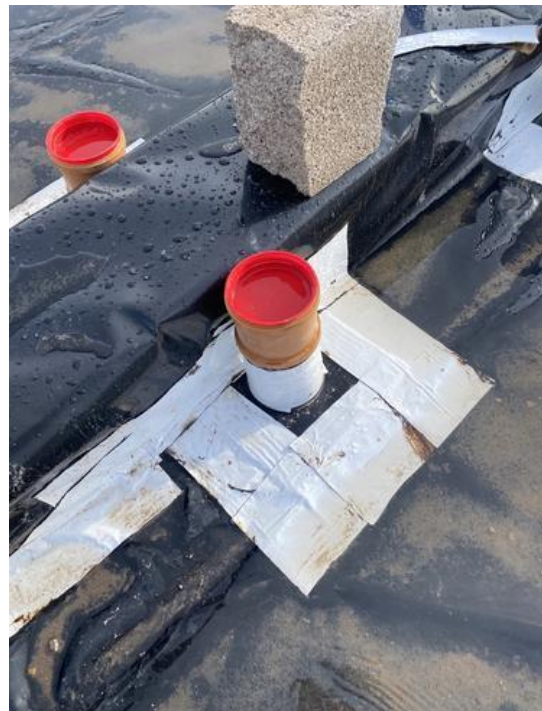
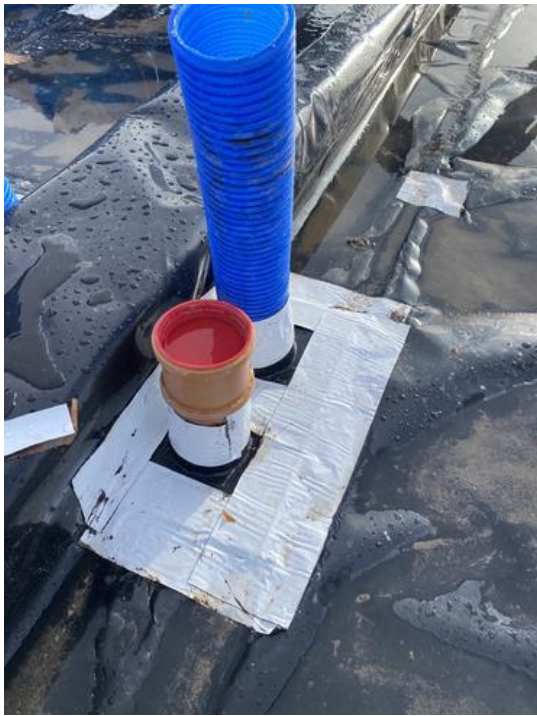
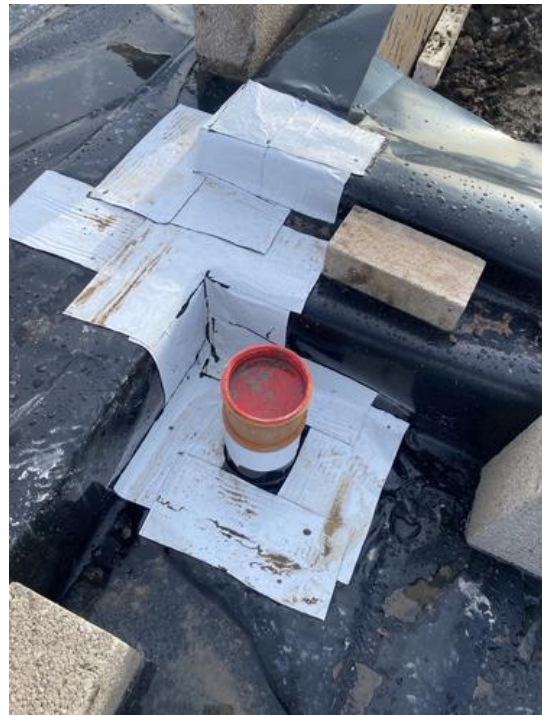
Laps, welds, and joints seals: Joints lapped and sealed in accordance with manufacturer's requirements/ specification? Minimum overlap insured? Sections taped twice? Are welds complete? Appropriate joining/double-sided tape used, Folds running in line with joints? (no joints cutting across folds)

Pass

Service entries seals: Top hats seal arrangements fixed around service entries? Use of Jubilee clips?

Yes

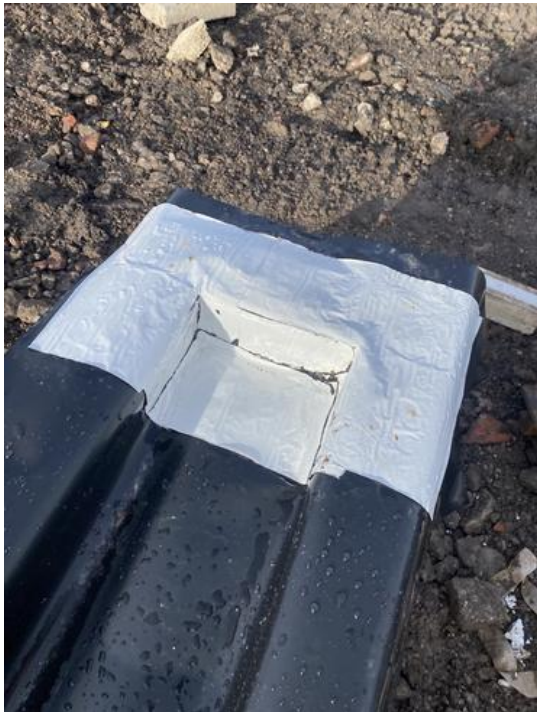
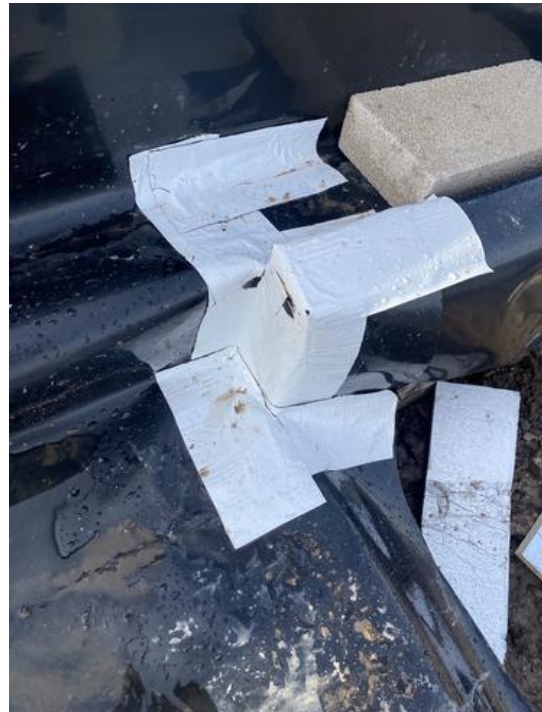
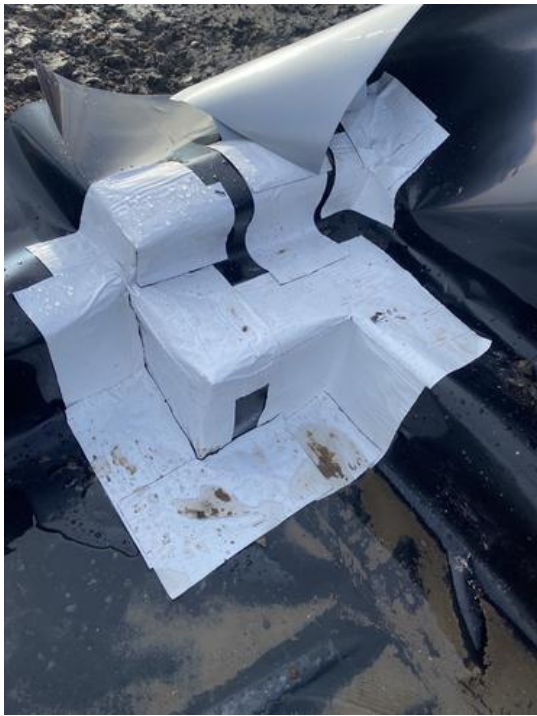
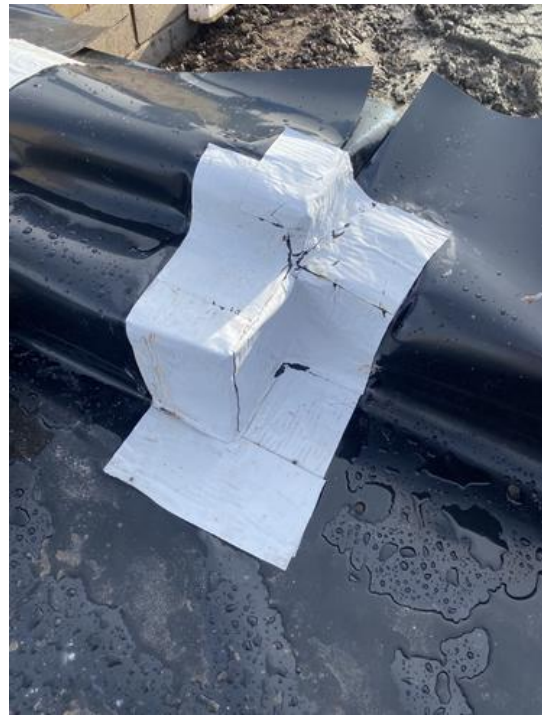
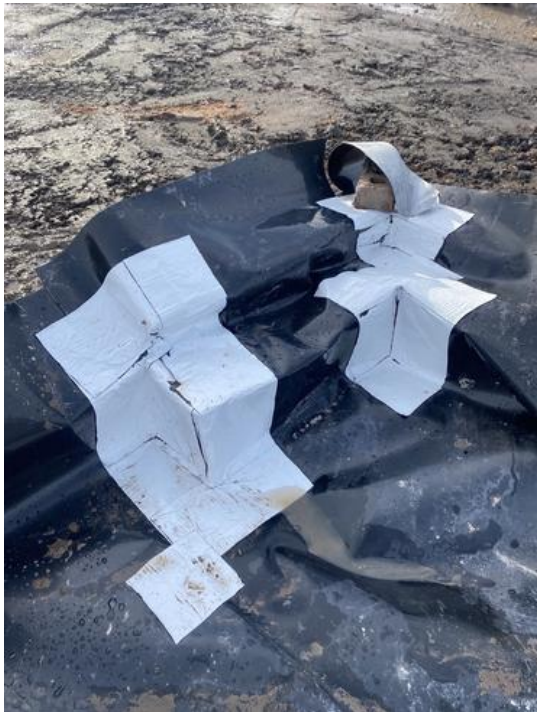
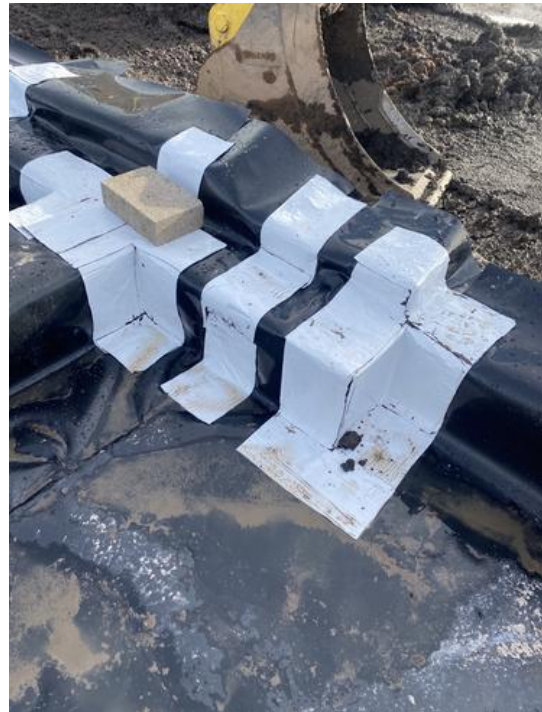
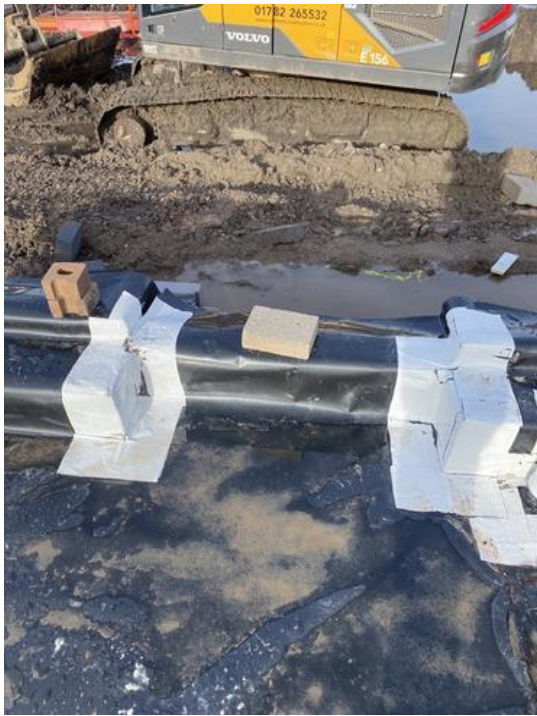
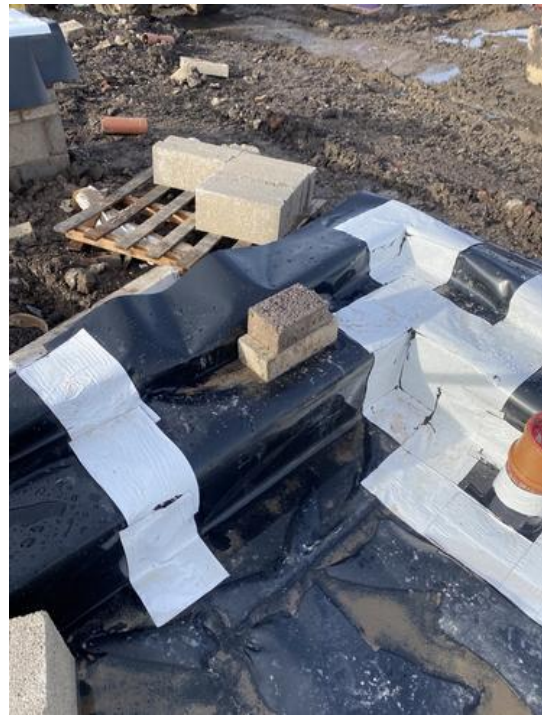
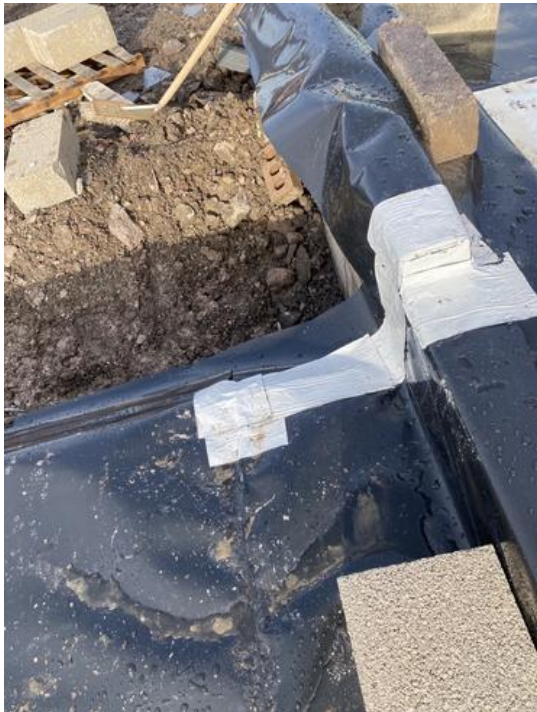
Corners / Internal joints: Check all corners are correctly formed or contractor has used preformed corners.

Pass

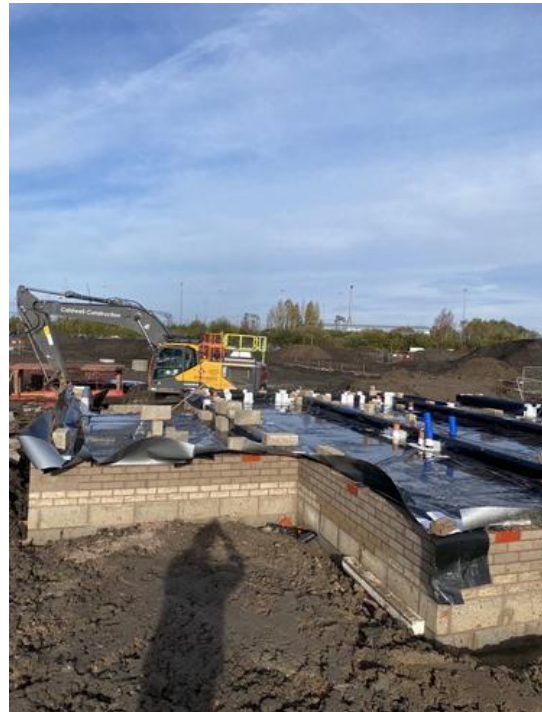
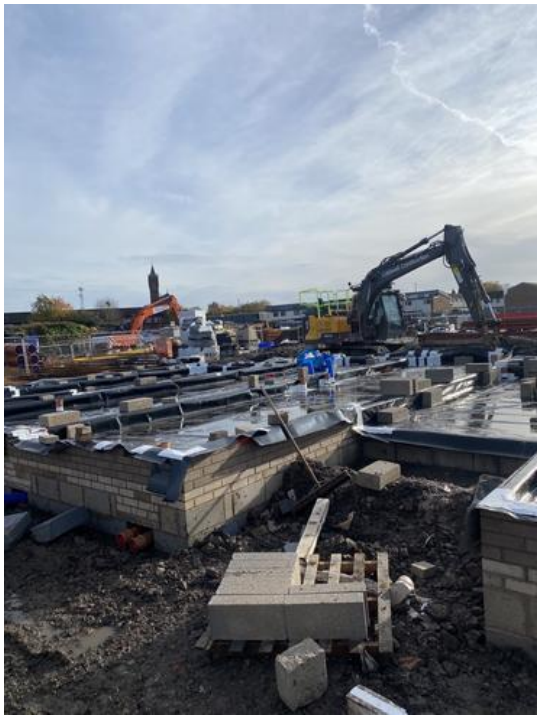
Extent of Coverage: Is the membrane covering the entire plot? Does membrane span over outside walls?

Yes

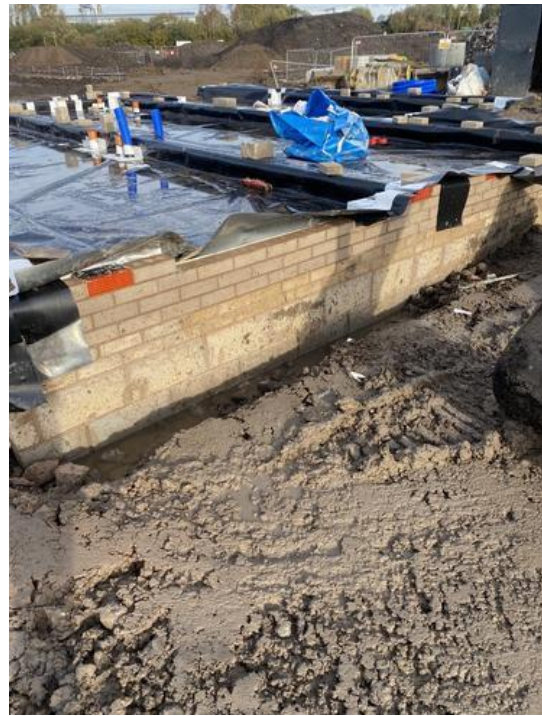
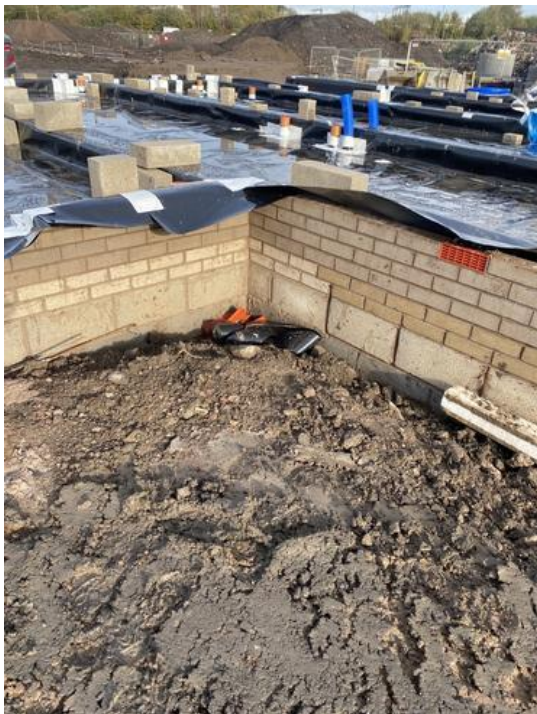
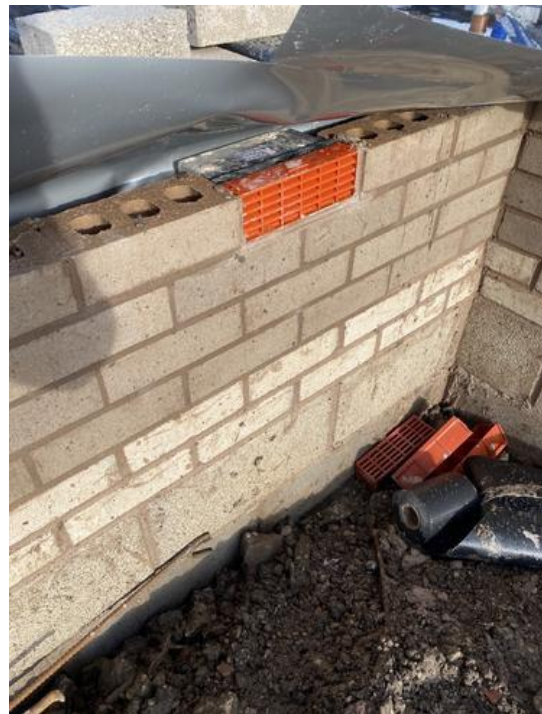
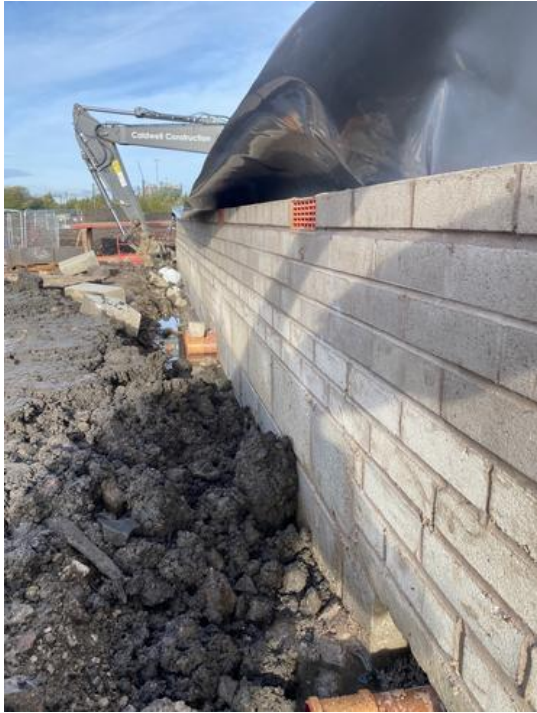
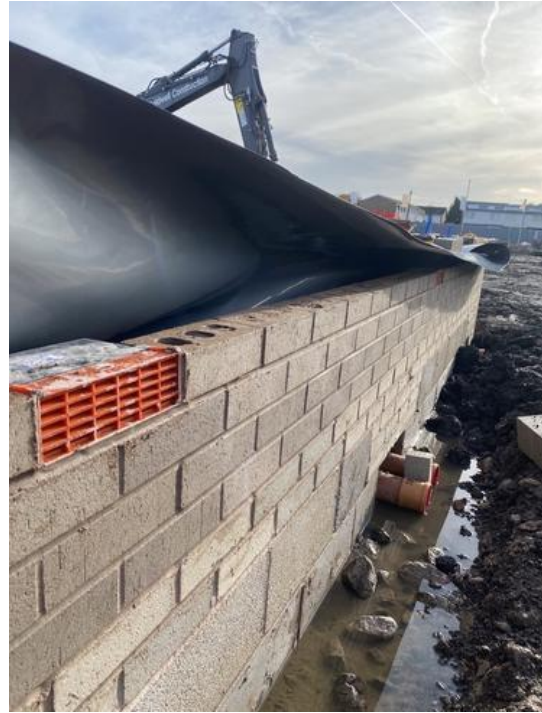
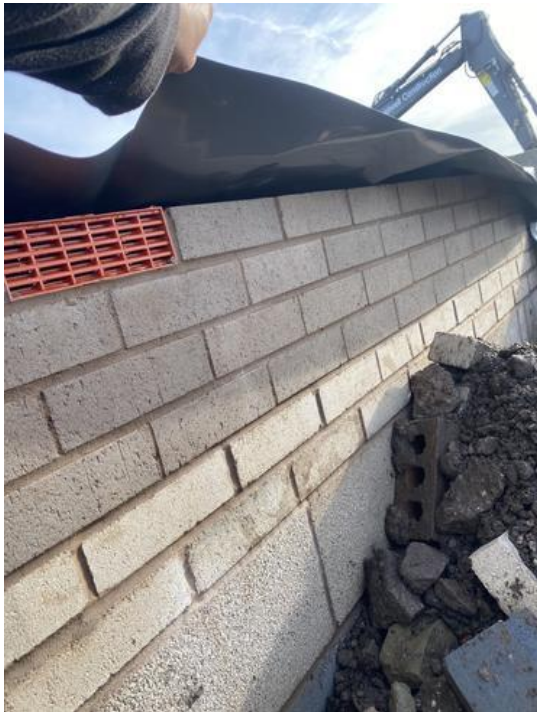
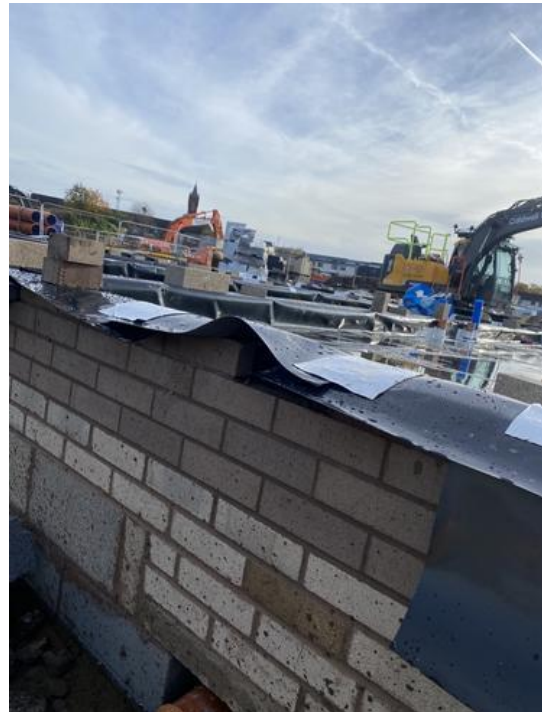
External Wall Air bricks: Numbers, size. positions as design drawing? (Minimum of 3 walls)

Pass

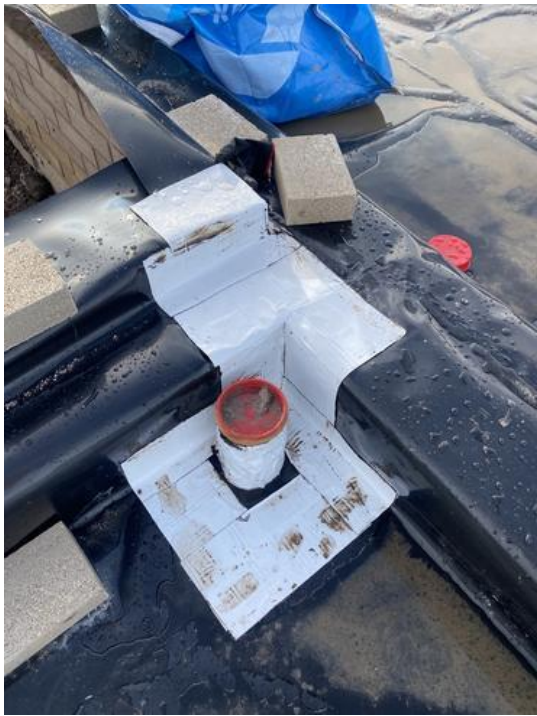
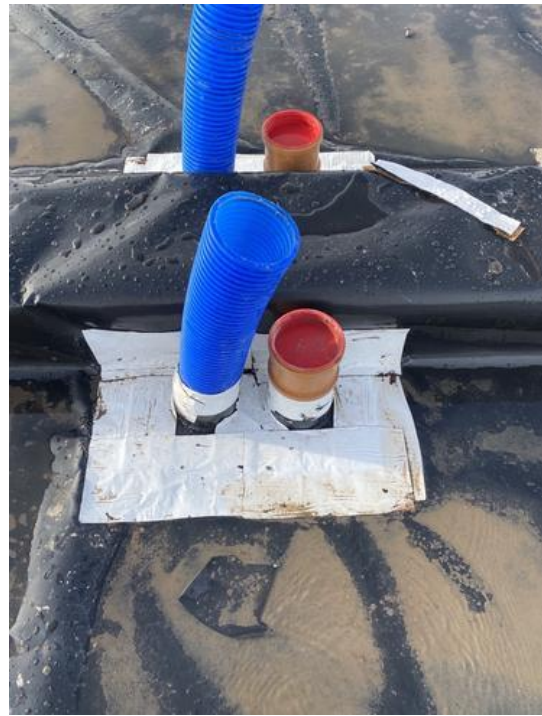
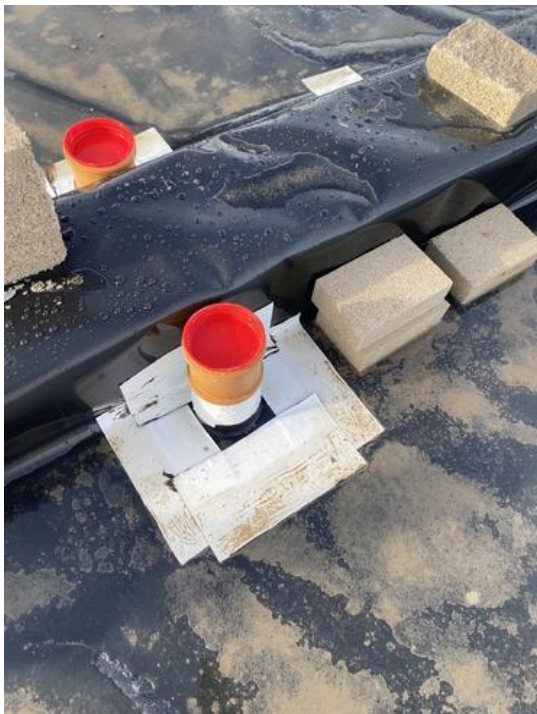
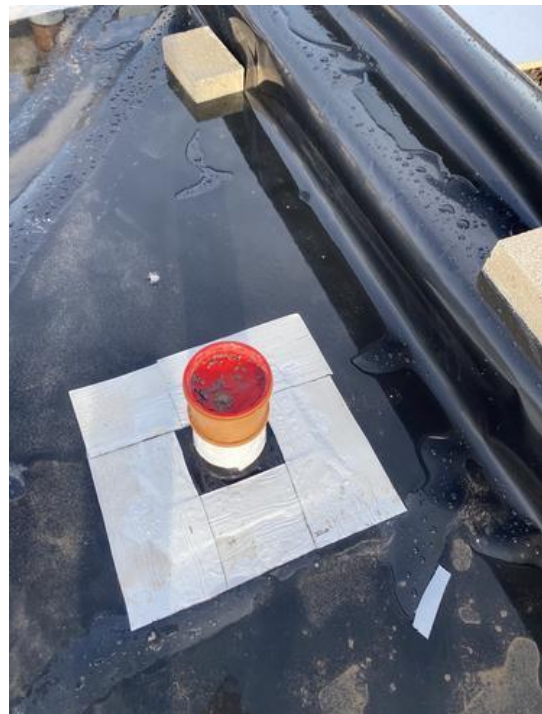
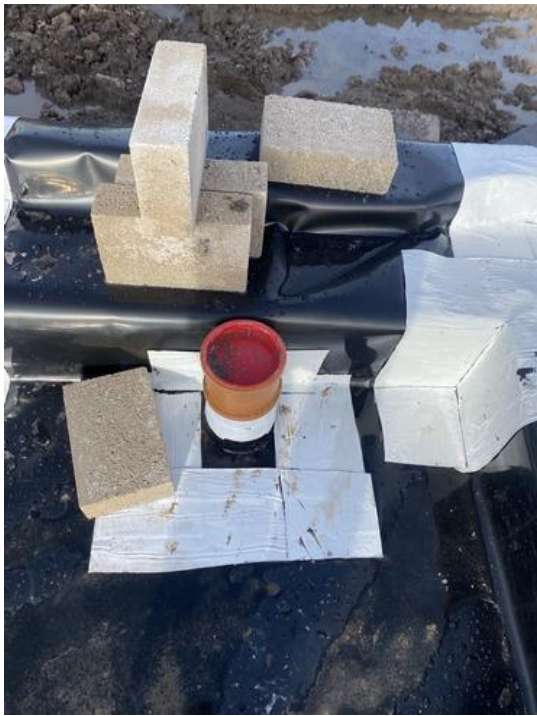
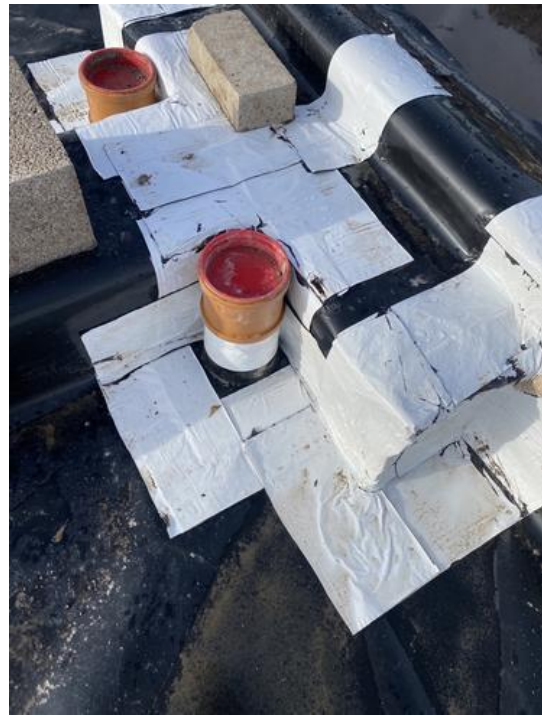
| Laps, welds, and joints seals: Joints lapped and sealed in accordance with manufacturer's requirements/ specification? Minimum overlap insured? Sections taped twice? Are welds complete? Appropriate joining/double-sided tape used, Folds running in line with joints? (no joints cutting across folds) | |
| | Pass |
| Service entries seals: Top hats seal arrangements fixed around service entries? Use of Jubilee clips? | |
| | Yes |

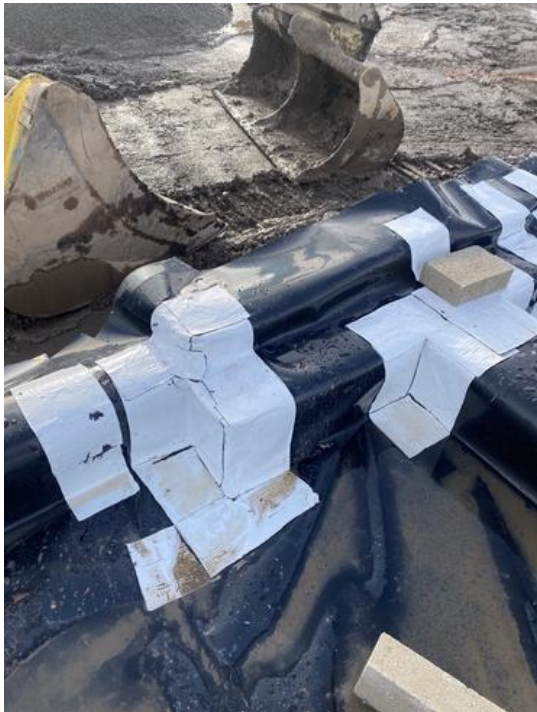
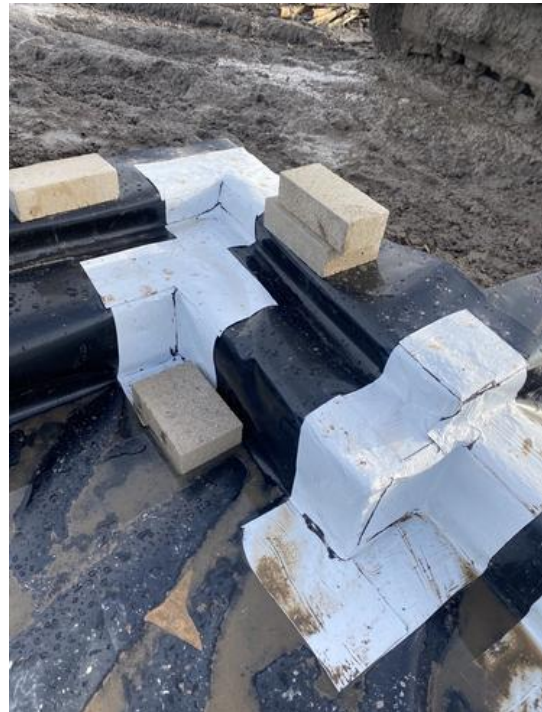
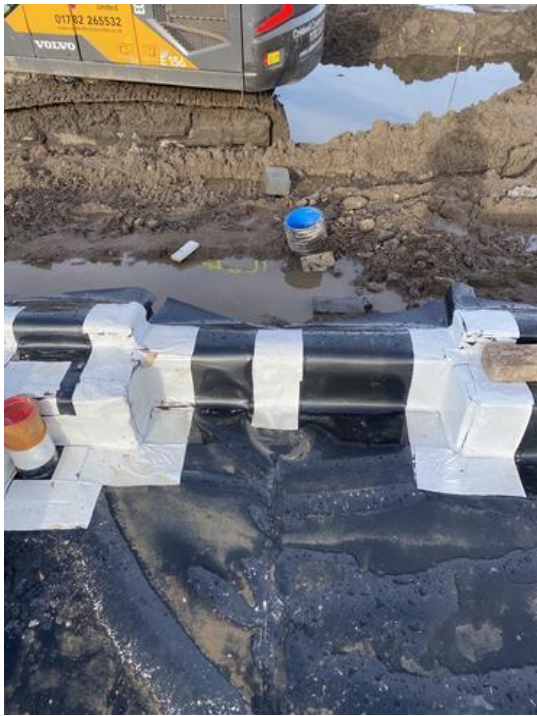
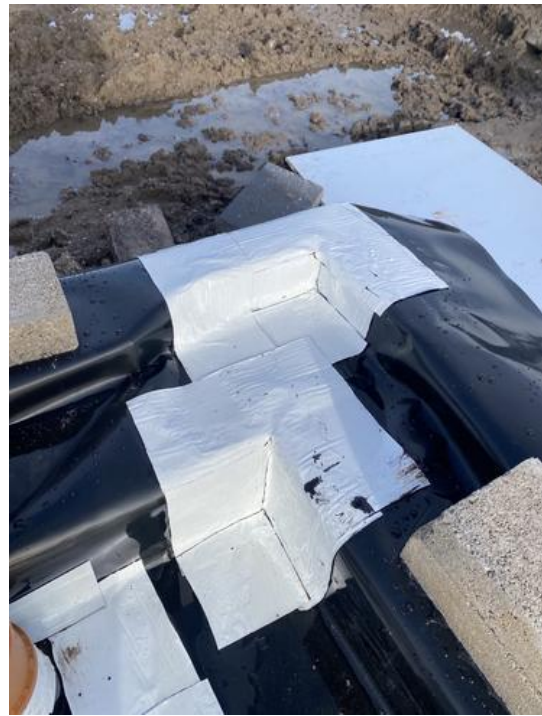
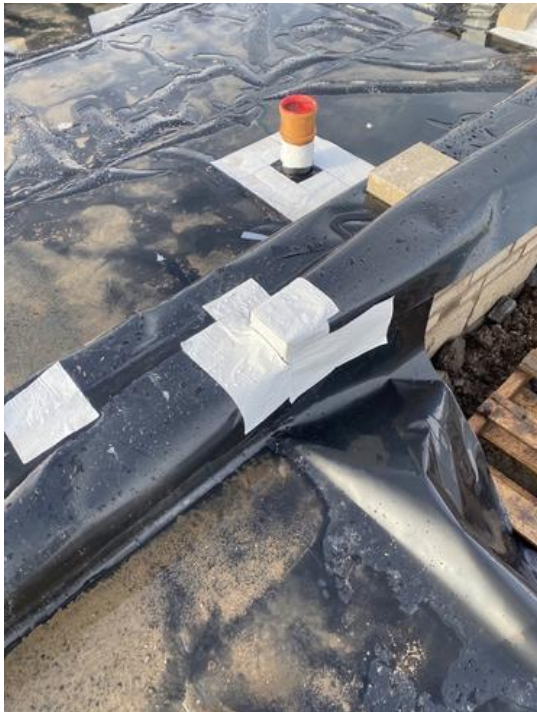
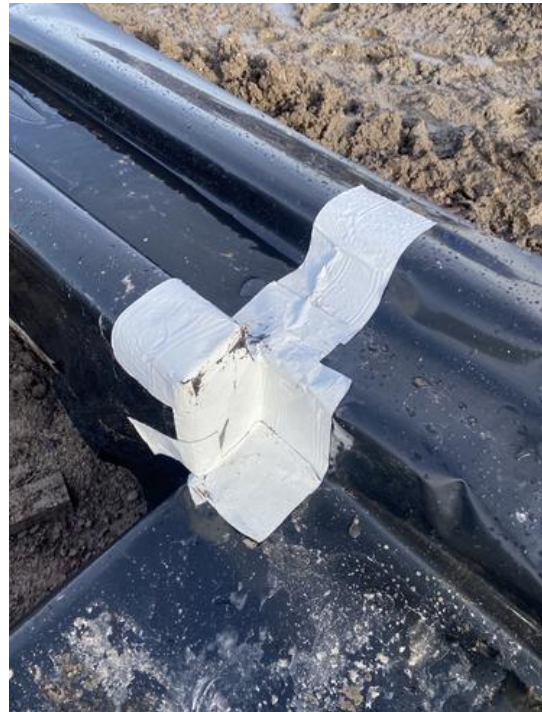
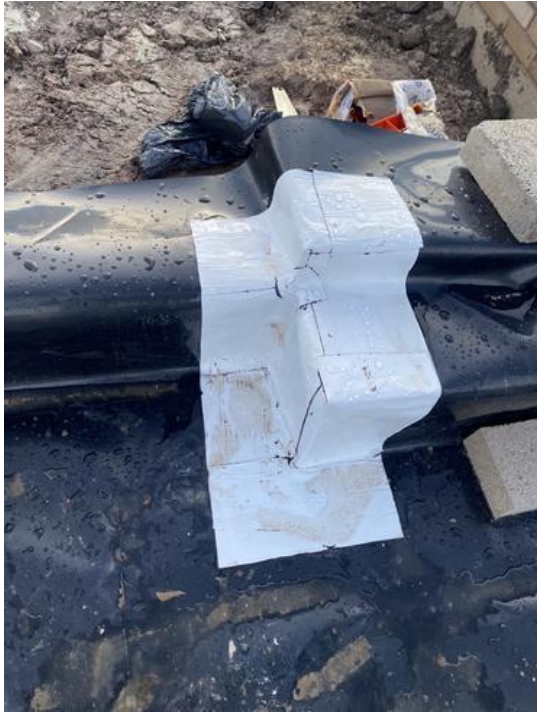
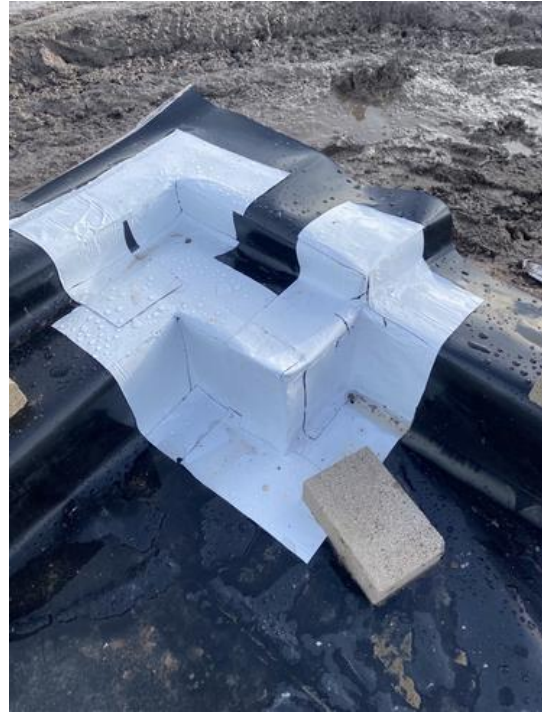
| Corners / Internal joints: Check all corners are correctly formed or contractor has used preformed corners. | |
| | Pass |

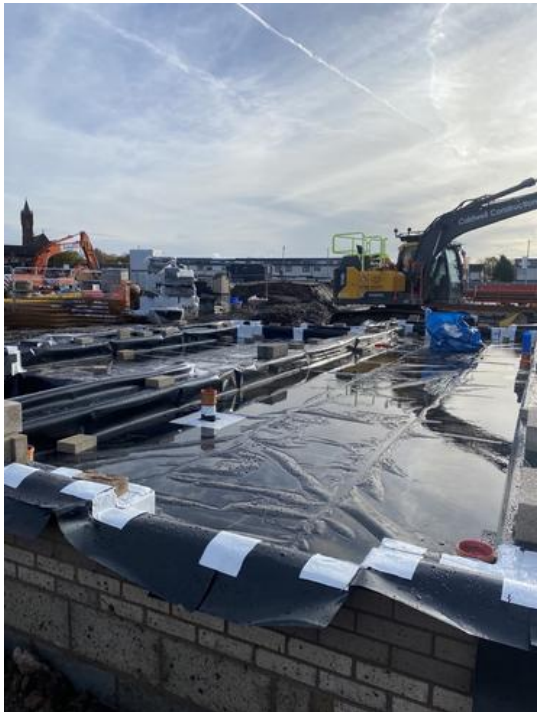
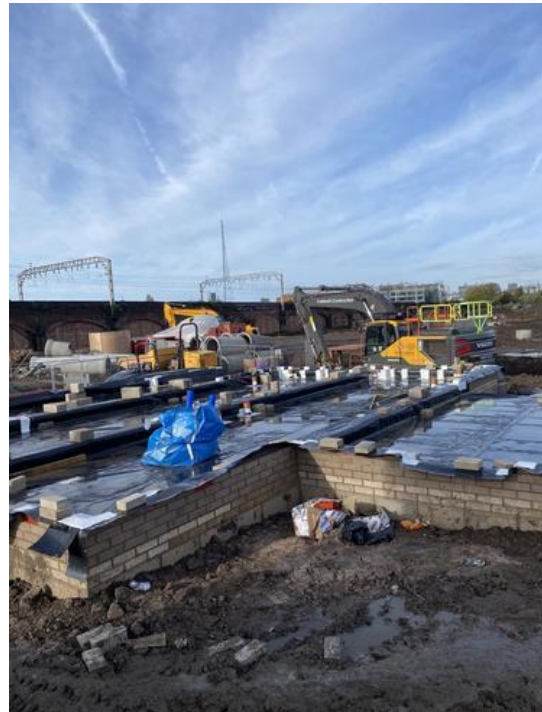
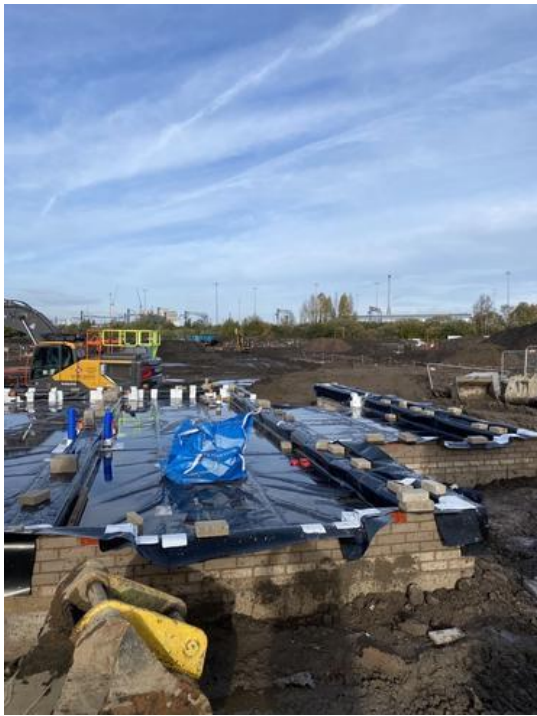
| Extent of Coverage: Is the membrane covering the entire plot? Does membrane span over outside walls? | |
| | Yes |

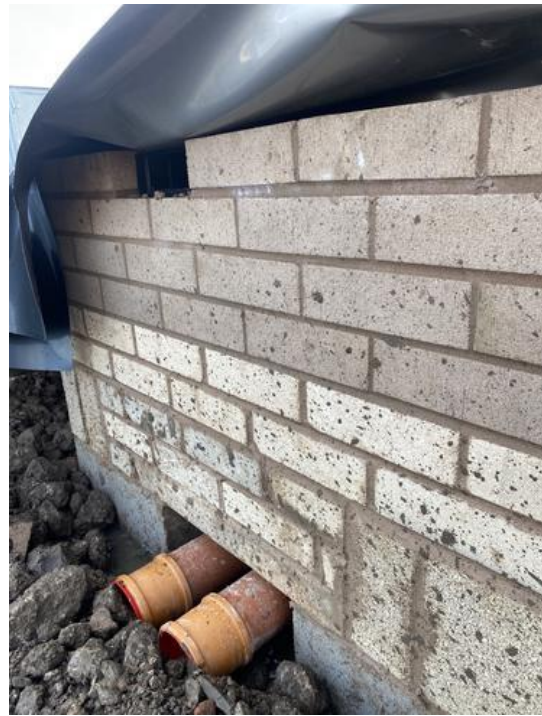
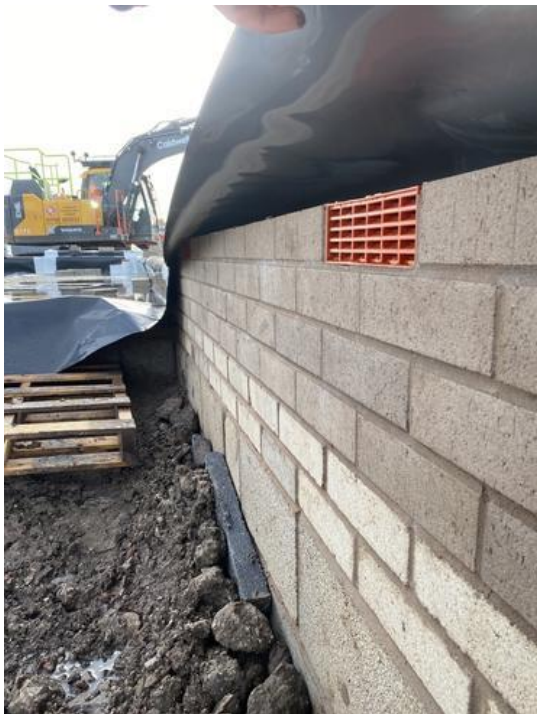
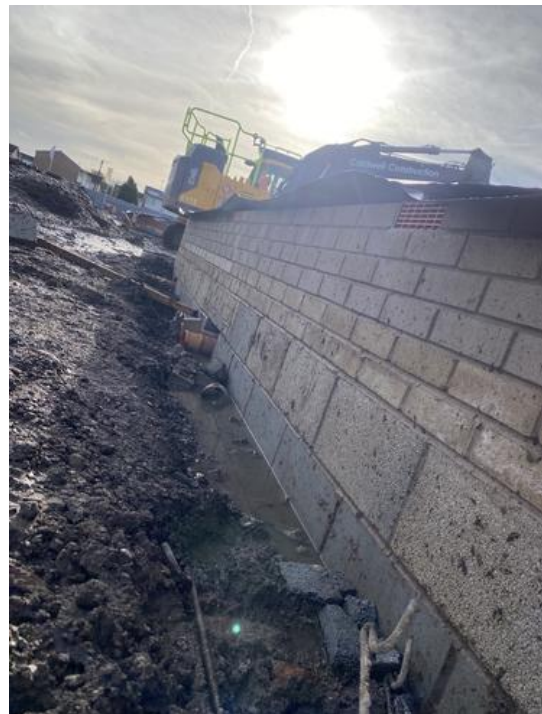
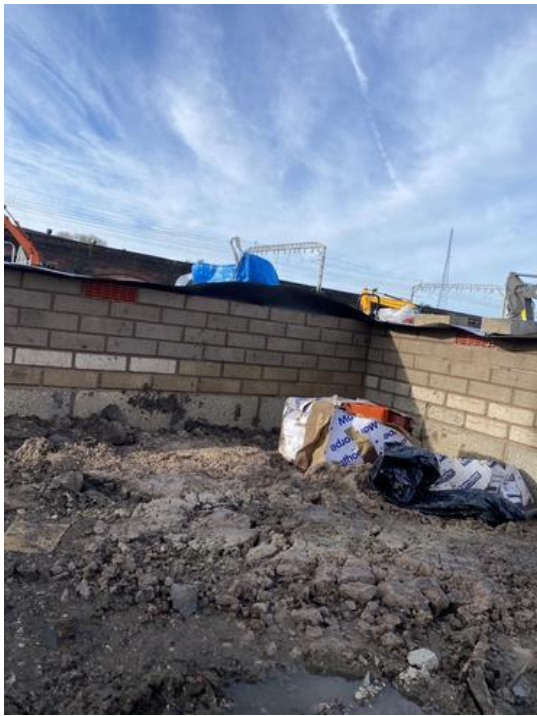
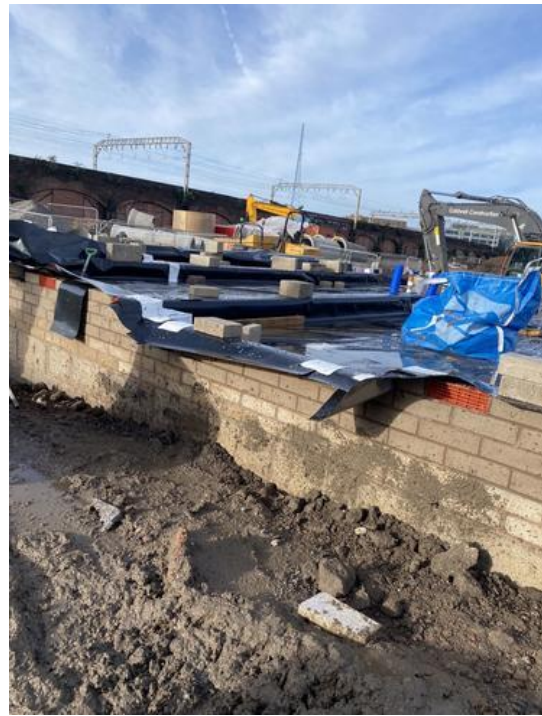
External Wall Air bricks: Numbers, size. positions as design drawing? (Minimum of 3 walls)

Pass
