Date: 30th October 2024  
Reference: 15-974 V17

## GAS MEMBRANE VALIDATION – BENNETT STREET

| <b>Project Number:</b> | 15-974 |
| <b>Plot:</b> | 99-100 and 91-92 garages |

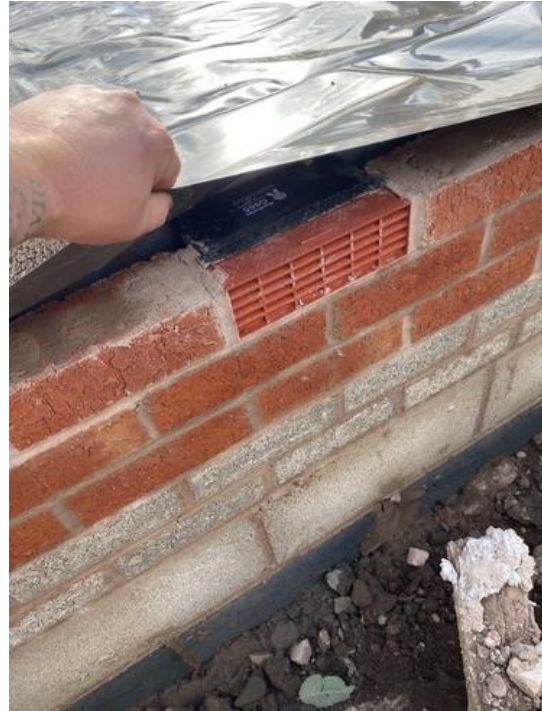
Photo 1

| Are telescopic vents present? | Yes |

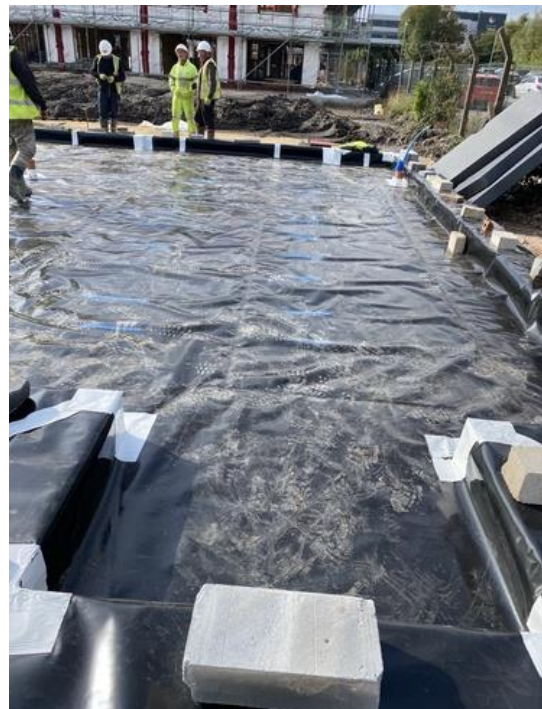
Photo 3

| <p>Gas Membrane Condition: Open punctures, tears, rips, stretching, Presence of debris, Repairs, Signs of weakness such as raised or sunken indentations, Protection plan in place to restrict access to lain gas membrane? IF FAIL DESCRIPTION IN ACTIONS AND PHOTOS REQUIRED</p> <div> </div> <div> <p>Photo 3</p> <p>Photo 4</p> <p>Photo 5</p> <p>Photo 6</p> </div> | Pass |

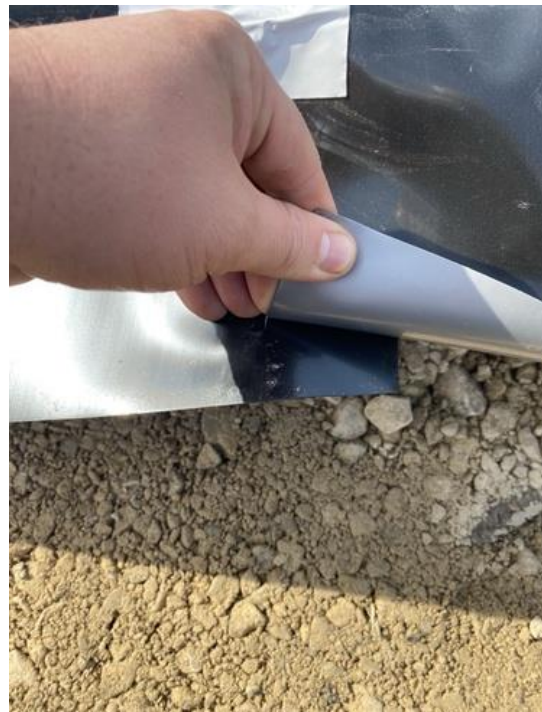
Photo 7

| Are welds complete? | Yes |

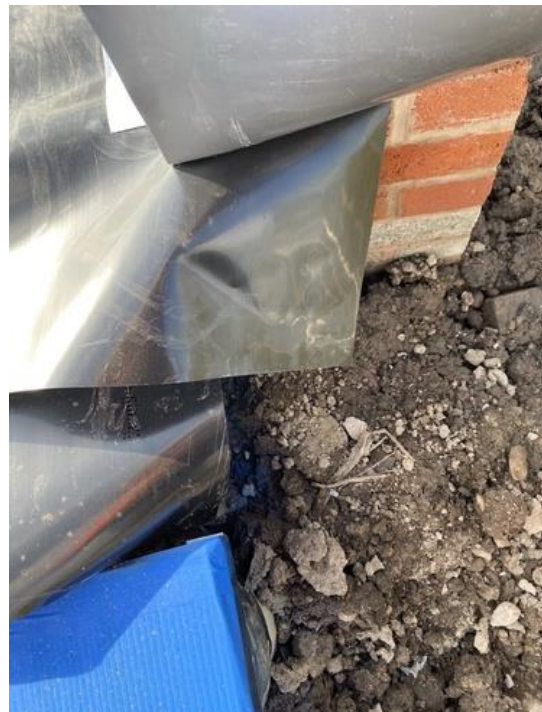
Photo 11

| Are Joints lapped and sealed in accordance with manufacturer's requirements/ specification? | Yes |

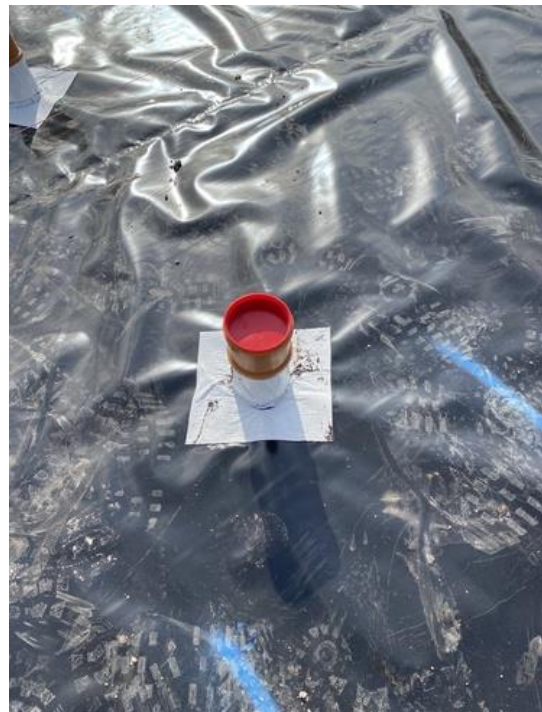
Photo 15

**Service entries seals: Top hats seal arrangements fixed around service entries? Use of Jubilee clips or Bitumastic Sealant**

Pass

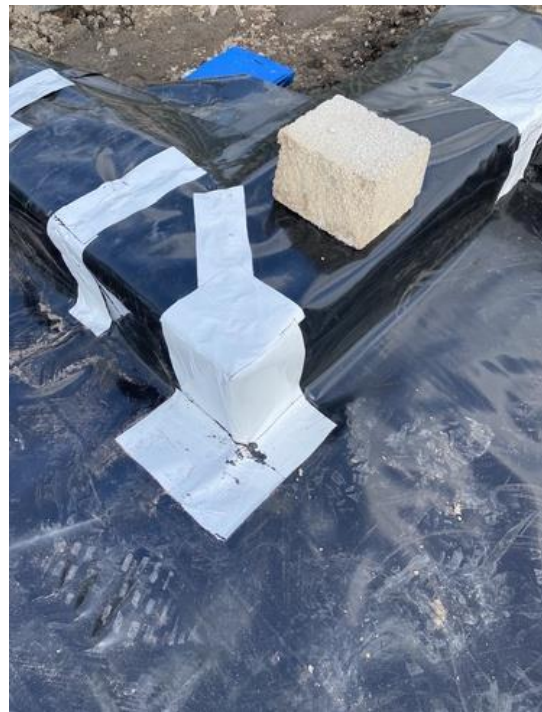
Photo 19

**Corners / Internal joints: Check all corners are correctly formed or contractor has used preformed corners.**

Pass

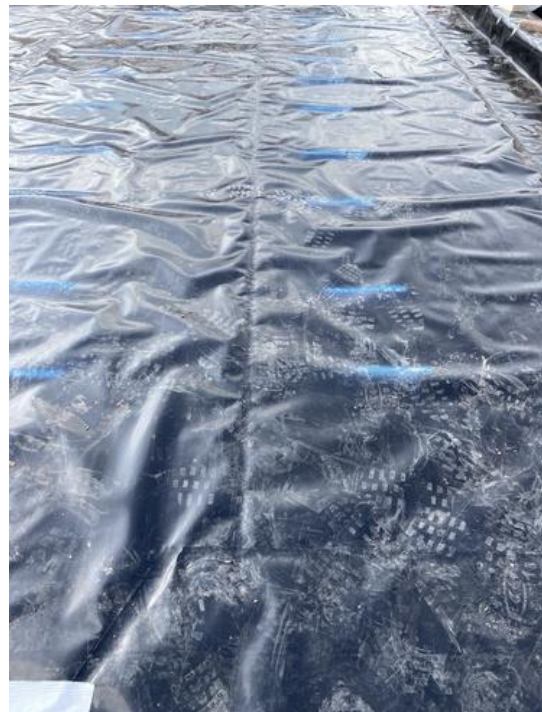
Photo 23

**Are folds running in line with joints? (no joints cutting across folds)**

Pass

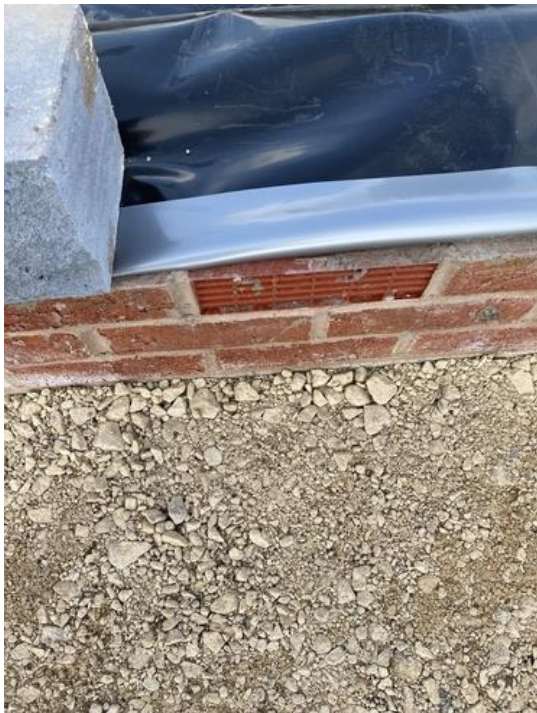
Photo 34

External Wall Air bricks: Numbers, size. positions as design drawing? (Minimum of 3 walls)

Pass

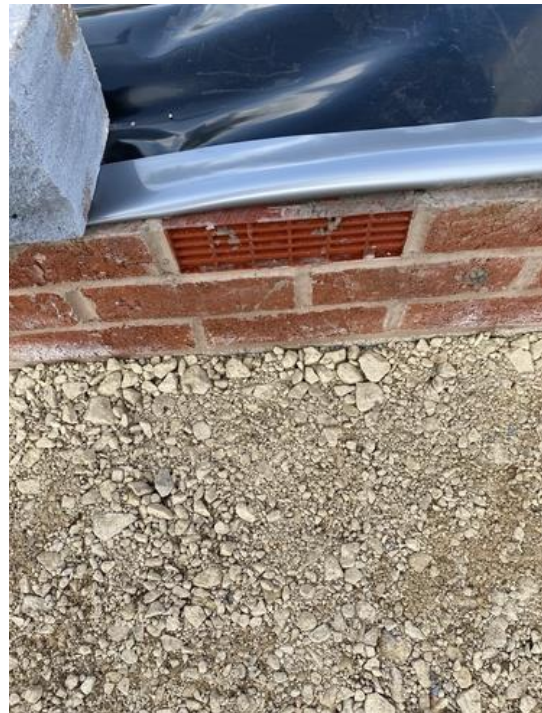
Photo 35

| Are telescopic vents present? | | Yes |

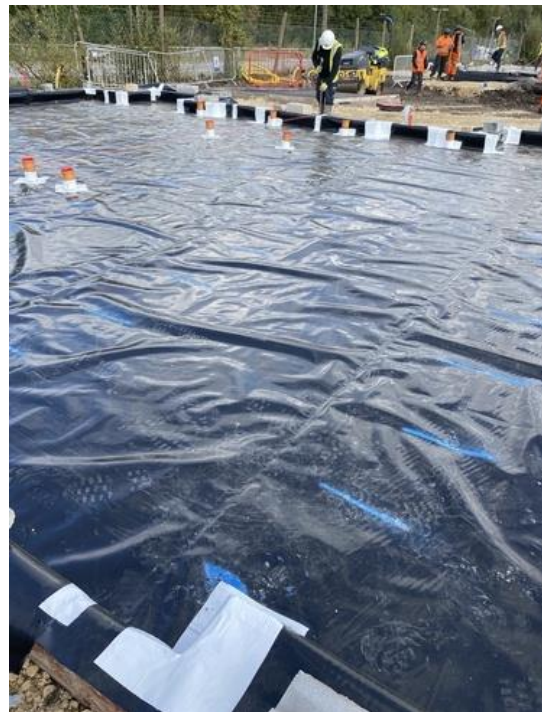
Photo 37

| Gas Membrane Condition: Open punctures, tears, rips, stretching, Presence of debris, Repairs, Signs of weakness such as raised or sunken indentations, Protection plan in place to restrict access to laid gas membrane? IF FAIL DESCRIPTION IN ACTIONS AND PHOTOS REQUIRED | | Pass |

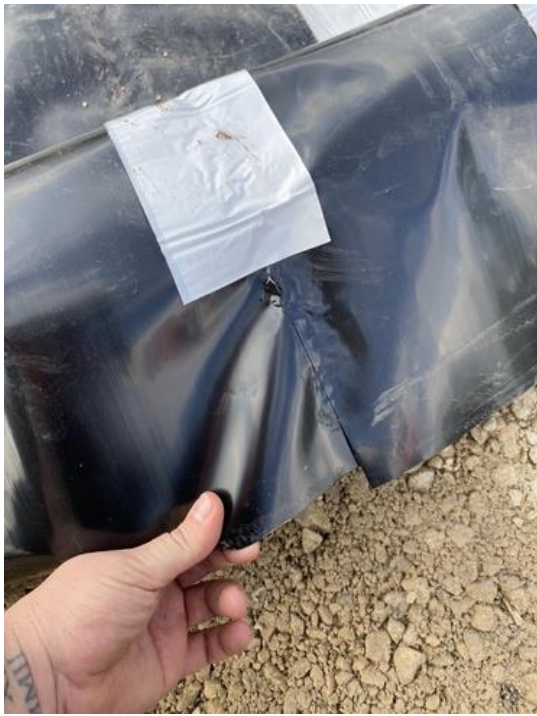
Photo 42

| Are welds complete? | | Yes |

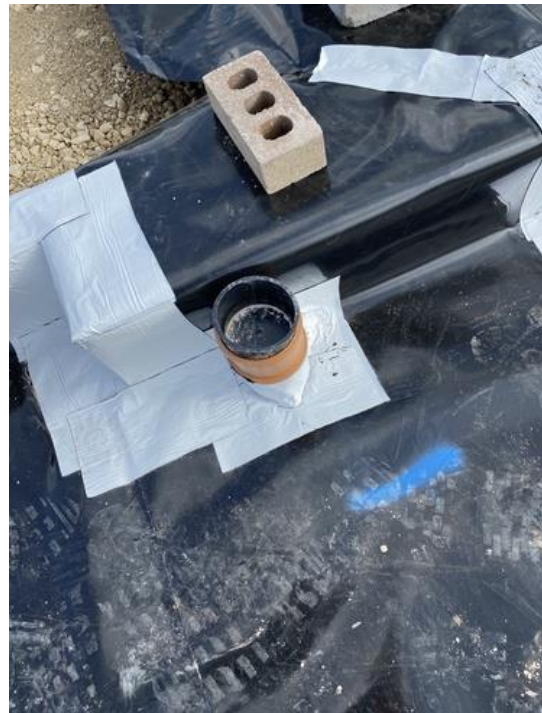
Photo 47

| Are Joints lapped and sealed in accordance with manufacturer's requirements/ specification? | | Yes |

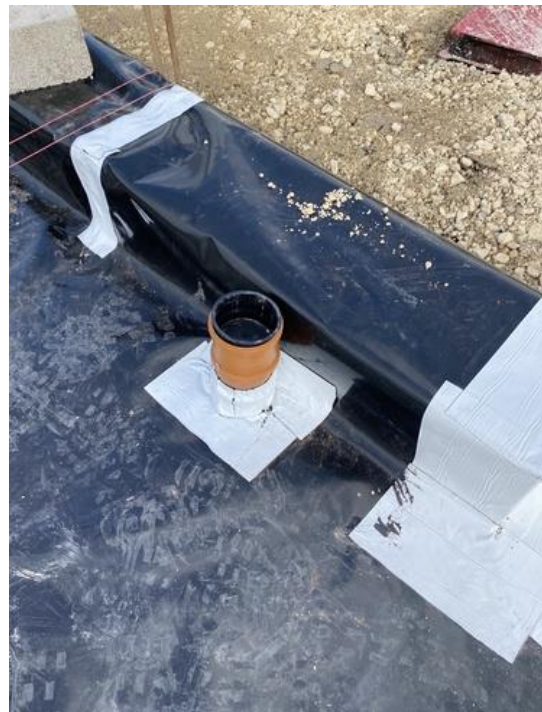
Photo 49

Service entries seals: Top hats seal arrangements fixed around service entries? Use of Jubilee clips or Bitumastic Sealant

Pass

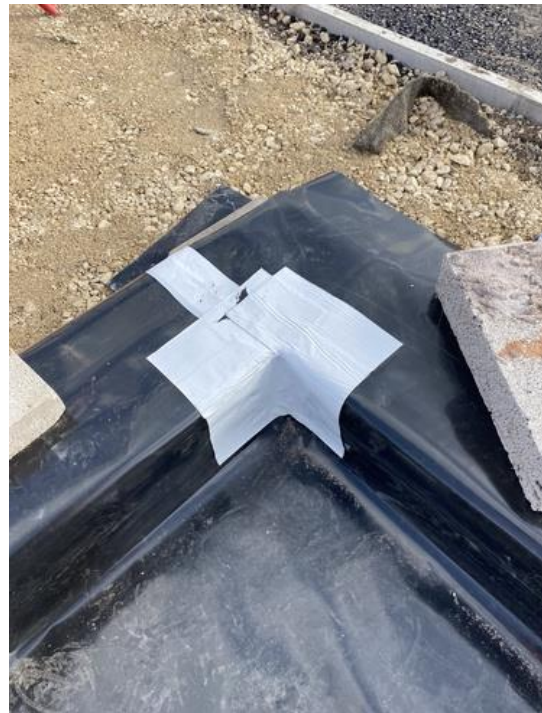
Photo 55

Corners / Internal joints: Check all corners are correctly formed or contractor has used preformed corners.

Pass

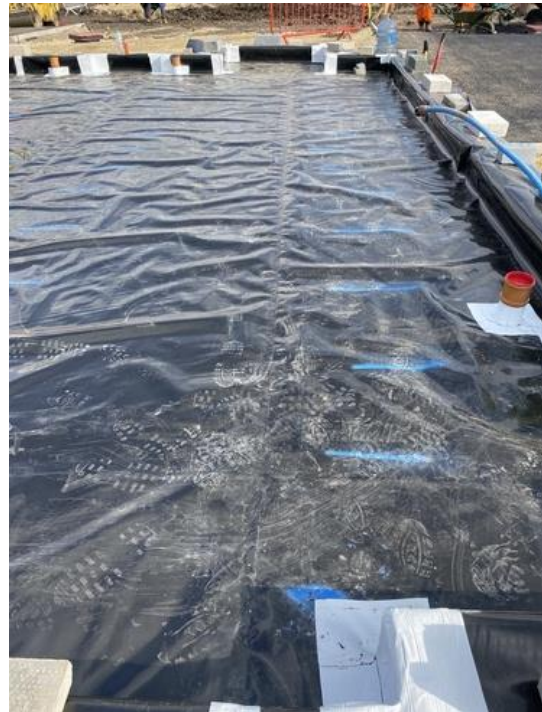
Photo 61

Are folds running in line with joints? (no joints cutting across folds)

Pass

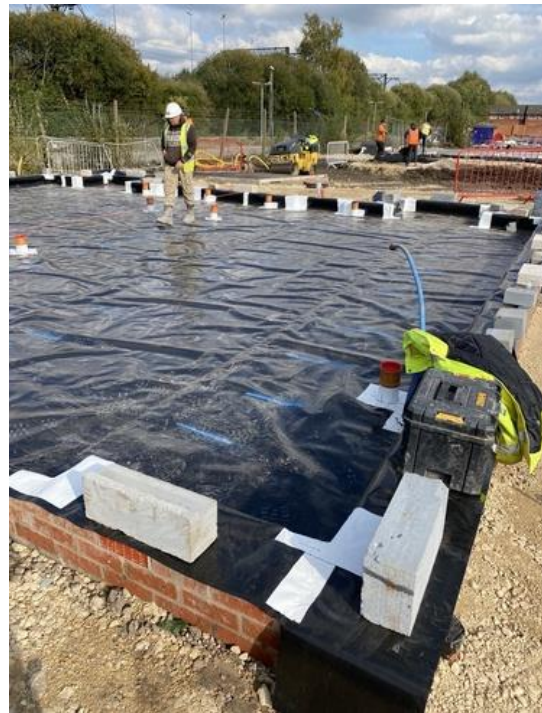
Photo 63

Extent of Coverage: Is the membrane covering the entire plot? Does membrane span over outside walls?

Yes

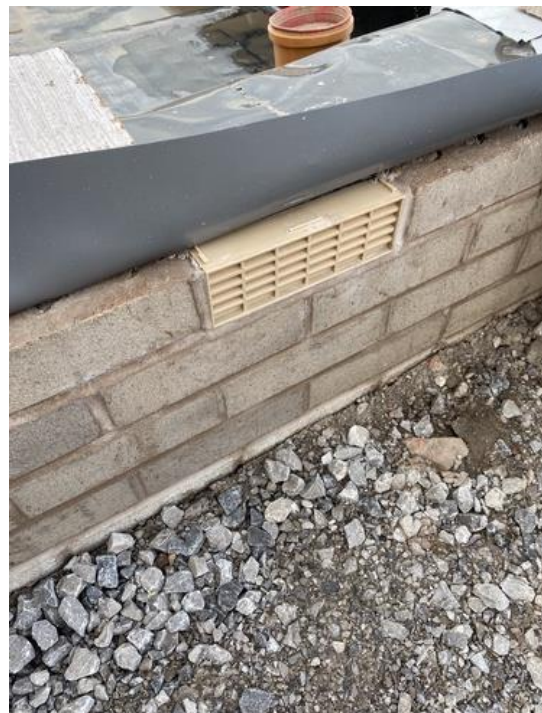
Photo 71

External Wall Air bricks: Numbers, size. positions as design drawing? (Minimum of 3 walls)

Pass

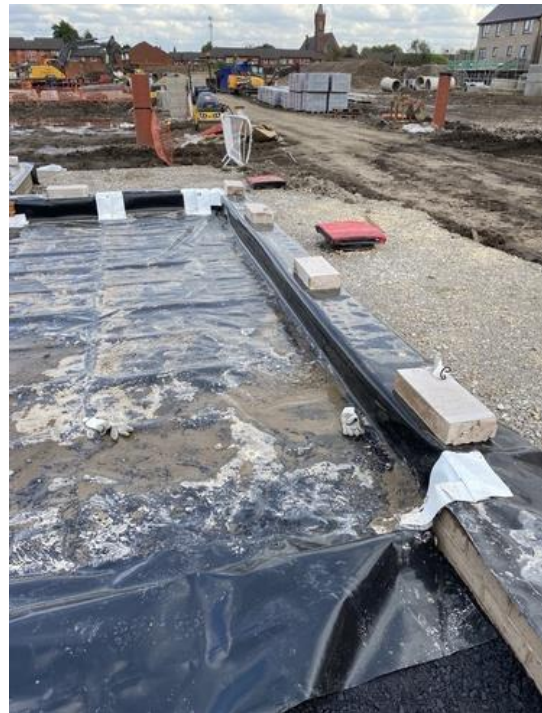
Photo 73

| Are telescopic vents present? | | Yes |

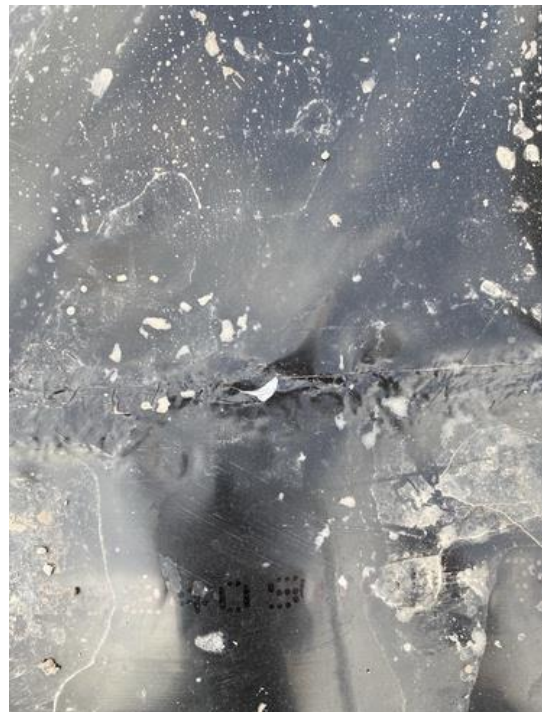
Photo 75

| <p>Gas Membrane Condition: Open punctures, tears, rips, stretching, Presence of debris, Repairs, Signs of weakness such as raised or sunken indentations, Protection plan in place to restrict access to lain gas membrane? IF FAIL DESCRIPTION IN ACTIONS AND PHOTOS REQUIRED</p> <p>Photo 74      Photo 75</p> | | Pass |

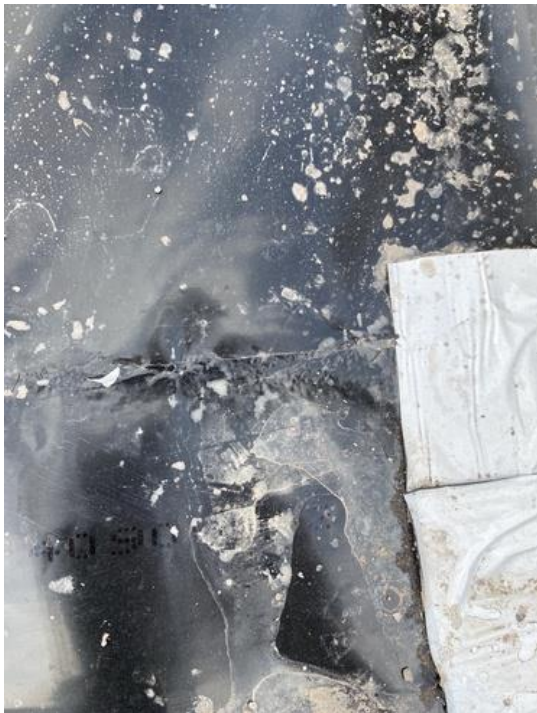
Photo 76

| Are welds complete? | | Yes |

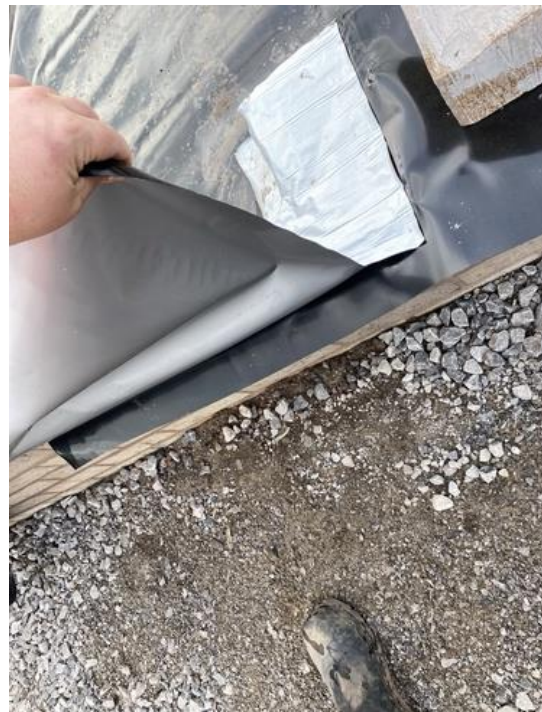
Photo 79

| Are Joints lapped and sealed in accordance with manufacturer's requirements/ specification? | | Yes |

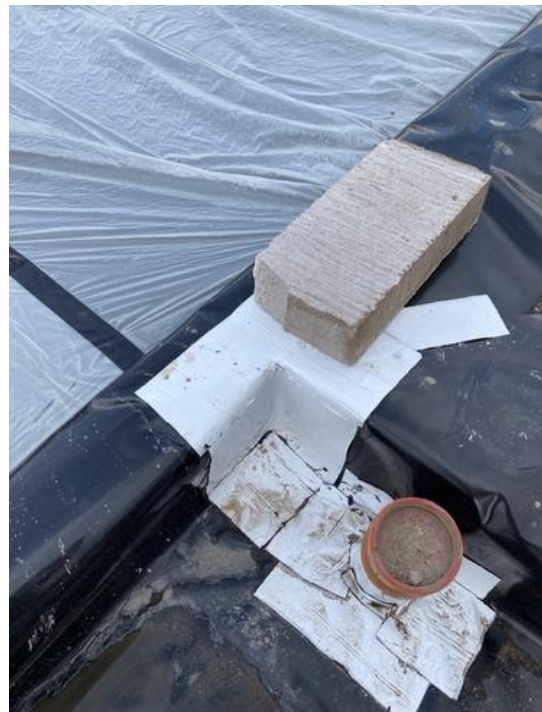
Photo 83

Service entries seals: Top hats seal arrangements fixed around service entries? Use of Jubilee clips or Bitumastic Sealant

Pass

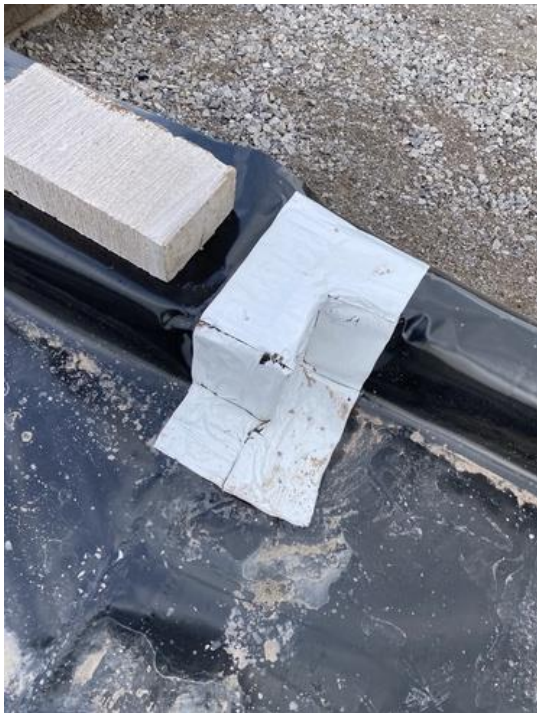
Photo 84

Corners / Internal joints: Check all corners are correctly formed or contractor has used preformed corners.

Pass

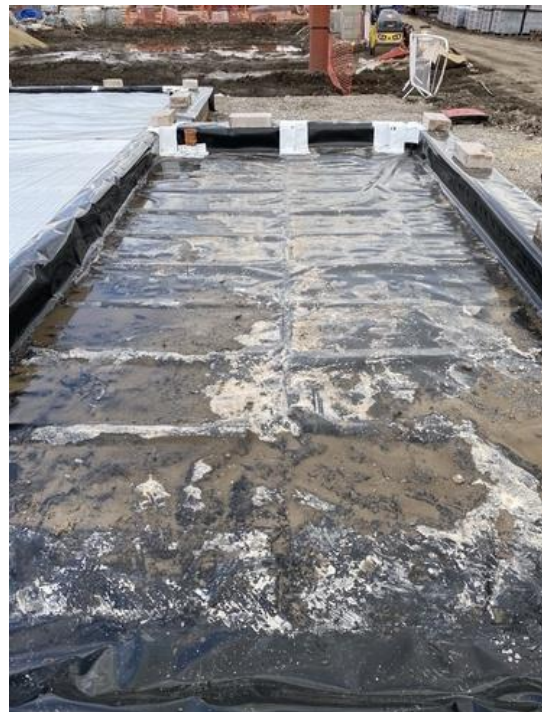
Photo 87

Are folds running in line with joints? (no joints cutting across folds)

Pass

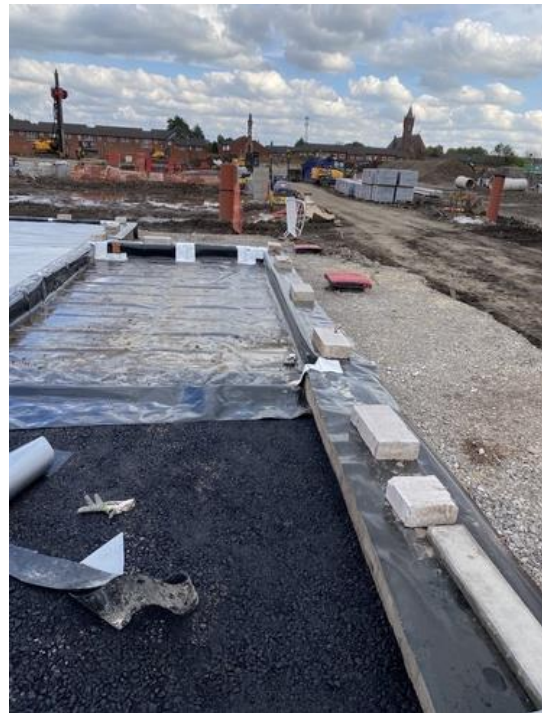
Photo 89

Extent of Coverage: Is the membrane covering the entire plot?  
Does membrane span over outside walls?

Yes

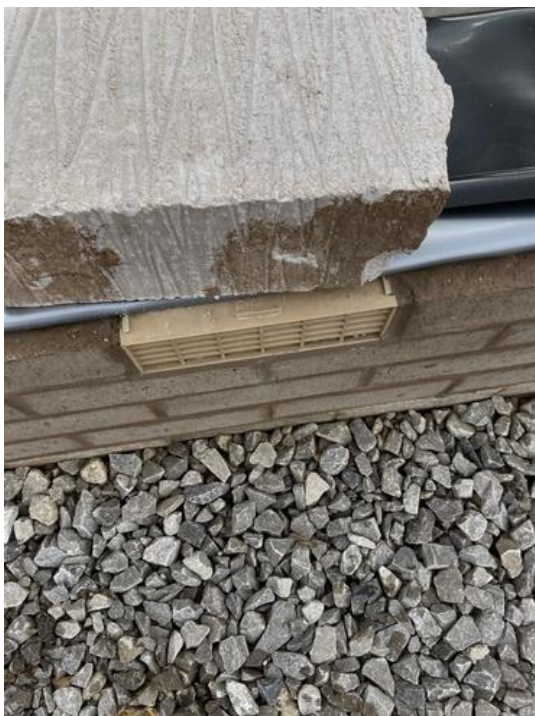
Photo 98

External Wall Air bricks: Numbers, size. positions as design drawing? (Minimum of 3 walls)

Pass

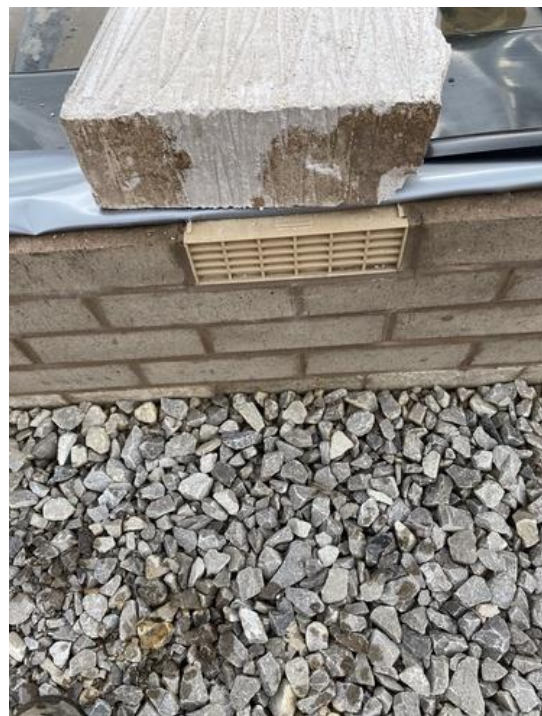
Photo 99

| Are telescopic vents present? | | Yes |

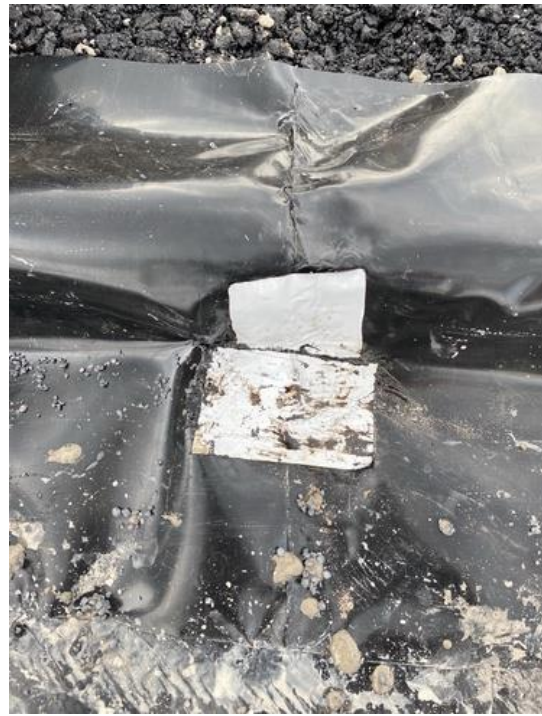
Photo 101

| Gas Membrane Condition: Open punctures, tears, rips, stretching, Presence of debris, Repairs, Signs of weakness such as raised or sunken indentations, Protection plan in place to restrict access to lain gas membrane? IF FAIL DESCRIPTION IN ACTIONS AND PHOTOS REQUIRED | | Pass |

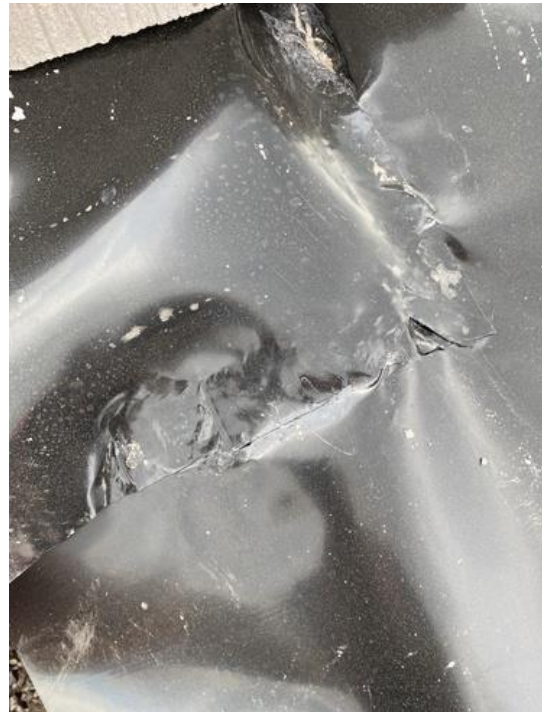
Photo 103

| Are welds complete? | | Yes |

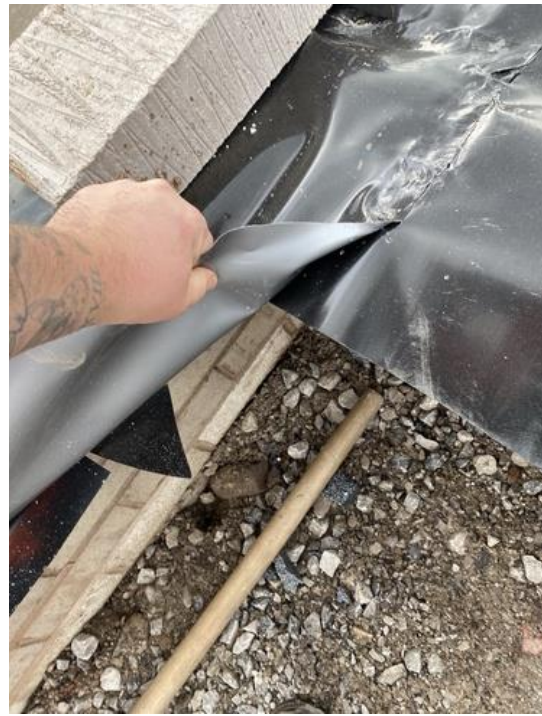
Photo 105

| Are Joints lapped and sealed in accordance with manufacturer's requirements/ specification? | | Yes |

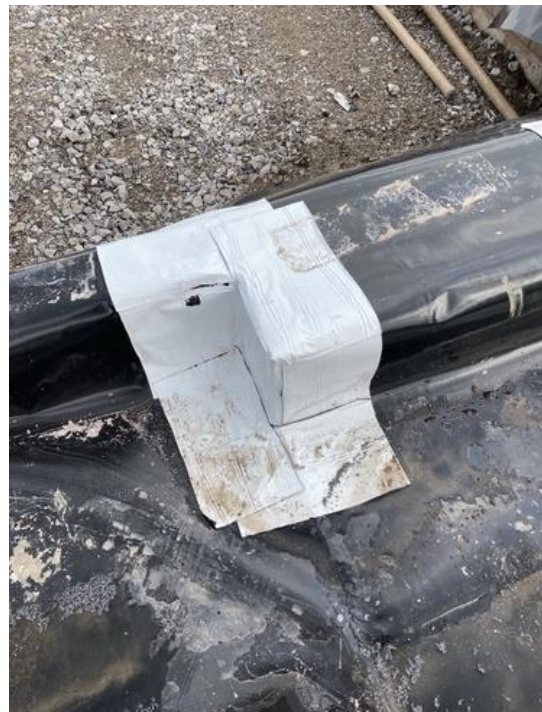
Photo 111

Service entries seals: Top hats seal arrangements fixed around service entries? Use of Jubilee clips or Bitumastic Sealant

Pass

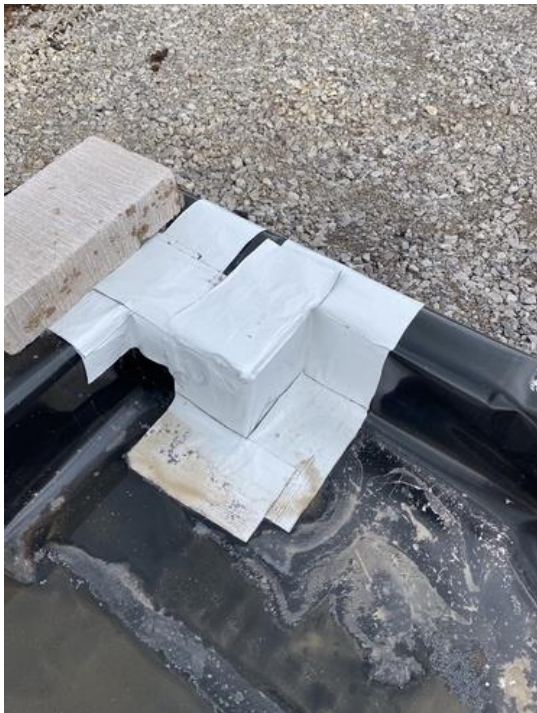
Photo 112

Corners / Internal joints: Check all corners are correctly formed or contractor has used preformed corners.

Pass

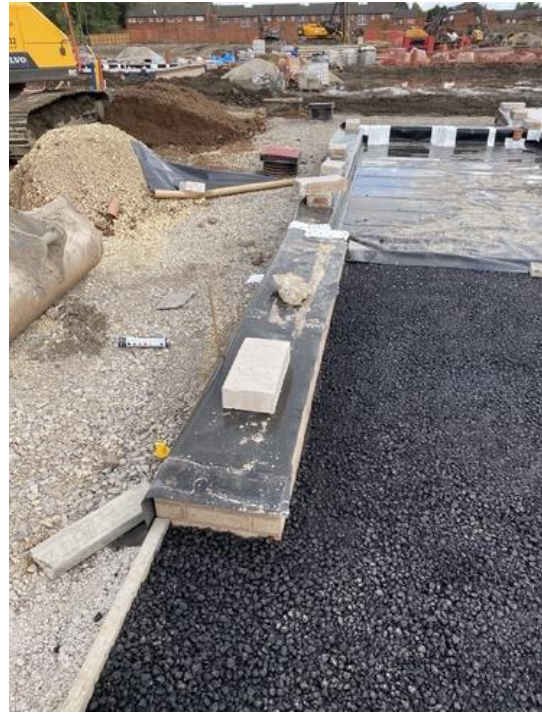
Photo 117

Are folds running in line with joints? (no joints cutting across folds)

Pass

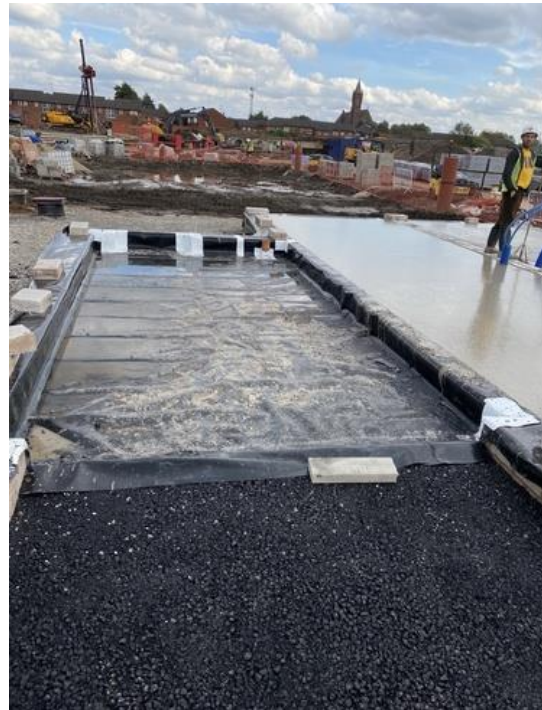
Photo 119

Extent of Coverage: Is the membrane covering the entire plot? Does membrane span over outside walls?

Yes
