Date: 23<sup>rd</sup> August 2024  
Reference: 15-974 V11

## GAS MEMBRANE VALIDATION – BENNETT STREET

| <b>Project Name:</b> | Bennett Street |
| <b>Project Number:</b> | 15-974 |

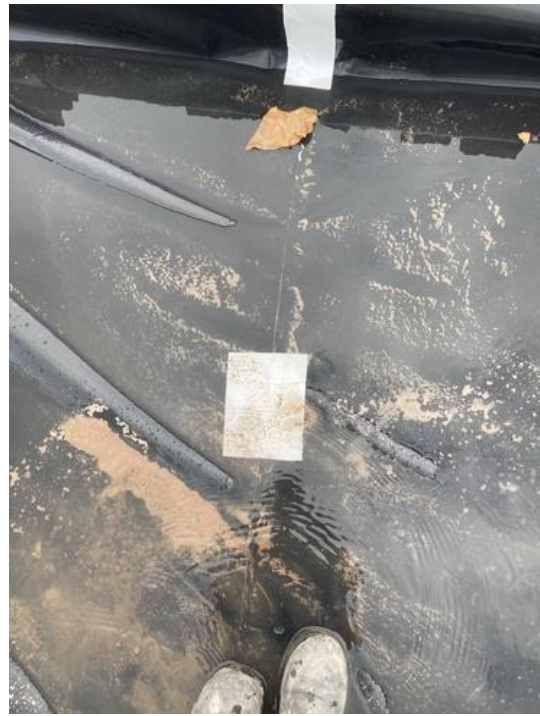
Photo 1

| <b>Gas Membrane Condition: Open punctures, tears, rips, stretching, Presence of debris, Repairs, Signs of weakness such as raised or sunken indentations, Protection plan in place to restrict access to lain gas membrane? IF FAIL DESCRIPTION IN ACTIONS AND PHOTOS REQUIRED</b> | Pass |

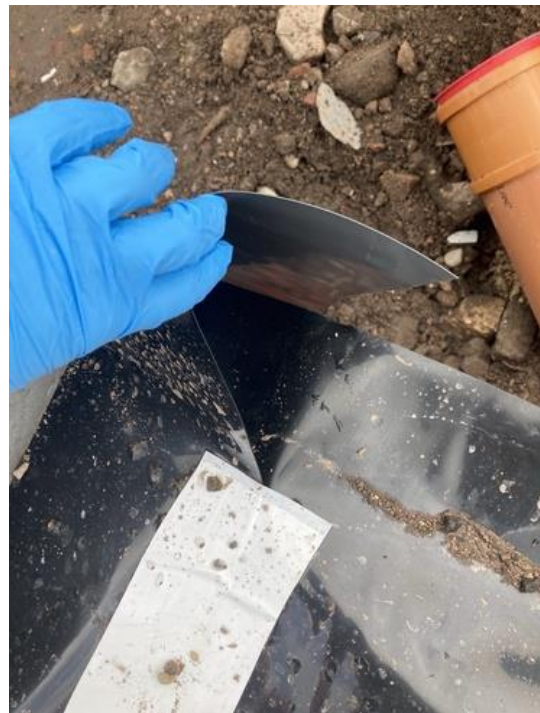
Photo 3

| <b>Are welds complete?</b> | Yes |
| <b>Are Joints lapped and sealed in accordance with manufacturer's requirements/ specification?</b> | Yes |

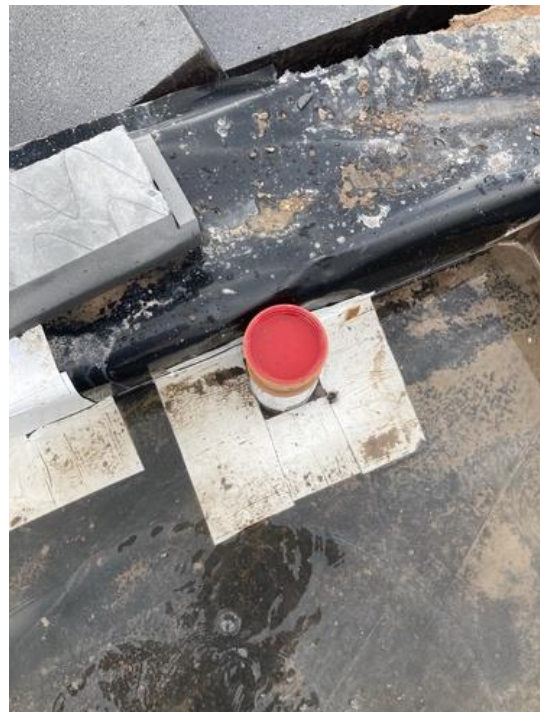
Photo 7

| <b>Service entries seals: Top hats seal arrangements fixed around service entries? Use of Jubilee clips or Bitumastic Sealant</b> | Pass |

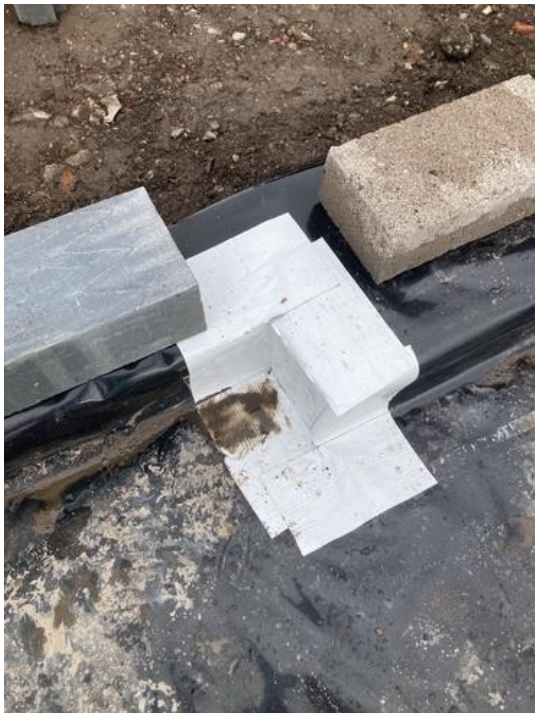
Photo 12

**Corners / Internal joints: Check all corners are correctly formed or contractor has used preformed corners.**

Pass

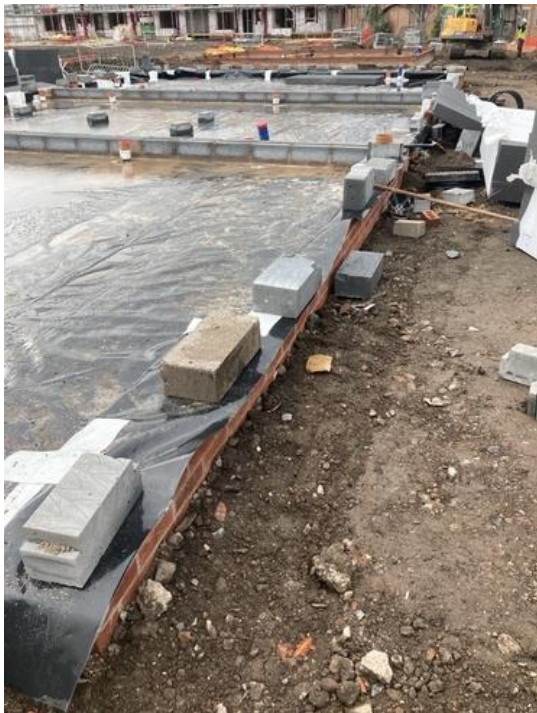
Photo 24

**Extent of Coverage: Is the membrane covering the entire plot? Does membrane span over outside walls?**

Yes

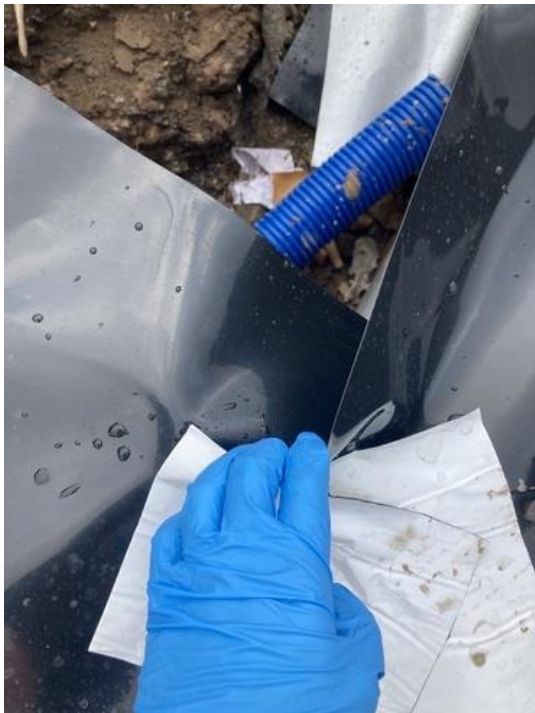
Photo 36

| <b>Gas Membrane Condition: Open punctures, tears, rips, stretching, Presence of debris, Repairs, Signs of weakness such as raised or sunken indentations, Protection plan in place to restrict access to lain gas membrane? IF FAIL DESCRIPTION IN ACTIONS AND PHOTOS REQUIRED</b> | Pass | |

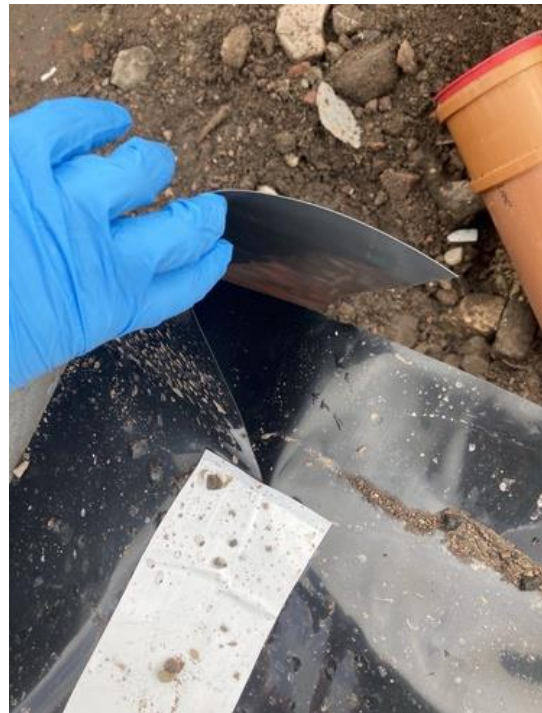
Photo 37

| <b>Are welds complete?</b> | Yes | |
| <b>Are Joints lapped and sealed in accordance with manufacturer's requirements/ specification?</b> | Yes | |

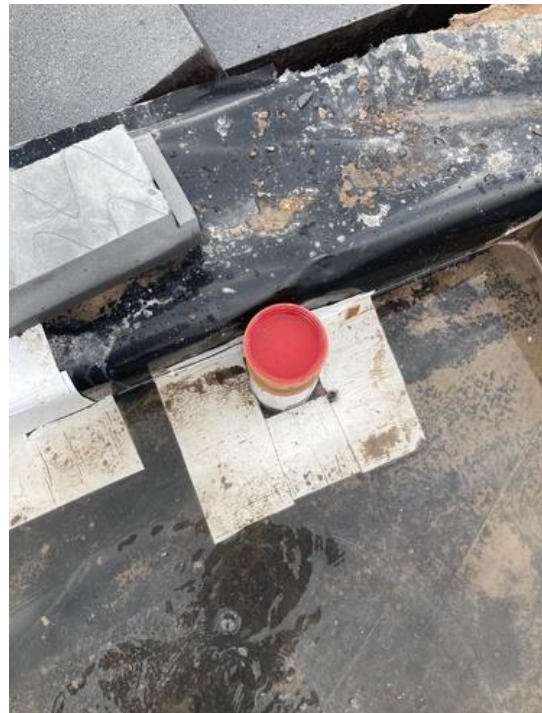
Photo 41

| <b>Service entries seals: Top hats seal arrangements fixed around service entries? Use of Jubilee clips or Bitumastic Sealant</b> | Pass | |

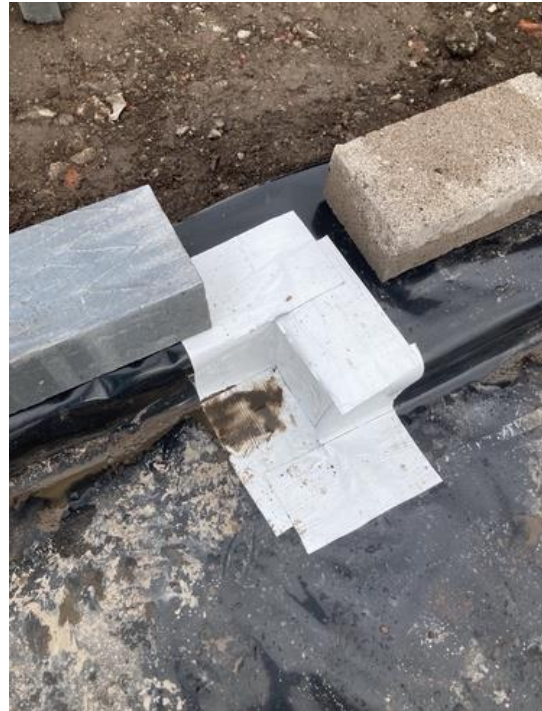
Photo 45

| <b>Corners / Internal joints: Check all corners are correctly formed or contractor has used preformed corners.</b> | Pass | |

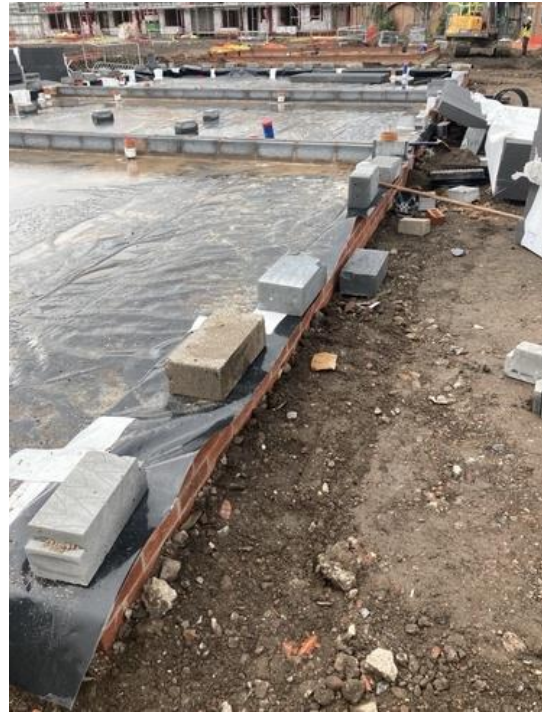
Photo 57

**Extent of Coverage: Is the membrane covering the entire plot? Does membrane span over outside walls?**

Yes

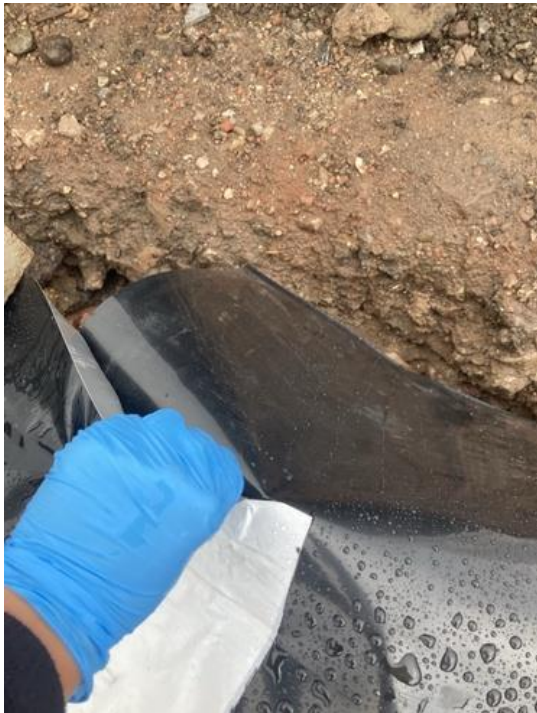
Photo 68

| <b>Gas Membrane Condition: Open punctures, tears, rips, stretching, Presence of debris, Repairs, Signs of weakness such as raised or sunken indentations, Protection plan in place to restrict access to lain gas membrane? IF FAIL DESCRIPTION IN ACTIONS AND PHOTOS REQUIRED</b> | Pass | |

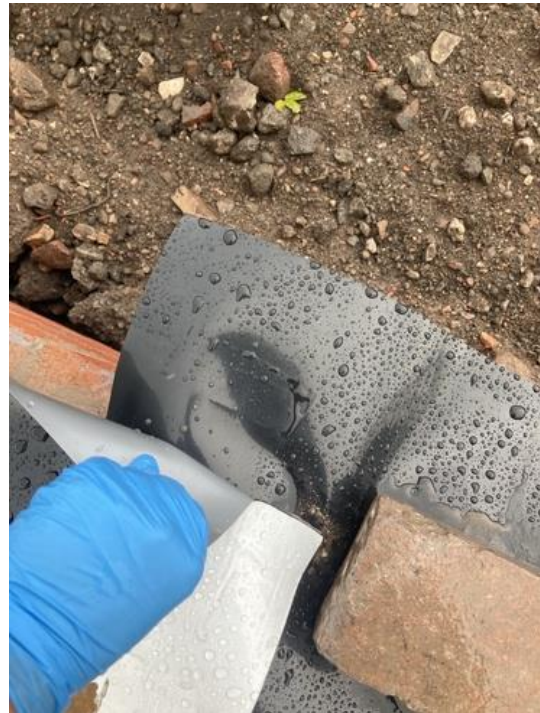
Photo 69

| <b>Are welds complete?</b> | Yes | |
| <b>Are Joints lapped and sealed in accordance with manufacturer's requirements/ specification?</b> | Yes | |

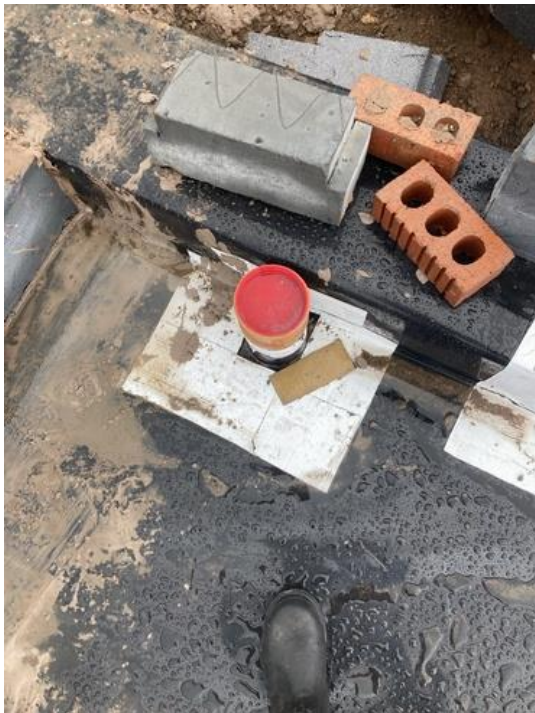
Photo 72

| <b>Service entries seals: Top hats seal arrangements fixed around service entries? Use of Jubilee clips or Bitumastic Sealant</b> | Pass | |

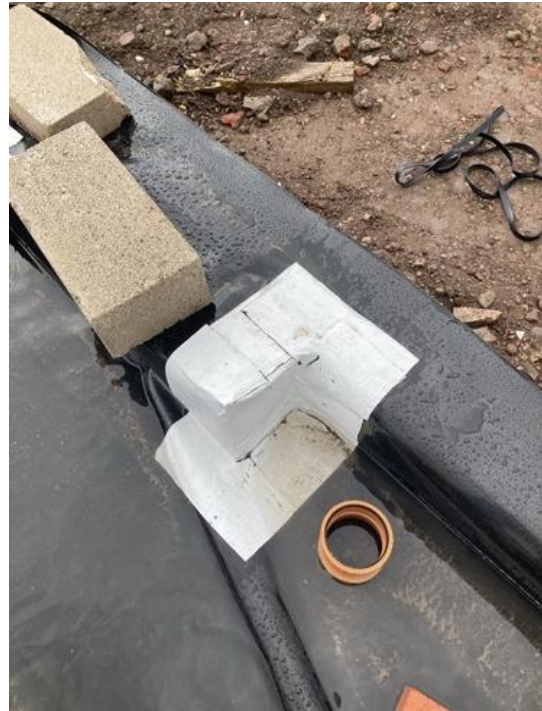
Photo 77

| <b>Corners / Internal joints: Check all corners are correctly formed or contractor has used preformed corners.</b> | Pass | |

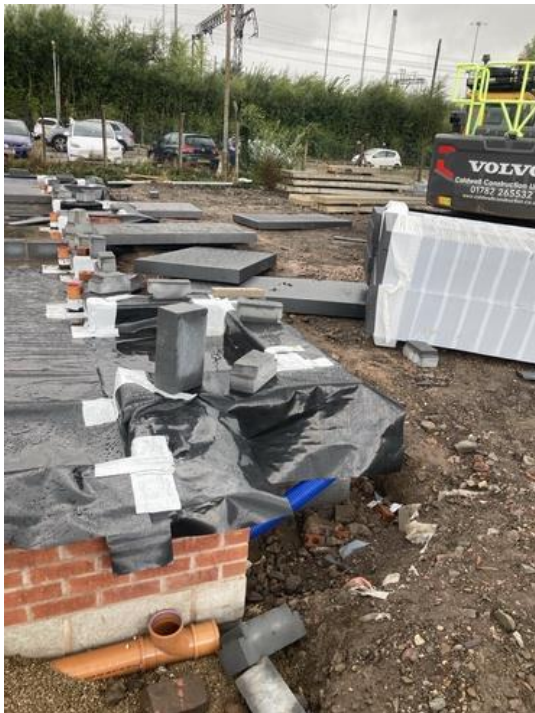
Photo 88

**Extent of Coverage: Is the membrane covering the entire plot? Does membrane span over outside walls?**

Yes

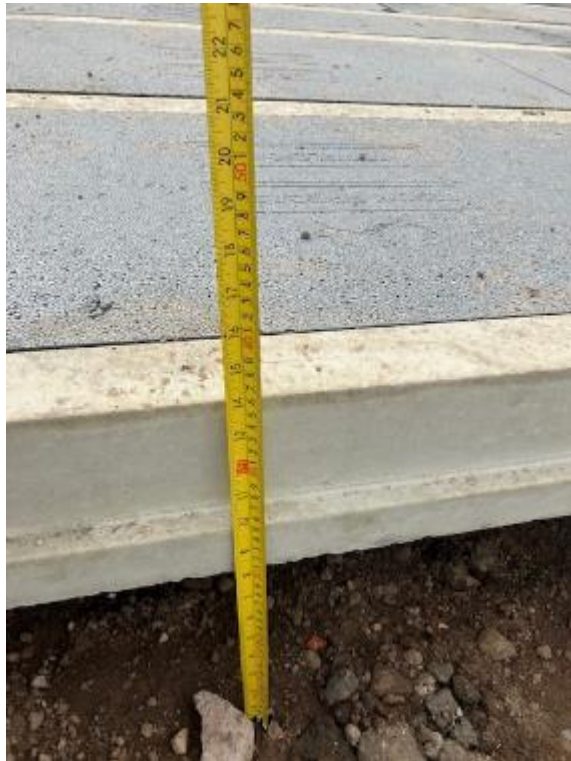
Plot 119

As per the Build Phase Contamination Risk Mitigation Strategy (report ref: 15-974-R5), sub-floor voids require inspection and validation at 50% ratio of substructures completed. E3P undertook subfloor void inspections for adjacent Plots 119-122 on the 19<sup>th</sup> August, inspections confirmed there was a minimum void space of 150 mm for each plot. Validation photographs included within this letter.
