**Aldi Store, Victoria  
Road East, Moston**

**Surface Water Drainage  
Verification Report**

**9104-SWF-XX-XX-TR-C-0202**

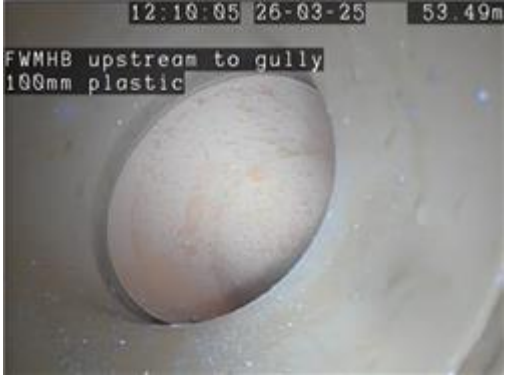
| Pos | Video Ref | Code | Description | Image |
|---|---|---|---|---|
| 53.49m | | MHF | Finish node type, manhole GULLY | <p>Image Provided - Ref: 6_9999</p> <p>12:10:05 26-03-25 53.49m</p> <p>FWMHB upstream to gully<br/>100mm plastic</p> |

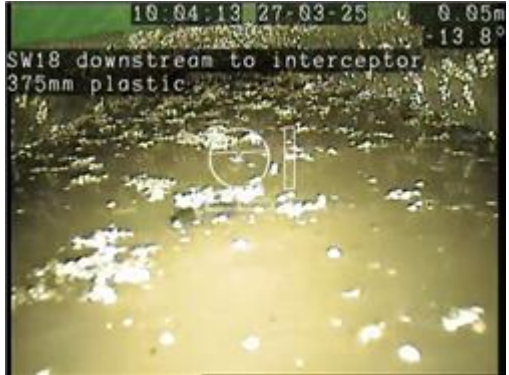
| Pos | Video Ref | Code | Description | Image |
|---|---|---|---|---|
| 00.50m | 0:00:00 | WL | Water level: 50% Height/Diameter | <p>Image Provided - Ref: 40_1</p> <p>10:04:13 27-03-25 0.05m -13.8°<br/>SW18 downstream to interceptor<br/>375mm plastic</p> |

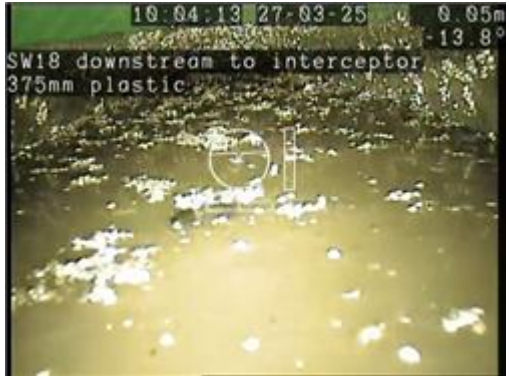
| Pos | Video Ref | Code | Description | Image |
|---|---|---|---|---|
| 00.50m | | MHF | Finish node type, manhole INTERCEPTOR | <p>Image Provided - Ref: 40_9999</p> <p>10:04:13 27-03-25 0.05m -13.8°<br/>SW18 downstream to interceptor<br/>375mm plastic</p> |
