## GAS MEMBRANE VALIDATION

| <b>Site Name:</b> Belle Vue | <b>Project Number:</b> 12-123 |
| <b>Company Name:</b> Countryside Properties | <b>Date:</b> 05-10-2022 |

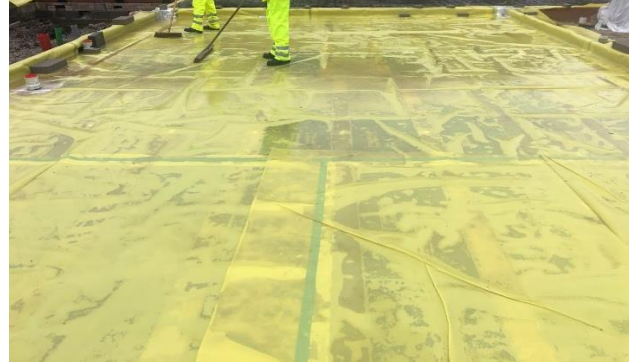
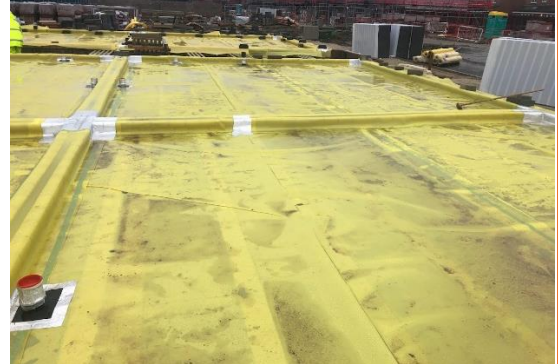
**Plot – Block 1**

**General Condition of Membrane-Good Condition**

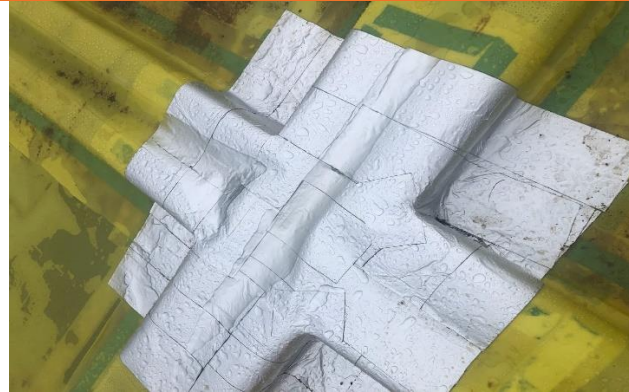
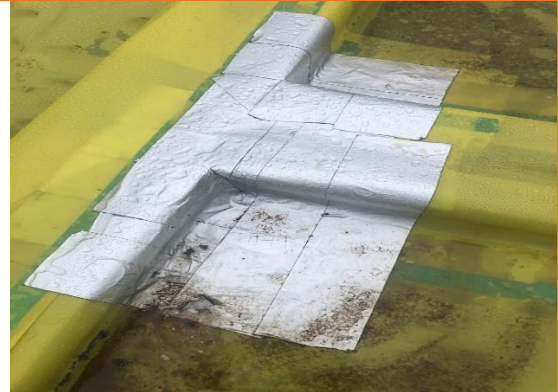
**Verification of Joints and Seals-Good Condition**

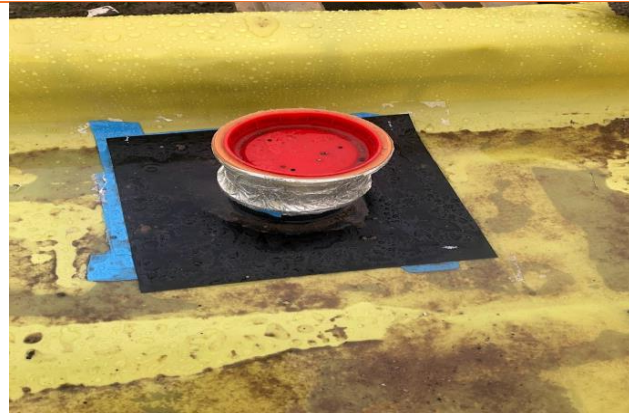
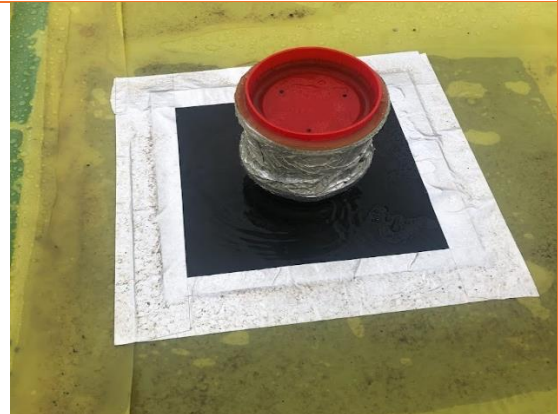
**Verification of Service Penetrations-Good Condition**

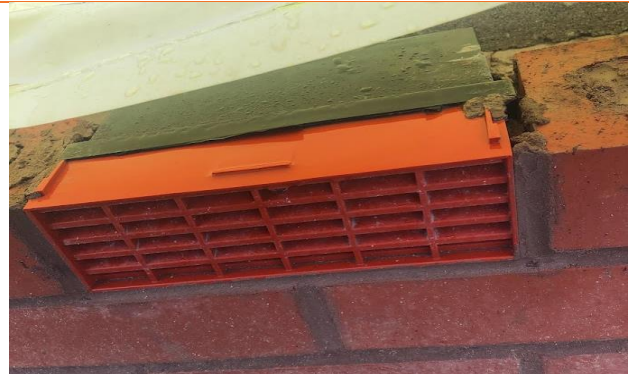
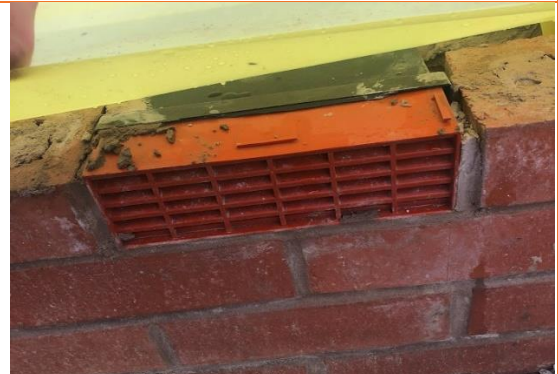
**Verification of Ventilation-Good Condition**

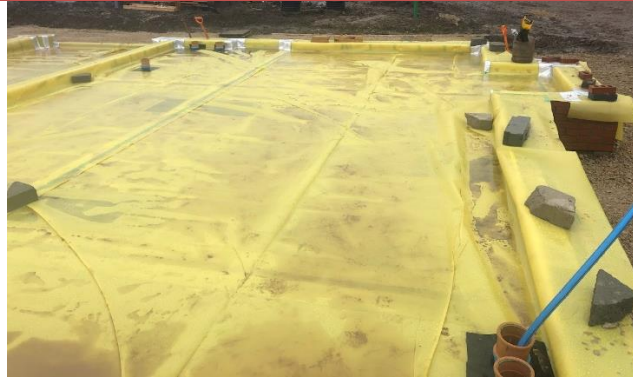
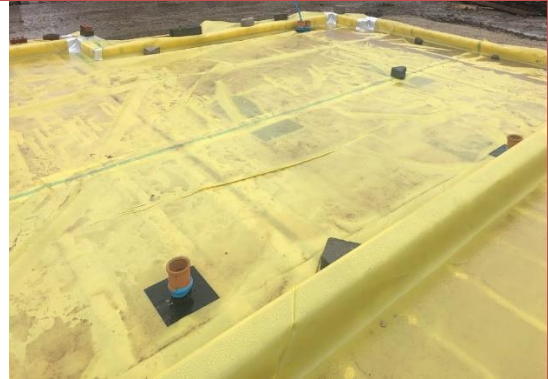
**Plot - 170**

**General Condition of Membrane-Good Condition**

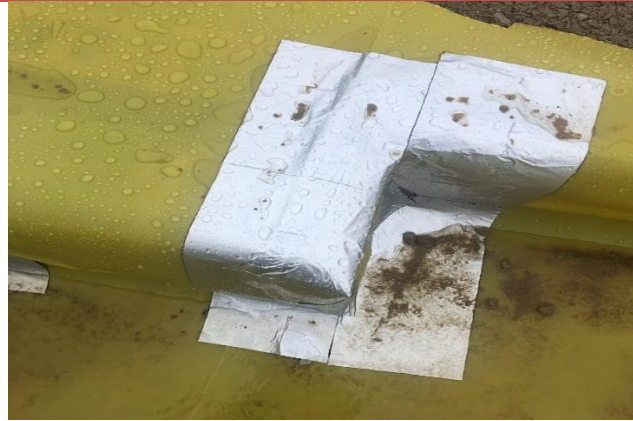
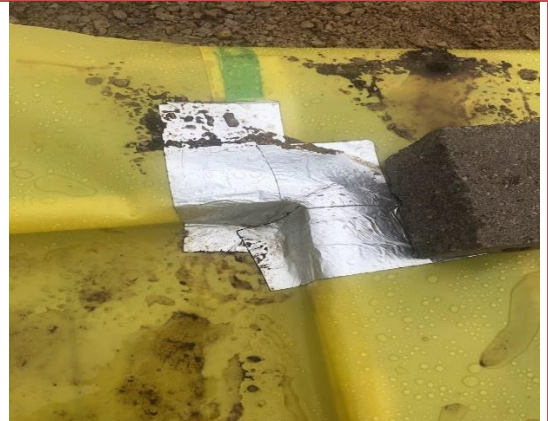
**Verification of Joints and Seals-Good Condition**

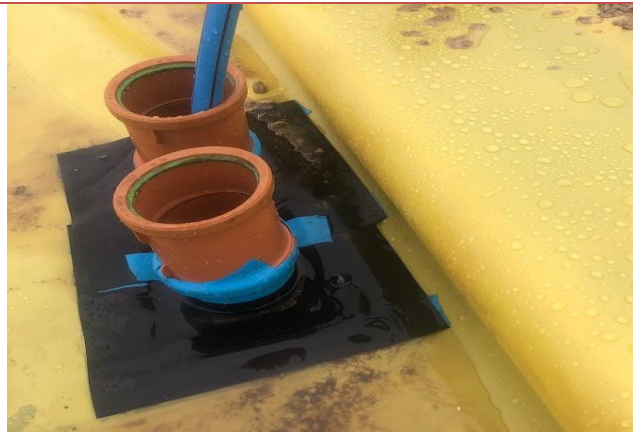
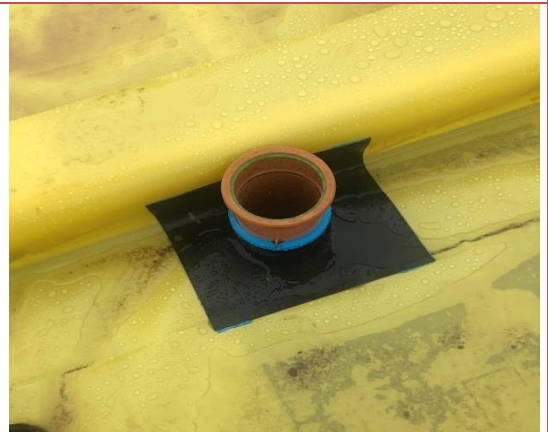
**Verification of Service Penetrations-Good Condition**

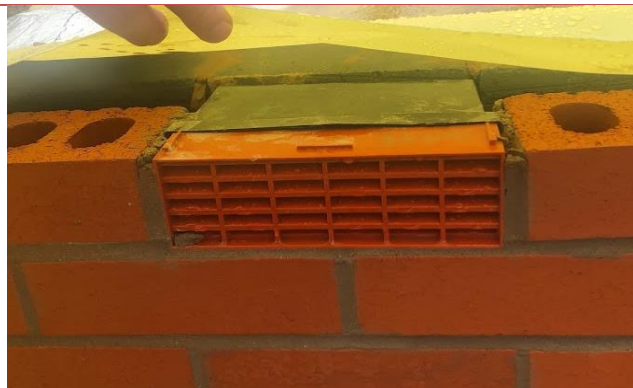
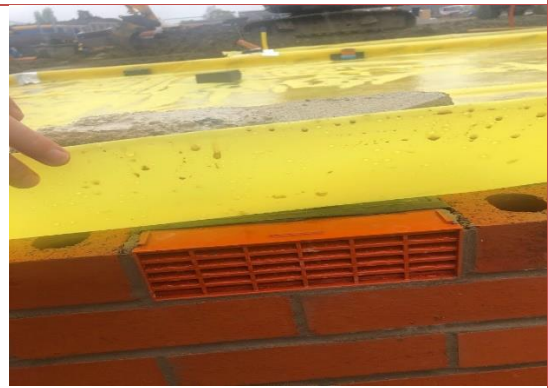
**Verification of Ventilation-Good Condition**
