## Building Survey Report

Holiday Inn Express, 2 Oxford Road, Manchester, M1 5QA

June 2022

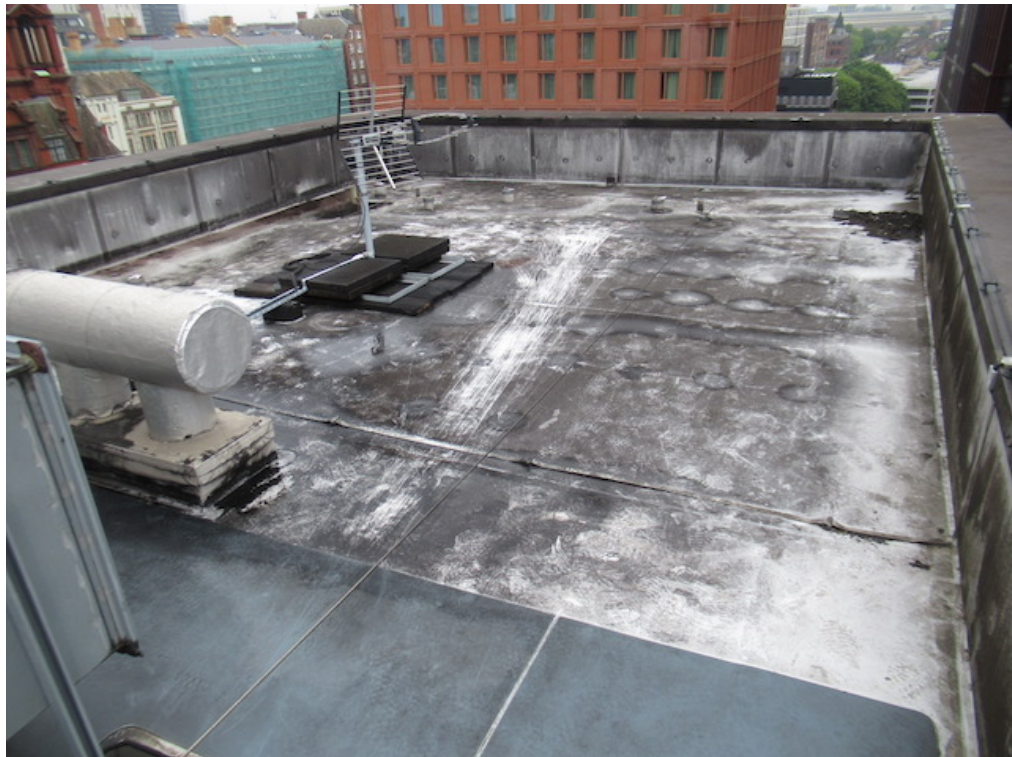
- 4.7 Where visible, the flat single ply membrane roof covering was generally in a fair condition and no significant defects were noted. However, roof covering was heavily soiled throughout and should be periodically cleaned as part of a planned maintenance programme.

- 4.13 The roof covering was heavily soiled throughout and should be periodically cleaned as part of a planned maintenance programme.
- 4.14 The walkway area of the roof had peeling joints, some of which have been historically repaired. We recommend that the joints be repaired immediately to prevent trip hazards and/or water ingress.

4. Typical soiling throughout flat roofs

| Works Required | | Budget Cost (£) |
|---|---|---|
| 1. | Clean down all roof coverings and drainage outlets. | 3,000 |

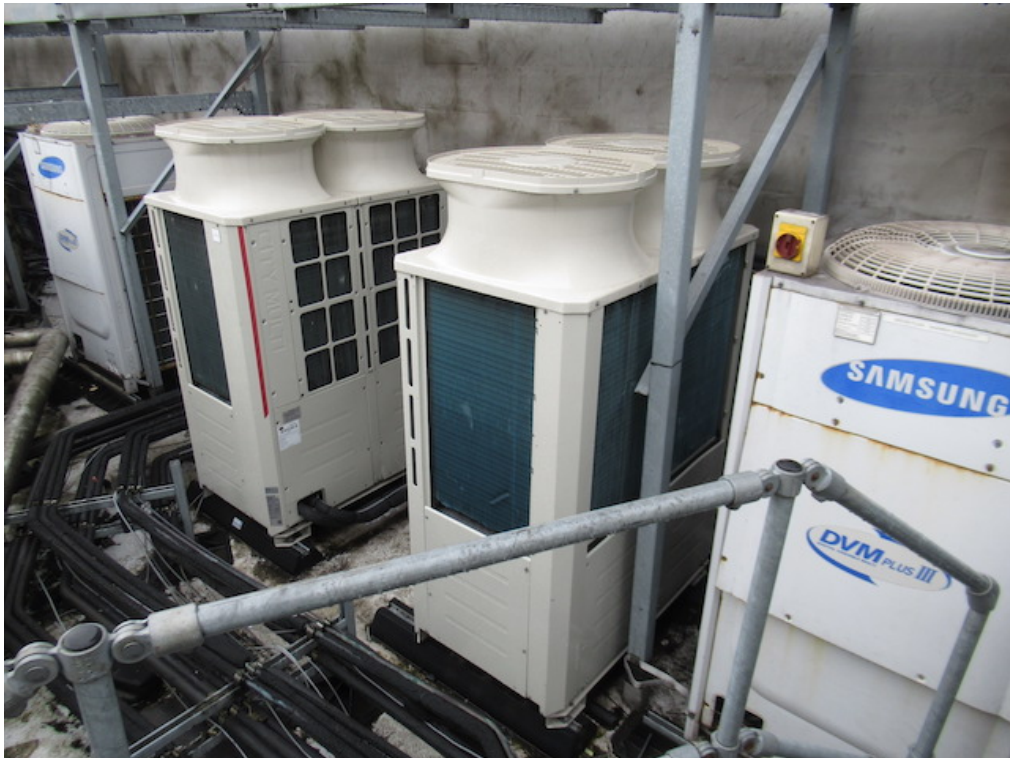
- 4.49 The water mist fire suppression system was last serviced by Tyco Fire & Integrated Solutions on 21 October 2021.
- 4.50 Four heat pump condenser units are present to the 10<sup>th</sup> floor roof. Two condensers are the original Samsung 'DVM Plus III' condensers dating from 2010, with two Mitsubishi 'City Multi' condensers dating from 2020. We understand that the Samsung condensers are due to be replaced as part of the phased air-conditioning refurbishment works.

7. General view of original and replacement condensers to main roof

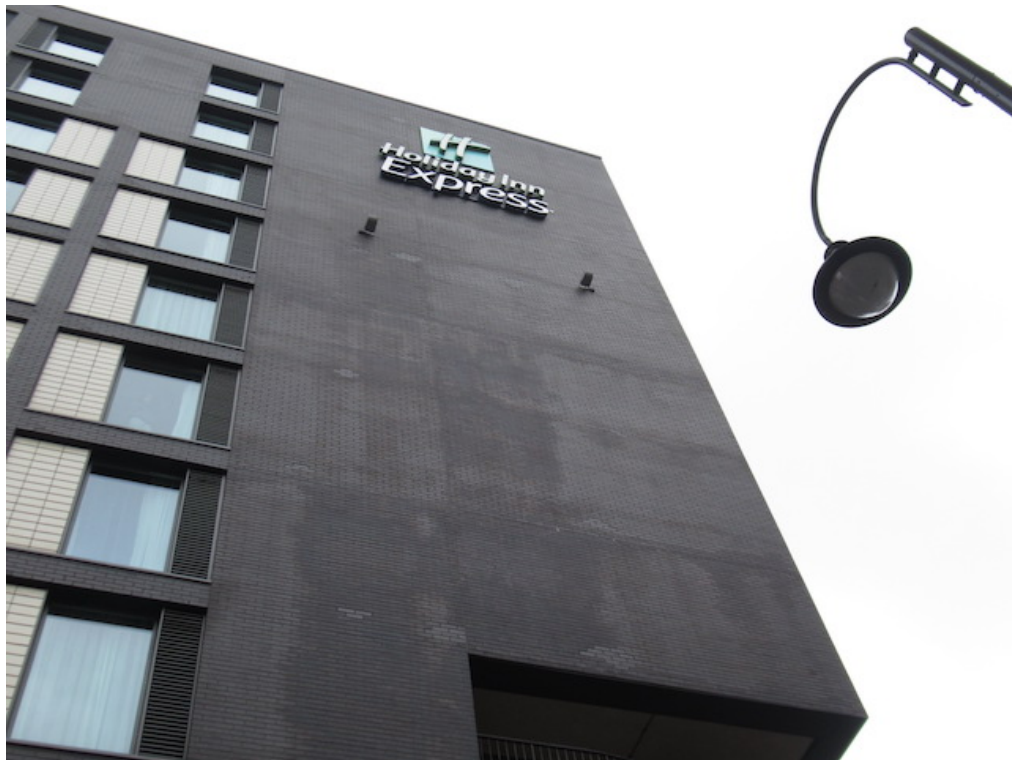
- 4.25 A number of slightly mismatching sections of brickwork were present to the right-hand side of the Hulme Street elevation. These sections date from the original construction are an aesthetic issue not requiring repair.
- 4.26 The brickwork to the left of the Spar retail unit on the Hulme Street elevation was heavily soiled and had localised graffiti, which should be removed in the short term.

9. Mismatched brickwork to right side of Hulme Street elevation

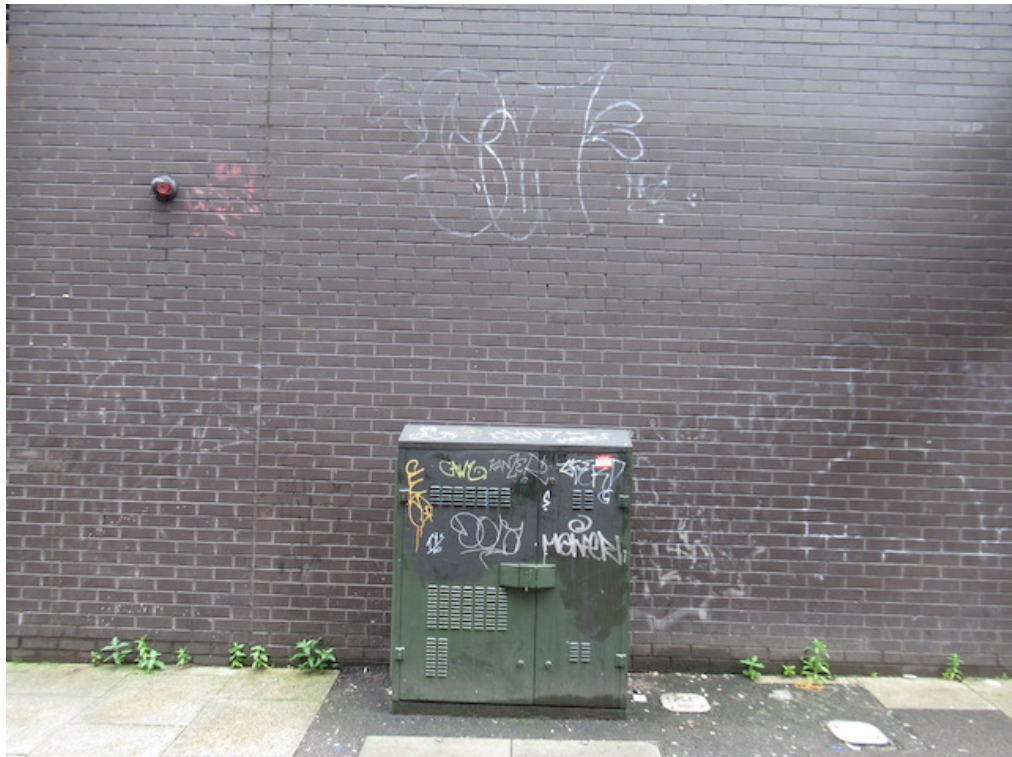
10. Graffiti to Hulme Street elevation

| Works Required | | Budget Cost (£) |
|---|---|---|
| 4. | Remove graffiti from Hulme Street elevation brickwork. | 2,000 |

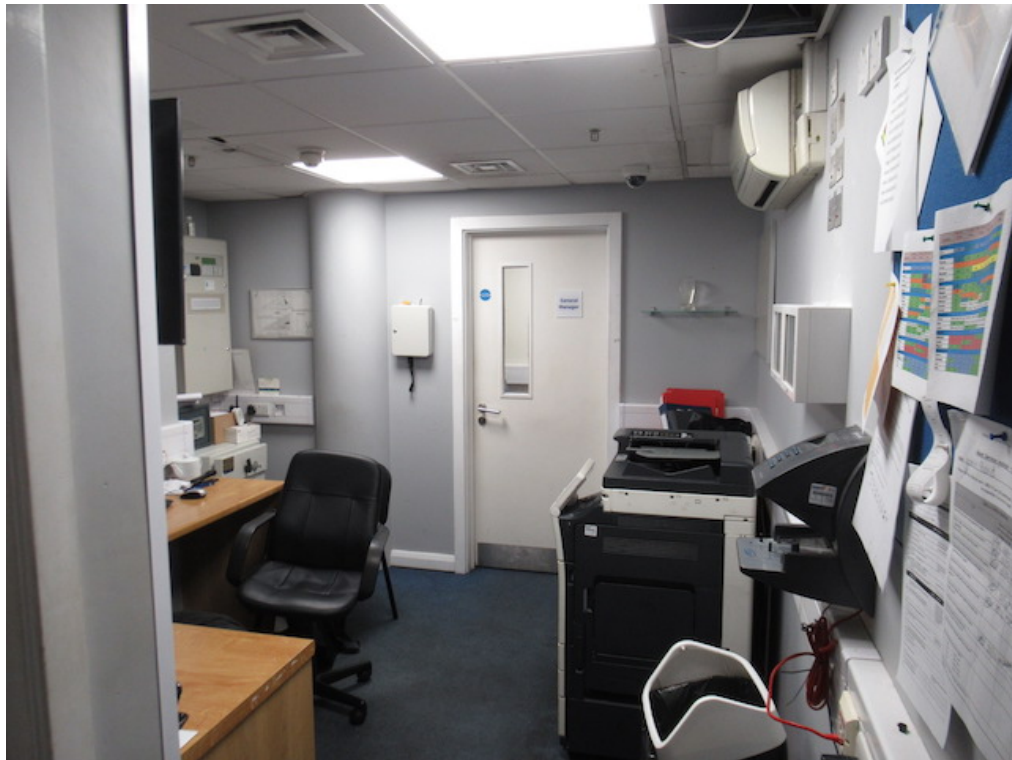
- 
- 4.38 Internal finishes to the 'back of house' areas were generally in a poor decorative condition commensurate with the usage of the areas. Scuffs and marks were noted to the walls and internal joinery and localised areas of water damaged suspended ceiling tiles were present. Floor finishes were also heavily soiled throughout.

14. Typical worn finishes to 'back of house' offices

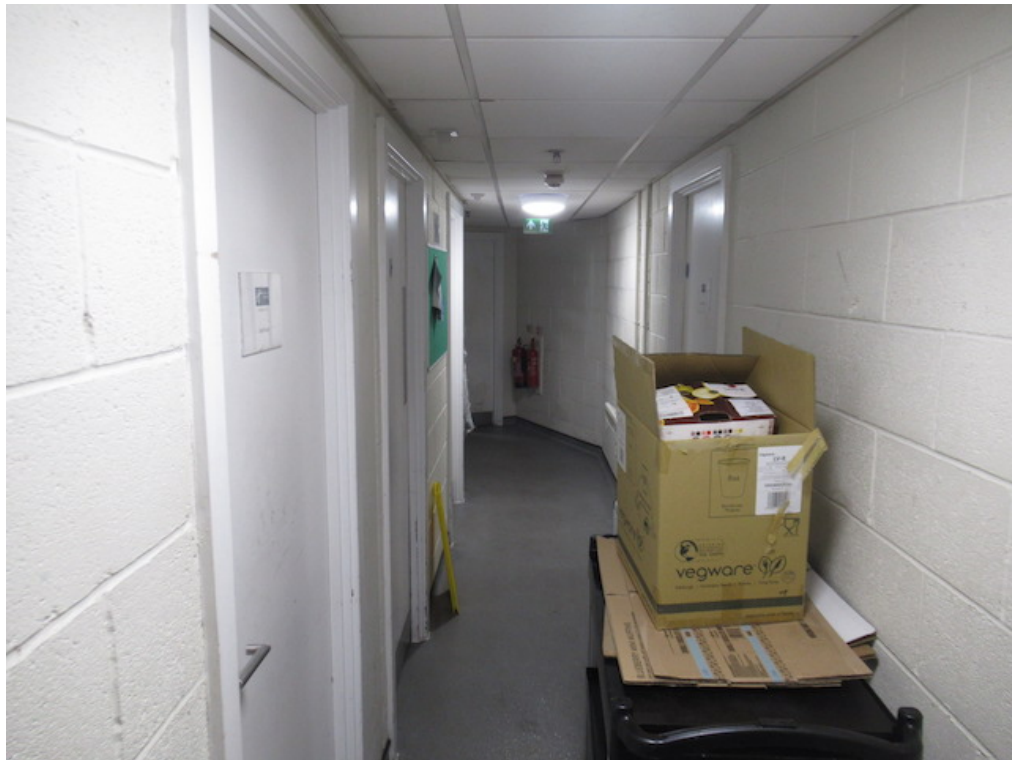
16. Typical worn finishes to 'back of house' staff area finishes

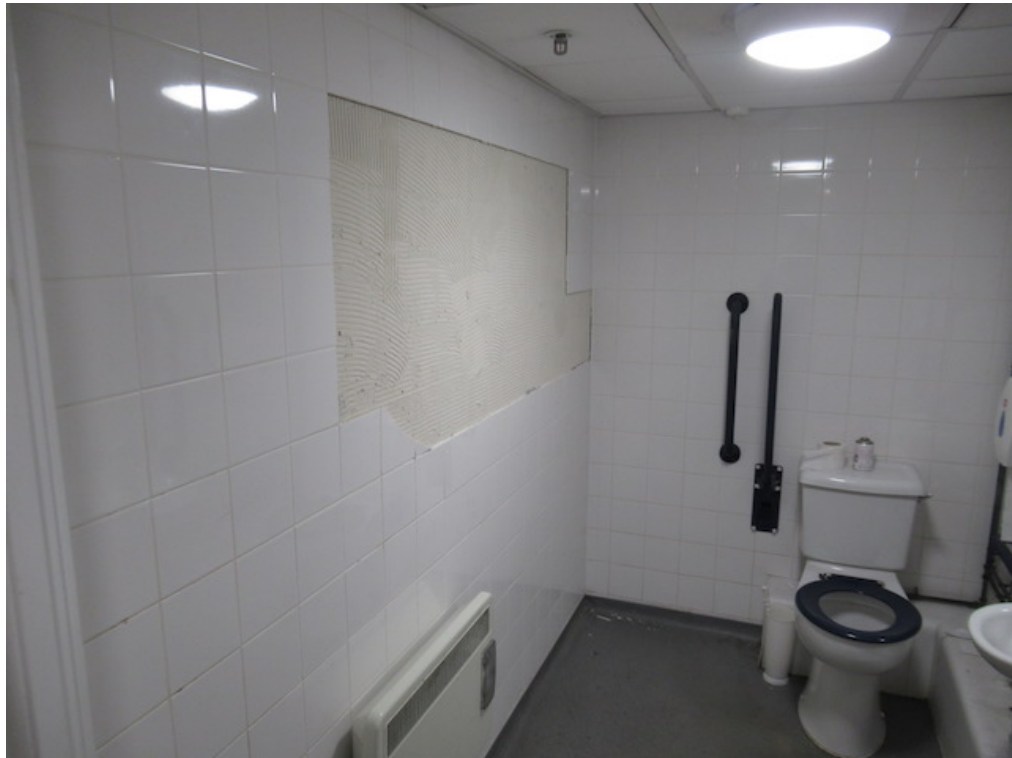
17. Absent and debonded tiles to male staff changing areas / toilets

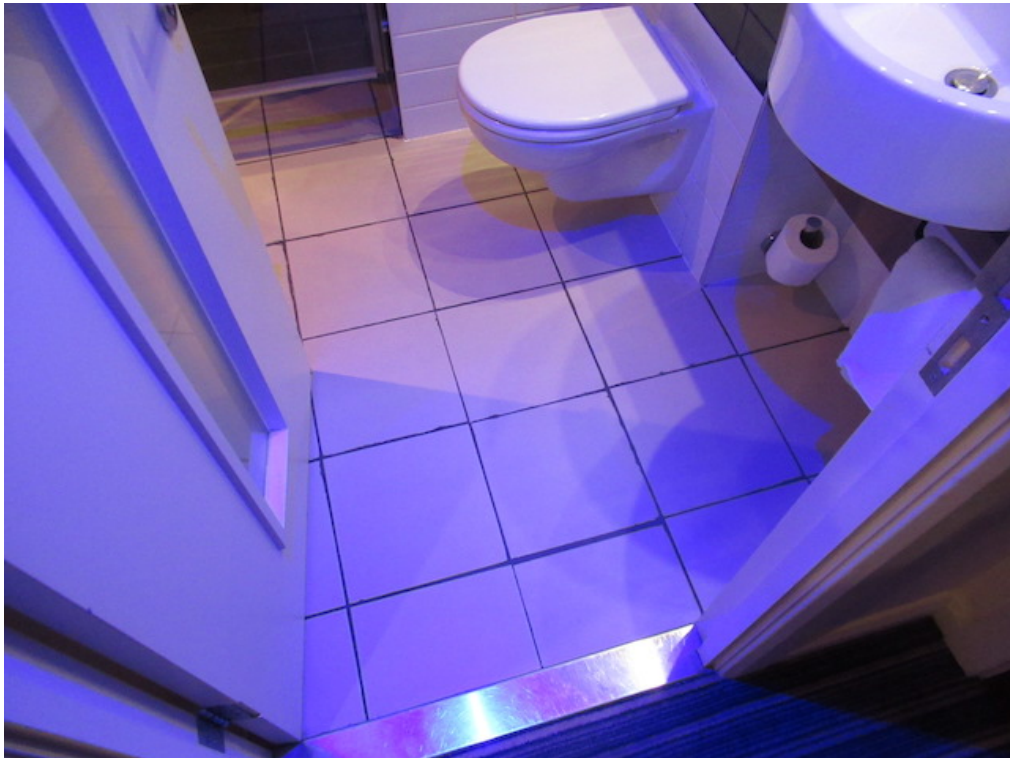
4.37 A significant number of the inspected bathrooms had poor and/or cracked floor tiles and poor grouting. Some of the floors had been re-tiled, although the repairs have been undertaken to a poor standard and the white floor grouting has discoloured. The cracked tiles also present a potential health and safety issue for the hotel guests. We understand that the hotel management is aware of the defects in the bathroom floors and has instigated a process of repair/replacement works.

23. Poor condition of floor tiles and grout to bathroom pods

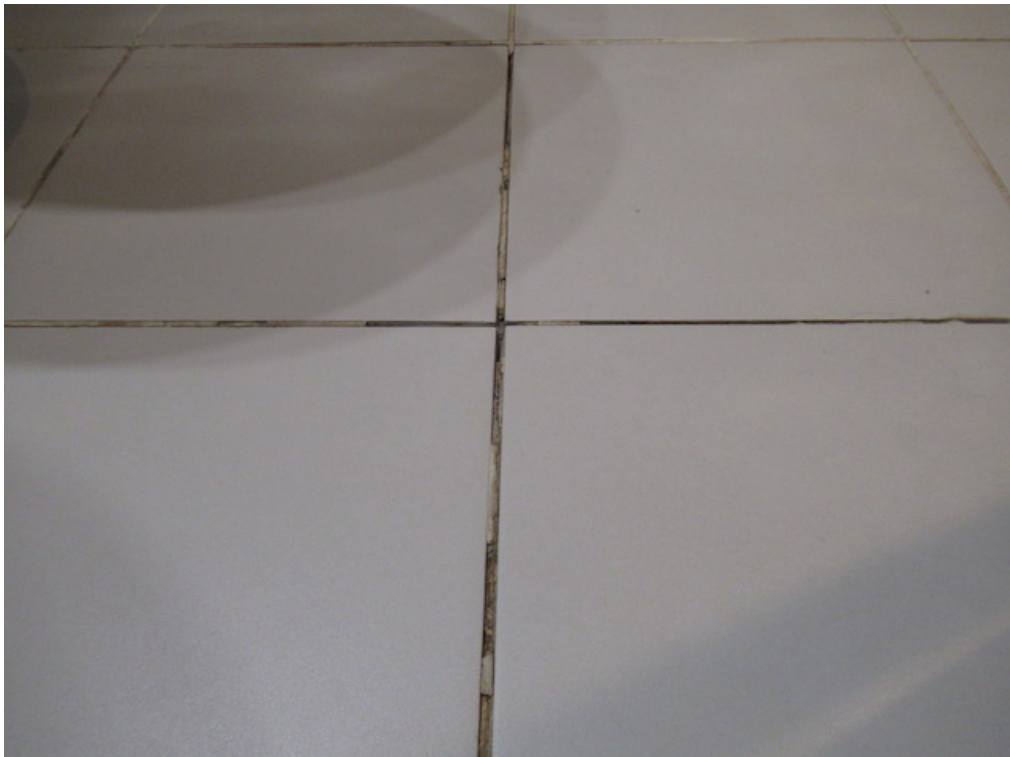
24. Poor condition of floor grout to bathroom pods

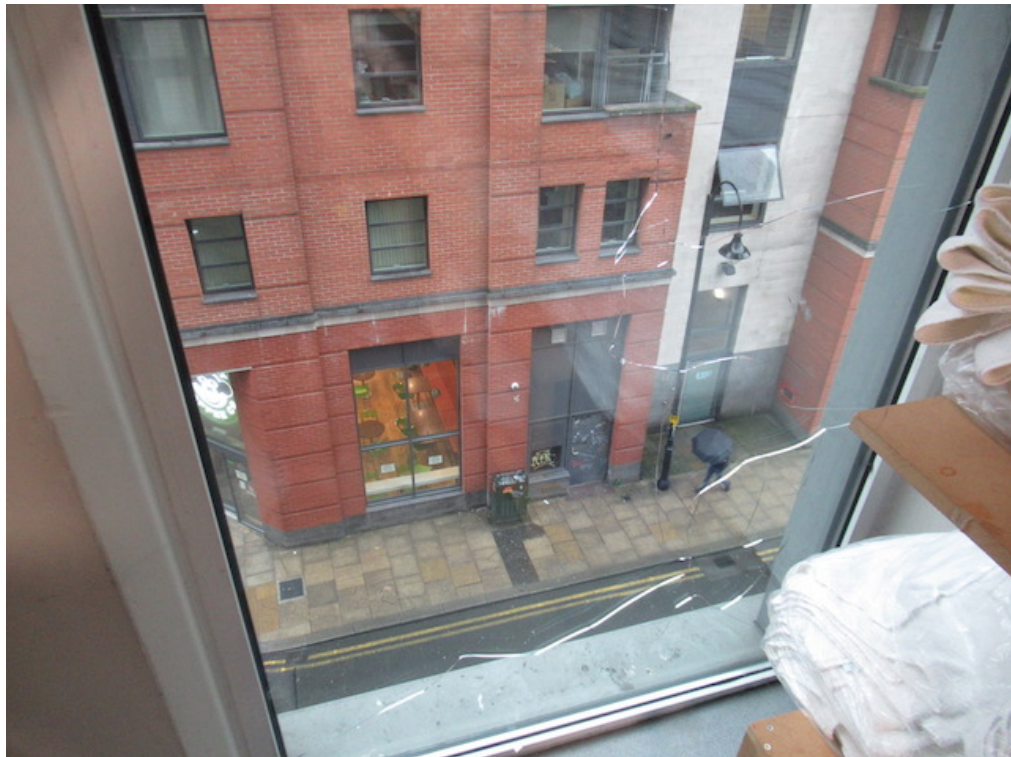
- 4.29 The windows to the 2<sup>nd</sup> and 3<sup>rd</sup> floor linen stores had smashed inner panes and should be replaced immediately. The glass appears to have been broken due to impact from cleaner's trolleys, etc. and we recommend that the windows at all levels be fitted with crash barriers to prevent further accidental damage.

26. Typical smashed inner panes to linen store windows

| Works Required | | Budget Cost (£) |
|---|---|---|
| 5. | Replace cracked double-glazed panes to 2 <sup>nd</sup> and 3 <sup>rd</sup> floor linen rooms and provide barriers to all. | 8,000 |
