| <b>Project:</b> | William Kay House, The University of Manchester | |
| <b>WML reference number:</b> | 12023R-WML-XX-ZZ-RP-S-5001 | 17 <sup>th</sup> February 2025 |

| <b>Survey Brief:</b> | Structural condition survey in advance of proposed refurbishment project |

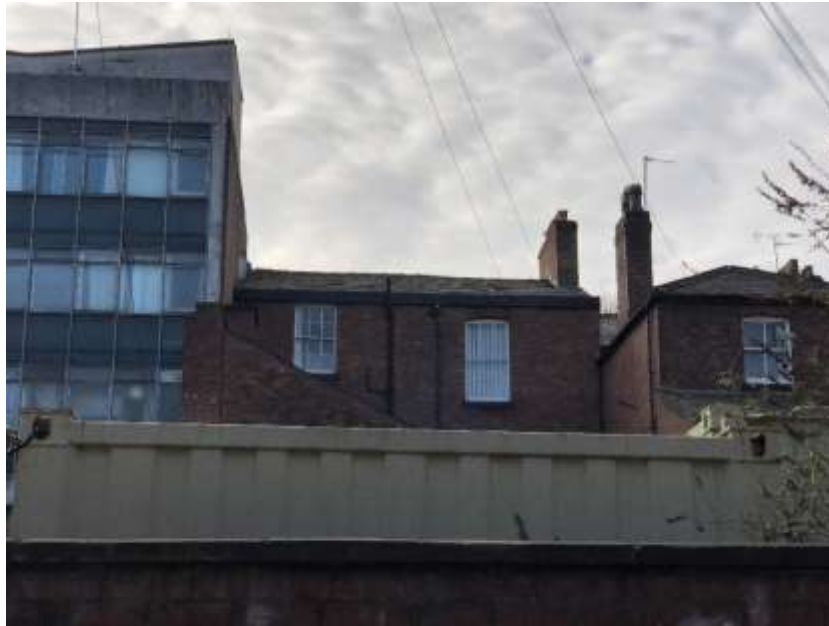
Photo 1

- The roofs generally appears to be in relatively good condition, although the ridgeline to the southern building appears to dip, and there may be some distortion of the rear roof plane and disruption to the slates (photo 1)

- The loft space was not accessed during the inspection. It is recommended that the roof structure is surveyed, in particular to assess whether the dip in the ridge line represents a failed ridge member. A timber rot and damp specialist should be consulted.
- Some local brickwork repointing will be required to the rear.
- The condition of the main entrance canopy structure will need to be investigated. Existing finishes should be removed to allow an inspection.
- The minor cracking to the front elevation should be investigated. Existing finishes should be removed to allow an inspection of the masonry.
- The damaged entrance step will require concrete repairs.
- It is considered that the south boundary wall will need to be partially taken down and rebuilt, with other areas patch repaired and repointed.

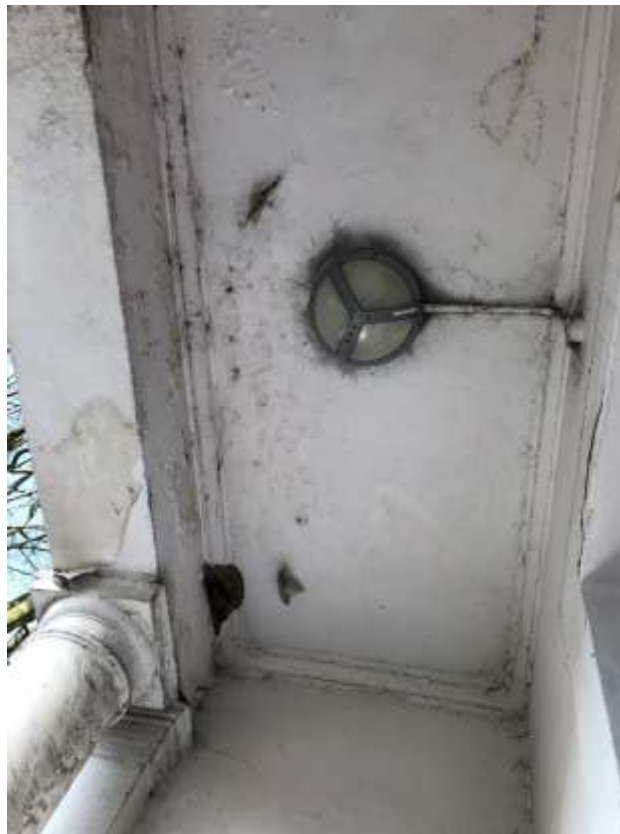
Photo 2

- The soffit of the canopies to the main entrance on the front elevation shows signs of significant water ingress with spalling paint and fungus growth (photo 2). The condition of the underlying stone could not be determined.

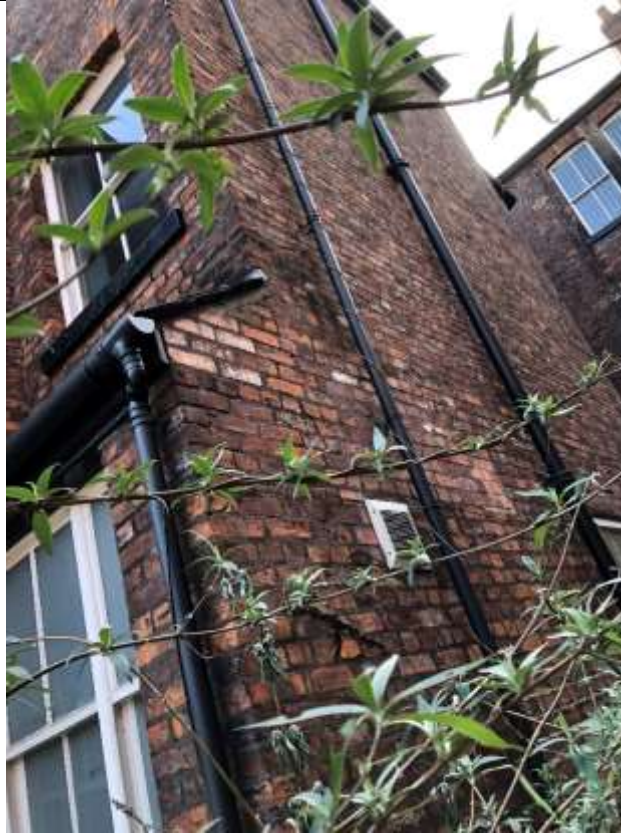
Photo 3

- External elevations generally appeared to be in relatively good condition with walls in good vertical and horizontal alignment. There are some limited areas of defective pointing at the rear of the property (photo 3), and some areas of vegetation growth as referenced in the UoM report.

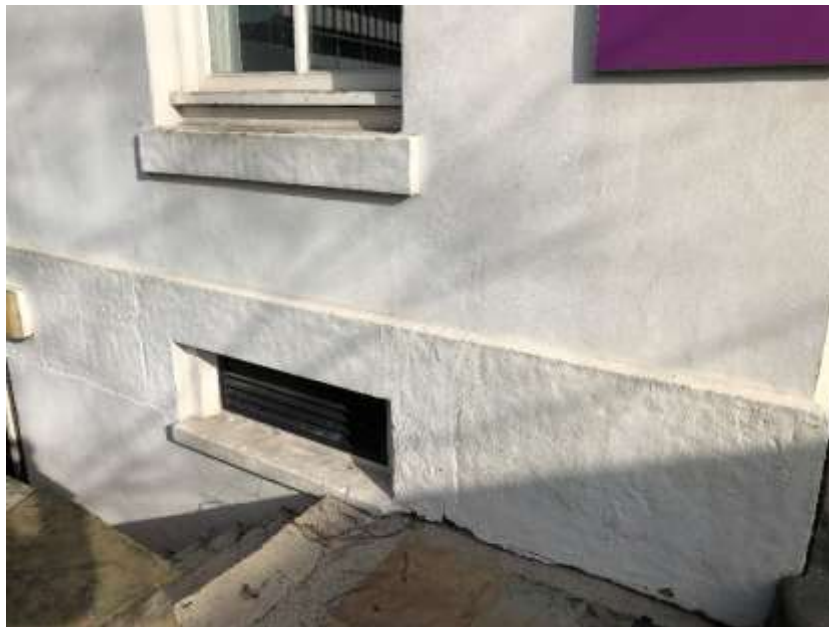
Photo 4

- There appeared to be some minor cracking to the front elevation masonry around windows (photos 4&5)
- The south wall is rendered and the render has numerous cracks. Render is not a structural element and recommendations for this are included in the UoM report.

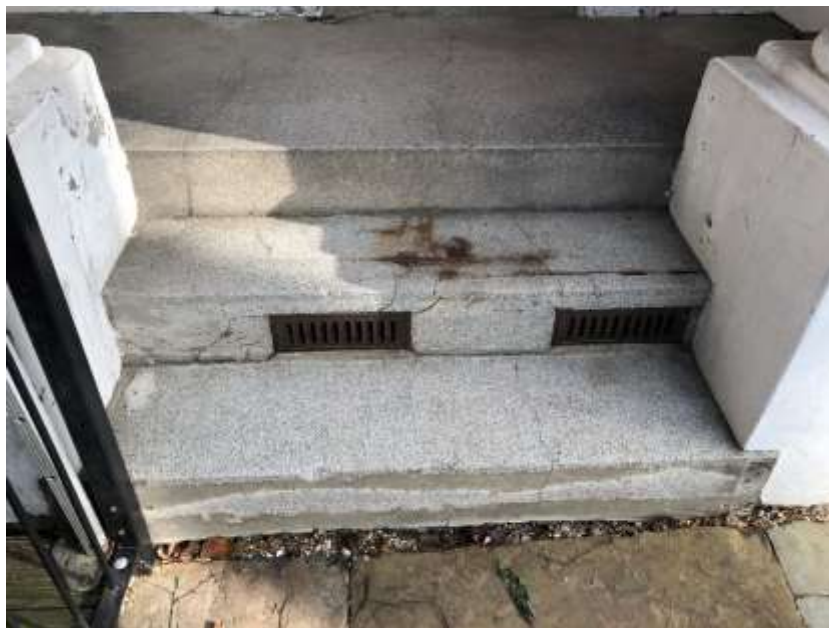
Photo 6

- Spalled concrete and exposed reinforcement was noted to one of the entrance steps (photo 6)
- The boundary garden wall to the south is in poor condition with missing pointing and a bow to the south (photos 7&8)

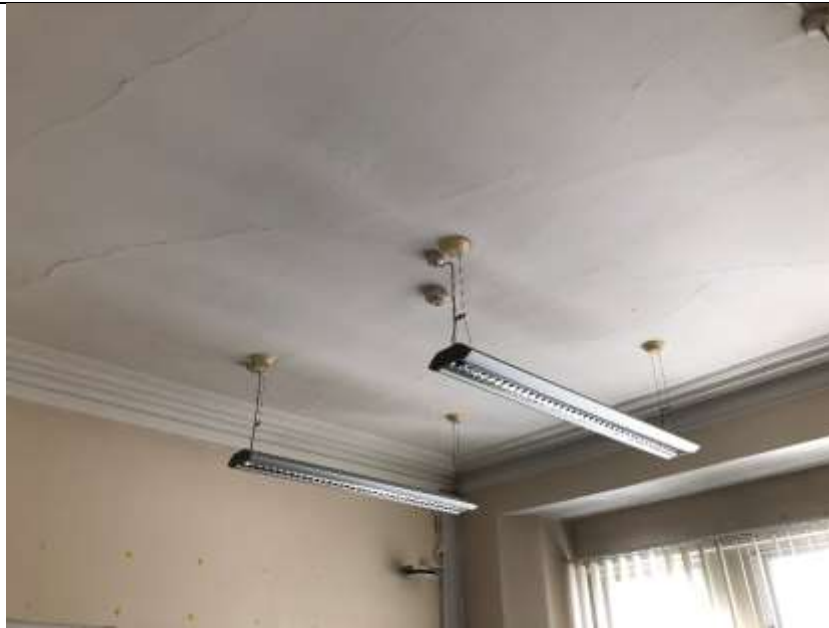
Photo 9

- The loft space was not accessed.
- There is plaster cracking to walls and ceilings in a number of rooms at second floor level (typical photo 9). In some cases ceiling cracking connects with wall cracks suggesting some movement of the structure, the north building staircase is an example of this (photo 10)

- Plaster cracking at second floor to walls and ceilings is noted in the UoM report as de-bonded lath and plaster. This is likely to be the case in most instances, however it is considered that some cracks may reflect underlying masonry cracking and could reflect some movement at eaves level/defective lintels. It is recommended that plaster is removed at key cracking locations to determine whether there are underlying structural defects which require remedial works.

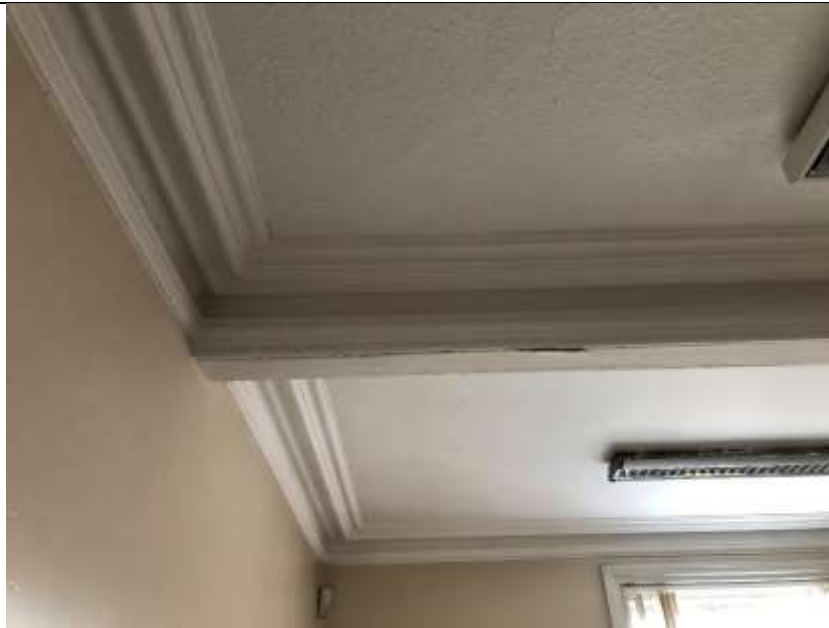
Photo 11

- Water ingress was noted around a timber beam over room M.002/M1.02 (photo 11).
- There was some plaster cracking to the inside of the front elevation around windows at first and second floor levels (photo 12).

- It is recommended that timbers are tested for damp and rot by a timber specialist in any areas where there appears to have been water ingress / damp, for example room M.002/M1.02, areas at ground floor level, and basement timber lintels.

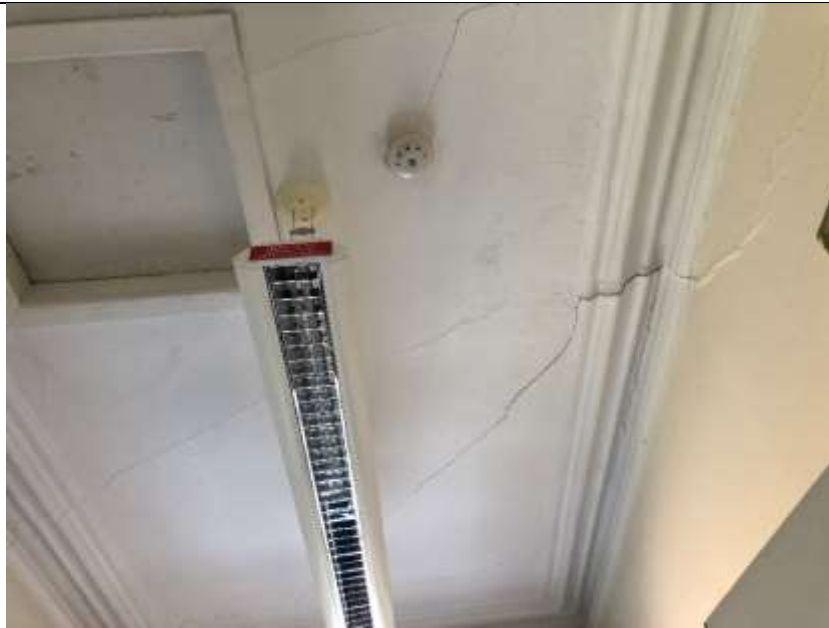
Photo 13

- There is relatively significant plaster cracking to the first-floor room 1.015/1.05A (photo 13).
- More plaster cracking was noted to walls and ceilings at first floor level.

- Similar investigation of the masonry condition behind the plaster is recommended for the front elevation at first floor level, and for first floor room 1.015/1.05A.

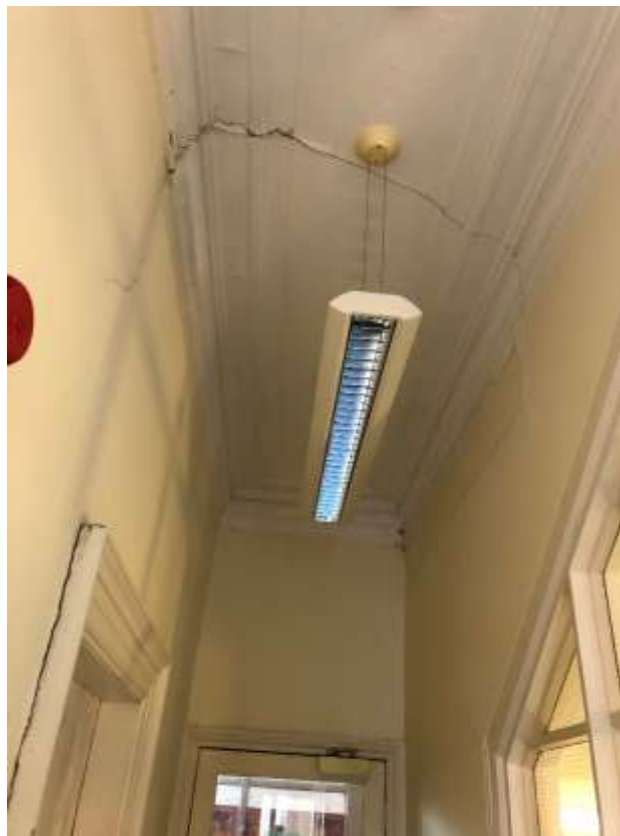
Photo 14

- It was noted that the main staircase is supported by a stainless-steel tension rod system, which is clearly a modern intervention. There is cracking to the walls and ceilings of the adjacent corridors which may be related to previous movement of the staircase (photo 14)

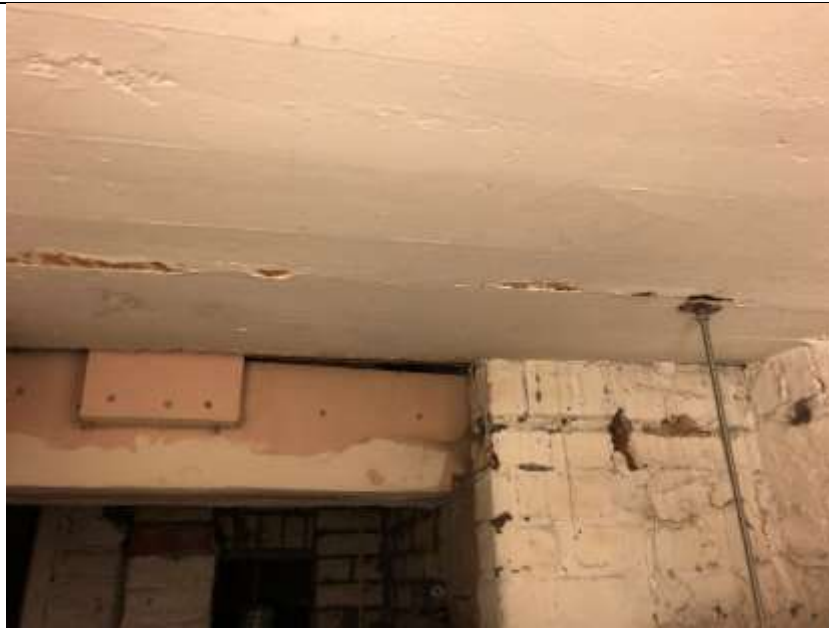
Photo 15

- Some areas of damp were noted to walls at ground floor and basement level.
- The floor over the north end of the basement corridor B.004/B.013 is a concrete filler joist slab and there is evidence of corrosion to the embedded steelwork (photo 15). There were also steel lintels in this area and cracked brickwork which suggests corrosion of embedded steelwork (photo 16).

- The area of concrete filler joist slab to the rear (over B.004/B013) should be hammer tested to remove any loose concrete, exposed steelwork should be cleaned and treated and the concrete reinstated using a specialist concrete repair mortar.

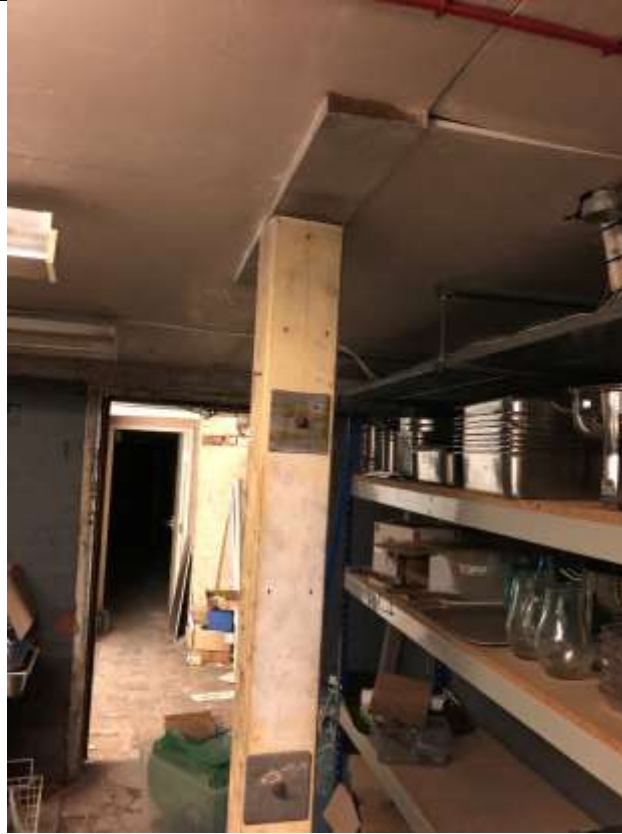
Photo 17

- A timber column has been installed in the basement room B.013/B.008. The column is formed from a pair of timbers bolted together and appears to be an engineered solution (photo 17). The purpose of the column is not clear as the location does not appear to align with any structure above.

- Current proposals for the basement do not require the timber post to be removed. The post appears to be in good condition and as such it is suggested that it should remain.
