# Inspection Certificate for Hygiene Facility

Certificate No.: **HF-20241219140305**

Project No.: **P-57053**

Site: **Kellen Homes Housing Site**

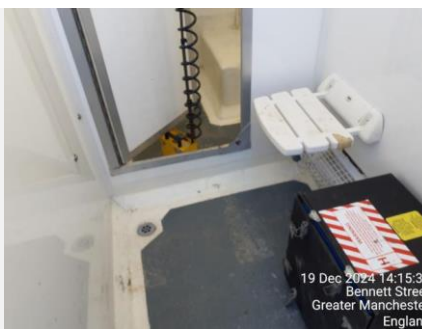
Sample 004 and Sealed NPU
