# Certificate of Re-Occupation

Certificate No.: **RC-20241219083055**

Project No.: **P-57053**

Site: **Kellen Homes Housing Site**

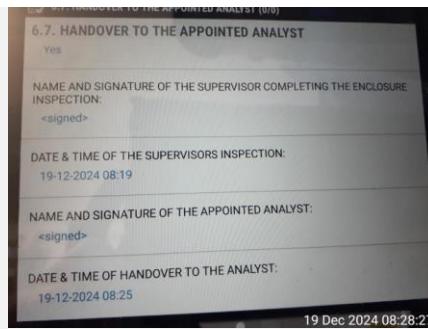
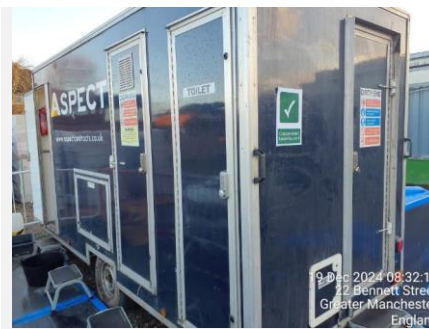
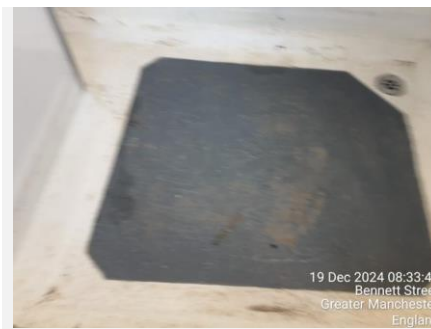
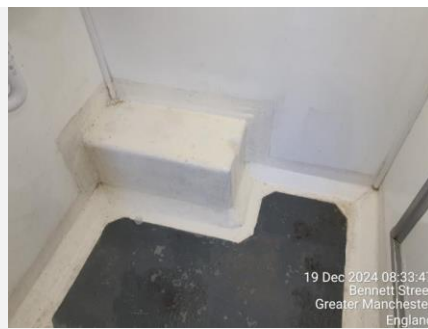
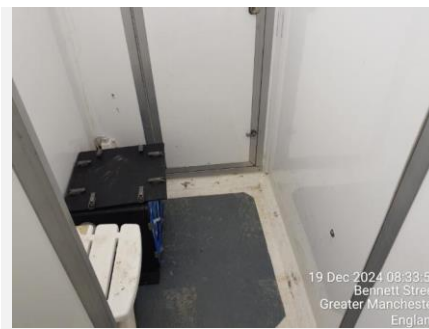
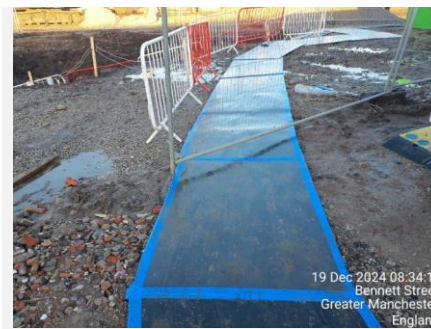
| Comments: | Work area presented to a satisfactory standard by supervisor Brian Hart. | | |

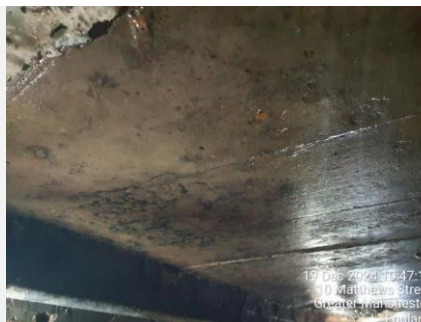
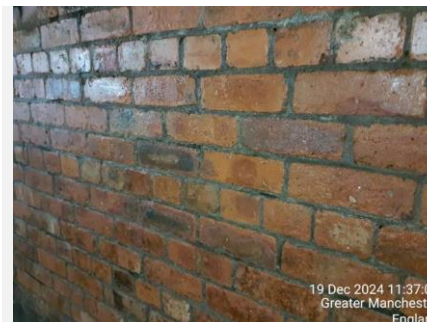
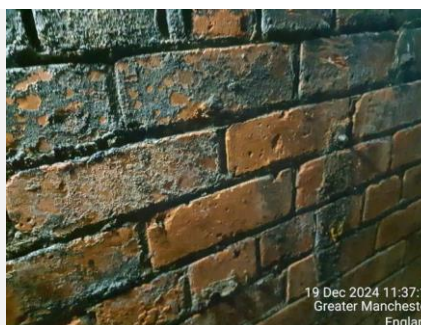
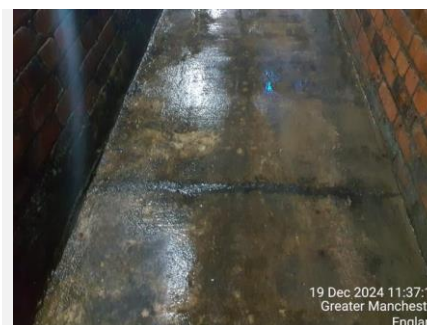
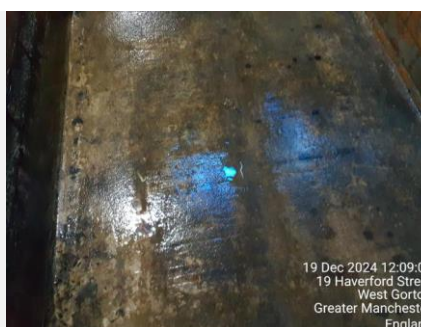
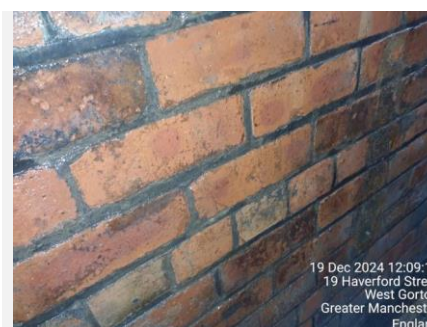
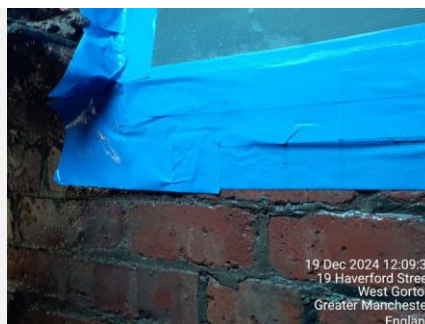
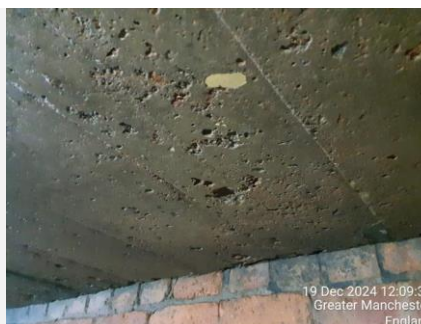
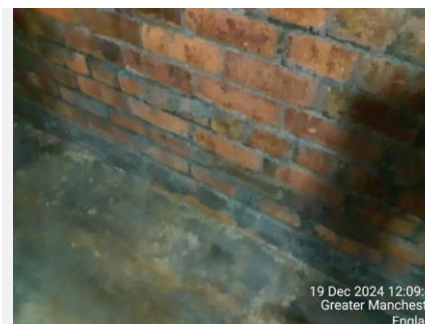
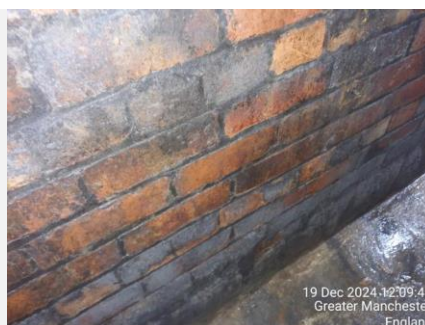
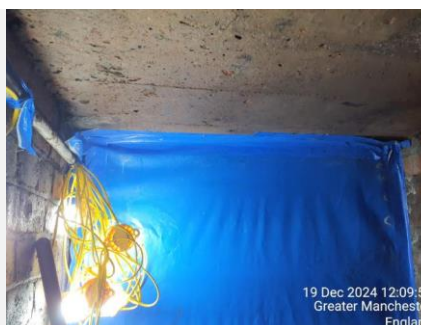
The visual inspection carried out as part of the four stage clearance was passed after some minor amounts of residual dust were cleaned (<10 minutes) whilst present which ultimately led to achieving a satisfactory standard of cleanliness.

All Pipework and brackets cut out and removed from Enclosure.  
All walls, floors and ceiling wire brushed and cleaned as far as reasonably practicable.  
Surfaces very damp due to weather conditions and the Duct being below natural water level. This was dried out as far as reasonably practicable by LARC prior to 4 Stage Clearance.

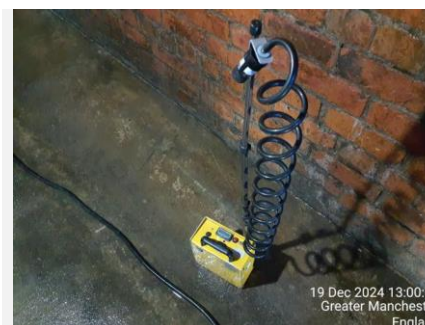
Stage 3 - Sample 001

| Sample no. | Pump no. | Cowl no. | Sample / Test Type | Location / Description | Start time (mins) | Finish time (mins) | Sample time (T) | Initial flow (l/m) | Final flow (l/m) | Average flow (F) (l/m) | Volume (V) (V=T*F) | Fibres (N) | Fields (n) | Limit of quantification (f/m) | Calculated result (f/m) | Reported result (f/m) |
|---|---|---|---|---|---|---|---|---|---|---|---|---|---|---|---|---|
| 001 | SP09 | 09 | Clearance | Floor Duct | 12:46 | 13:27 | 41 | 12.2 | 12.2 | 12.2 | 500 | 6 | 200 | 0.010 | 0.003 | < 0.01 |

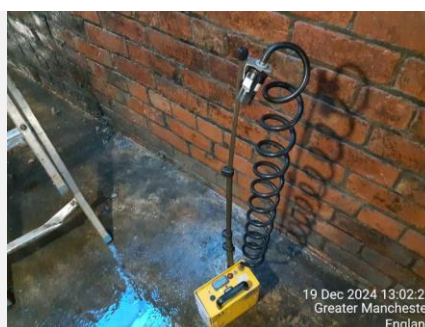
Stage 3 - Sample 002

| Sample no. | Pump no. | Cowl no. | Sample / Test Type | Location / Description | Start time (mins) | Finish time (mins) | Sample time (T) | Initial flow (l/m) | Final flow (l/m) | Average flow (F) (l/m) | Volume (V) (V=T*F) | Fibres (N) | Fields (n) | Limit of quantification (f/m) | Calculated result (f/m) | Reported result (f/m) |
|---|---|---|---|---|---|---|---|---|---|---|---|---|---|---|---|---|
| 002 | SP10 | 10 | Clearance | Floor Duct | 12:47 | 13:27 | 40 | 12.2 | 12.2 | 12.2 | 488 | 3 | 200 | 0.010 | 0.002 | < 0.01 |

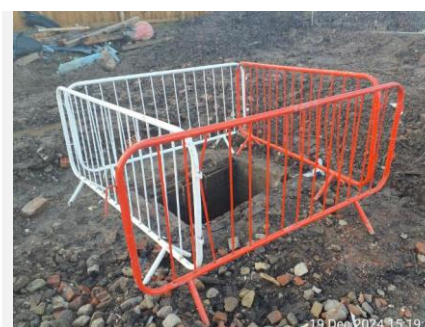
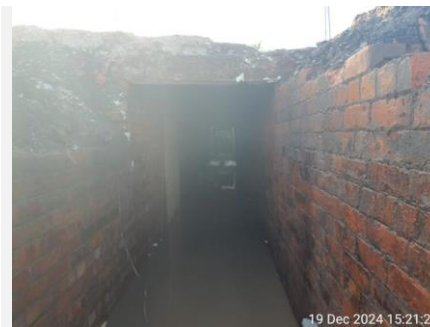
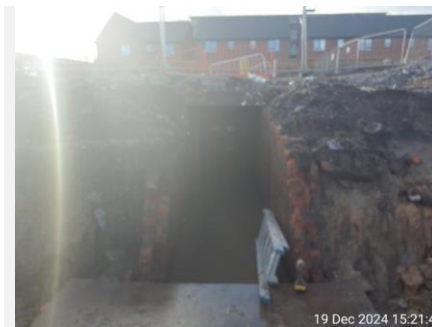
Comments: General Debris/Mud to surrounding areas due to the nature of the site.
