**Re: 15 Twyford Close, Didsbury, Greater Manchester. M20 2YR**

## PRELIMINARY ARBORICULTURAL REPORT

Survey address: 15 Twyford Close, Didsbury, Greater Manchester. M20 2YR

| <b>Survey carried out by:</b> | Guy Smallthwaite | <b>Date:</b> | 20.07.2021 |

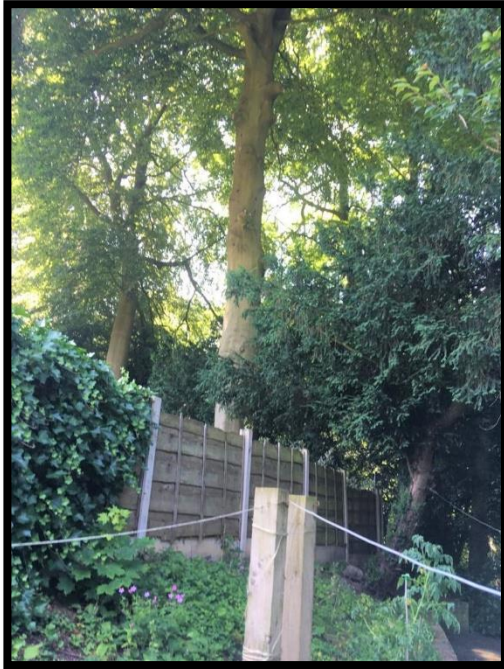
**Comments and description:** A very large healthy, mature tree with no apparent defects. It has a single stem with evidence of a recent canopy raise to allow more natural light into the rear gardens (tree located in neighbouring garden).

Plate 1. Large beech tree (T4) located in neighbouring garden with T10 to the left.

**Tree work:** No work required at present.

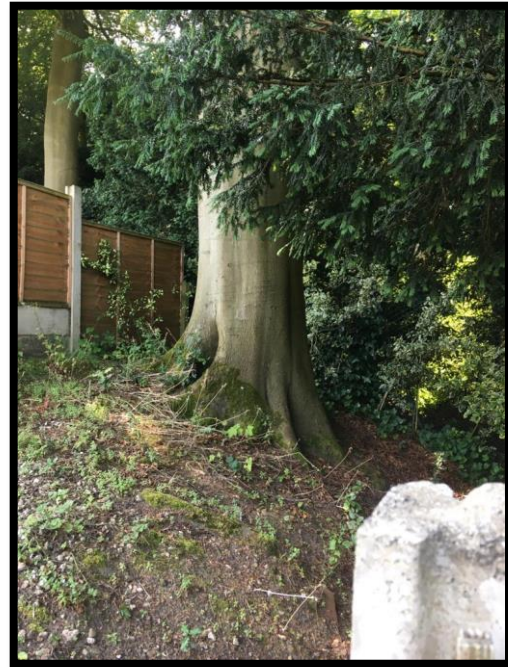
Plate 2. The beech (T4) located in far corner of neighbouring garden.

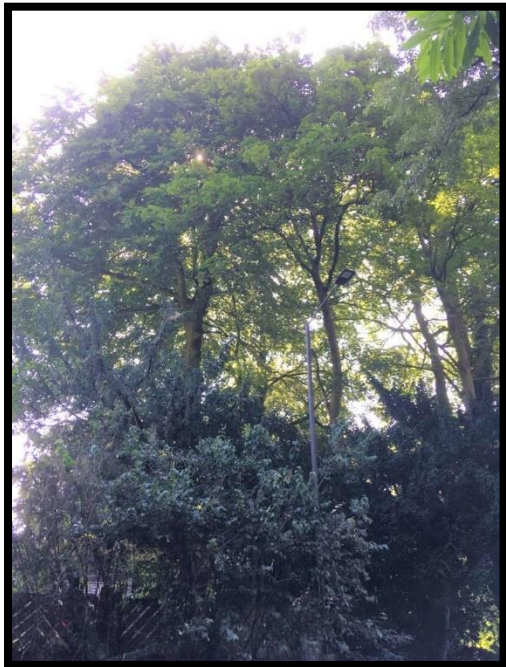
**Comments and description:** Tree in good health with a single, vertical stem and no apparent defects. It has a weight bias towards the north west (tree located on third party land).

Plate 3. T4 to the left, the sycamores T8 and T7 to the right.

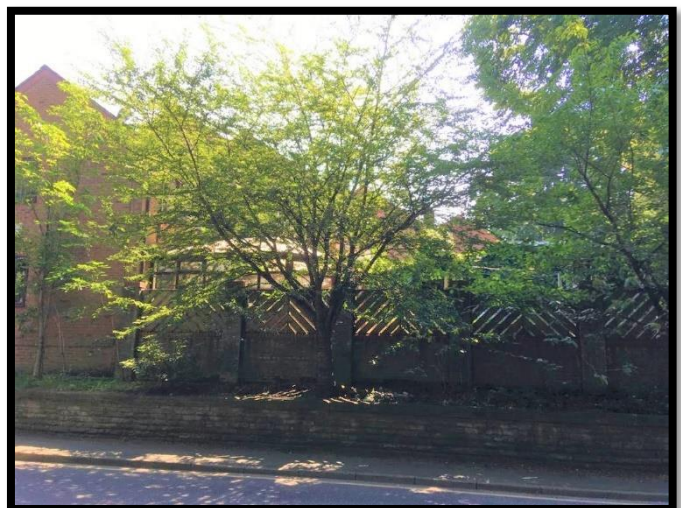
| Tree No. | Species | Age Range | Co nd. | Height (m) | Crown Spread (m) | Diameter (mm) | Dist.to Structure (m) | Ownership |
|---|---|---|---|---|---|---|---|---|
| <b>Comments and description:</b> Healthy tree with no apparent defects. It will require pruning to retain size and shape. Branches are starting to extend over conservatory.<br><b>Tree work:</b> Future pruning will be required due to its location. | | | | | | | | |
| <b>Comments and description:</b> A healthy multi-stemmed tree with no apparent defects.<br><b>Tree work:</b> Future pruning will be required due to its location. | | | | | | | | |

**Comments and description:** Trees in good health with no apparent defects. They will require pruning back in the future to control size.

Plate 4. Image of the cherries(G1), T1 in the centre and T2 to the right.
