**Trial Holes Undertaken 08<sup>th</sup> May 2024**

**The Brunswick  
97 Piccadilly  
Manchester  
M1 2DB**

**TRUST PUBS**

**Document Ref: EQ92-HV-XX-XX-RP-S-0003**

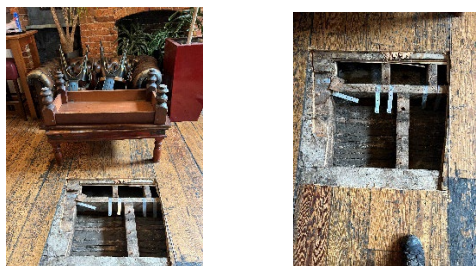
Figure 2 – Trail Hole 2

- 4.1.1. **Trial Hole 2** – Was within the main trade area and over the beer cellar. 130mmx150mm trimmers appear to run either side of the chimney breast, with 150x75mm standard members at 400mm c/c, similar to Trial Hole 1, however there appeared to be some addition trimming as can be seen in Figure 2 below.

- 5.2.1. **Area over Cellar, Area 1** – Complete replacement of floor
- 5.2.2. **Area over Kitchen Stoor, Area 2** – Floor to be retained, however allow a provisional sum for some strengthen / making good works in this area.

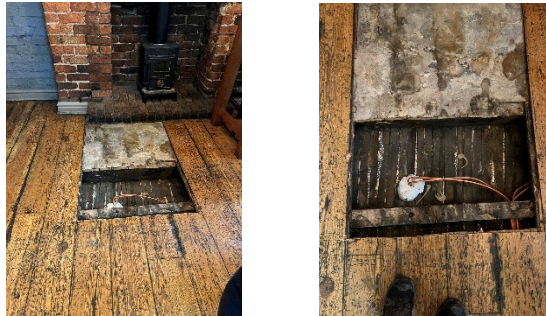
Figure 3 – Trial Hole 3

4.1.1. **Trial Hole 3** – Was within the main trade area and over the Kitchen Store below, the joist appear to span in the opposite direct to trial hole 1, but of similar size, being 150x75mm standard members at 400mm c/c.

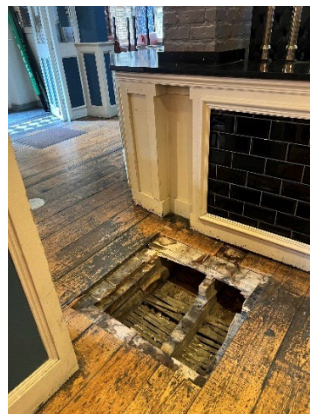
Figure 4 – Trial Hole 4

4.1.1. **Trial Hole 4** – Was positioned in front of the bar and over what is called the hallway below. The main structural member would appear to be from a 100x80mm timber member timber tongue a grooved board over, the floor is then counter battened out to make up the height to as the rest of the floor. It appears the front section of the bar is sat on these members, and they have deflected under the weight of the bar.

- Take load as above, Span  $2 \text{ m}$ ,  $100 \times 80$  Section  
SECTION FAILS, without LOAD of BAR!

- 5.2.3. **Area over Halfway, Area 3, and Area and Rear of Bar, Area 4** - Complete replacement of floor. Also note that this will require the removal and reinstatement of the bar.

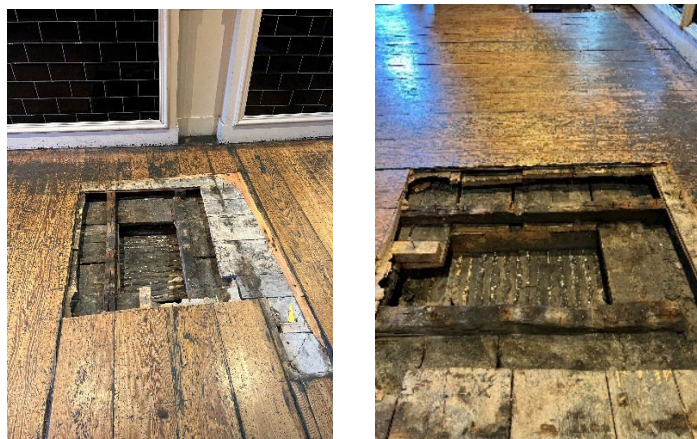
Figure 5 – Trial Hole 5

4.1.1. **Trial Hole 5** – Similar to Trail hole 4

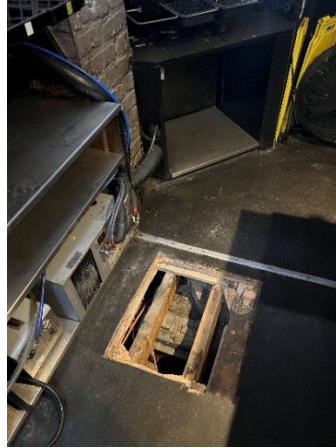
Figure 6 – Trail Hole 6

- 4.1.1. **Trial Hole 6** – Was positioned to the rear of the bar area, these timbers look to be of a more recent timber than the rest of the floor exposed and span parallel to the bar, from 150x50mm sections at 250mm c/c.

- Take load as above, Span  $2 \text{ m}$ ,  $100 \times 50$  Section  
- Section fails in deflection.

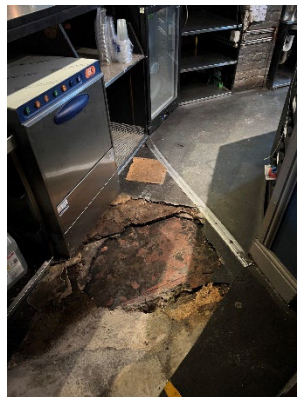
Figure 7 – Trail Hole 7

- 4.1.1. **Trial Hole 7** – Again to the rear of the bar, but appears to be ground bearing. This would match up with where we were unable to access, see Sketch 1 and assume a ground bearing floor. c/c.

- 5.2.5. It was also agreed that the area of assumed ground bearing floor a budget of, say 50% of the floor to be replaced / made good.
- 5.2.6. A provisional sum allowance should also be made for ventilation of the floor.

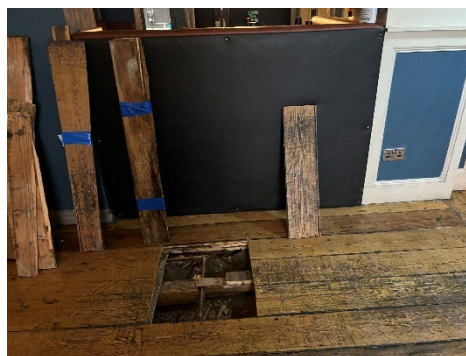
Figure 8 – Trail Hole 8

- 4.1.2. **Trial Hole 8** – Was within the main trade area and appears to be ground bearing. This would match up with where we were unable to access, see Sketch 1 and assume a ground bearing floor. There were timbers that appeared to be spanning above the ground below by about 50mm.

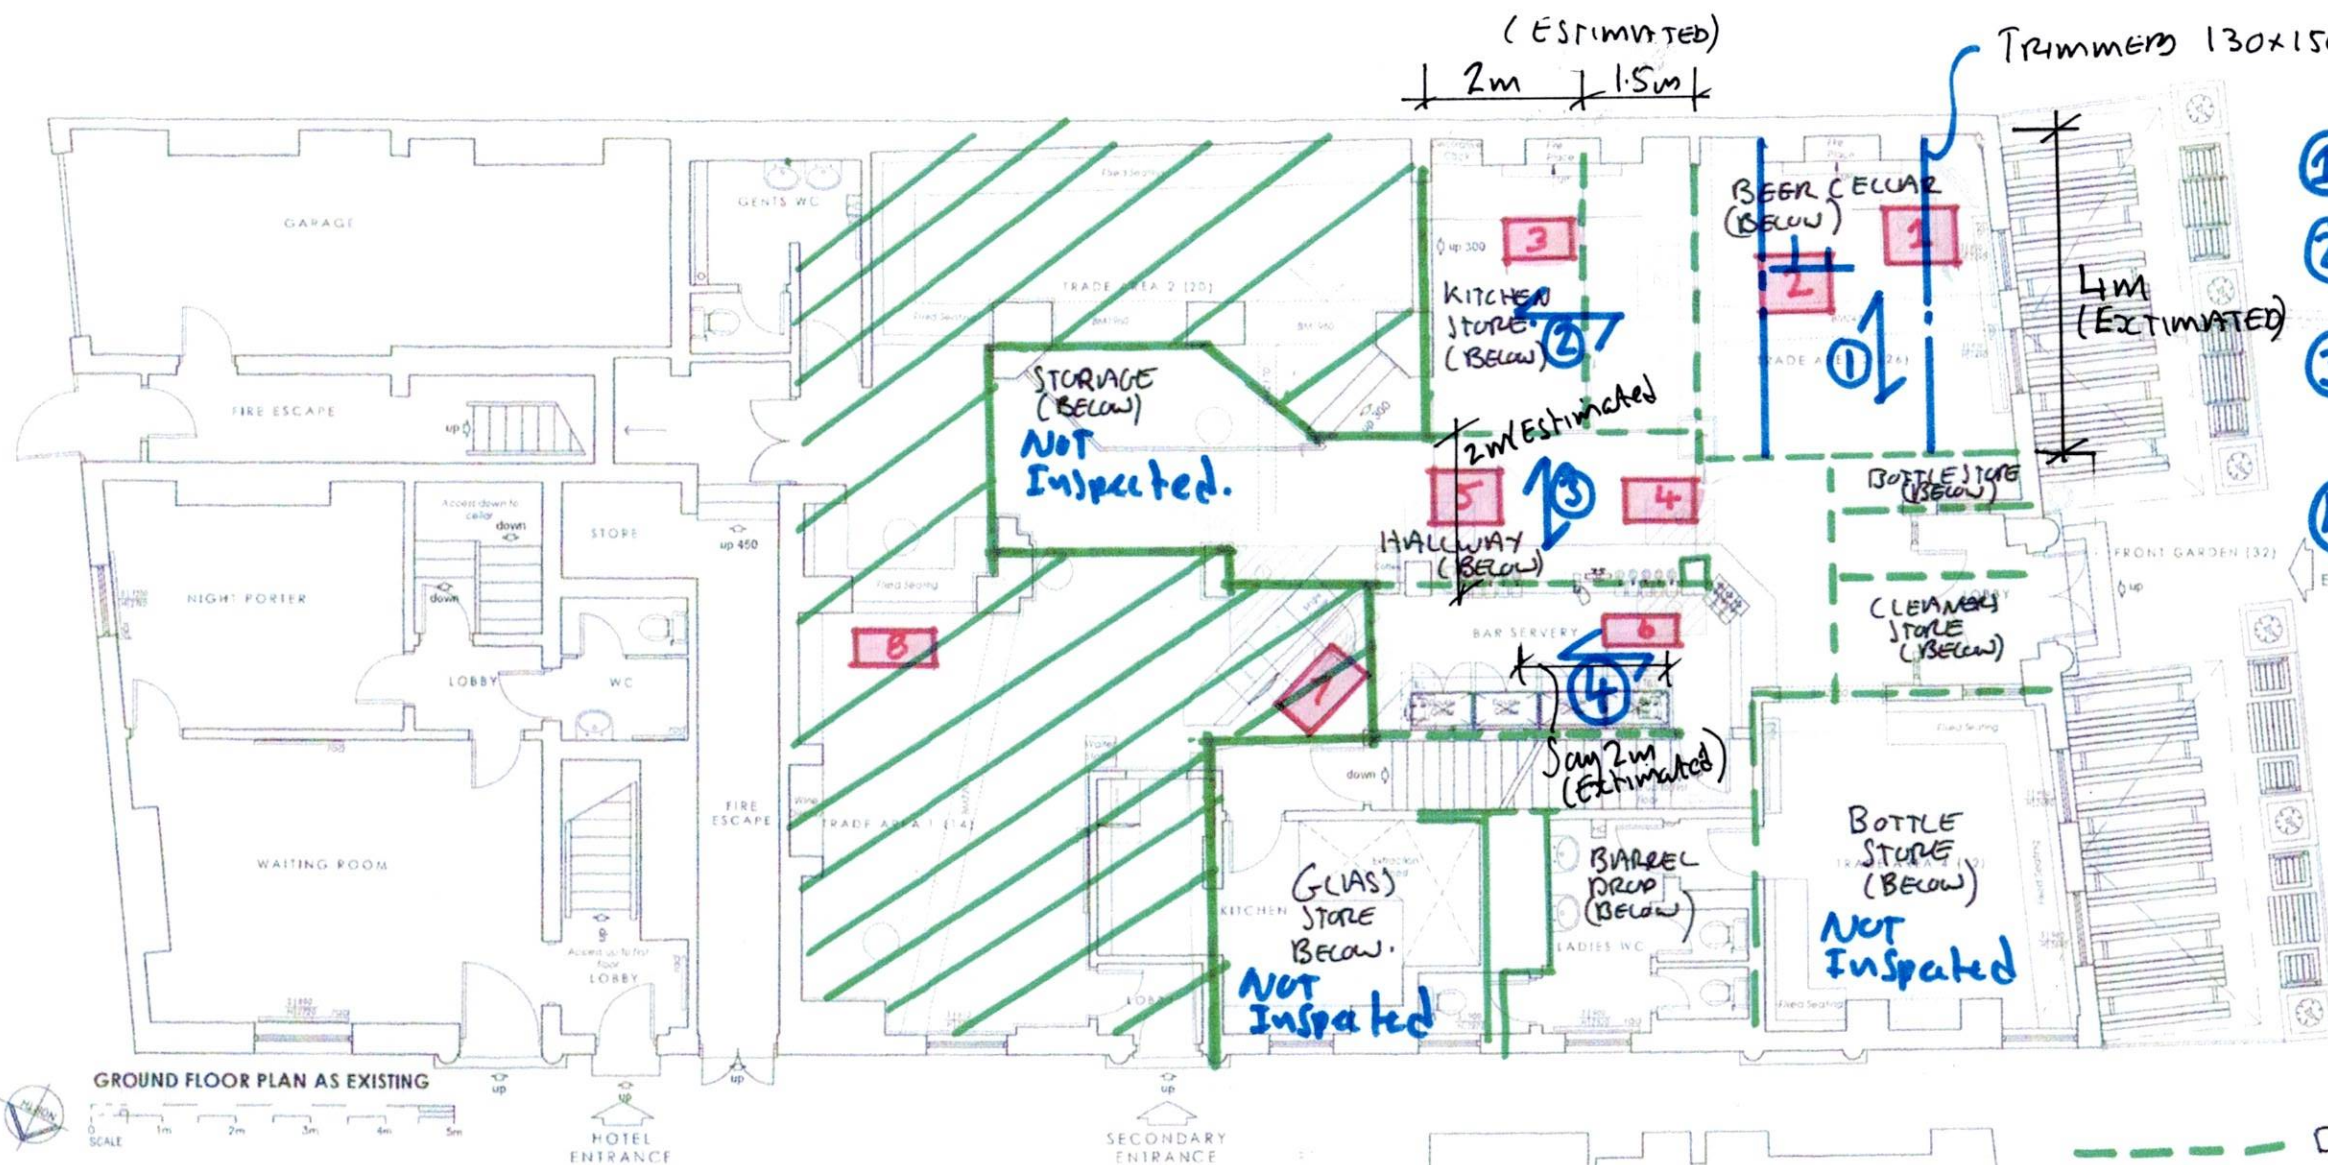
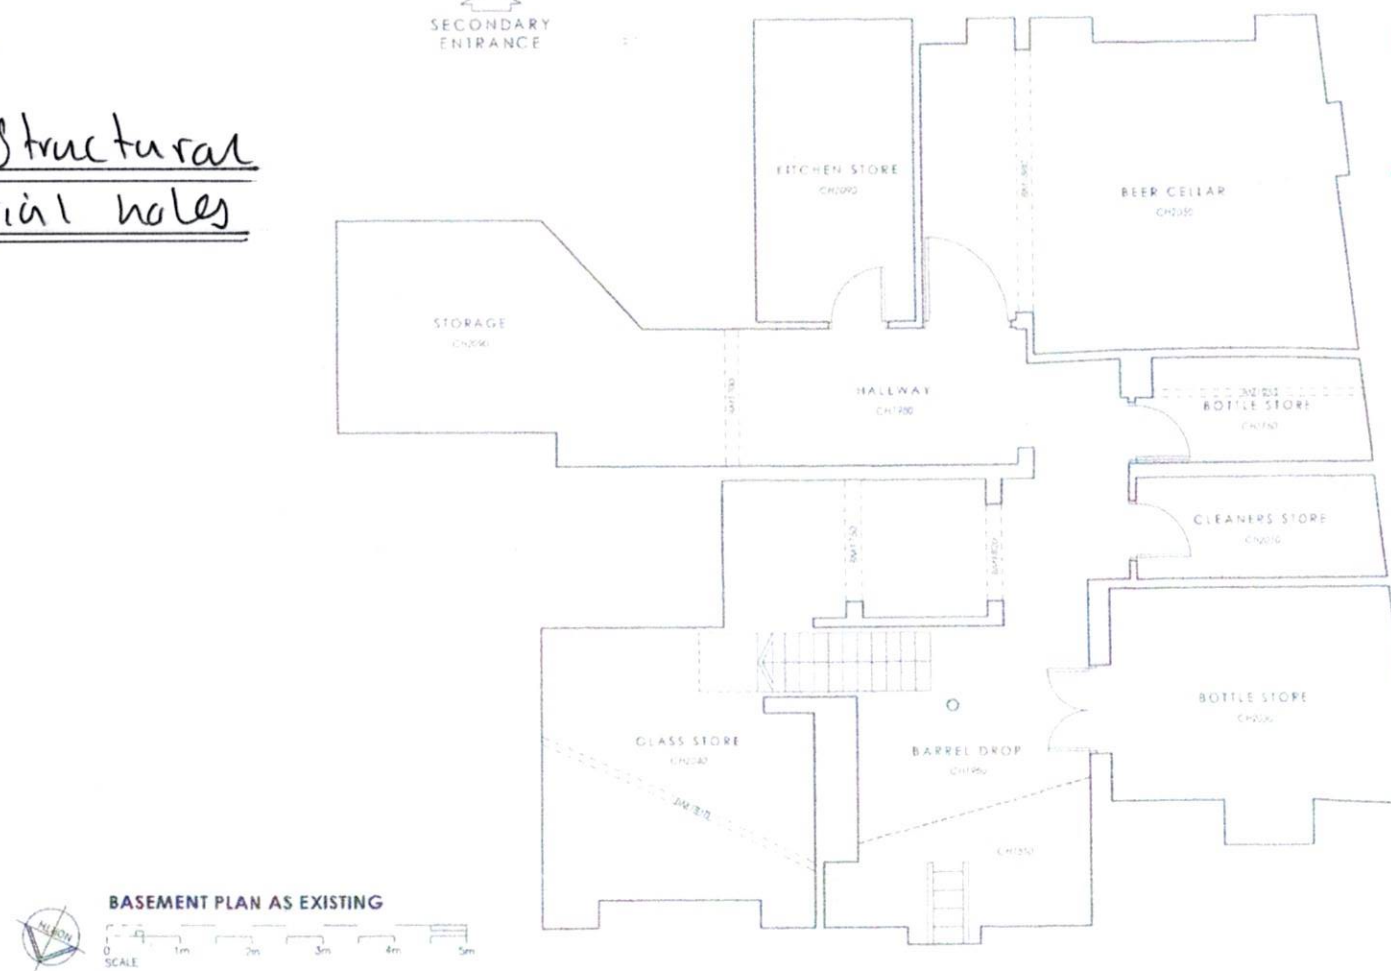
SKETCH 2 - ASSUMED Structural layout following trial holes of 08/05/2024.

- ① - 150x75, 4m Span @ 400mm c/c
- ② - 150x75, 4m Span @ 400mm
- ③ - 100x80, 2m Span @ 350mm
- ④ - 150x50, 2m Span, @ 250mm c/c.

ASSUMED TIMBER STRUCTURAL MEMBER SIZES BASED ON TRIAL HOLE of 08/05/2024, - ALL TO BE CHECKED ONCE ASBESTOS REMOVED.
