Preliminary Roost Assessment

23 Radium Street, Ancoats

Reference: 81-588-R1-2

Date: February 2025

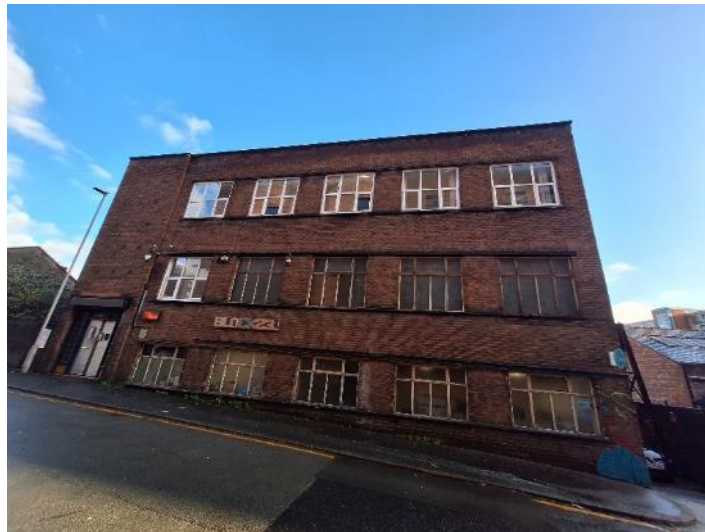
PLATE 1      SHOWING SOUTH-WEST ASPECT OF BUILDING

The on-site building was an active detached three-storey commercial building, comprising red brick walls with a flat concrete roof. A redbrick chimney, which was in good condition, was present on the north-west aspect of the building. A metal three-storey staircase was present on the north-east aspect of the building. The staircase did not appear to be in good condition, with metal sheeting covering multiple steps. Two streetlamps were present adjacent to the building; one directly adjacent to the north-west aspect of the building, and adjacent on the opposite side of Radium Street on the south-west aspect. Therefore, it was determined that the south-west aspect of the building will be illuminated by artificial light at night. No evidence of bat droppings or staining was identified throughout the entire building, both internally and externally.

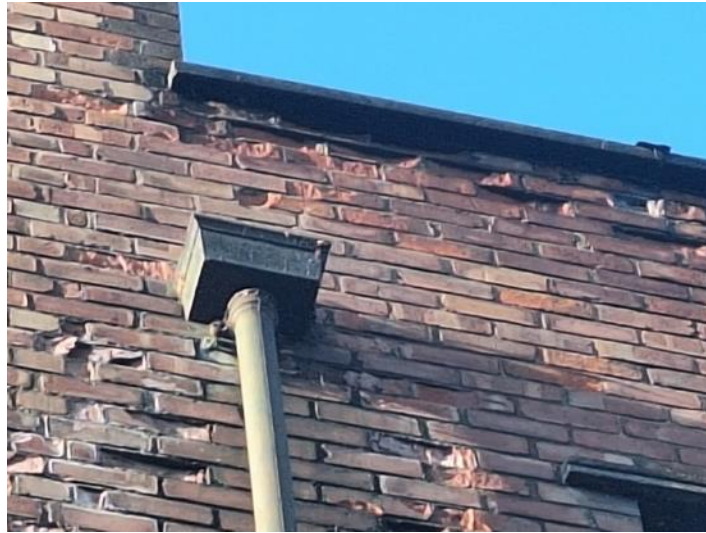
PLATE 2      SHOWING SUPERFICIAL DAMAGE AT TOP OF WALL PLATE

The brickwork was mostly in good condition on all aspects of the building; however, there were multiple cracks and crevices present within the brickwork (F1 to F6), which may support roosting bats on a regular basis. Superficial damage to the brickwork was also present along the top of the wall plate on all aspects of the building. No cracks or crevices which would be deep enough to support roosting bats, including on an occasional basis by opportunistic crevice-dwelling bats, such as pipistrelle species, were identified. It was therefore determined that there were no suitable bat roost features present within the brickwork at the top of the wall plate on all aspects of the building.

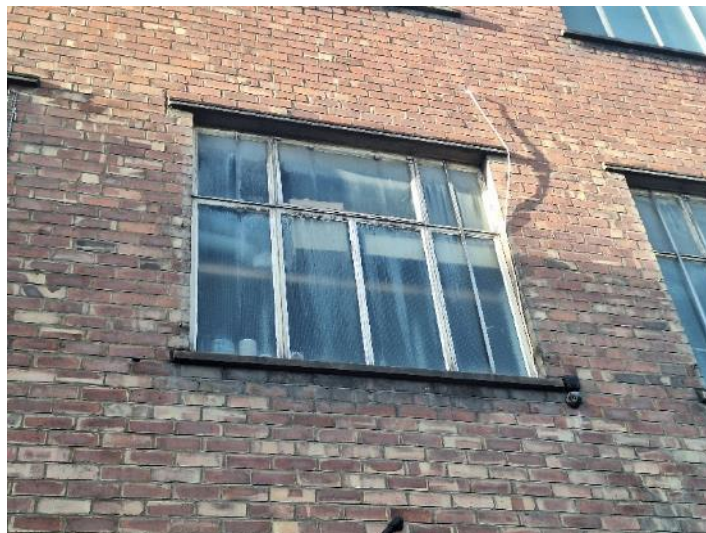
PLATE 3      SHOWING CASEMENT WINDOW

Casement windows with metal frames were noted on all levels and aspects of the building. The windows, and brickwork surrounding the windows were generally in good condition and well-sealed (excluding F1), with no obvious cracks or crevices present which could be utilised by roosting bat species. The gaskets surrounding the windows were also in good condition and well-sealed and therefore did not provide any potential bat roost features or access into the building for bat species.

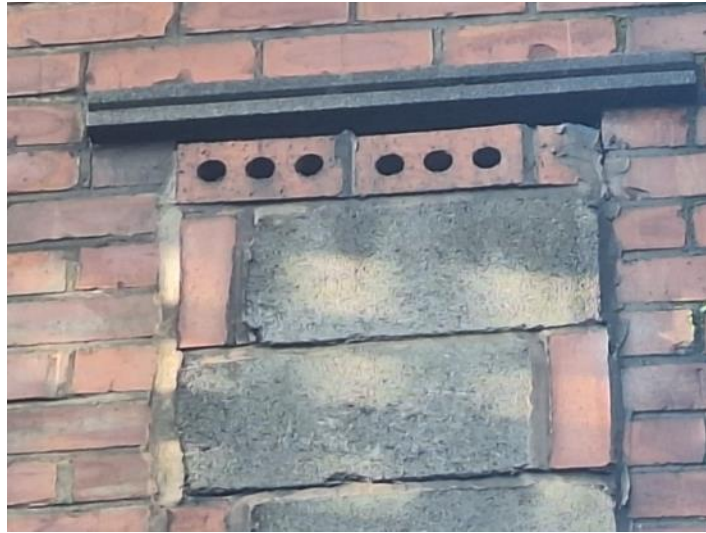
PLATE 4      SHOWING FILLED IN WINDOW

Multiple windows had been filled in with red bricks, cinder blocks and concrete on the north-east and north-west aspects. These filled in windows have created multiple crevices, such as between the mantle and filled in bricks, and within the extruded bricks. It was determined that these crevices are too exposed, resulting in fluctuating temperatures, and too shallow to be utilised by crevice-dwelling bat species. It was therefore determined that no potential bat roost features were located within the filled in windows.

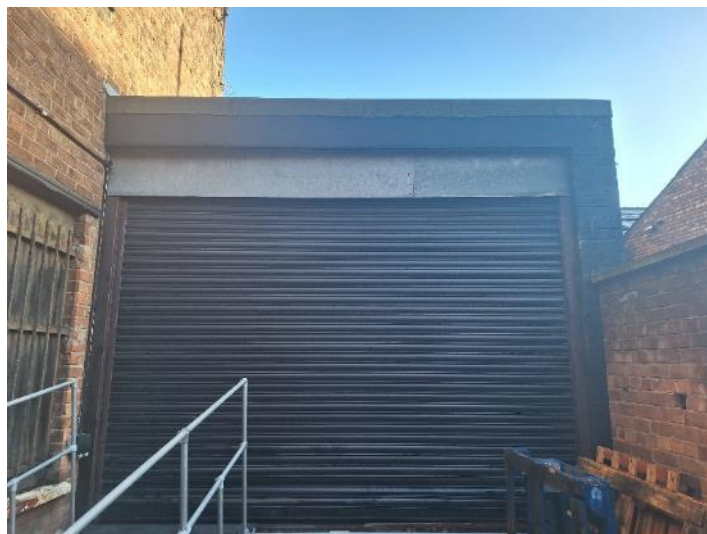
PLATE 5      SHOWING LOADING BAY

A red brick loading bay with a metal roller door and flat felt roof was present on the south-east corner of the building. The loading bay led to an elevator which serviced the 1st and 2nd floors of the building. The loading bay could not be accessed internally during the survey, as it could only be accessed via the 2nd floor elevator; the 2nd floor could not be accessed at the time of inspecting the loading bay. Furthermore, the active nature of the loading bay is likely to result in disturbance and fluctuating temperatures (via the continuous opening and closing of the metal roller door), reducing the overall suitability for roosting bats within the loading bay. The brickwork was mostly in good condition; however, several cracks were present on the external south-east aspect of the loading bay (F5). The roof was mostly in good condition; however, some lifted lead flashing was present on the south-west aspect of the loading bay (F7) between the main building and the loading bay. F5 and F7 may support opportunistic bat species on an occasional basis. It is unlikely that these features can support roosting bats on a more regular basis due to the small size and exposed nature of the features.

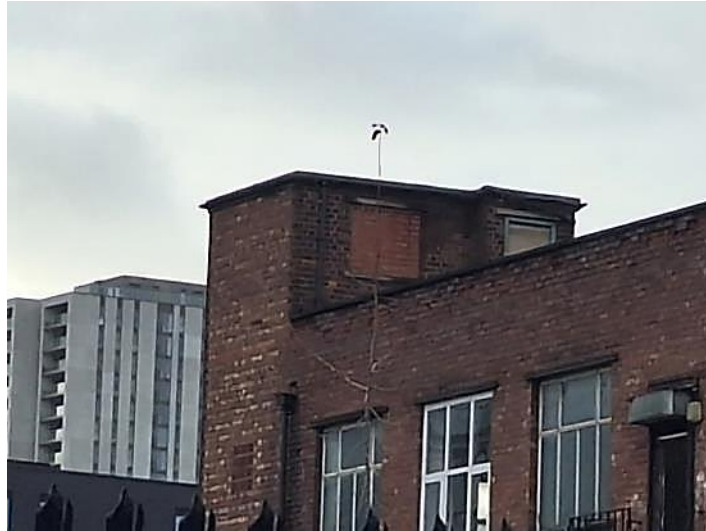
PLATE 6      SHOWING ROOF FROM GROUND LEVEL

The roof could not be accessed during the survey as the roof hatch could not be opened; aerial images were utilised to determine the material and condition of the flat roof. The flat roof mostly appeared to be in good condition and comprised concrete and lead flashing; however, some lifted lead flashing was present (F8), which could be examined from ground level. F8 may support roosting bats on an occasional basis. The feature is unlikely to support roosting bats on a more regular basis due to its small size and exposed nature.

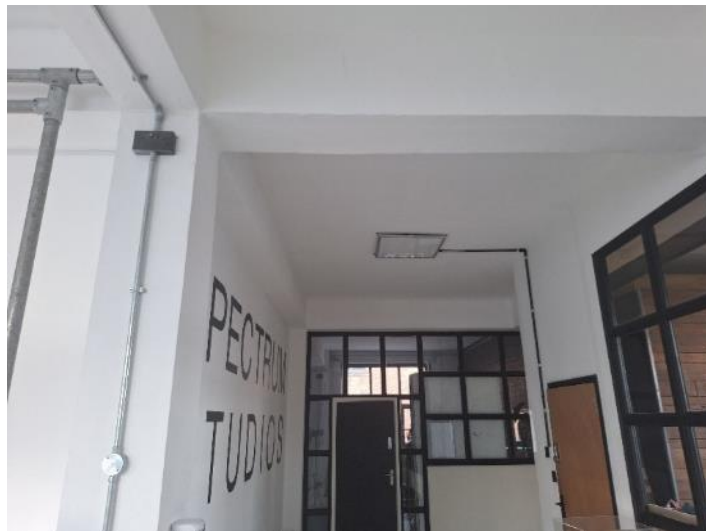
PLATE 7      SHOWING INTERNAL 2ND FLOOR

An internal inspection of the building was undertaken. Due to the active nature of the site, the building was lit during the day. The building was well-sealed internally, with no obvious access points that could be utilised by bats. No loft void or basement was present. No evidence of bats were identified. It was determined that no suitable bat roost features were located internally within the building.

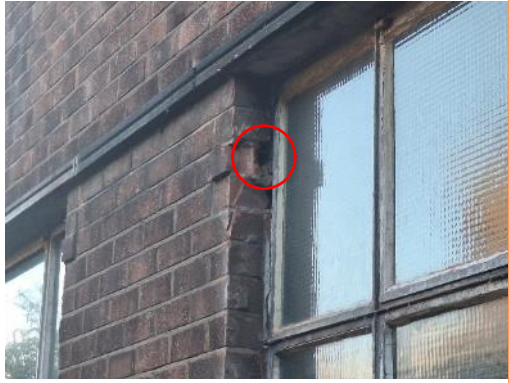
| FEATURE | DESCRIPTION | PHOTOGRAPH |
|---|---|---|
| F1 | Cracks and crevices in brickwork around window frame on north-west aspect of building, approximately 2 m high. Feature may be used by opportunistic crevice-dwelling bat species on an occasional basis. Unlikely to support bats on a more regular basis due to exposed nature and small size of feature. | |

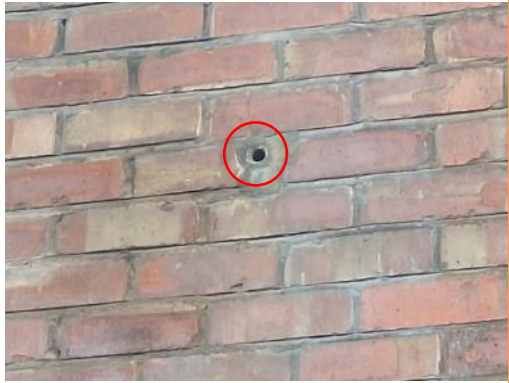
| FEATURE | DESCRIPTION | PHOTOGRAPH |
|---|---|---|
| F2 | Circular hole in brickwork on north-east aspect of building, approximately 5 m high. Presumed that feature leads into wall cavity on a precautionary basis. Could provide roosting opportunities for bats on a regular basis as feature may provide shelter within wall cavity. | |

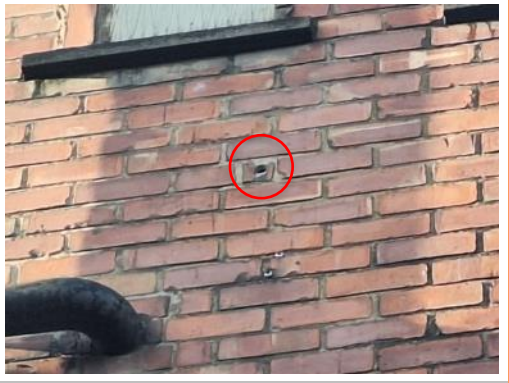
| FEATURE | DESCRIPTION | PHOTOGRAPH |
|---|---|---|
| F3 | Circular hole in brickwork on north-east aspect of building approximately 2 cm diameter and 12 m high. Presumed that feature leads into wall cavity on a precautionary basis. Could provide roosting opportunities for bats on a regular basis as feature may provide shelter within wall cavity. | |

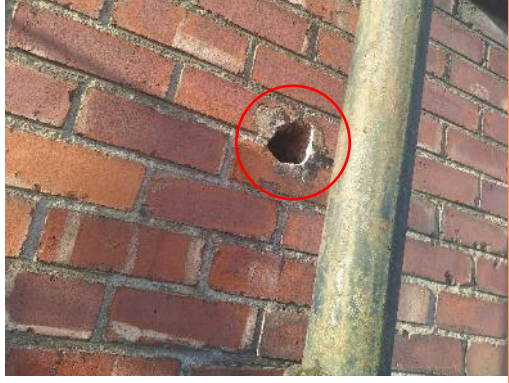
| FEATURE | DESCRIPTION | PHOTOGRAPH |
|---|---|---|
| F4 | Large circular hole in brickwork on the north-east aspect, approximately 12 m high. The feature was observed from the metal staircase to gain a better vantage point; however, it could not be determined how deep the feature went. Presumed that feature leads into wall cavity on a precautionary basis. Could provide roosting opportunities for bats on a regular basis as feature may provide shelter within wall cavity. | |

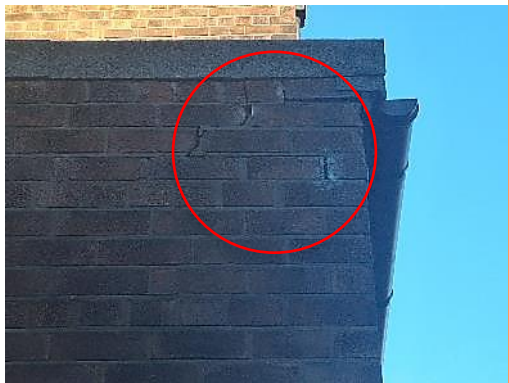
| FEATURE | DESCRIPTION | PHOTOGRAPH |
|---|---|---|
| F5 | Damaged mortar between brickwork on south-east aspect of loading bay, approximately 5 m high. Crevices were covered in cobwebs at time of survey. Features may be used by opportunistic crevice-dwelling bat species on an occasional basis. Unlikely to support bats on a more regular basis due to exposed nature and small size of feature. | |

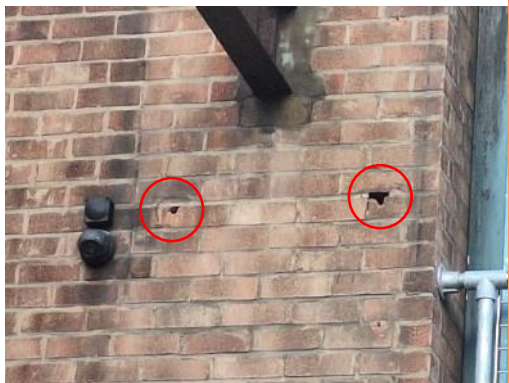
| FEATURE | DESCRIPTION | PHOTOGRAPH |
|---|---|---|
| F6 | Damaged brickwork on south-east aspect of building, approximately 5 m high. Presumed that feature leads into wall cavity on a precautionary basis. Could provide roosting opportunities for bats on a regular basis as feature may provide shelter within wall cavity. | |

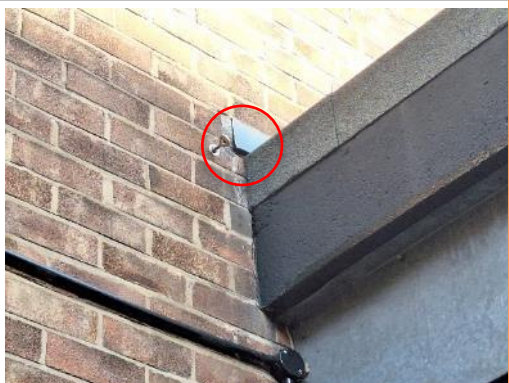
| FEATURE | DESCRIPTION | PHOTOGRAPH |
|---|---|---|
| F7 | Lifted lead flashing between loading bay and main building, approximately 6 m high. Feature may be used by opportunistic crevice-dwelling bat species on an occasional basis. Unlikely to support bats on a more regular basis due to exposed nature and small size of feature. | |

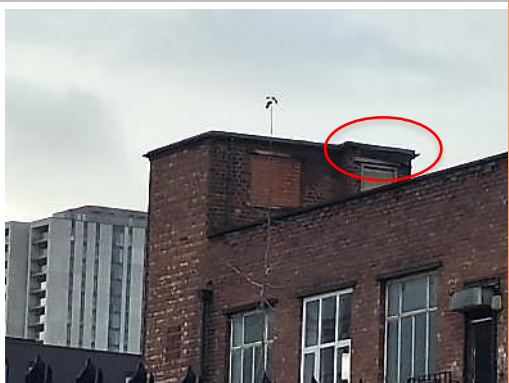
| FEATURE | DESCRIPTION | PHOTOGRAPH |
|---|---|---|
| F8 | Lifted lead flashing on flat roof, approximately 22 m high. Feature may be used by opportunistic crevice-dwelling bat species on an occasional basis. Unlikely to support bats on a more regular basis due to exposed nature of feature. | |

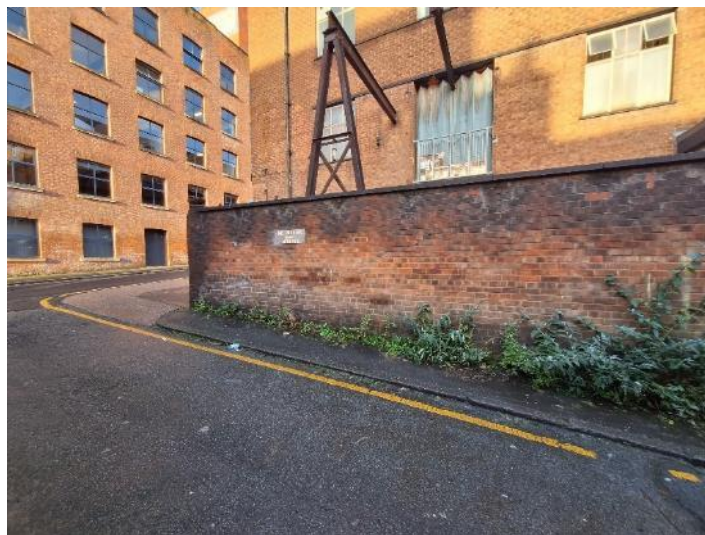
PLATE 8      SHOWING WALL

A redbrick wall was present along the south-east aspect of the site. The wall was approximately 2 m high and 10 m in length. The brickwork and mortar was in good condition, with no obvious cracks or crevices that could be utilised by roosting bat species.

The wall was assessed as having Negligible bat roosting potential due to a lack of suitable bat roost features.
