## Project

**Project Name:** DK Adana City labs Hathersage Rd Manchester 19 02 24  
**Project Description:** WinCan Import in Miraculix Standard  
**Project Date:** 20/02/2024

**Company:** ADANA CONSTRUCTION  
**Contact:** DK Adana City labs Hathersage Rd Manchester 19 02 24

**Company:** NRCWWS  
**Contact:** Derek Kearns  
**Department:** Director  
**Street:** unit D. Russell Road  
**Town or City:** Rock Ferry  
**County:** Wirral  
**Post Code:** CH42 1LU  
**Phone:** 0151 643 0800  
**Email:** derek.kearns@nrcwws.co.uk

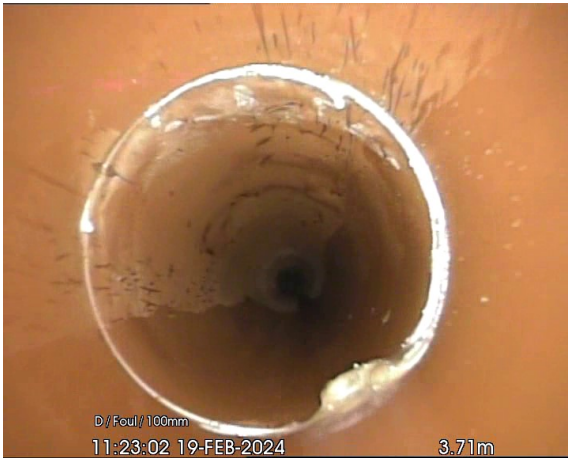
5X\_9152fba8-ba31-4409-a825-1384a7787cf2\_20240220\_130  
128\_571.jpg, 00:00:13, 3.21 m

| Scale: | 1:83 | Position [m] | Code | Observation | MPEG | Photo | Grade |
|---|---|---|---|---|---|---|---|
| | | 3.21 | DEE | Attached deposits, encrustation from 4 o'clock to 5 o'clock, 5% cross-sectional area loss | 00:00:13 | 5X_9152fb<br>a8-ba31-4<br>409-a825- | 3 |

Attached deposits, encrustation from 4 o'clock to 5 o'clock, 5%  
cross-sectional area loss

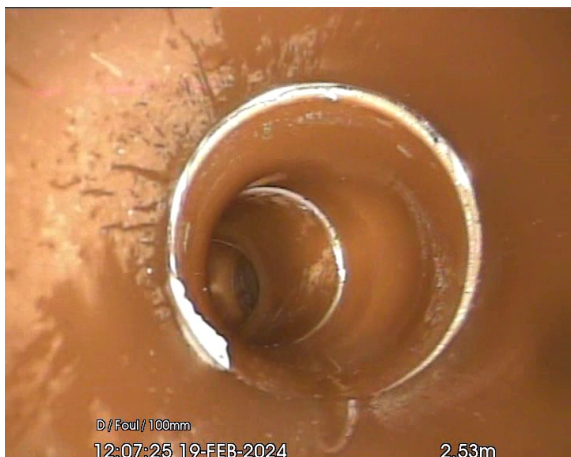
18X\_4407e400-db61-41bf-a106-9af9e3682a95\_20240220\_13  
0452\_072.jpg, 00:00:12, 2.53 m

Attached deposits, encrustation at 7 o'clock, 5%  
cross-sectional area loss

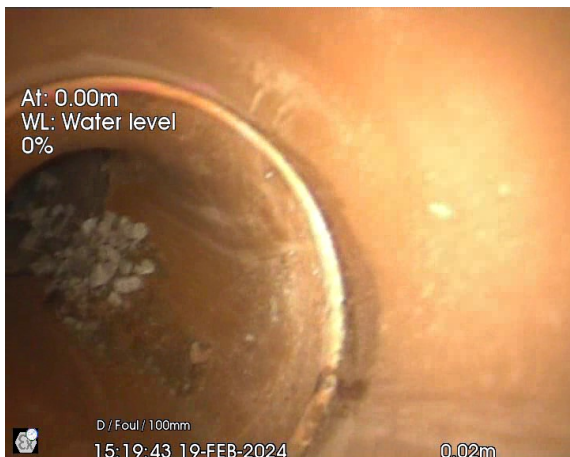
23X\_c9193ec7-2856-419d-b543-537437b5a12a\_20240220\_130726\_204.jpg, 00:00:16, 0.53 m  
Settled deposits, hard or compacted, 5% cross-sectional area loss, STONES UNABLE TO JET

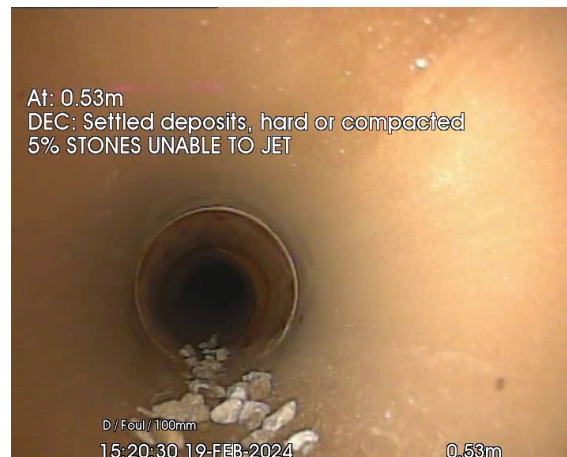
23X\_a6fa35dc-f304-4b1b-a927-afd43327ad87\_20240220\_130737\_782.jpg, 00:00:16, 0.53 m  
Settled deposits, hard or compacted, 5% cross-sectional area loss, STONES UNABLE TO JET

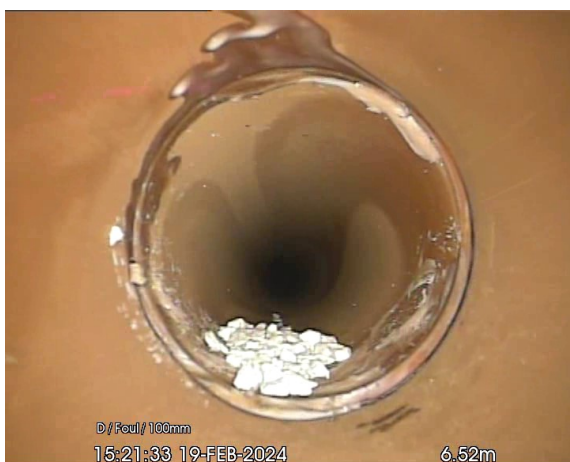
23X\_02178932-7984-4a5b-b4ee-d4d9c6864987\_20240220\_130752\_169.jpg, 00:00:40, 6.64 m  
Settled deposits, hard or compacted, 5% cross-sectional area loss, STONES

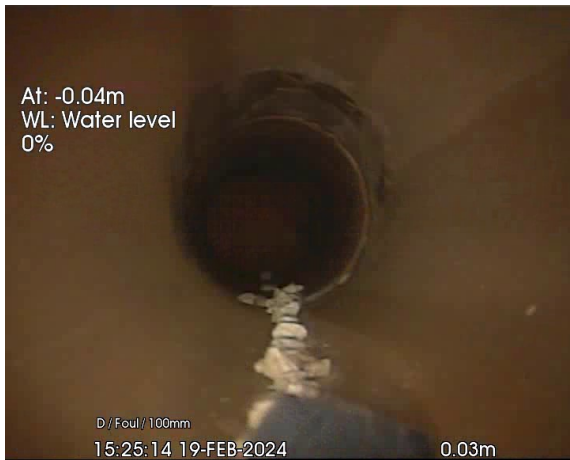
25X\_771747d0-0e43-4179-86a4-d82d3fb5ba30\_20240220\_1  
30837\_022.jpg, 00:00:02, 0.30 m

Settled deposits, coarse, 5% cross-sectional area loss

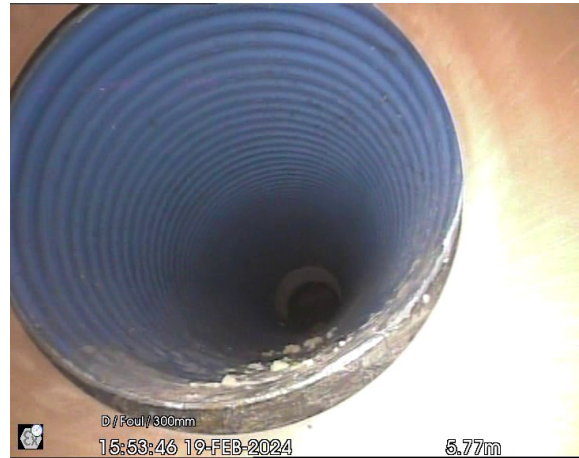
38X\_a70927c2-bff9-48aa-8fd6-2b3f1407405a\_20240220\_131215\_332.jpg, 00:00:26, 5.91 m  
Joint displaced, medium

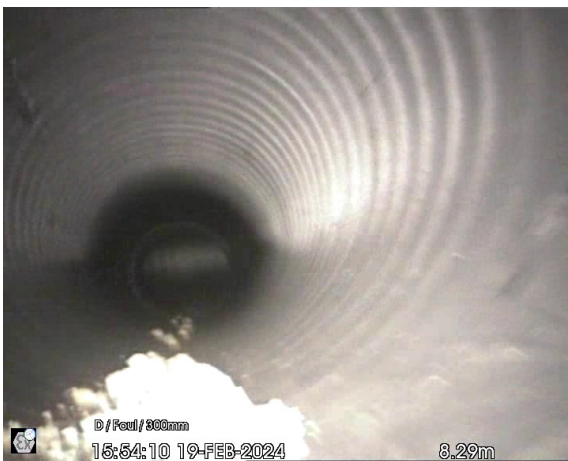
38X\_7fd9689b-7494-4b8b-9ffd-75b43d27888f\_20240220\_131350\_953.jpg, 00:00:36, 8.29 m  
Settled deposits, coarse, 5% cross-sectional area loss

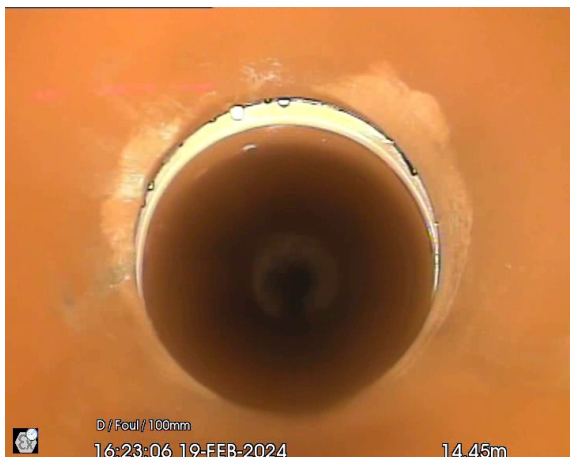
FWMH2X\_8c1af0ea-f610-4d69-abc1-e5237699f7e9\_20240220\_131509\_849.jpg, 00:00:44, 14.55 m  
Joint displaced, medium

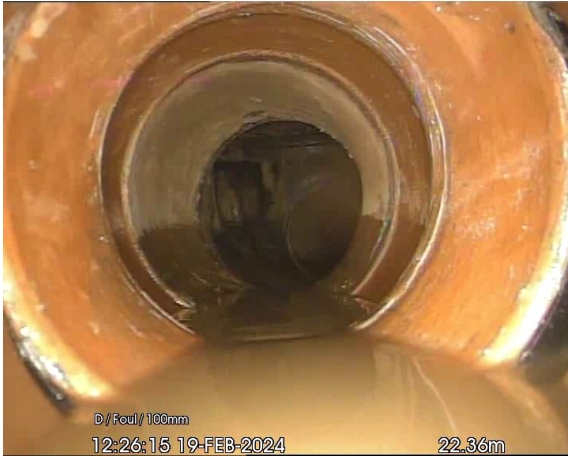
IFWMH1.2X\_146a26f1-f6ec-4d74-aa87-7f4b7a251f0d\_20240  
220\_131732\_303.jpg, 00:01:24, 22.36 m  
Joint displaced, medium

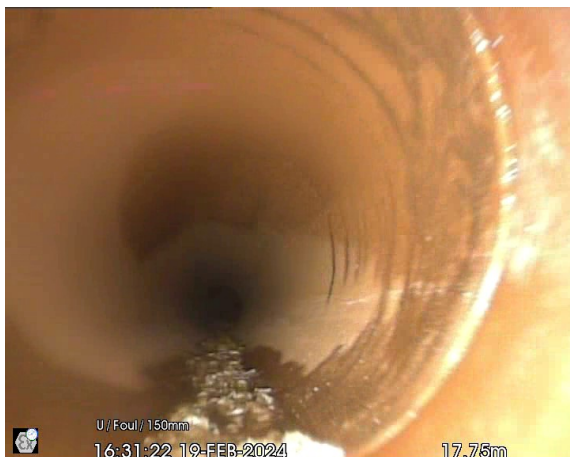
IFWMH3.0X\_ee769270-ee18-4794-84a9-1b85726d17e2\_202  
40220\_131839\_359.jpg, 00:00:40, 17.70 m

Settled deposits, coarse, 5% cross-sectional area loss, start
