# Arboricultural Consultancy for Aviva - Commercial

| Insured | Mayfield Road Management Company Limited | Address | Flat 1-6, 14 Mayfield Road, Whalley Range, Manchester, M16 8FT | | |
| Client | Subsidence Management Services | Contact | Alun Dwyer | Claim No. | IFS-AVI-SUB-24-0113675 |
| Report Date | 15/10/2024 | | | | |

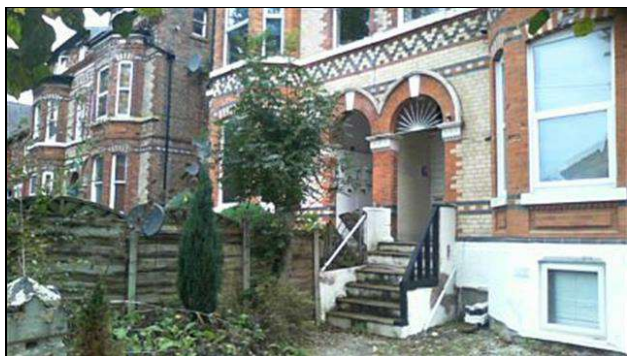
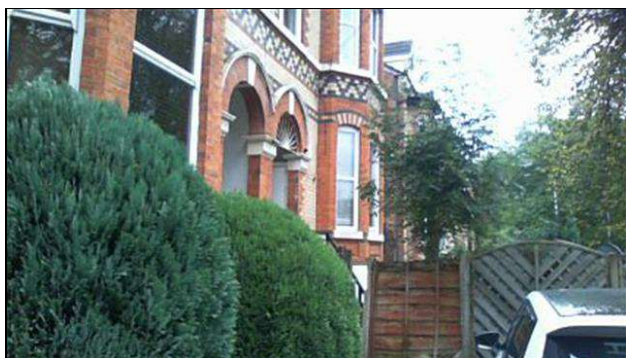
With due regards to species profile, size and proximity, the Ash (T3), the Cypress trees (T1 & T2) and the Hydrangea (S1) are considered the dominant features proximate to the focal area(s) of movement and accordingly, where vegetation is confirmed as being causal, we have identified them as the primary cause of the current subsidence damage.

| Tree No. | Species | Age Cat | Approx. Height (m) | Distance to Building (m) * | Ownership | Action | Requirement |
|---|---|---|---|---|---|---|---|
| T3 | Ash | 1 | 5.1 | 2.8 | A - Third Party | Remove | Remove close to ground level and treat stump to inhibit regrowth. |

T3 - Ash

Consequently, we have advocated the complete removal of the Ash (T3), the Cypress trees (T1 & T2) and the Hydrangea (S1) as it will offer the most certain arboricultural solution likely to restore long-term stability.

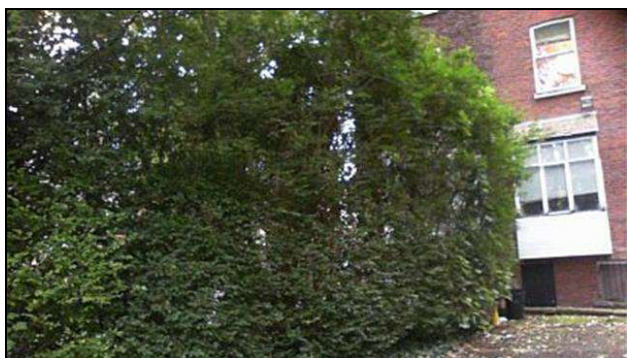
| Tree No. | Species | Age Cat | Approx. Height (m) | Distance to Building (m) * | Ownership | Action | Requirement |
|---|---|---|---|---|---|---|---|
| H1 | Privet | 1 | 4.8 | 4.8 | C - Insured | Action to avoid future risk | Maintain at, or below current dimensions by way of regular pruning. |

H1 - Privet

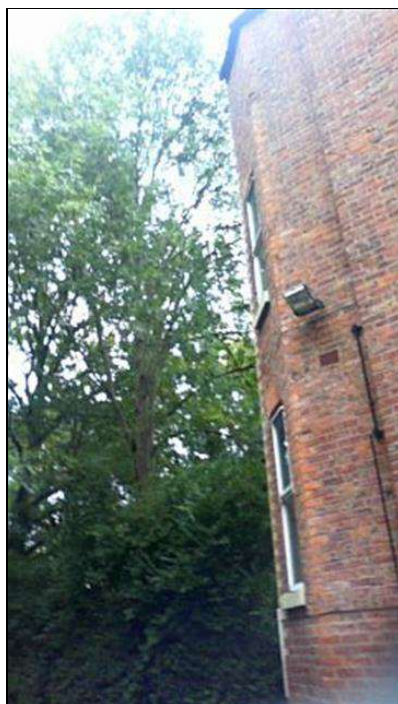
| Tree No. | Species | Age Cat | Approx. Height (m) | Distance to Building (m) * | Ownership | Action | Requirement |
|---|---|---|---|---|---|---|---|
| T6 | Ash | 1 | 24 | 8.2 | E - Boundary Veg (ownership to be confirmed) | Action to avoid future risk | Crown reduce overall canopy by 30% (minimum) to achieve a crown volume reduction in line with BRE IP7/06. Maintain at reduced dimensions by re-pruning back to points of previous reduction on a 3 year (max) cycle. |

T6 - Ash

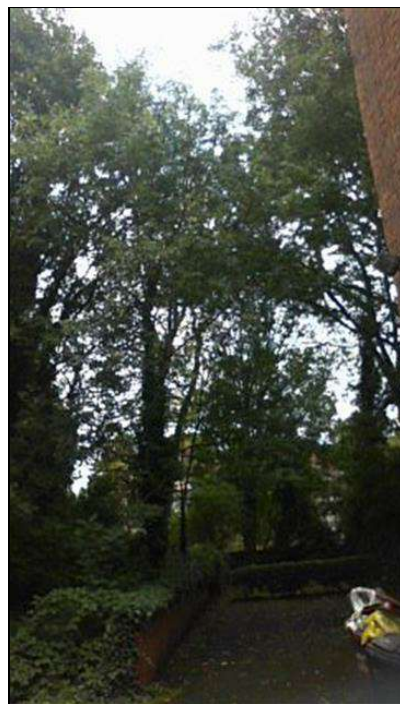
| Tree No. | Species | Age Cat | Approx. Height (m) | Distance to Building (m) * | Ownership | Action | Requirement |
|---|---|---|---|---|---|---|---|
| T7 | Ash | 1 | 13.2 | 7.5 | A - Third Party | Action to avoid future risk | Crown reduce overall canopy by 30% (minimum) to achieve a crown volume reduction in line with BRE IP7/06. Maintain at reduced dimensions by re-pruning back to points of previous reduction on a 3 year (max) cycle. |

T7 - Ash

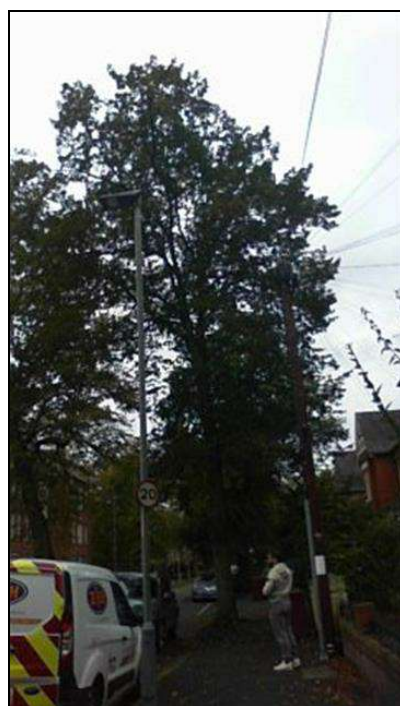
| Tree No. | Species | Age Cat | Approx. Height (m) | Distance to Building (m) * | Ownership | Action | Requirement |
|---|---|---|---|---|---|---|---|
| T4 | Lime | 1 | 16.3 | 11.25 | B - Local Authority | Action to avoid future risk | Recently reduced; maintain in line with BRE IP7/06 by re-pruning back to points of previous reduction on a 3 year (max) cycle. |

T4 - Lime

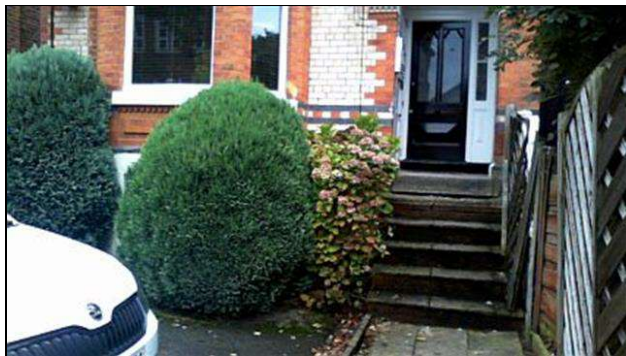
| Tree No. | Species | Age Cat | Approx. Height (m) | Distance to Building (m) * | Ownership | Action | Requirement |
|---|---|---|---|---|---|---|---|
| S1 | Hydrangea | 1 | 1.8 | 0.25 | C - Insured | Remove | Remove close to ground level and treat stump to inhibit regrowth. |

S1 - Hydrangea

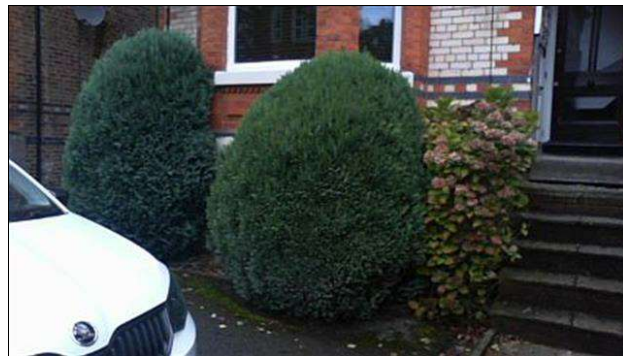
| Tree No. | Species | Age Cat | Approx. Height (m) | Distance to Building (m) * | Ownership | Action | Requirement |
|---|---|---|---|---|---|---|---|
| T2 | Cypress | 1 | 2 | 0.25 | C - Insured | Remove | Remove close to ground level. |

T2 - Cypress

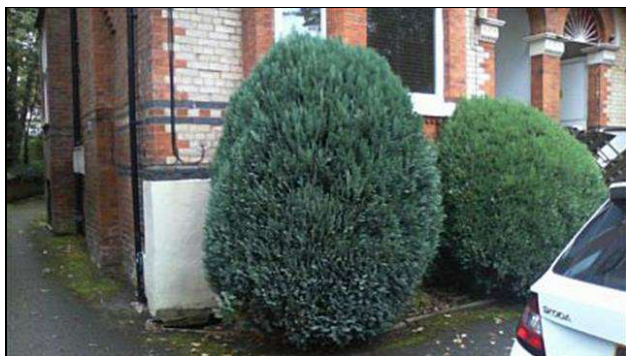
| Tree No. | Species | Age Cat | Approx. Height (m) | Distance to Building (m) * | Ownership | Action | Requirement |
|---|---|---|---|---|---|---|---|
| T1 | Cypress | 1 | 2.4 | 1 | C - Insured | Remove | Remove close to ground level. |

T1 - Cypress

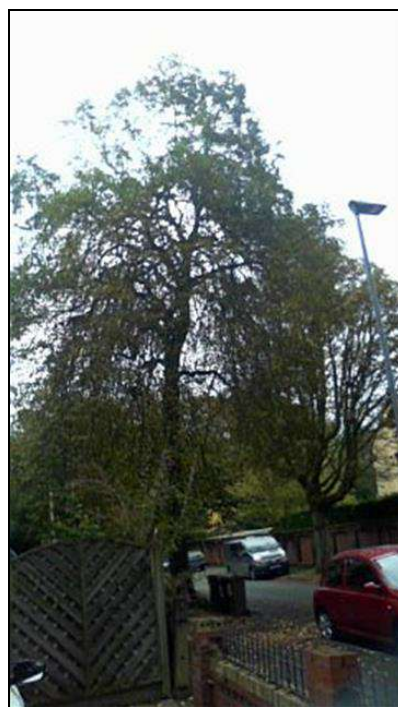
| Tree No. | Species | Age Cat | Approx. Height (m) | Distance to Building (m) * | Ownership | Action | Requirement |
|---|---|---|---|---|---|---|---|
| T5 | Lime | 1 | 17.4 | 12.25 | B - Local Authority | Action to avoid future risk | Recently reduced; maintain in line with BRE IP7/06 by re-pruning back to points of previous reduction on a 3 year (max) cycle. |

T5 - Lime

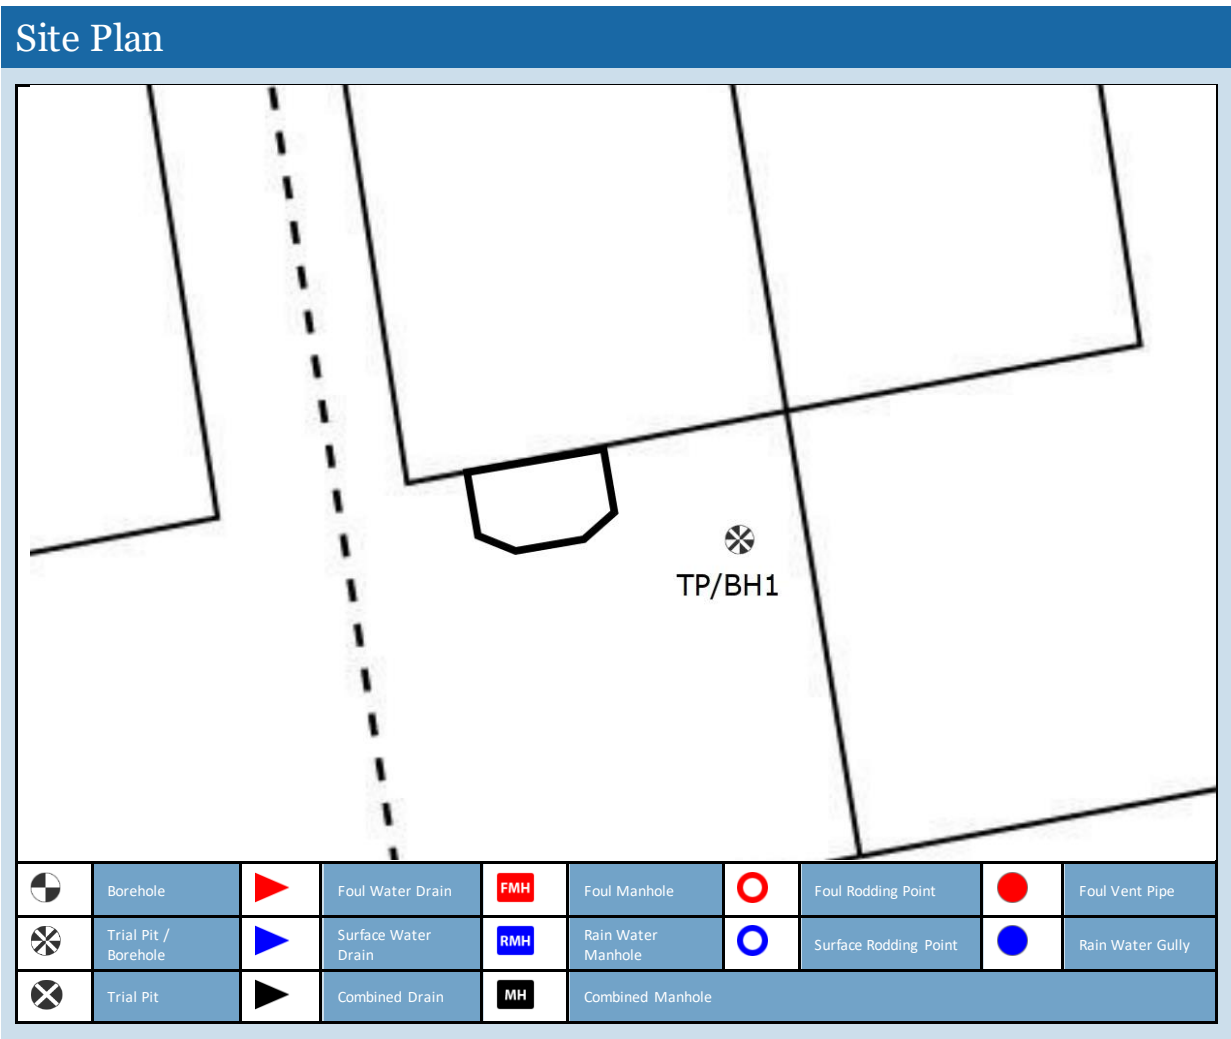
-- End of borehole at 4.00m --  
Trial pit excavated to 1.20m bgl. Borehole completed by mech window sampler. Roots encountered to 2.10m bgl. Groundwater strikes not encountered. PEN = Hand Penetrometer (kg/sq cm).

At 0.13m bgl UNDERSIDE OF STEPS FOUNDATION in TP/BH1.

At 0.13m to 2.10m bgl numerous roots of live appearance encountered and sampled in TP/BH1.
