Project 2045 | Midland West Entrance - Fire  
Issued

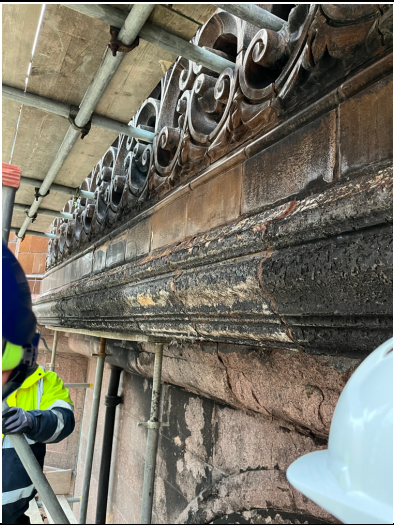
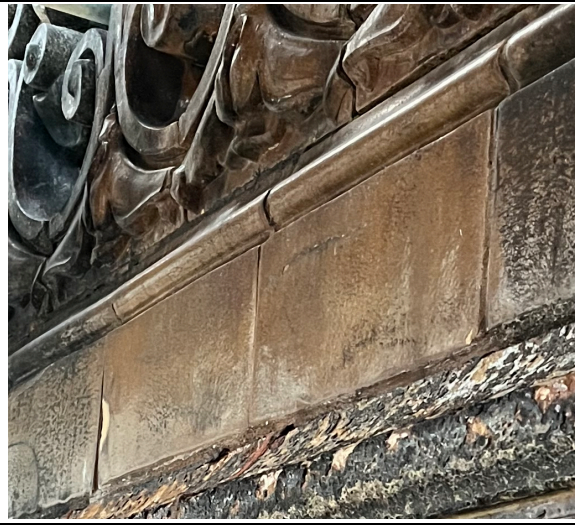
| Image 1 | Image 2 |

| NO. | TYPE | NBS REF. | LOCATION | DETAILS | DATE | AGREED WITH ARCHITECT | AGREED WITH PLANNER/CO |
|---|---|---|---|---|---|---|---|
| 2 | Doff clean of terracotta | C40. See Bullen methodology document. | Front elevation | Lowest pressure required. Needs to be soaked for 1-2 days before DOFF treatment, and use of mild handheld abrasive pad. | 24-12-10 | Y | Y - Paul Mason. |
