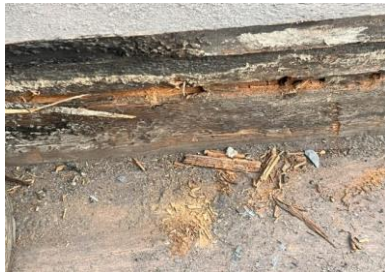
| C/VB/11<br><br>Bearing end opposite VB9 | <div><div><div>95mm</div><div>275mm</div></div><div><div>1000mm</div><div>50mm</div><div>Maximum 25mm depth</div></div><div><div></div><div>Decayed section</div></div></div> | Decay 1 metre long 50mm high to maximum depth of 25mm | | <p><b>Recommendations</b></p> <p>De-frass the decay back to sound timber and splice a new section wedge shaped glue with Sikadur 31 EF 2 Part Epoxy Structural adhesive</p> <p>Buro Happold Comment 2-12-2024<br/>BH requested additional de-frassing and investigation. After update agreed to splice repair as per email dated 13/12/2025</p> |

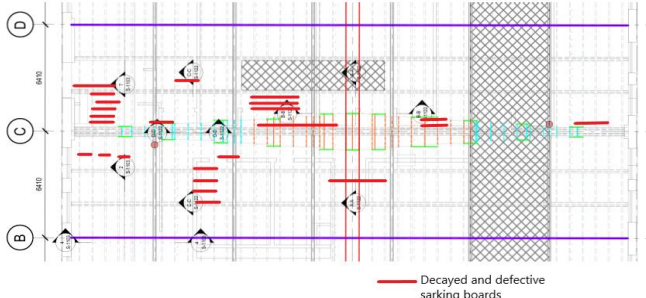
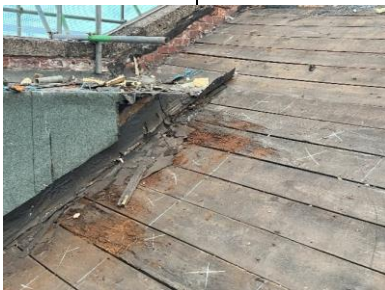
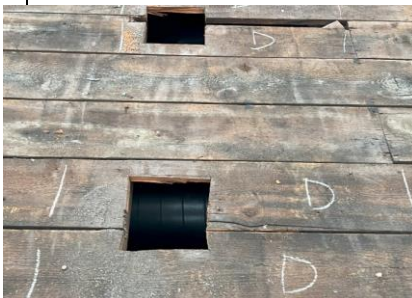
| Sarking Board | <div><div><div>D</div><div>C</div><div>B</div></div><div></div><div><div>Decayed and defective sarking boards</div></div></div> <div></div> <div></div> | | <p><b>Recommendations</b> Renew sarking boards using 19x225mm redwood timber</p> <p>Buro Happold Comment<br/>replace all decayed sarking boards like for like</p> | |
