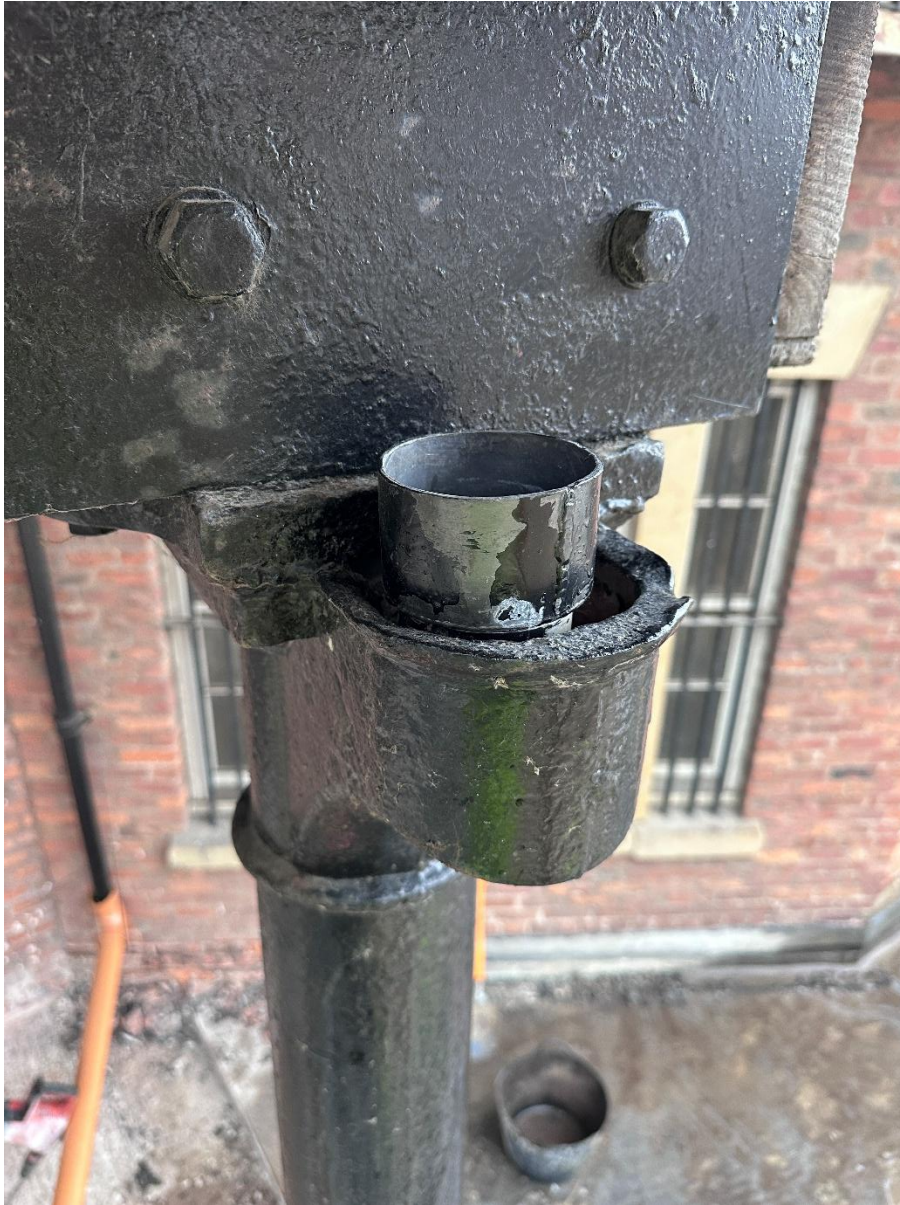
**Photograph 3** – Head connection with internal column

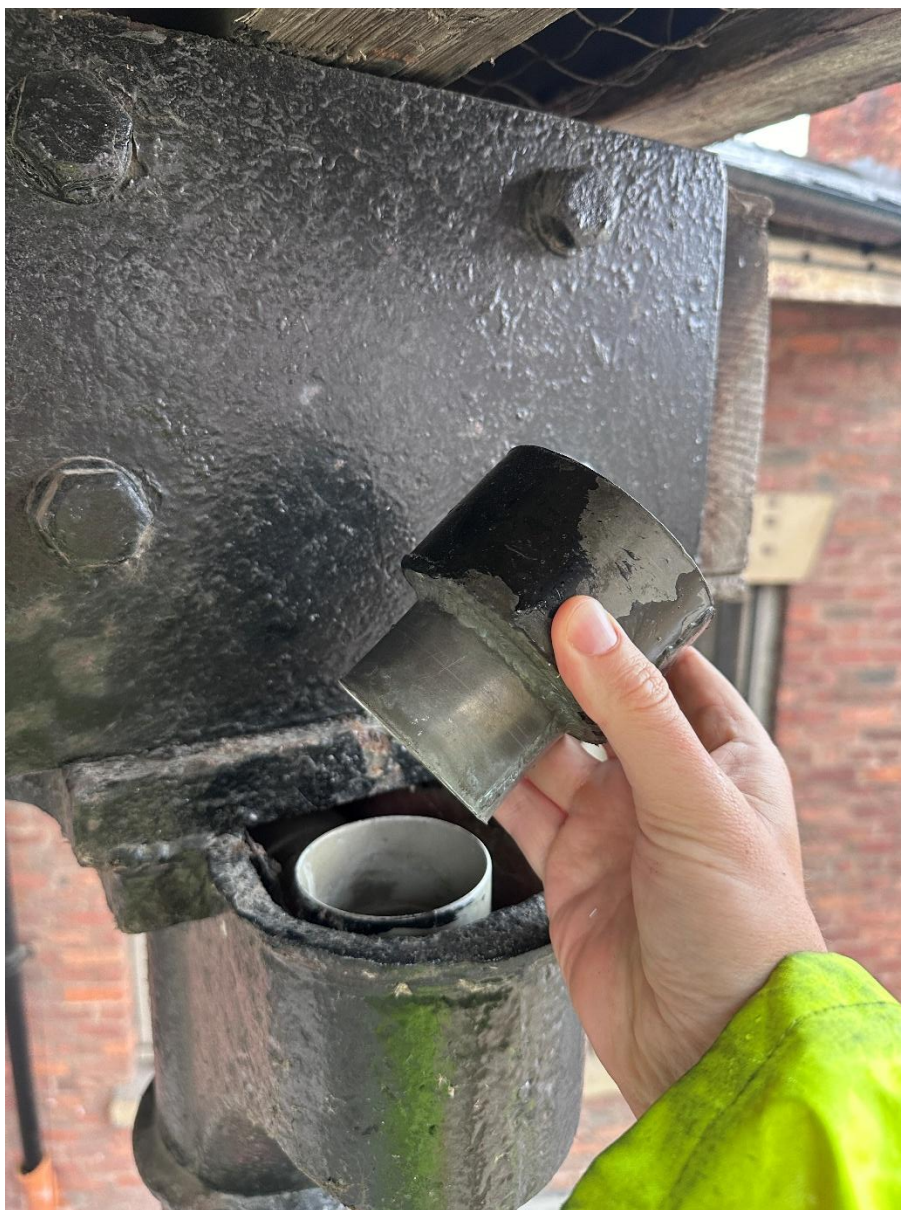
**Photograph 4** – Head connection with internal column with removable lead spigot and upvc lining pipe visible

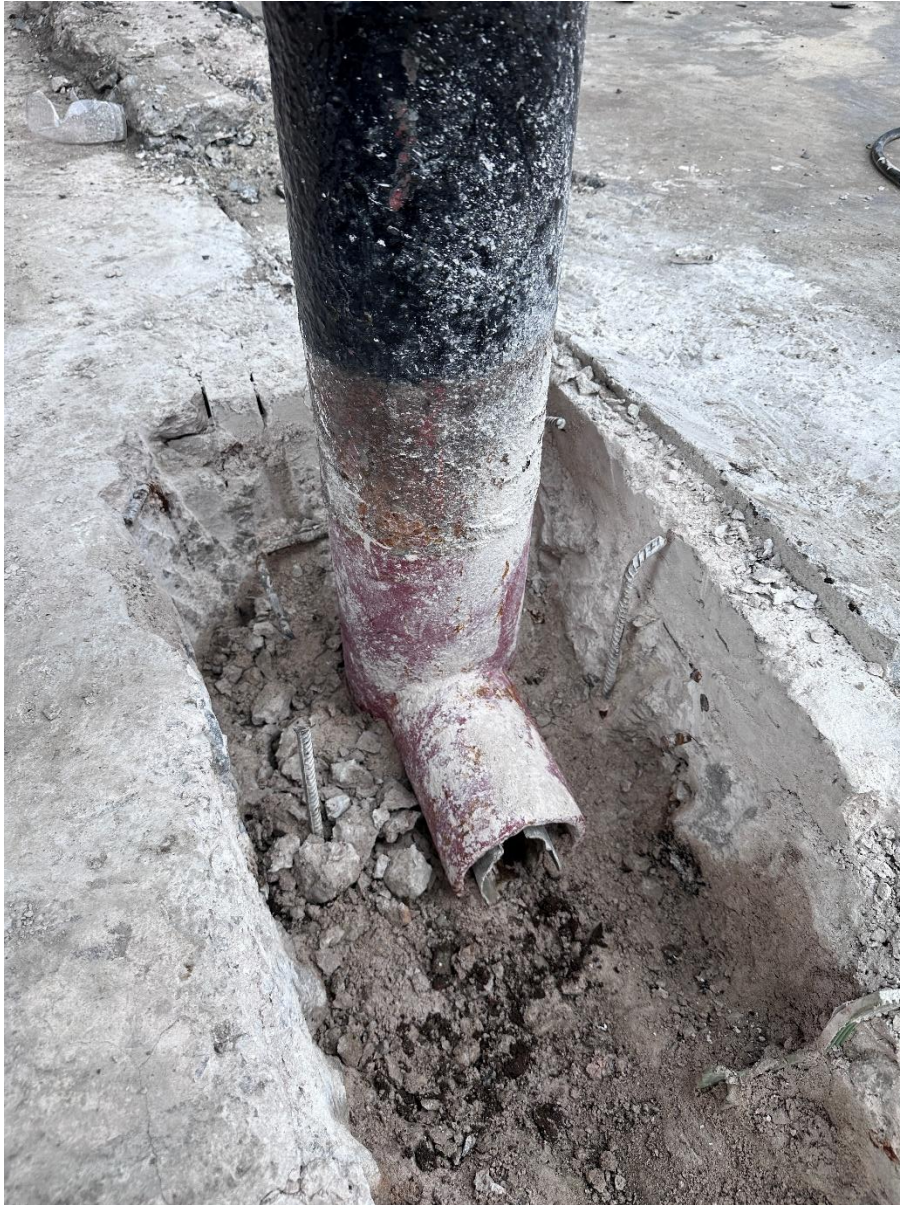
**Photograph 5** – base of column with upvc lining pipe visible

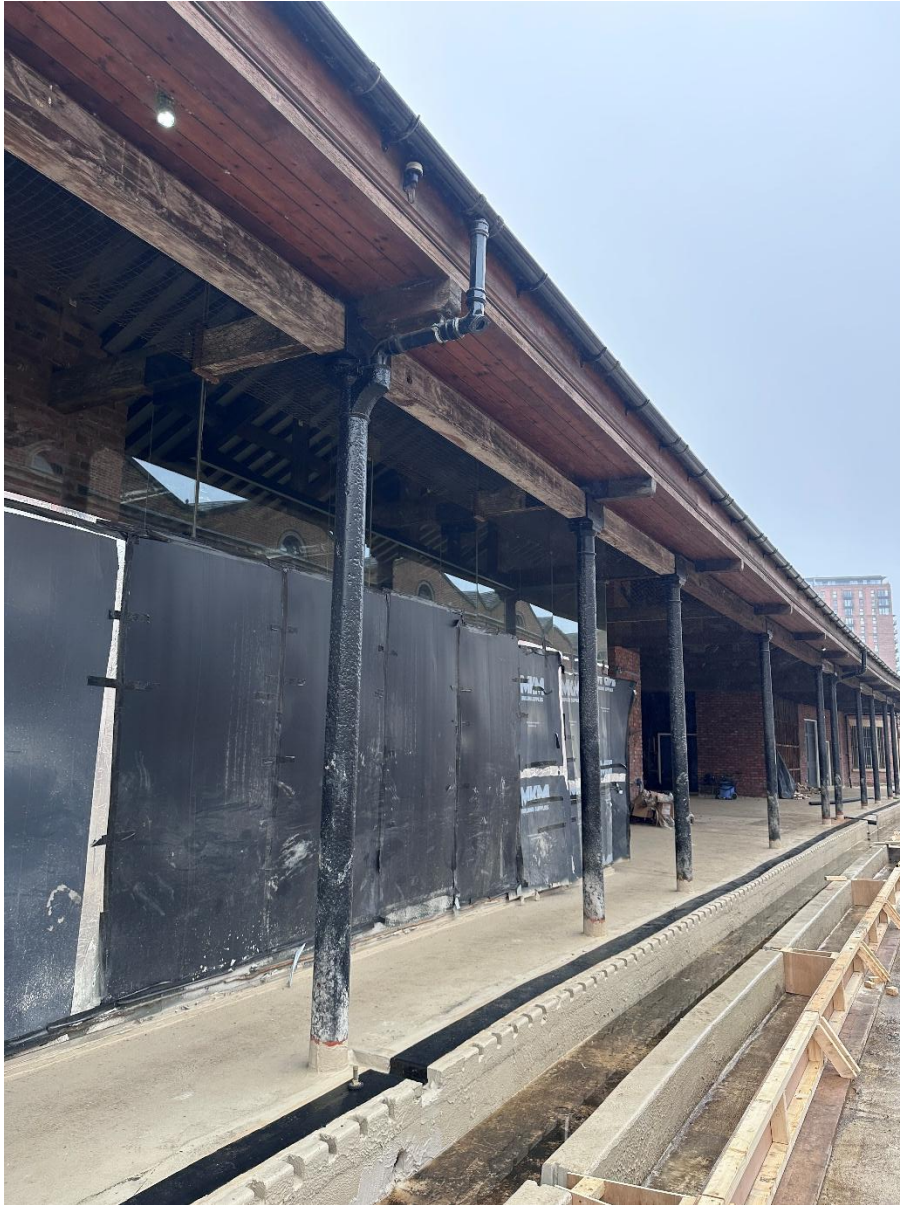
**Photograph 6** – existing / current arrangement of transition pipe into internal lining pipe
