# Equivalent Quality and Quantity Site Assessments (EQQA)

Client: Views (Holdings) Ltd

Project: Burnage Cricket Club & Cringle Playing Fields

Report date: 23/01/2025

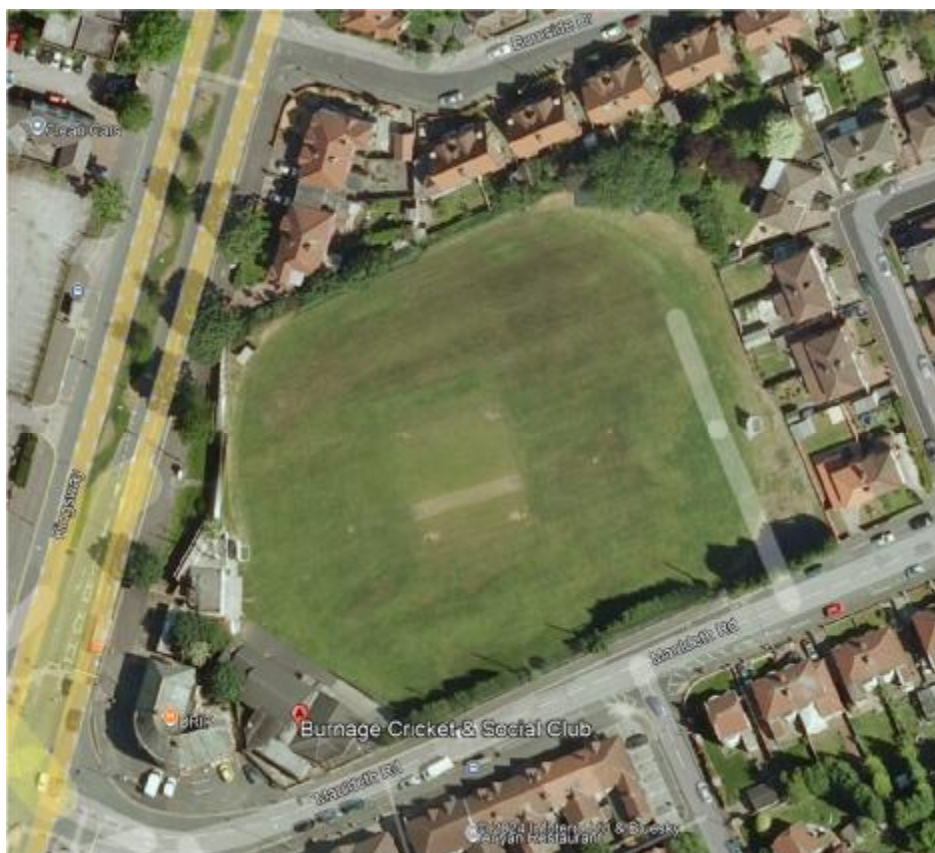
Figure 7 Layout of the former Burnage Cricket Club site

- Google time lapse confirmed that cricket had been played on the Burnage site in the past. However, the cricket square was oriented west-east, which does not align with Sport England's recommended north-south wicket orientation, making the site not fit for purpose.

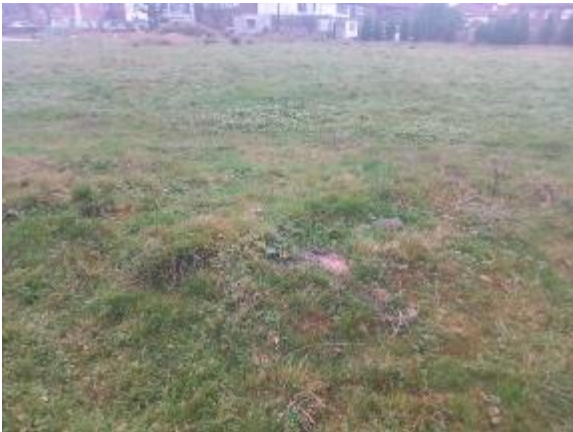
- During the site visit, it was observed that a large pile of topsoil had been deposited in the northeast corner of the site, which was approximately 5 feet high. This discarded topsoil has significantly reduced the usable playing field area compared to when cricket was played on the site historically. Additionally, stone material has been deposited along the eastern boundary of the site, which appears to have been used for car parking, according to analysis of aerial imagery. This further decreases the available playing field area.

Photo 3: Mounded area within the centre of the site.

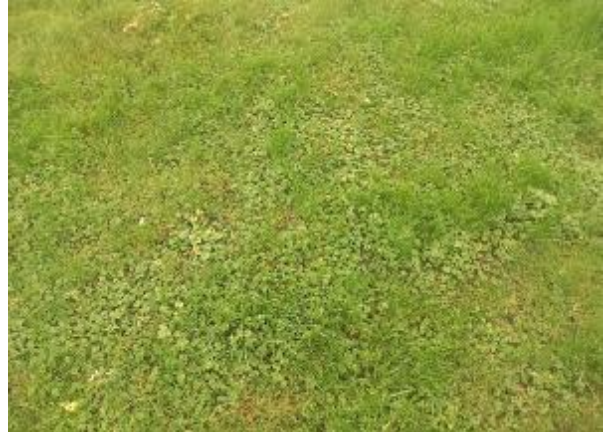
- The site was in poor condition due to prolonged neglect, with broadleaf weeds such as buttercups and rushes dominating the overgrown vegetation, indicating wet soil conditions. The playing field was deemed unsuitable for use in its current state.

Photo 4: Broad leaf vegetation.

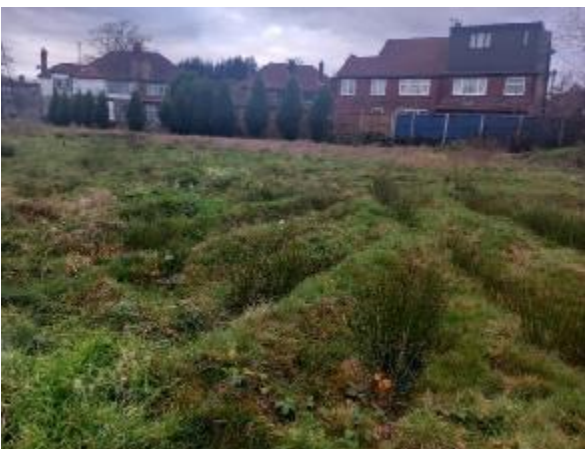
It was apparent during the site walk that the surface levels were very poor, with severe dips and hollows observed throughout the area. These dips and hollows are believed to have been caused by vehicles driving across the site, as visible tire marks were seen. The uneven surface would pose an immediate injury risk to players, making the site unsuitable for use.

Photo 5: Surface deviations.

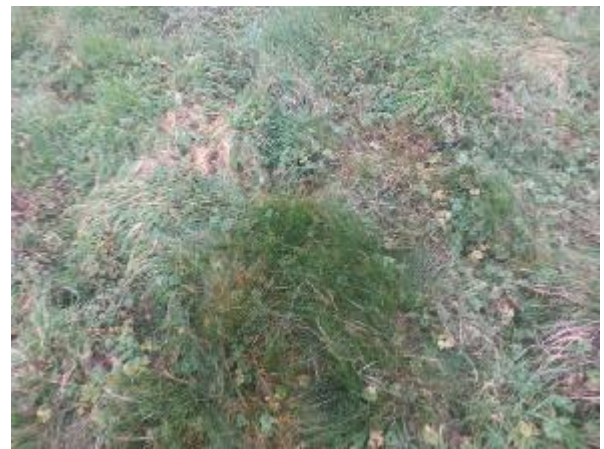
Photo 6: Vegetation.

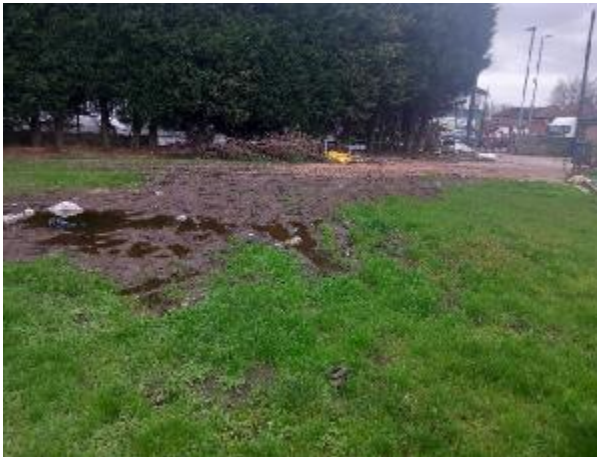
At the time of the appraisal, the ground conditions were soft, especially in the southern part of the site. Soft conditions were also observed in areas where surface water had accumulated in low-lying sections across the site.

Photo 7: Wet ground conditions.

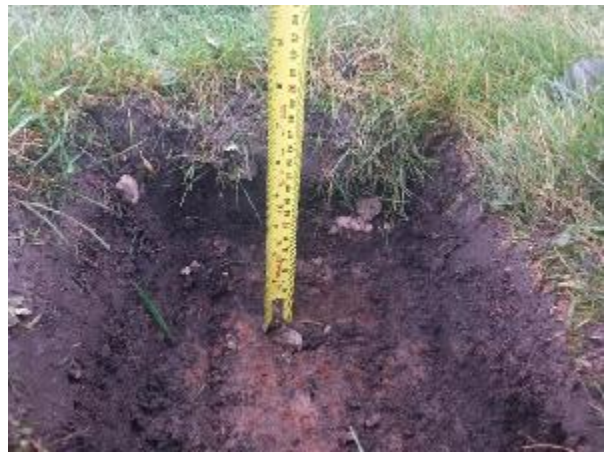
When visually observing the topsoil, it was clear that a shallow dark-brown clay loam material was present. Roots were penetrating to a maximum depth of 80 mm, which is considered shallow for this environment and is linked to the shallow topsoil depth. No large stones greater than 25 mm were observed in the excavated trial pits.

Photo 8: Excavated test pit.

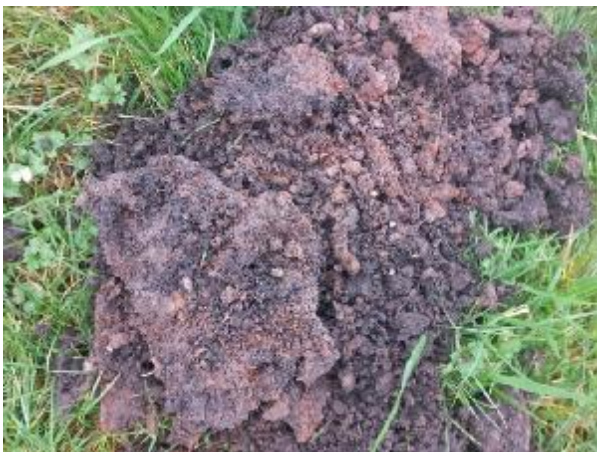
Photo 9: Excavated soil.

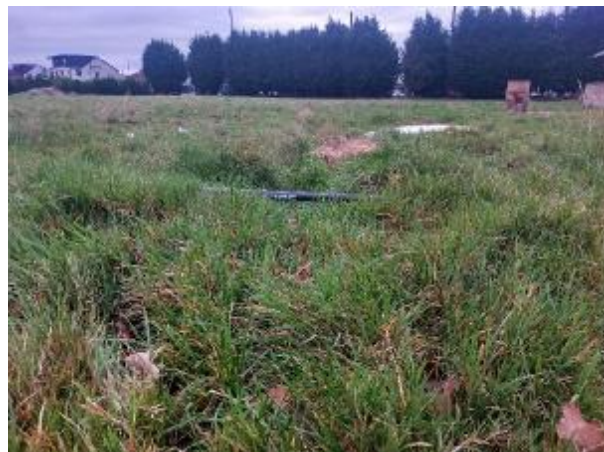
Photo 10: Surface deviations.

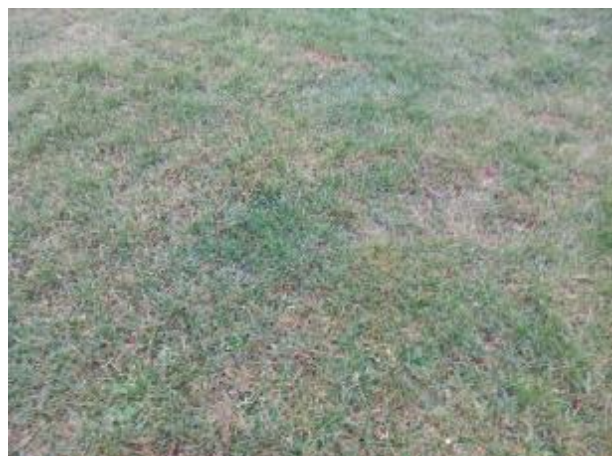
| General: | The turf across the area would be described as managed amenity turf, with various grass species present, such as perennial ryegrass ( <i>Lolium perenne</i> ) and Yorkshire fog ( <i>Holcus lanatus</i> ). Broadleaf weeds, including chickweed ( <i>Stellaria media</i> ), minor buttercup ( <i>Ranunculus</i> ) in the northern part of the playing field site, and ribwort plantain ( <i>Plantago lanceolata</i> ), were also observed. The presence of these broadleaf weeds suggests a degree of compaction across the playing field area. |

Photo 12: Existing vegetation.

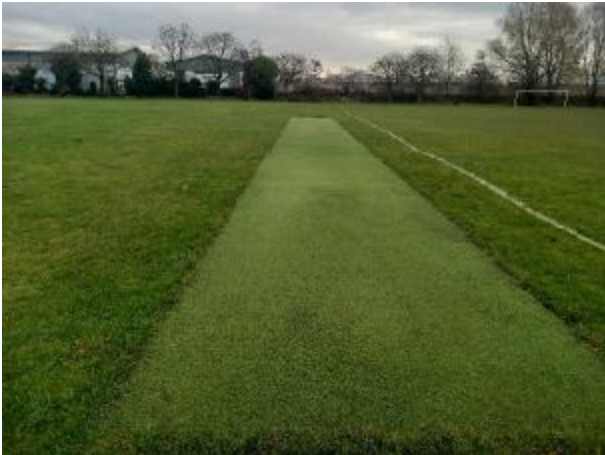
- Three artificial cricket wickets were identified on the site. One of these concrete wickets was in poor condition and not in use. Additionally, three natural grass football pitches were marked out, but no natural grass cricket wickets were visible.

Photo 13: Artificial Cricket wicket.

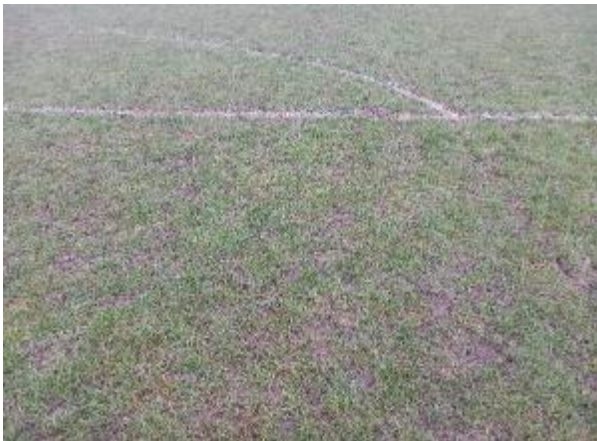
| Agronomic condition: | Agronomically, the turf was in relatively good condition within the marked-out football pitch areas, with grass cover measuring approximately 40%, indicating that these areas are heavily used. In contrast, the area outside the marked football pitches sustained better grass coverage, which is linked to the lack of usage in those areas. |

Photo 15: Reduced grass cover.

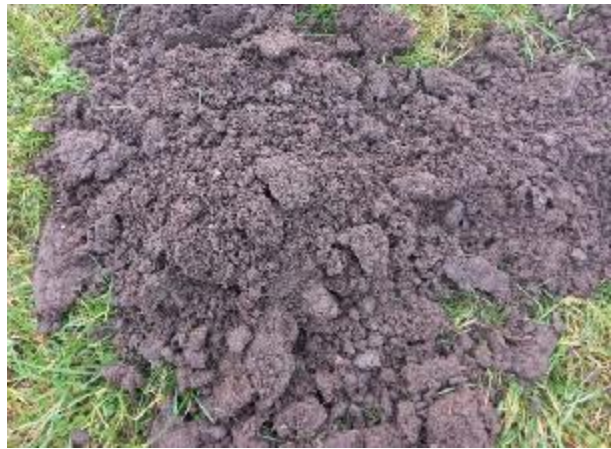
When visually observing the topsoil, it was clear that a dark-brown sandy clay loam material was present. Roots were penetrating to a maximum depth of 100 mm therefore indicating that there was no significant compaction issues present detrimental to root development. No large stones greater than 25 mm were observed within the excavated trial pits.

Photo 18: Excavated topsoil.

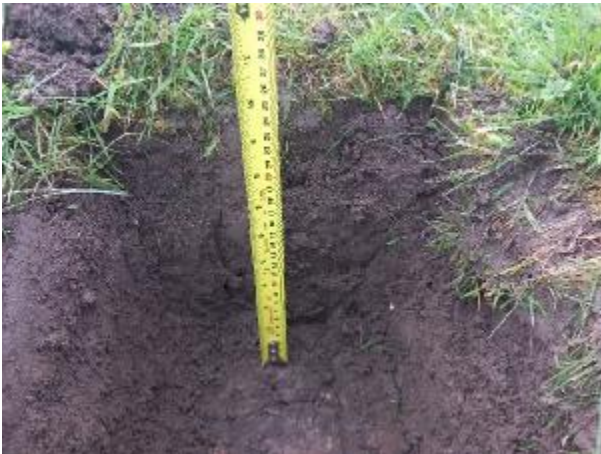
Photo 19: Excavated test pit.

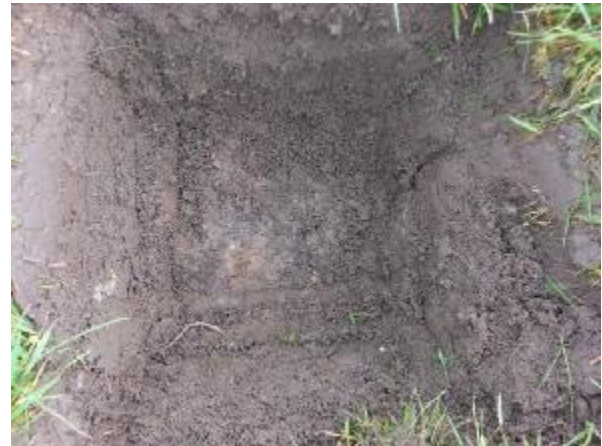
Photo 20: Excavated test pit.

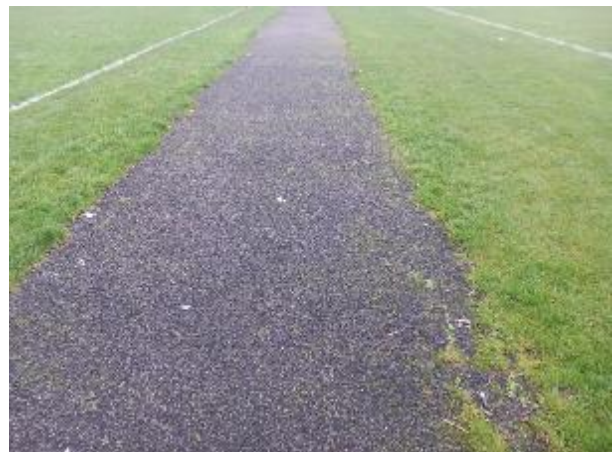
Photo 22: Tarmac Cricket wicket.
