BH | SIM SITEWIDE - Gantry | **Secondary Frame Repair (Type 8 Repair)**

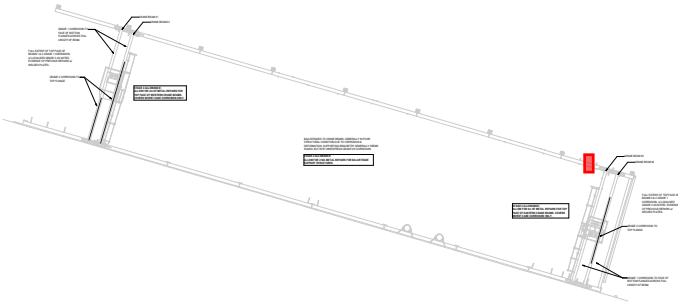
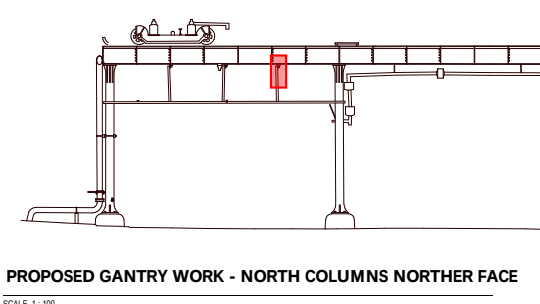
THIS SKETCH COVERS THE PROPOSAL FOR A STEEL REPAIR FOR AN ELEMENT OF SECONDARY FRAMING ON THE GANTRY LOCATED TO THE NORTH FACE OF THE NORTH BEAMS, WHERE SIGNIFICANT CORROSION IS OBSERVED.

A NEW PLATE AND BOLT HOOK ARE PROPOSED TO BE INSTALLED TO STRENGTHEN THE EXISTING STRUCTURE.
