# structural planning report

Rylands Building, Manchester  
CD9 Properties (Manchester) Limited

Project Title: Rylands Building, Manchester  
Client: CD9 Properties (Manchester) Limited  
Project No: 196002

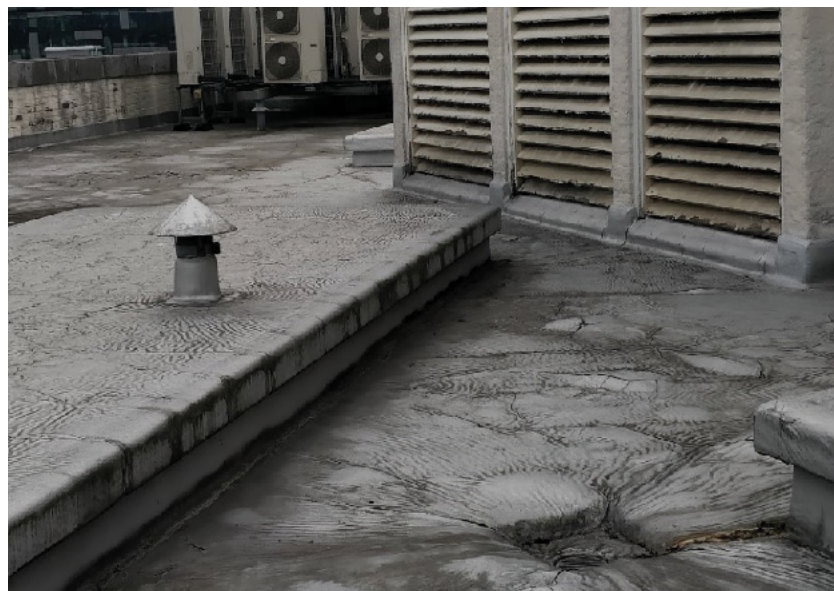
Figure 2.3: Asphalt Surface

The mastic asphalt surface on the roof is in poor condition, as evident from Figure 2.3.

There are several roof leaks which have caused damage to the internal finishes as well as to existing concrete encasement, exposing reinforcement and structural steelwork.

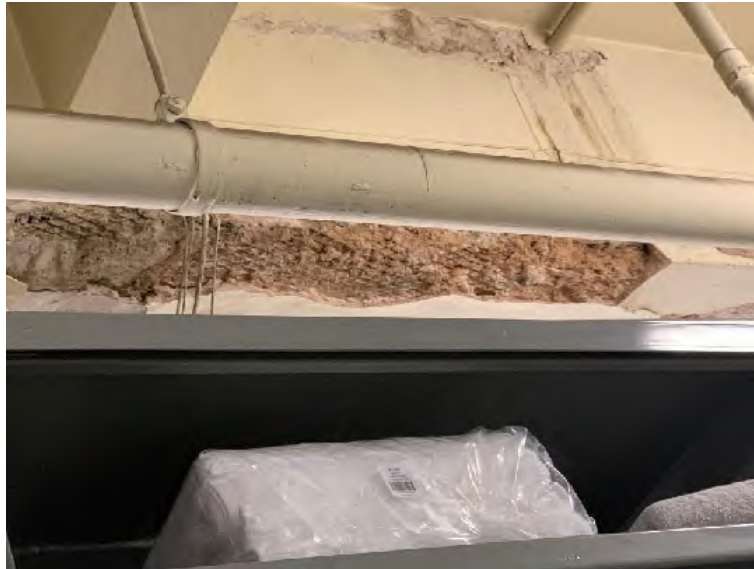
Figure 4: Beam Encasement - Fourth Floor

In general, the beams and columns appear to be in reasonable condition except for in some noted locations such as in Figure 4.

It is unclear whether the missing encasement from Figure 4 is related to previous opening up works, the water ingress above the beam, or another cause.

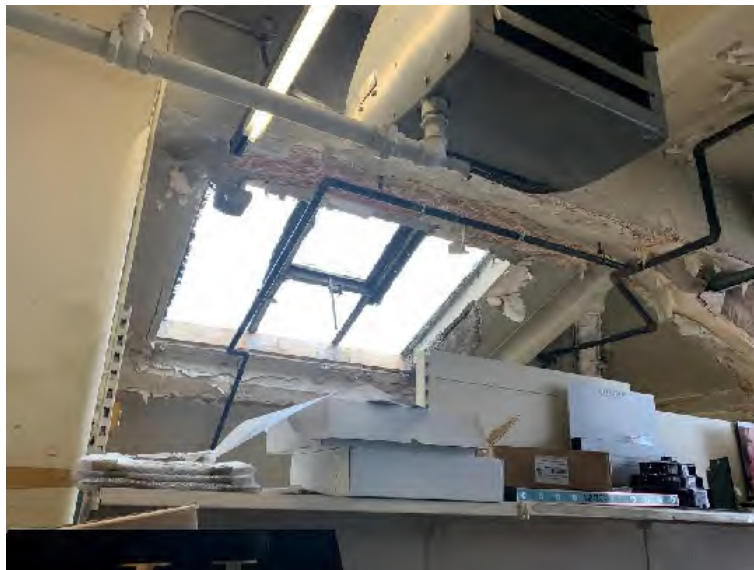
Figure 5: Water Ingress - Fourth Floor

The most notable exception to the state of the fourth floor is in the northwest corner of the floor plate, where there is significant water ingress. Previous surveys of the structure in 2017 have noted water ingress across the structure, though the extent of the water ingress at the time is unknown. The current extent of the water ingress damage is evident from Figure 5 and Figure 6

The source of the water ingress in the northwest corner of the fourth floor appears to be stemming from the rainwater goods. It has been noted from previous reports that poor maintenance of the rainwater goods has led to plant growth and backing up of the respective pipework. The smell of damp is easily noted in the room.

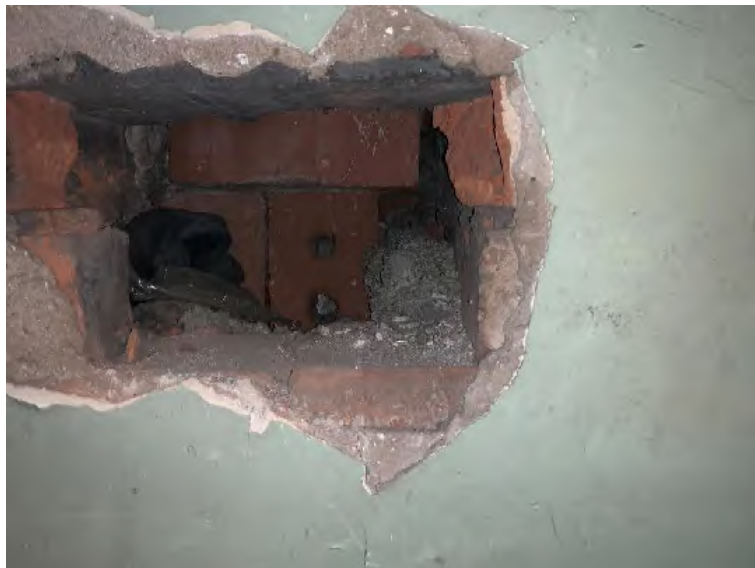
Figure 7: Opening Up Works - Fifth Floor

There appears to be a range of beams and columns with encasement missing in parts, and previous opening up works adjacent to the façade as shown in Figure 7.

It should be noted that it is unknown if the opening up shown in Figure 7 is related to determining the condition of the structure or the investigation of other aspects, for example water ingress.

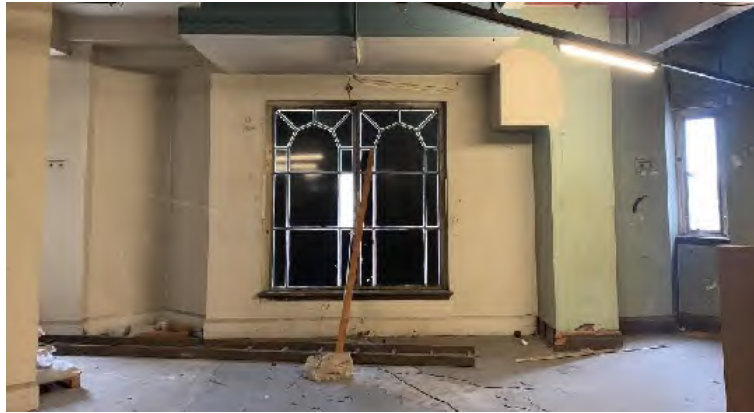
Figure 8: Windows - Fifth Floor

There is evident of further lack of upkeep regarding windows, whereby more than one window is propped up using timber and ballast. An example of this is shown in Figure 8.

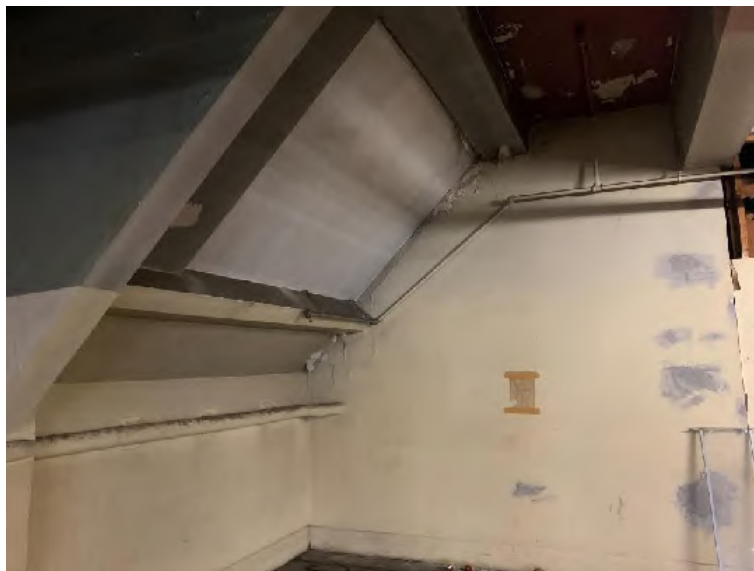
Figure 9: Mansard Roof - Fifth Floor

Additionally, windows which form the lower portion of the mansard roof have been boarded up, presumably to prevent further water ingress in this corner of the building.

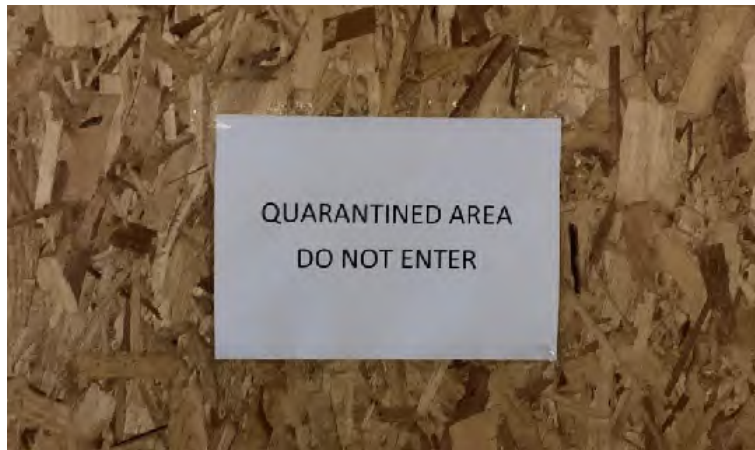
Figure 10: Quarantine: Fifth Floor

On the internal elevation on High Street, there are a number of boards – some of which are no longer standing – which restrict access to the elevation. On the boards, shown in Figure 10, is the notice of the area being quarantined.

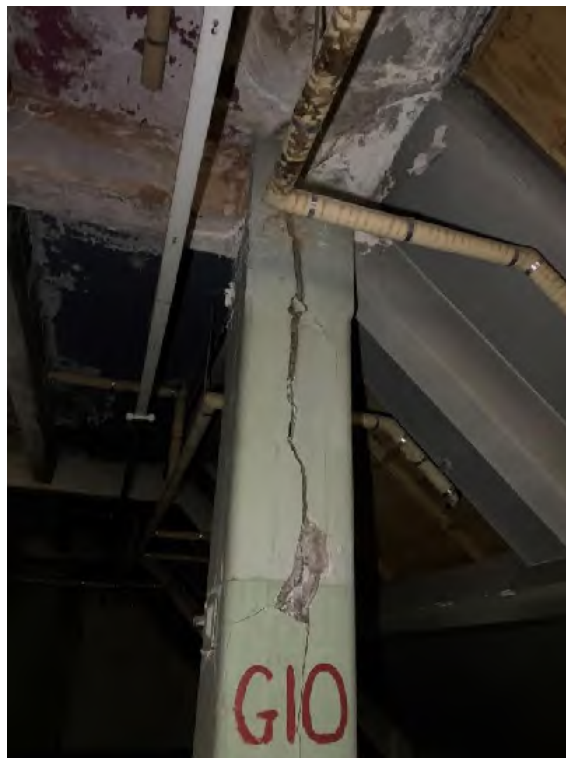
Figure 11: Column Cracking - Sixth Floor

Adjacent to the mansard roof, a column – shown in Figure 11 – has suffered extensive cracking over more than half the column stack.

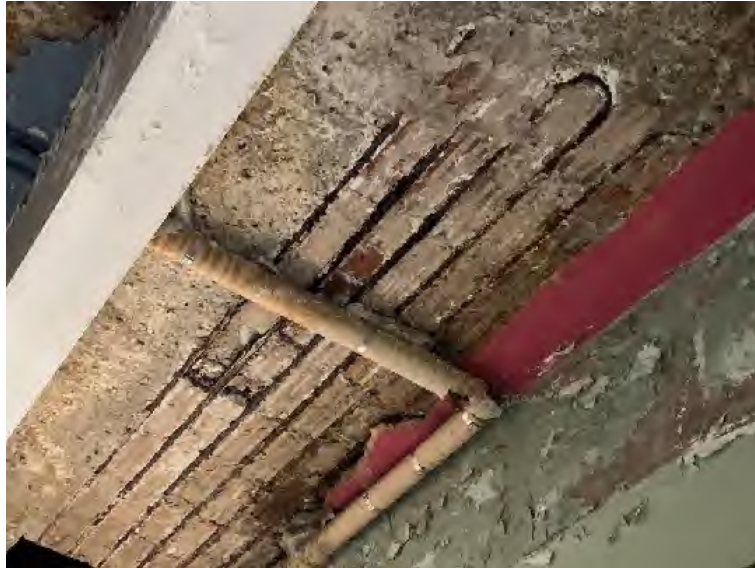
Figure 12: Exposed Reinforcement - Sixth Floor

The past water ingress is evident across much of the underside of seventh, with numerous locations whereby the slab reinforcement is fully exposed. Two examples of this instance are shown in Figure 12 and Figure 13.

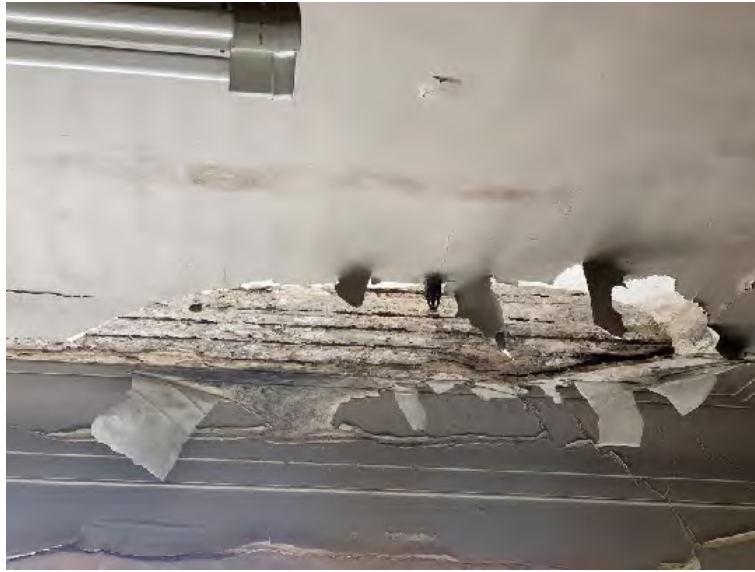
Figure 14: Exposed Reinforcement - Seventh Floor

In a similar manner to sixth floor, exposed reinforcement is also evident at seventh. One such example is in the office with the parquet flooring, which is shown in Figure 14.

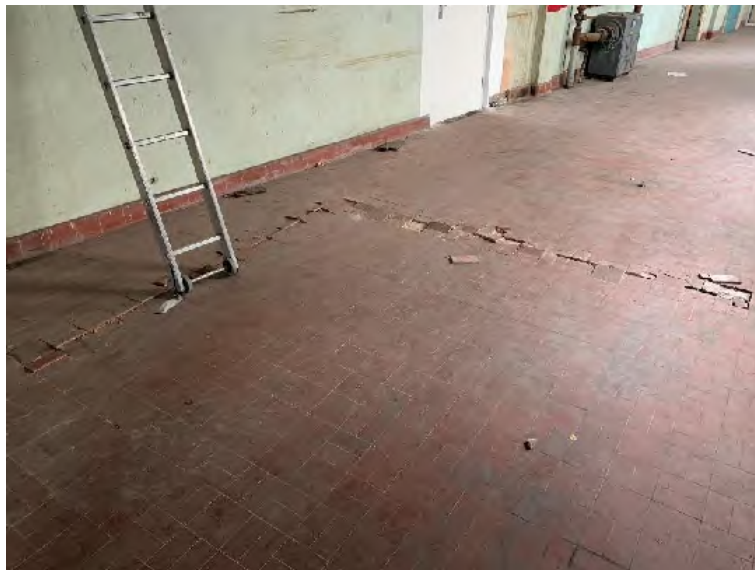
Figure 15: Tiled Floor - Seventh

In the kitchen area, it is noted that there are raised tiles which form a 90 degree angle. It is thought this might be due to two structural elements converging or the expansion of a submerged element causing the ridged tile lines.

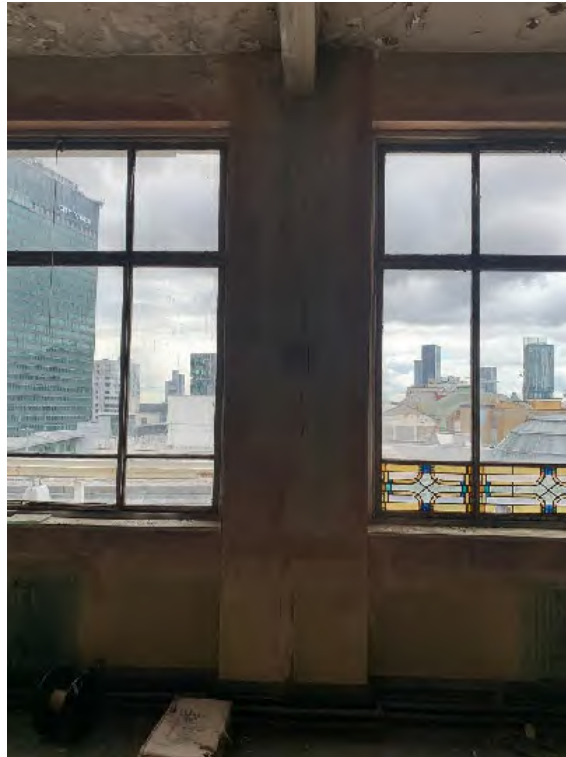
Figure 16: Deansgate Disorder - Seventh Floor

Regent Street Disease (or Deansgate Disorder) is evident along the internal elevation on Market Street on multiple columns. Figure 16 displays an example of one of these columns whereby the cracking is the full height of the column stack.

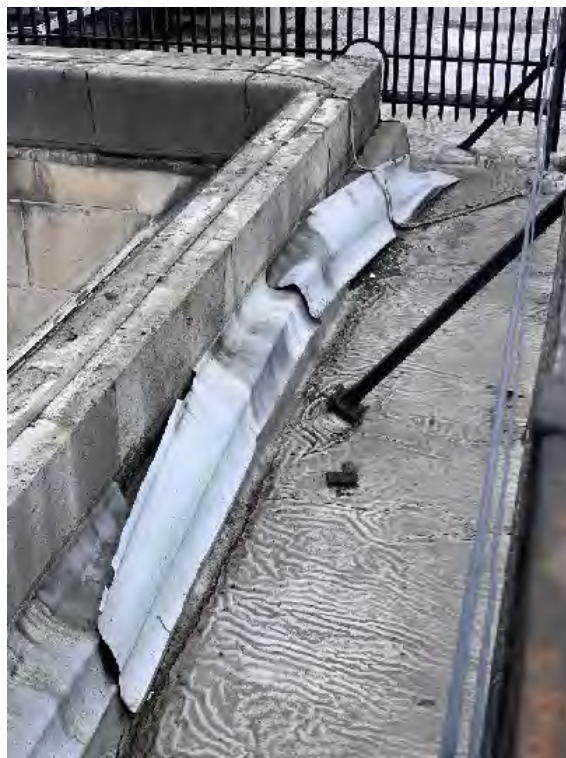
Figure 17: Mansard Roof – Seventh

Around the perimeter of seventh floor, it is evident that the waterproofing is no longer providing a barrier around the full perimeter. An example of the failing waterproofing is above the mansard roof. One portion of the failed waterproofing is shown in Figure 17.

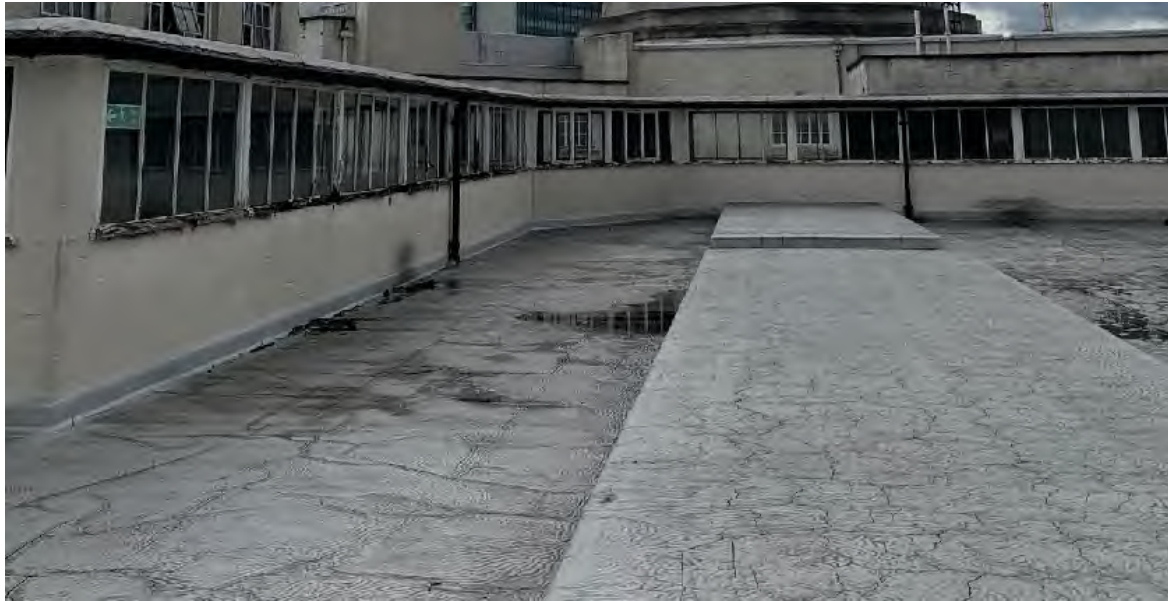
Figure 18: Bitumen - Seventh Floor

As noted in a previous structural inspection by Sandy Porter, there is extensive cracking in the bitumen covering which has been laid across seventh.
