## Hammerstone Road Depot, Manchester

# Discharge of Planning Condition 11

**Curtins Ref: HRD-CUR-00-XX-T-RE-006**

**Project****Project Name:** Adana Hammerstone Rd Goreton Manchester projects**Project Description:** WinCan Import in Miraculix Standard**Project Date:** 17/10/2023**Inspection Standard:** MSCC5 Sewers & Drainage GB (SRM5 Scoring)

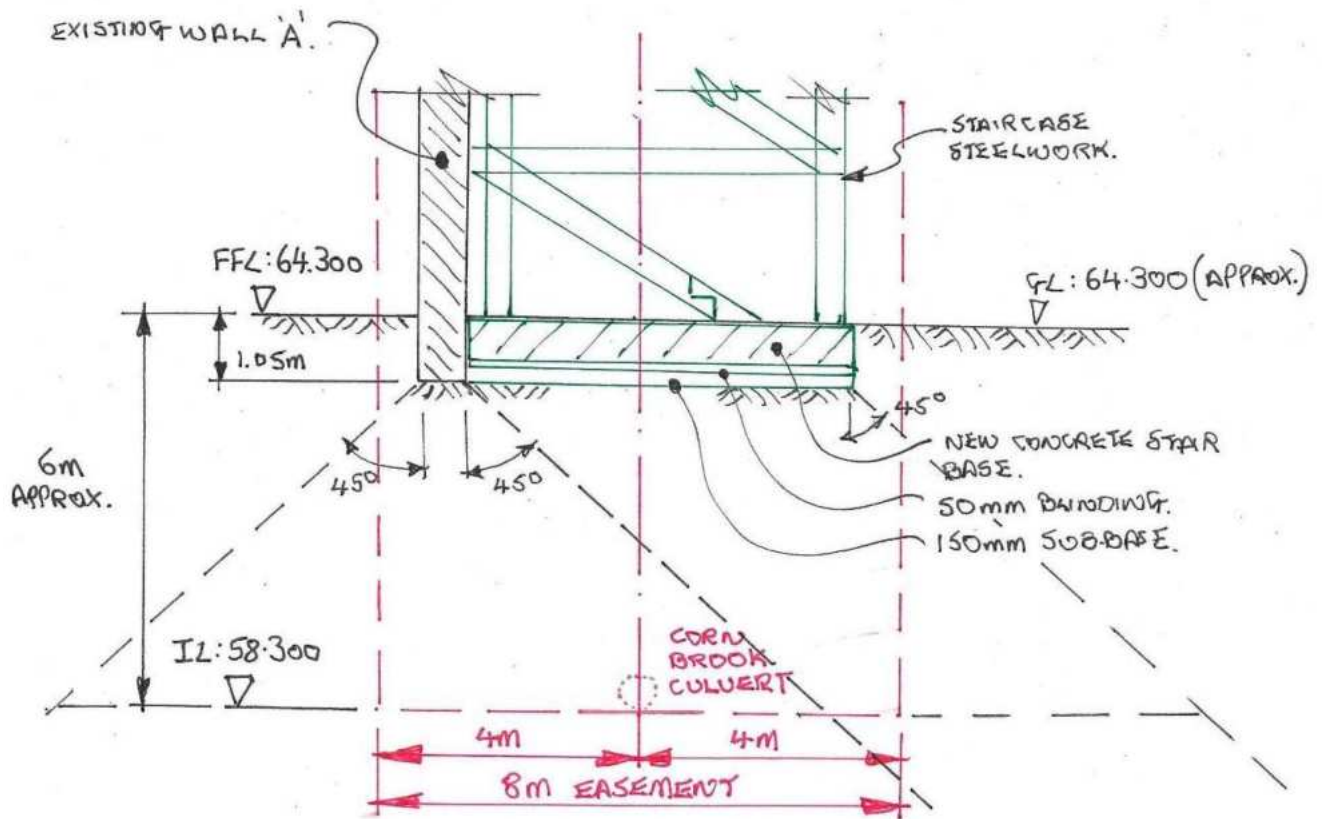
Figure 2.1 – Sectional View

The bearing pressure located directly below the underside of the existing wall foundation equates to the above Total UDL divided by the width of the existing wall. In this case the average width will be used of 0.6m.

**Bearing Pressure at Foundation :**  $166\text{ kN/m} / 0.6\text{m} = \underline{\underline{276\text{ kN/m}^2}}$

**The new loading imposed on the Corn Brook Culvert from the new pad foundation and staircase** is :  $81.25 \text{ kN/m}^2 / 17.8\text{m} = \underline{\underline{4.5 \text{ kN/m run}}}$

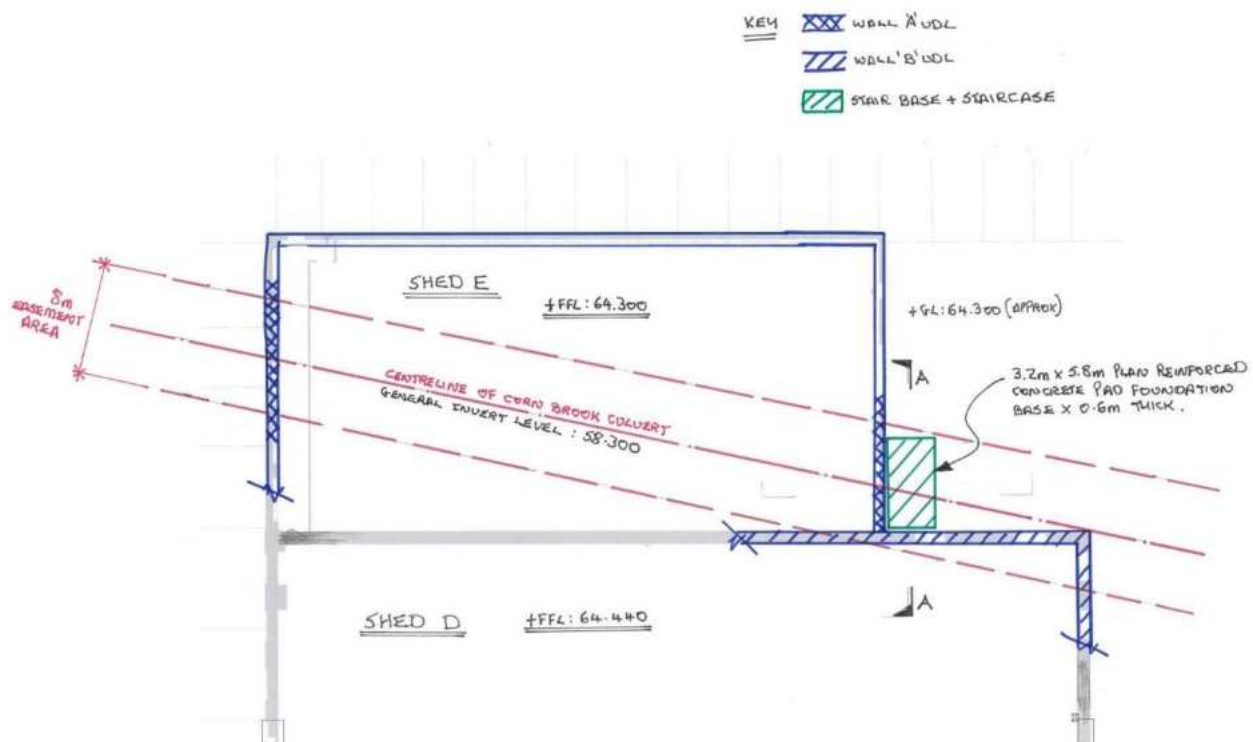
Figure 3.1 – Foundation Plan

With reference to Figure 3.1 above and Figure 2.1 and associated notes, loadings and descriptions within Section 2.0, the relationship between the existing building, existing Corn Brook Culvert and the proposed new staircase and pad foundation are indicated and explained.

As discussed previously, Existing Walls 'A' and 'B' are built directly over the existing Corn Brook Culvert, imposing considerable loads. The new staircase and pad foundation are small in comparison not only in scale but also in actual applied load.

As determined within Section 2.0, the existing building load applied at the Corn Brook Culvert level is 23 kN/m run, the new staircase and pad foundation create an additional 4.5 kN/m run, and approximate 20% increase. The reduction of the building use-imposed load from 20 kN/m<sup>2</sup> to 5 kN/m<sup>2</sup> is a reduction in load of 75%.

The design of the concrete pad foundation has been determined to spread the steel staircase loads over its area ( $3.2\text{m} \times 5.8\text{m} = 18.56\text{m}^2$ ) to ensure that the load applied to the ground are kept to a minimum and evenly over the area.

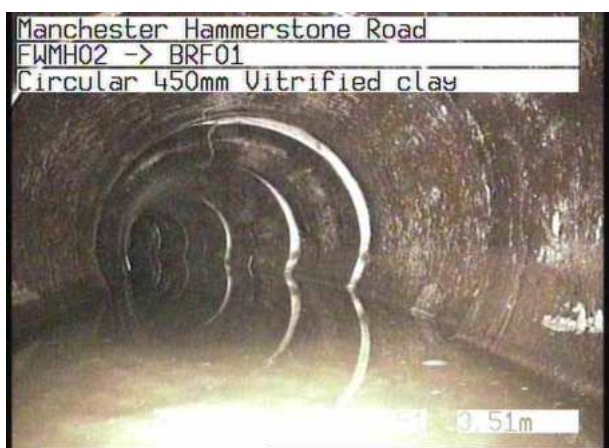
| Scale: 1:135 | Position [m] | Code | Observation | MPEG | Photo | Grade |
|---|---|---|---|---|---|---|
| | 3.51 | CCJ | Crack, circumferential at joint from 11 o'clock to 2 o'clock | 00:02:00 | FWMH02X_e7d97b54-054d-48 | 2 / 2 |

FWMH02X\_e7d97b54-054d-4842-80fd-ac972e072d39\_20230704\_091850\_824.jpg, 00:02:00, 3.51 m  
Crack, circumferential at joint from 11 o'clock to 2 o'clock

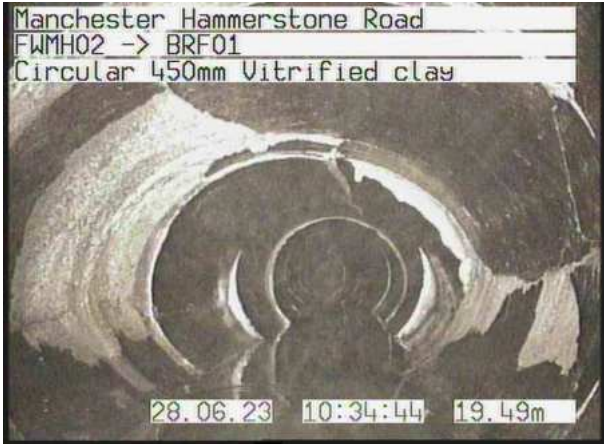
| Scale: | 1:135 | Position [m] | Code | Observation | MPEG | Photo | Grade |
|---|---|---|---|---|---|---|---|
| | | 19.49 | ID | Infiltration, dripping at 12 o'clock | 00:12:41 | FWMH02X_7c48f7e4-fcd9-4bc9 | |

FWMH02X\_7c48f7e4-fcd9-4bc9-810b-eea80249d89c\_202306  
28\_104110\_684.jpg, 00:12:41, 19.49 m  
Infiltration, dripping at 12 o'clock
