# Phase I Geoenvironmental Site Assessment

Site: Riverpark Road, Manchester, M40 2XP

Reference: 17-246-R1-5

Date: March 25

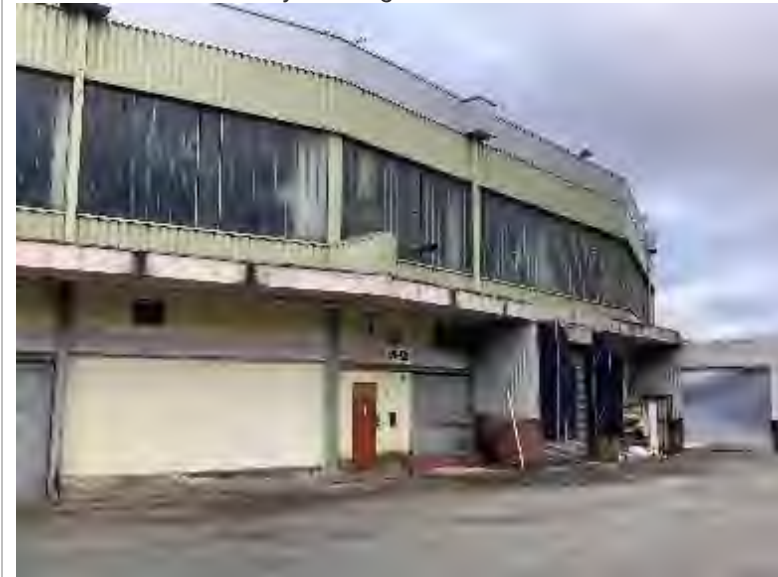
Central former butchery building:

Former butchery building utilised as workshop space (furniture repairs, textile wholesalers and meat wholesalers). A reduced level/cutting is present at the eastern side of the building to allow access to the centre of the circular building.

Buildings in this area of the site are generally two storey brick and concrete structures with sheet metal cladding.

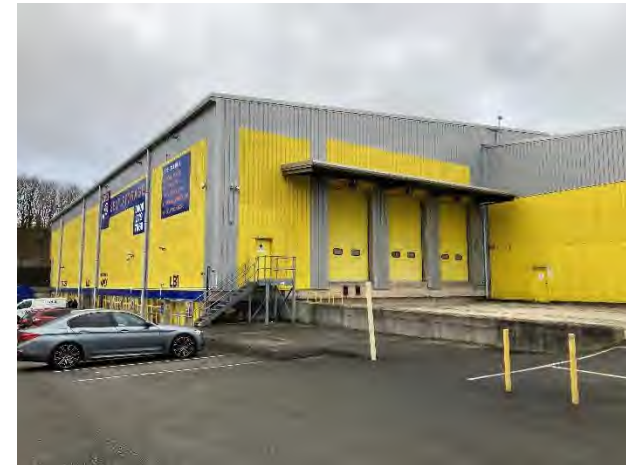
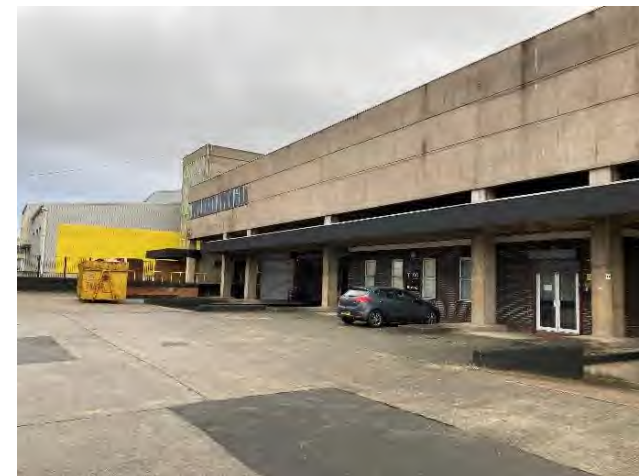
Warehouses in centre/east:

Semi-mature trees and shrubs occupy the area adjacent to the eastern boundary.

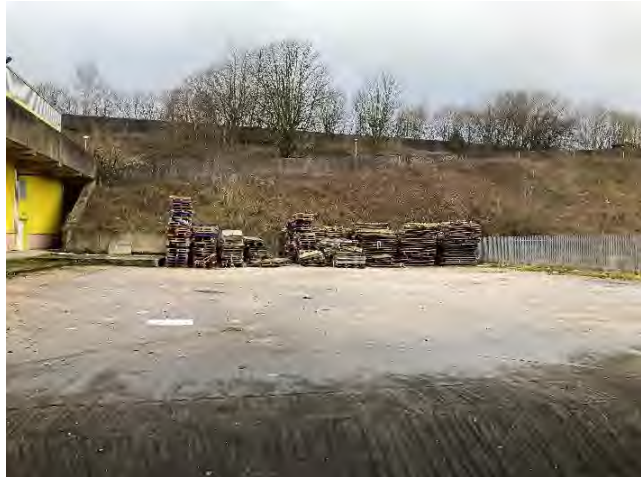
| | <p><b>Northern sector:</b><br/>A steep embankment vegetated with semi-mature trees, shrubs and Japanese knotweed traverses the northern boundary from west to east. A former livestock delivery ramp connects the site with the railway which is located on the crest of the embankment.</p> <p>A retaining wall is present at the base of the embankment, present from the central sector to the eastern boundary.</p> <p>As off 2025 demolition of onsite structures is ongoing.</p> | <p>Northern Embankment:</p> |

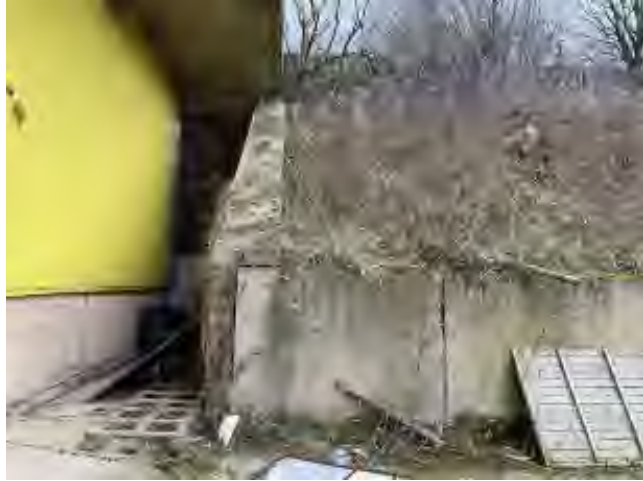
| <b>Retaining Structures</b> | <p>A slope and retaining wall are present along the northern boundary of the site, supporting the railway embankment shown in the image.</p> <p>A further retaining wall is present separating the warehouses in the east from the remainder of the site in the west, placing the east of the site at circa 1.00m lower in level than the west.</p> <p>Location of retaining features are shown on Drawing 17-246-004 in Appendix IV.</p> | |

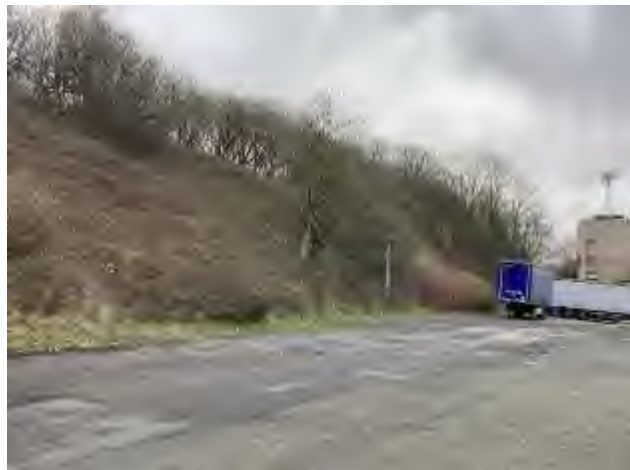
| <p><b>Slope</b></p> | <p>A steep slope is present along the northern boundary of the site, sloping in a southerly direction away from the railway and towards the site. The slope is well vegetated and currently appears stable, however, a slope stability model may be required. A large cast in situ reinforced concrete retaining wall is present at the base of the embankment, traversing from the central sector to the eastern site boundary.</p> <p>Generally, the site is uniform in topography, with a gentle slope to the east. However, a slope is present in the centre of the site with a low point at the base of the ramp access for the central circular building.</p> | |

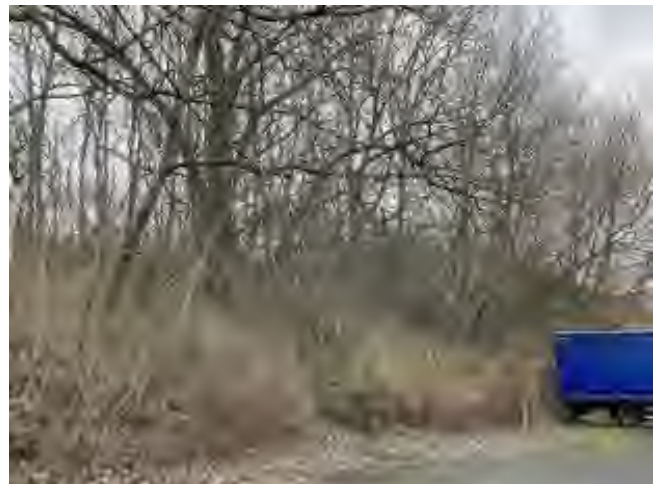
| <p><b>Vegetation/Ecology</b></p> | <p>The retaining wall and slope along the northern boundary of the site are populated with vegetation including multiple semi-mature and mature trees and scrub vegetation. There are also areas of landscaped grass along the southern boundary of the site and outside the eastern entrance of the central building.</p> <p>Japanese knotweed has been identified within the vegetation along the northern and western boundary.</p> <p>A habitat survey will be required to support the planning application.</p> | |

- ✚ Trees are present within the embankment at the northern boundary and clays in this area may be subject to desiccation, however, their removal is an unlikely option as their excavation may undermine the embankment. It is recommended that the conjectured extent of desiccation be modelled and that the appropriate foundation solution be adopted.

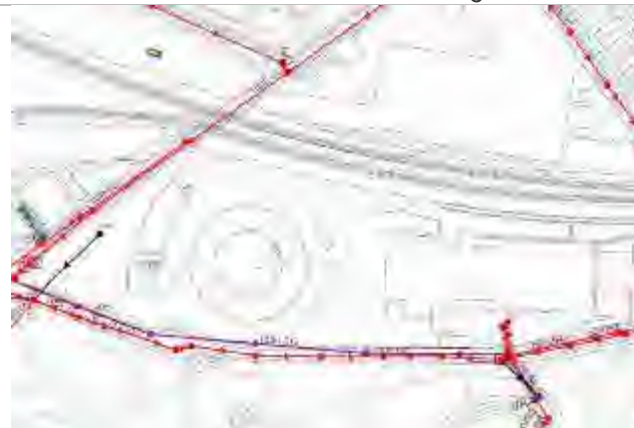
| <b>Drainage</b> | <p>A formal drainage survey has not been completed; however, a review of online records held by United Utilities indicates the presence of a combined sewer located to the central southern boundary and an abandoned sewer present along the western boundary. A control kiosk, sewer overflow and network storage tank are also present within the site boundary on the western boundary adjacent to Briscoe Lane.</p> | |

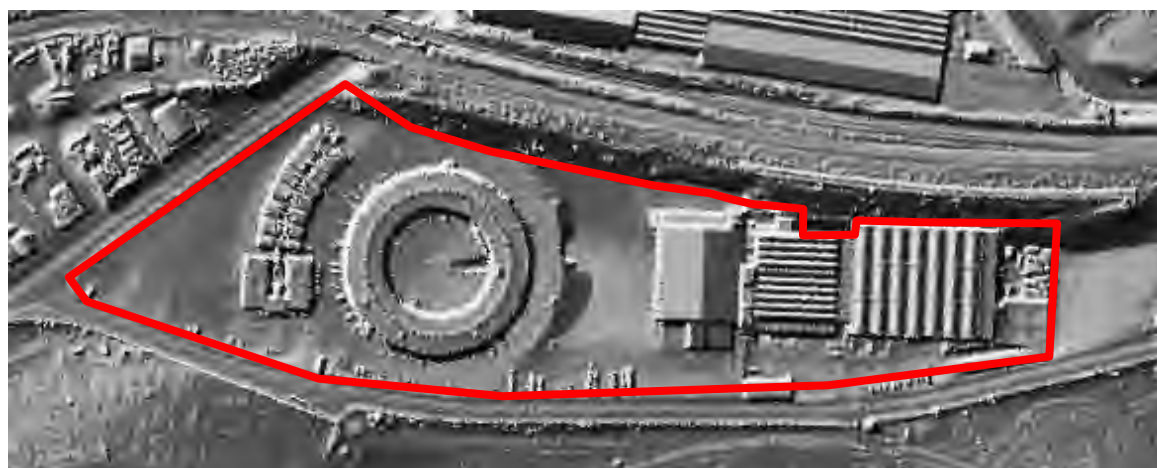
**Figure 10** Surface Lidar Data

It is likely that to during the creation of a development platform circa 1966, historical levelling and localised cut and fill works have occurred, this has resulted in an artificially level site with little topographical change. The depth of filling is unknown, however, aerial imagery (from 1939) and review of topography and historic contours on historic mapping suggest that the site was lowered with shallow excavations over time, with the development platform (circa 1966) constructed at the base of the former excavations.

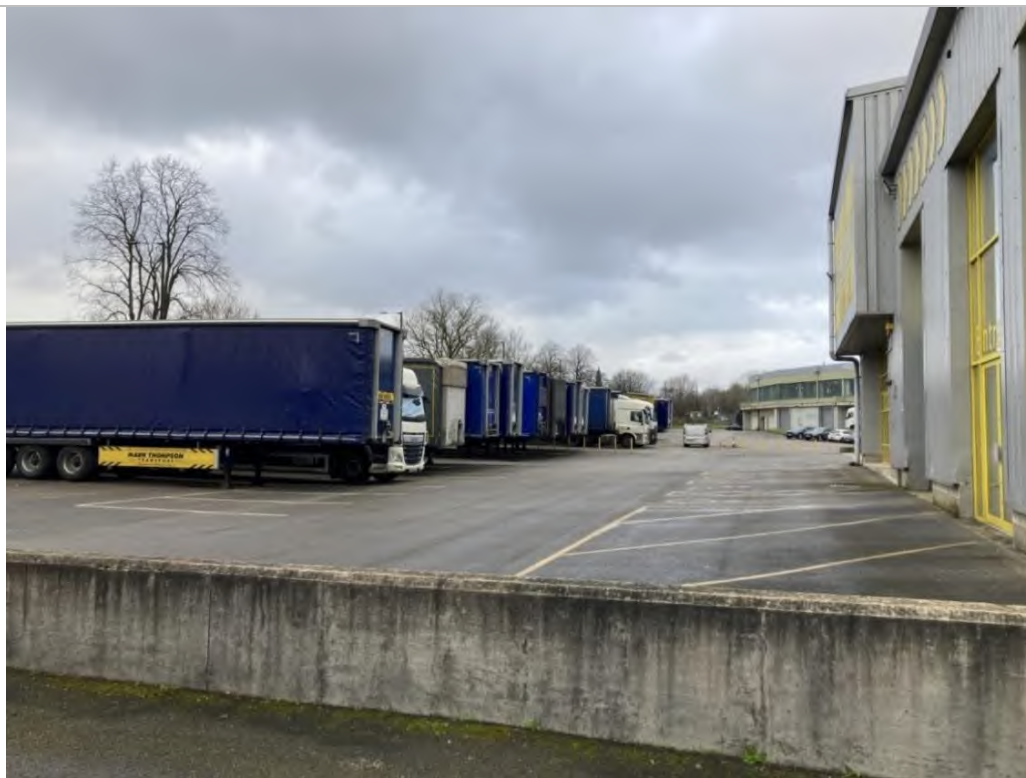
PLATE 2 SMALL RETAINING WALL IN THE EAST OF THE SITE

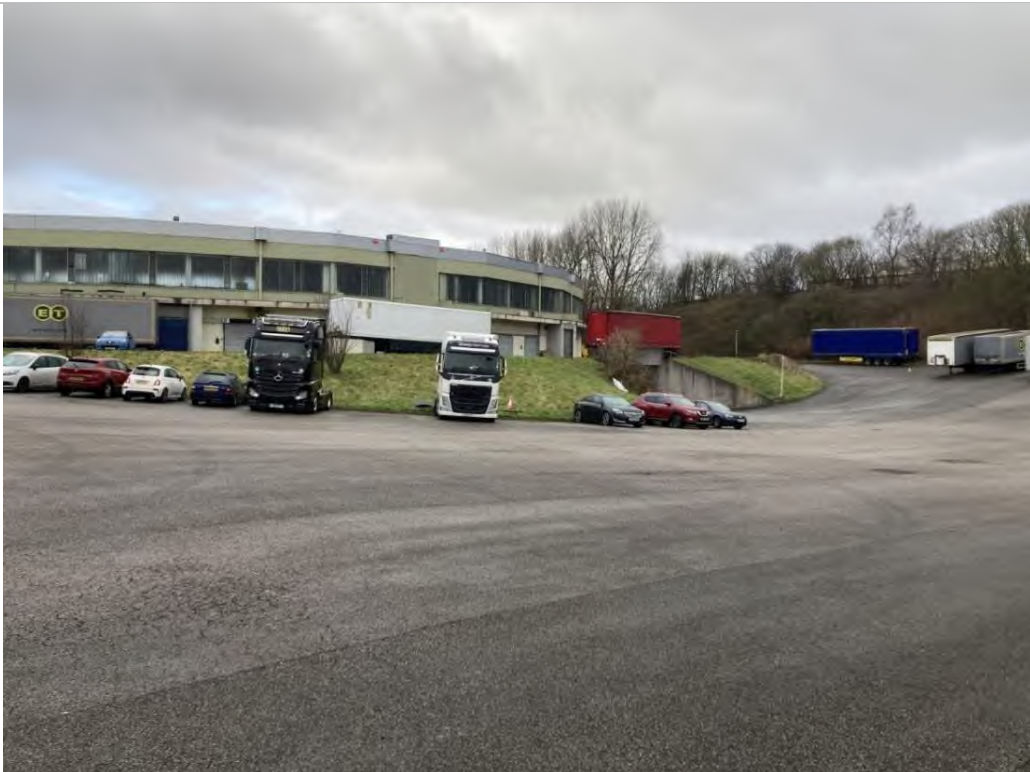
PLATE 6 SLOPE IN THE CENTRE OF THE SITE

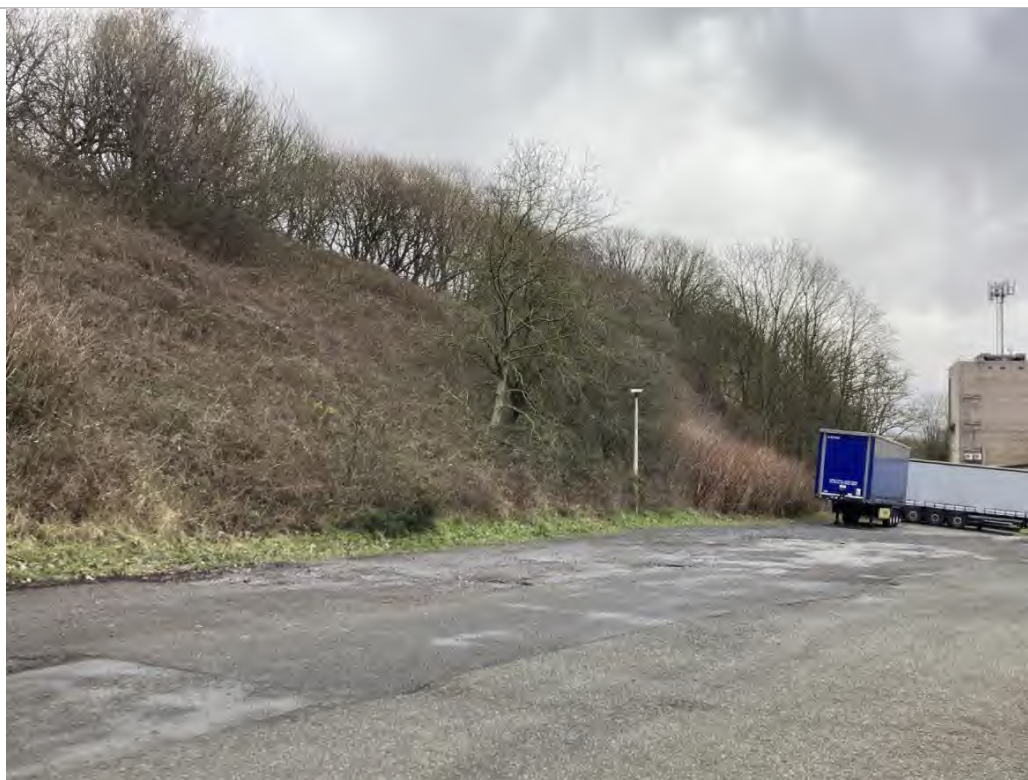
PLATE 8 RETAINING WALL AND SLOPE ALONG THE NORTHERN BOUNDARY

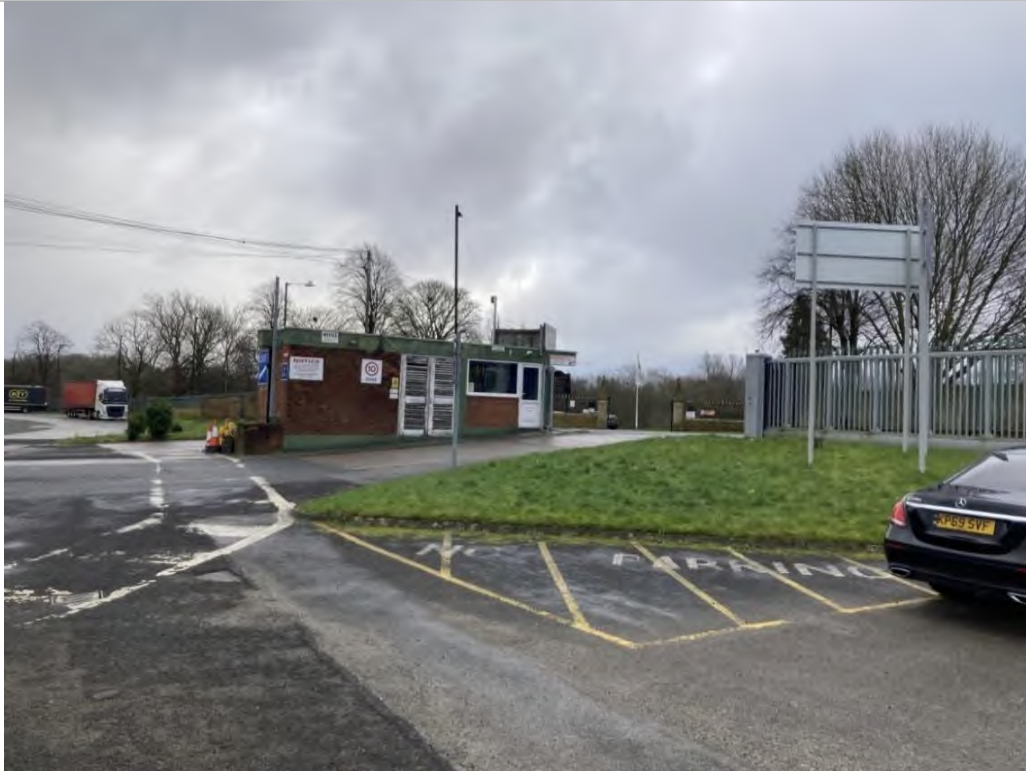
PLATE 9 ELECTRICAL SUBSTATION AT THE SITE ENTRANCE
