# Validation Report

Site: Bennett Street, Manchester

Reference: 15-974-R6-4

Date: February 2025

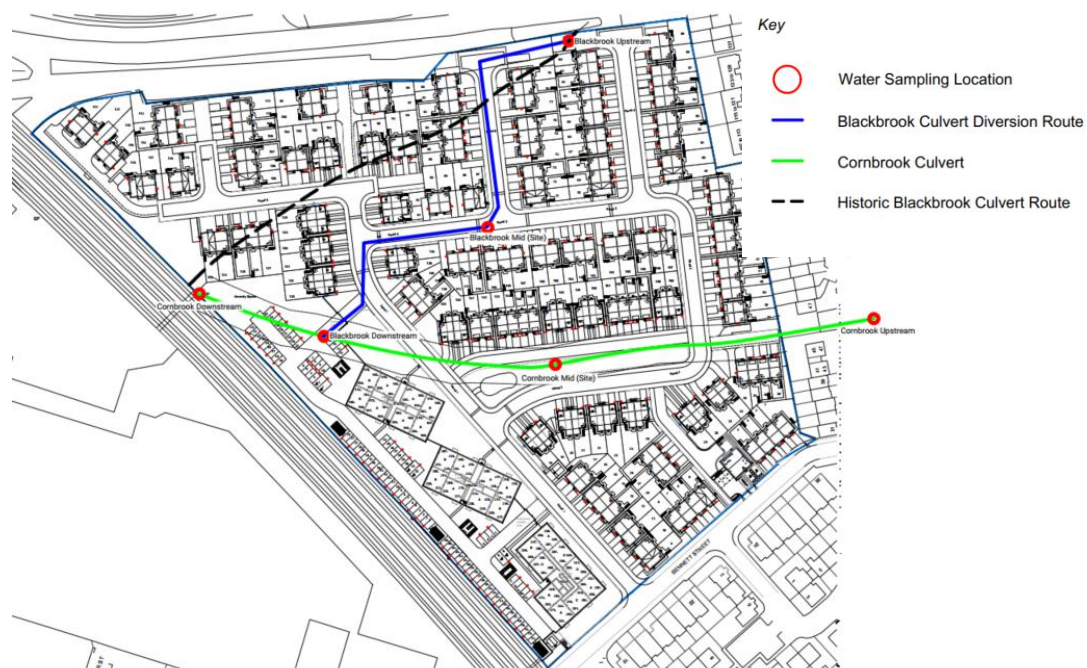
**FIGURE 4.1 – CULVERT WATER SAMPLE LOCATIONS**

Results of monthly sampling within the Cornbrook culvert show consistent elevations of heavy metals copper, zinc, cyanide, and nickel within upstream, on site and downstream samples compared to the EQS. No obvious or consistent increase between upstream and downstream values has been recorded, indicating this was background concentrations in the watercourse or the source was located upstream.

No elevations of benzene, toluene, ethylbenzene and xylene (BTEX) or TPH compounds have been identified within any of the Cornbrook samples. Additionally, no suspended soils were visually observed within water samples obtained.

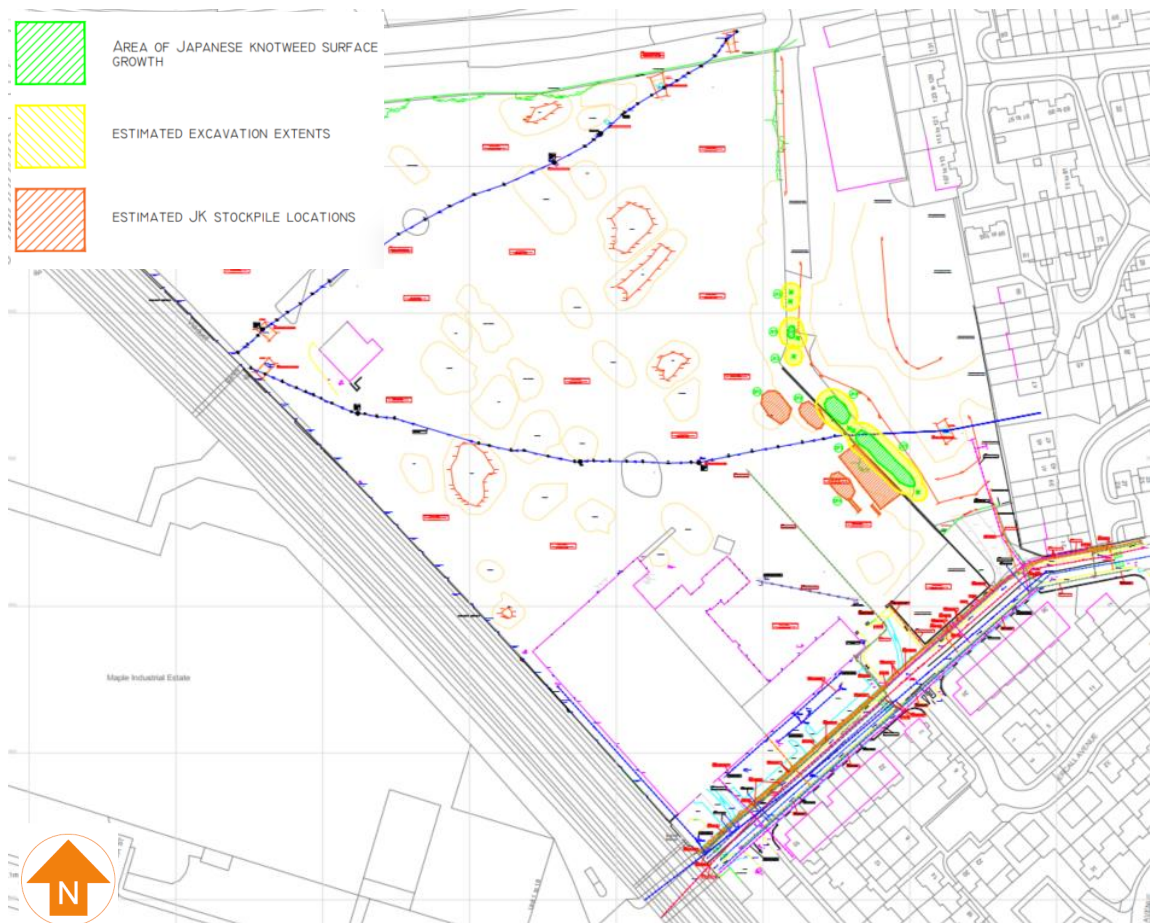
**FIGURE 4.2 – JAPANESE KNOTWEED LOCATION**

The location of Japanese knotweed impact is shown as areas of green, orange and yellow in the east of the site on Figure 4.2 below and within Japanese Knotweed Solutions report (ref: JK23/9266).

Japanese Knotweed impacted materials were excavated under the supervision of JKS in January 2024 with works completed by 2<sup>nd</sup> February 2024. Material excavated was placed in a temporary stockpile area on visqueen sheeting, tested by E3P, and subsequently removed from site.

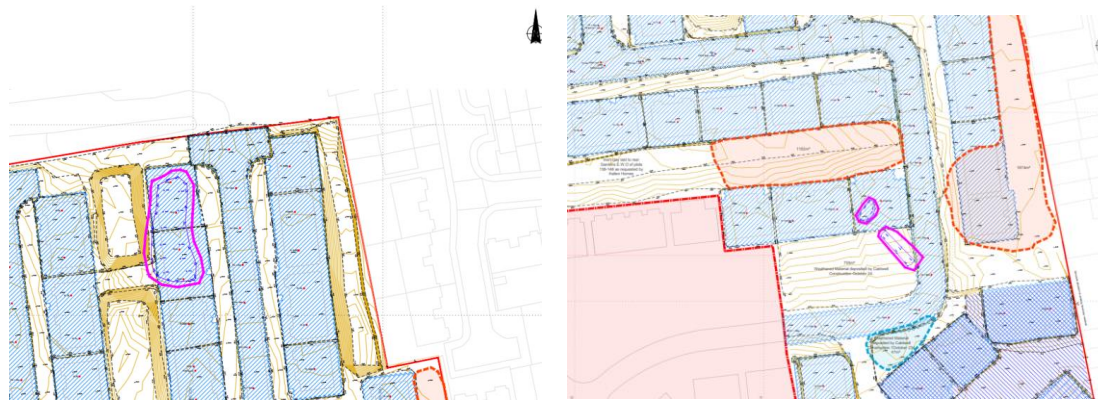
FIGURE 4.3 LOCATION OF ASBESTOS BURIAL PITS (NORTH – LEFT & SOUTH – RIGHT)

Additionally, during turnover on 19<sup>th</sup> August 2024, an area containing a layers of clearly visible asbestos cement sheeting was identified in the north of the site, referred to as 'northern asbestos burial pit' was identified below the proposed location of plots 60-63. The location of this ACM infill is shown as a purple outline on UR AsBuilt Sheet 2, UR drawing ref 395-002 in Appendix III and Figure 4.3. Fencing with appropriate health and safety signage was erected around the area, with soils remaining undisturbed until updated RAMS were produced by the appointed contractor.

E3P obtained a sample of the fine soil matrix for both the northern (ASB-B) and southern (ASB-A) asbestos pits. Sample of soils obtained from the southern asbestos area (ASB-A) recorded 3.6% w/w of chrysotile cement. No asbestos fibres were recorded within the soil matrix in the northern asbestos area (ASB-B).

In both instances work was ceased and a JIWG undertaken. The JIWG assessment concluded that the works were determined to be non-licensed work with the following precautions being suitable - EN149 type FFP3 disposable masks as RPE, manual localised dust suppression and localised basic decontamination facilities.

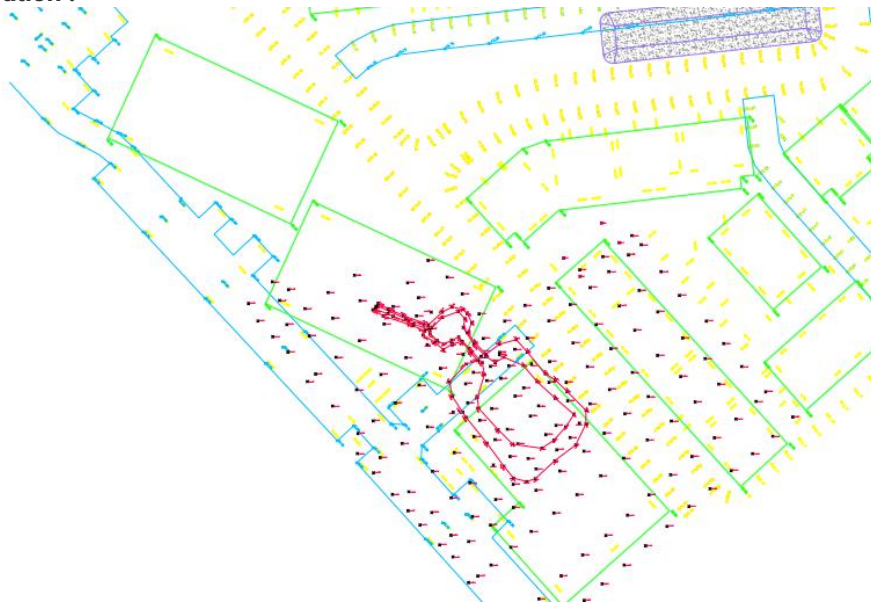
**Pond 1 Location :**

The base of Pond 1 was noted to be 1.50 m below the wider natural level.

No organic pond base was identified, it is likely this was historically grubbed out and nominally backfilled during construction of the historical structures. The resulting excavation was backfilled with geotechnically suitable site won Made Ground in line with the agreed specification for a piled foundation (RE-16).

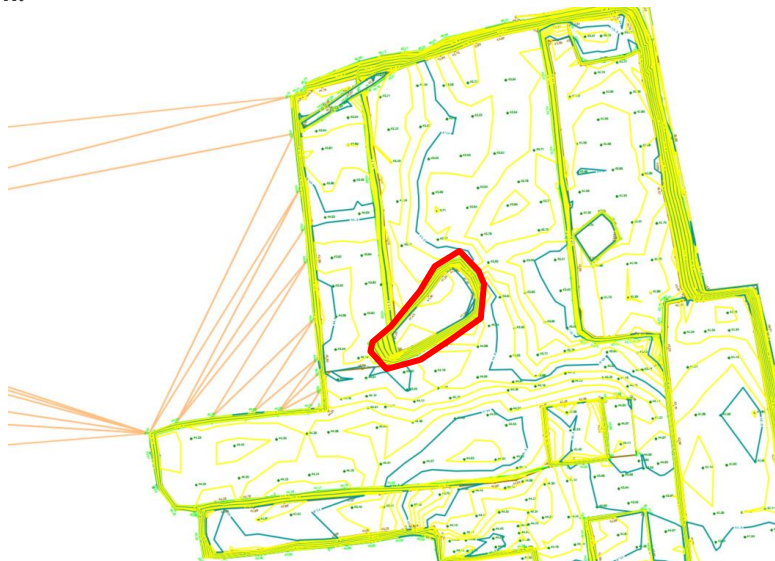
**Pond 2 Location:**

The base of Pond 2 was noted to be 1.75 m below the wider natural level.

No organic pond base was identified, it is likely this was historically grubbed out and nominally backfilled during construction of the historical structures. The resulting excavation was backfilled with geotechnically suitable site won Made Ground in line with the agreed specification for a vibro stone column foundation with in situ density testing conducting to confirm compliance with the specification (RE-16 & RE-17).

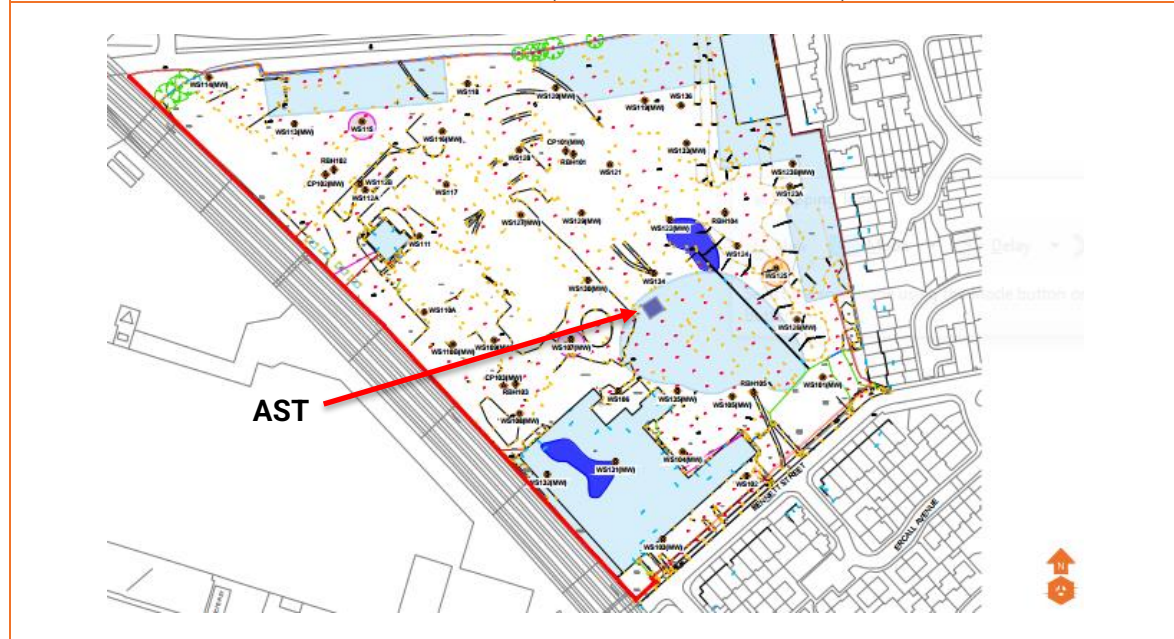
FIGURE 4.6 – HISTORICAL FEATURES PLAN (AST SHOWN IN PURPLE)

One redundant above-ground storage tanks (ASTs) was present in the central/eastern area of site, the location of which is shown as a purple square on E3P Drawing 15-974-004 and Figure 4.6.

The tank was noted to be empty with no residual fluids present. PID monitoring of tank openings and surrounding area did not record elevated readings (all readings <50 ppm).

E3P undertook a watching brief during the breaking out of the concrete base in June 2024. No visual or olfactory evidence of contamination was noted within Made Ground soils below the concrete subbase. Additionally, all PID readings were recorded <50ppm.

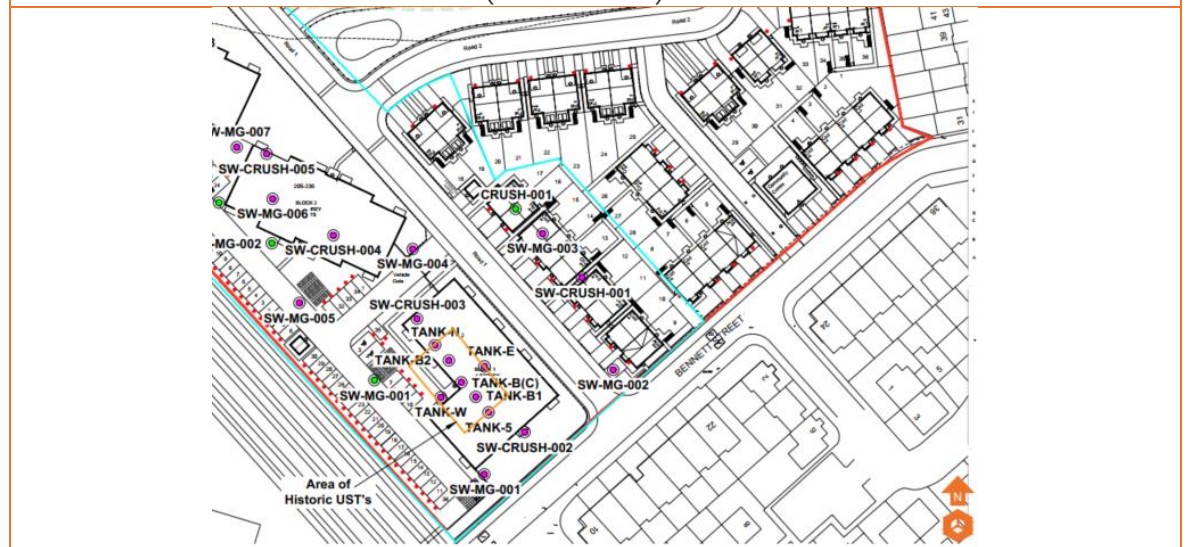
FIGURE 4.7 – HISTORICAL USTS PLAN (ORANGE BOX)

Following the demolition of the former bus depot in the south east, two adjacent underground storage tanks (UST) were encountered beneath/recessed within the floor slab. The location of the tanks is shown on Figure 4.7.

Tanks were noted to be empty with no residual fluids present. PID monitoring of tank openings and surrounding area did not record elevated readings (all readings <50 ppm).

Following the removal of the tanks, E3P undertook a visual and olfactory inspection with no visual, olfactory or PID readings above 50ppm noted. Concrete tank bases were broken out and added to the oversize stockpile for crushing and re-use on site (RE-8).
