Gas Membrane Installation  
Validation Report  
Casey Group  
The Enterprise Centre  
Benchill Road  
Wythenshawe  
M22 8LF

## Appendix 1 – Site Survey Sheets

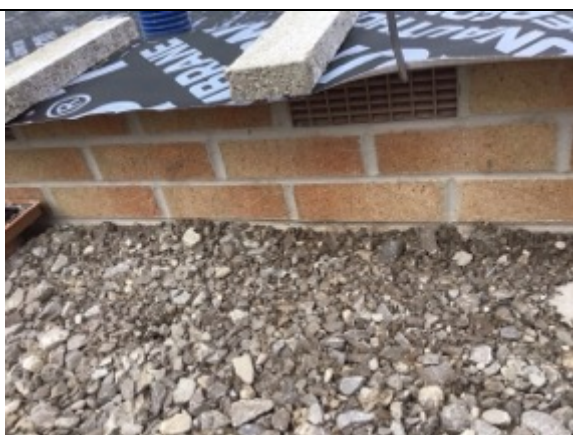
Cavity vents installed under the perimeter membrane

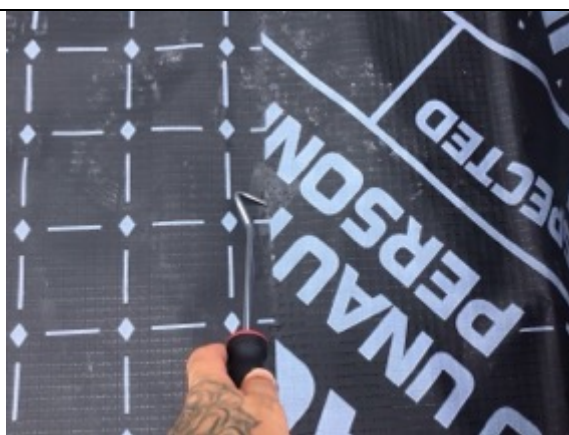
Pick testing sealed hand welded membrane lap joint

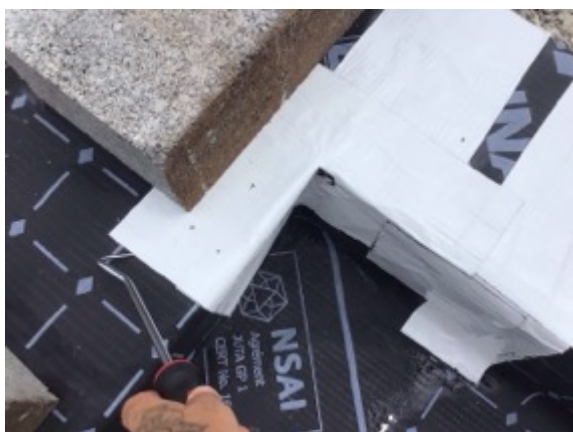
Pick testing detailing work

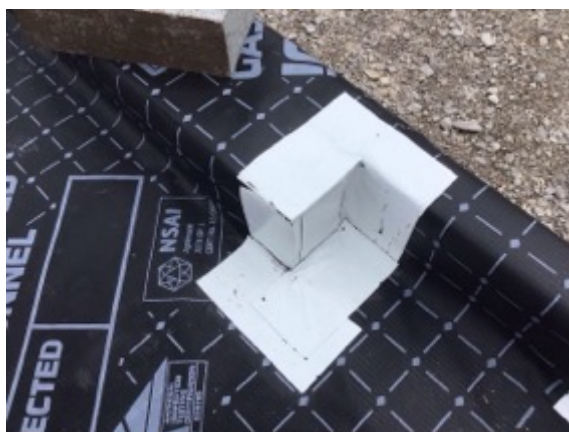
Plot 1 threshold detail sealed using Juta GP SAM and heat applied

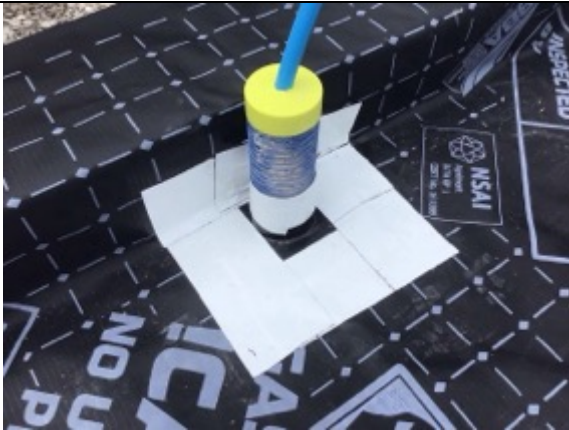
Plot 1 pipe penetrations sealed using Juta GP SAM and heat applied over a pre formed top hat

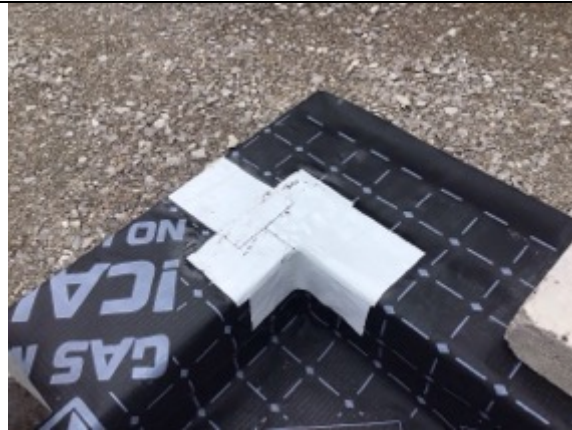
Plot 1 corner detailing sealed using Juta GP SAM and heat applied

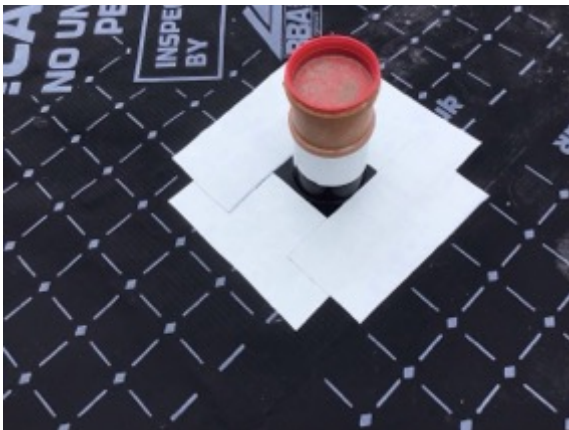
Plot 2 pipe penetrations sealed using Juta GP SAM and heat applied over a pre formed top hat

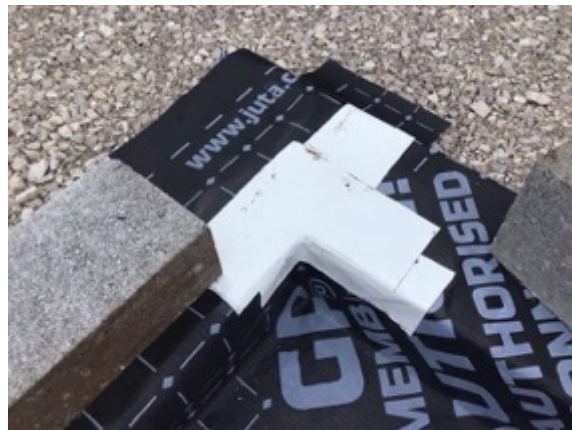
Plot 2 corner detailing sealed using Juta GP SAM and heat applied

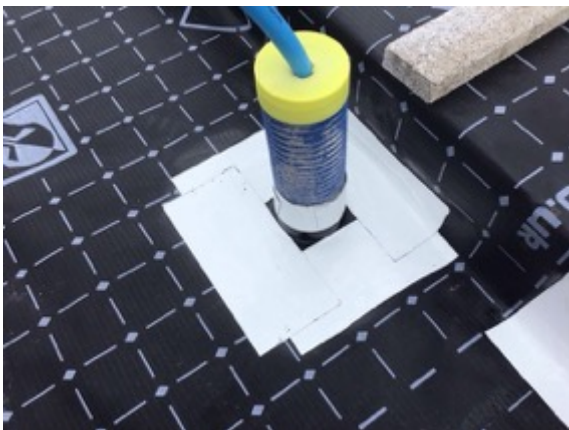
Plot 3 pipe penetrations sealed using Juta GP SAM and heat applied over a pre formed top hat

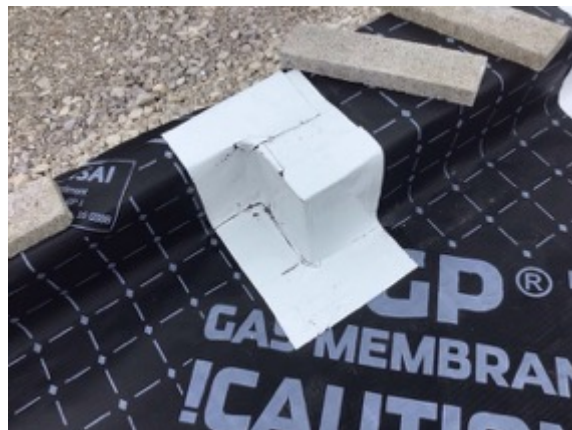
Plot 3 threshold detailing sealed using Juta GP SAM and heat applied

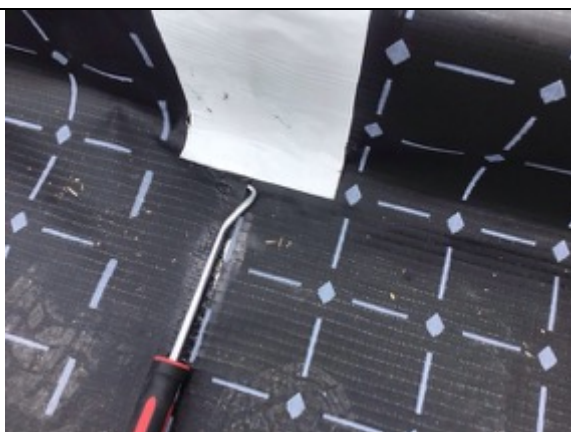
Recorded weld defect on plot 1

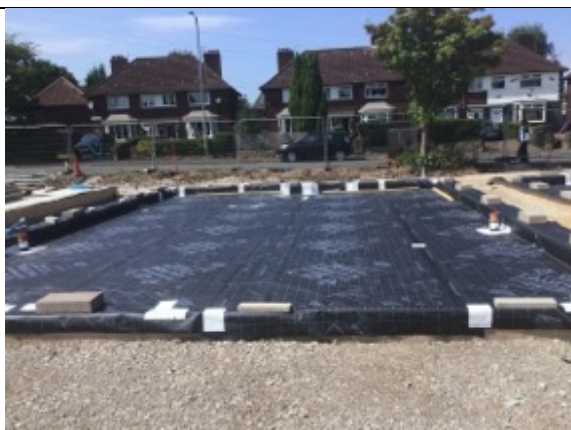
Plot 4 full line out overview

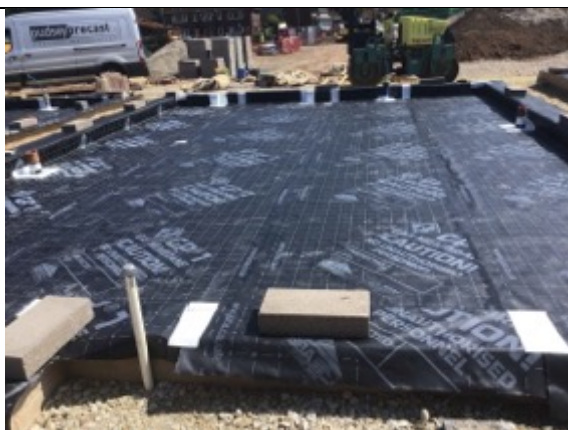
Plot 5 full line out overview

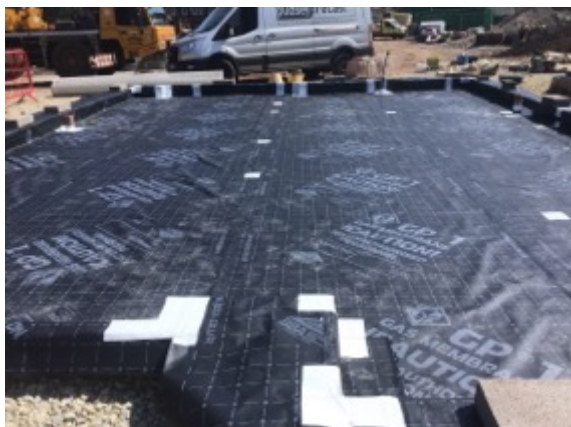
Plot 6 full line out overview

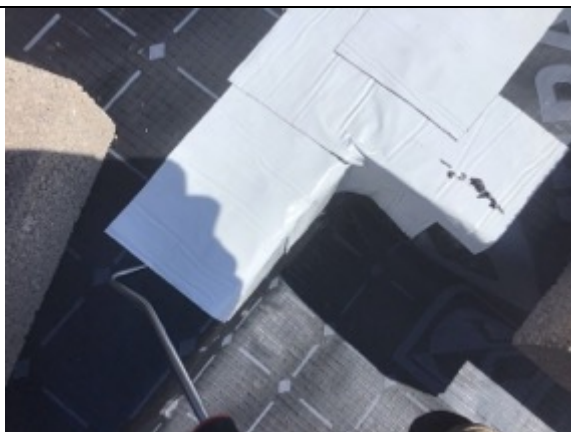
Plot 4 probe testing corner detail

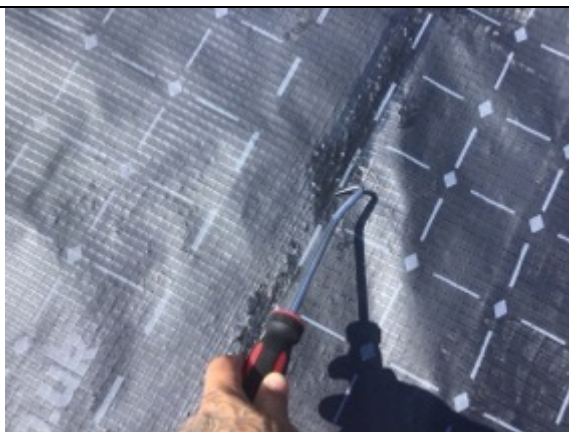
Plot 4 probe testing hand welded membrane lap joint

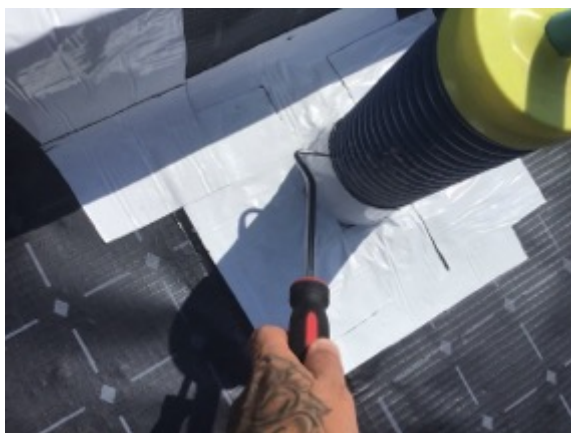
Plot 4 probe testing pipe penetration

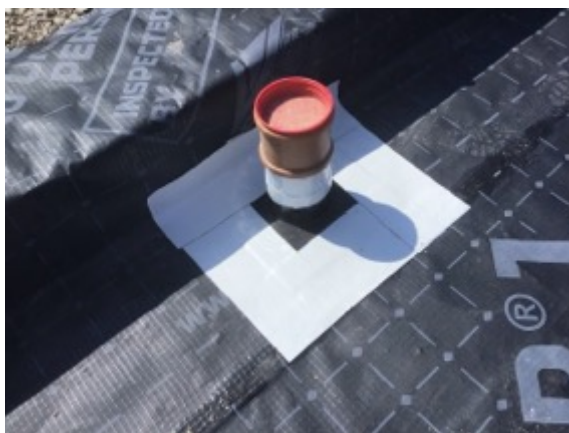
Plot 4 pipe penetration sealed with a preformed top hat and Juta GP SAM detailing

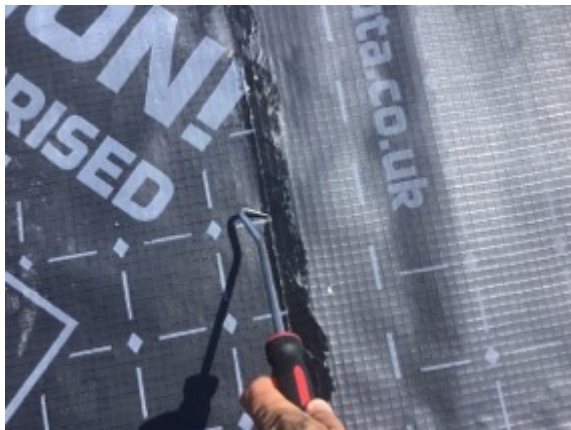
Plot 5 probe testing hand welded membrane lap joint

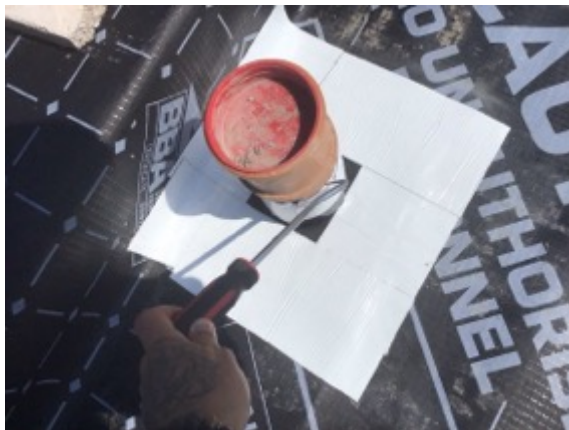
Plot 5 probe testing pipe penetration sealed with a preformed top hat and Juta GP SAM detailing

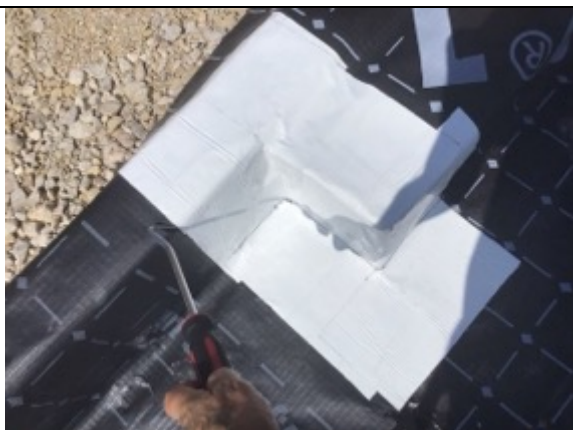
Plot 5 probe testing threshold detail

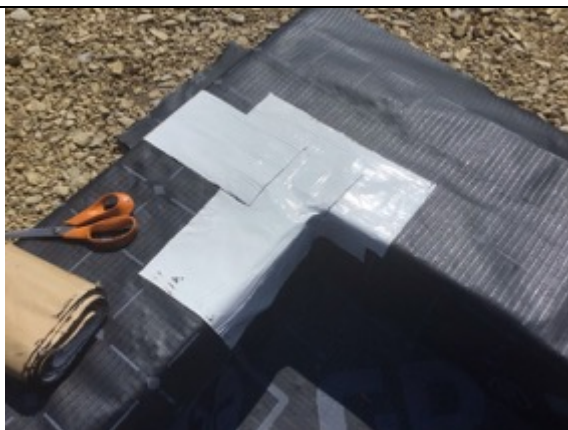
Plot 5 sealed corner detailing

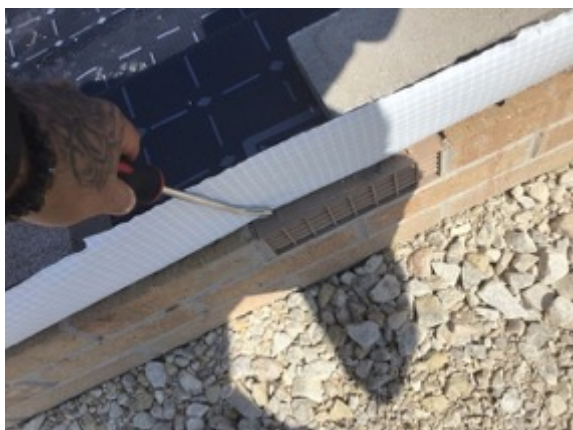
Cavity vents installed under the perimeter membrane

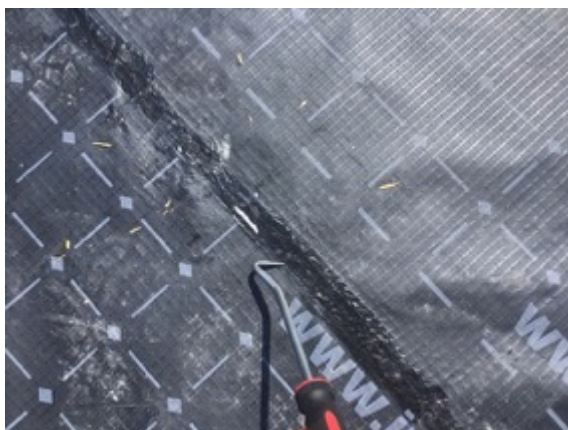
Plot 6 probe testing hand welded membrane lap joint

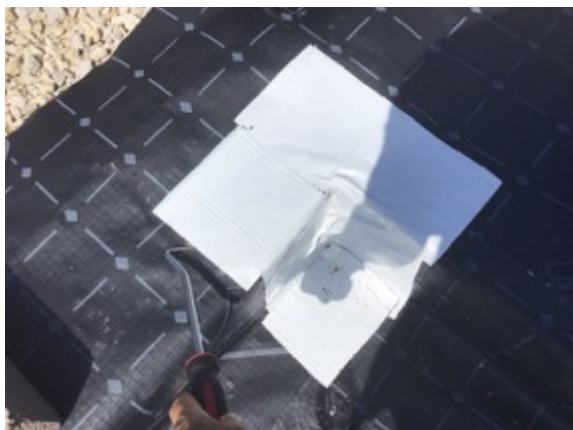
Plot 6 probe testing corner detailing

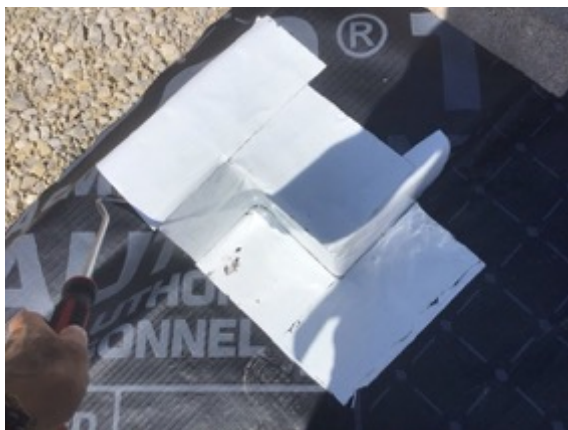
Plot 6 probe testing threshold detailing

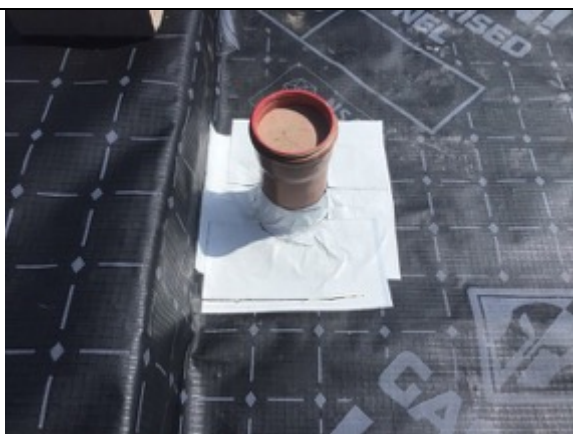
Plot 6 pipe penetration sealed using Jута GP SAM

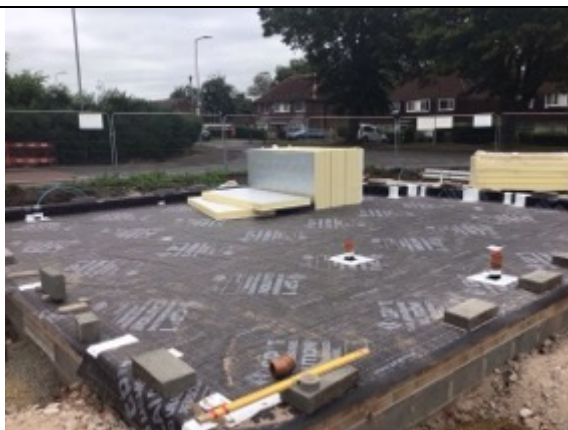
Plot 7 full line out installation

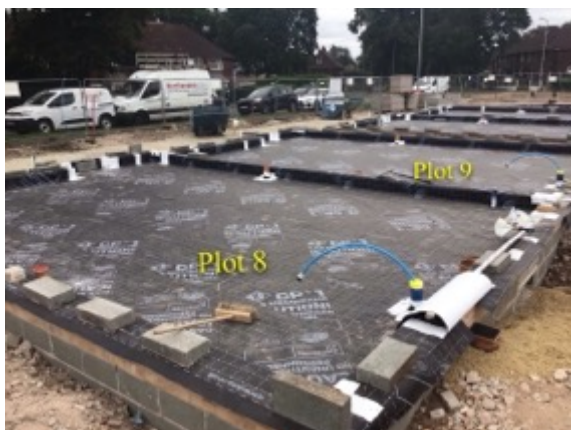
Plots 8 & 9 full line out installation

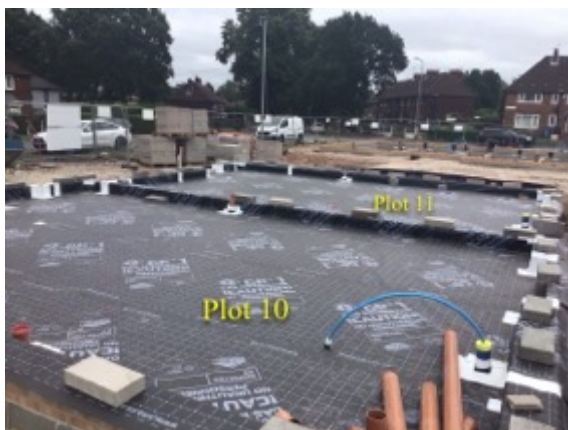
Plots 10 & 11 full line out installation

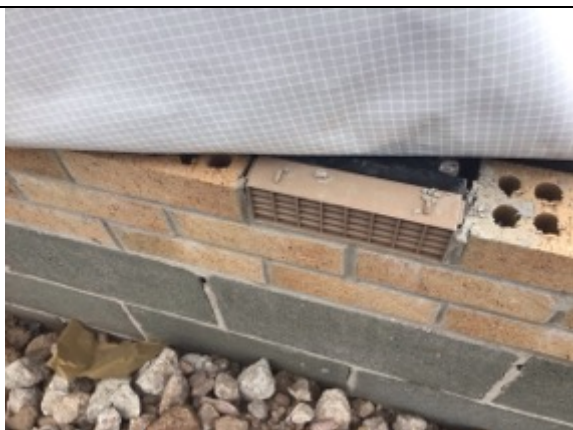
Perimeter cavity vents installed under the membrane

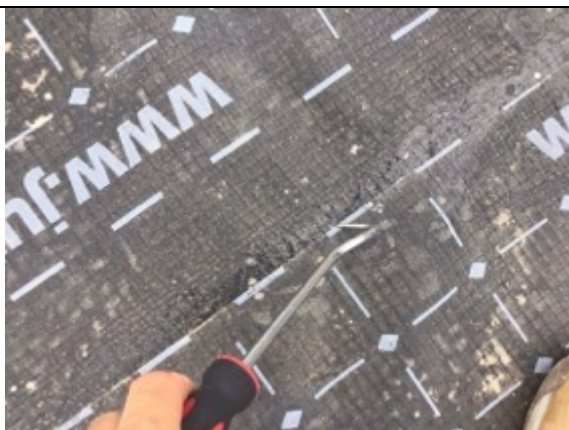
Plot 7 testing hand welded membrane lap joint

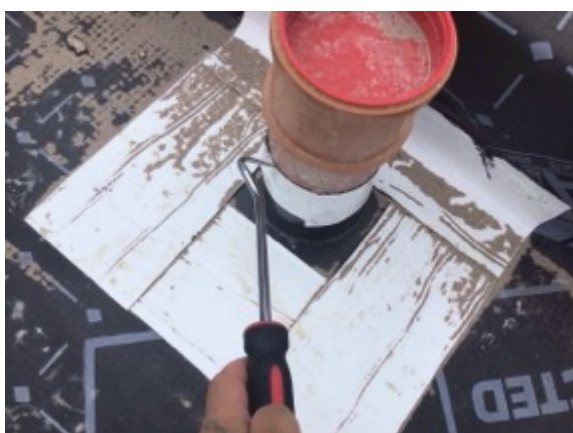
Plot 7 testing pipe seals

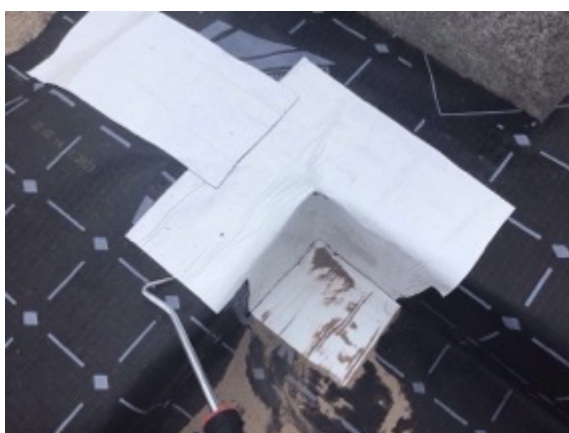
Plot 7 testing corner detailing

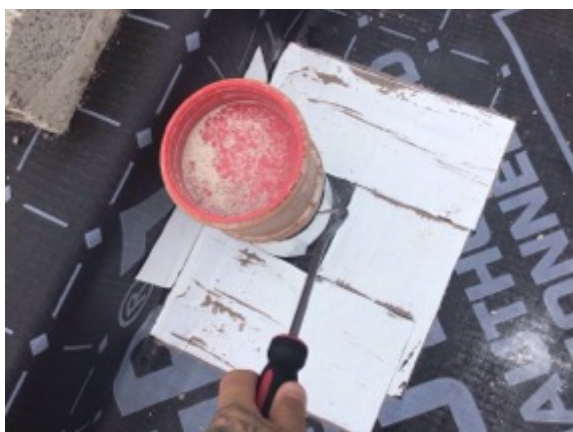
Plot 8 testing pipe seals

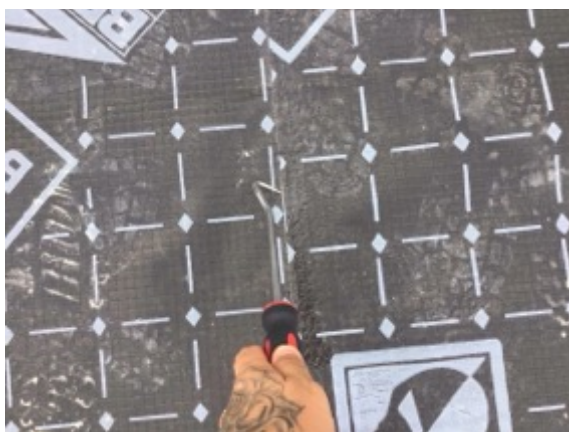
Plot 8 testing hand welded membrane lap joint

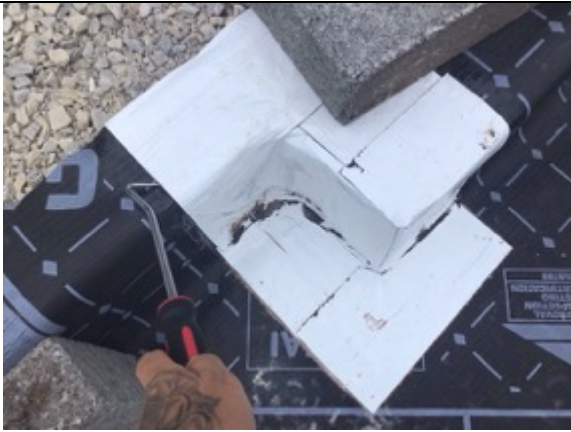
Plot 9 testing threshold detailing

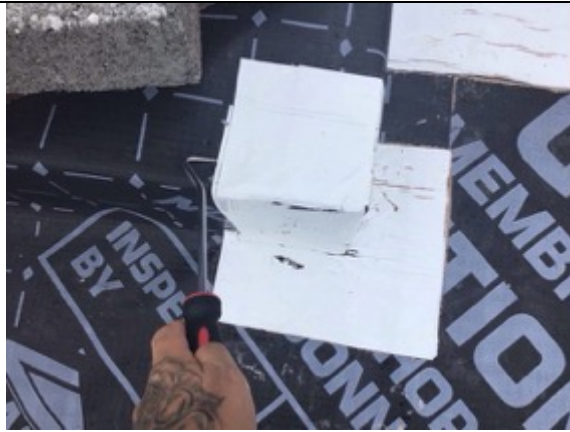
Plot 9 testing corner detailing

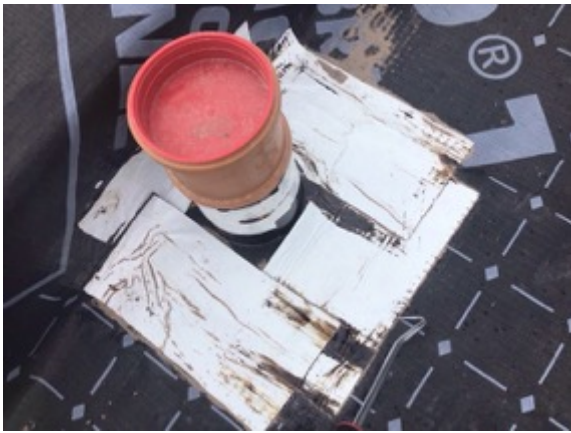
Plot 9 testing pipe seals

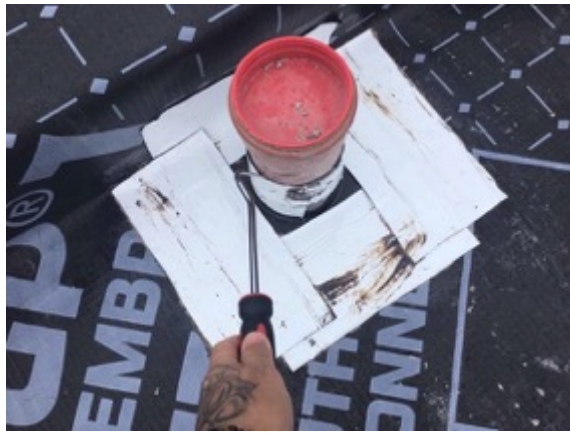
Plot 10 testing pipe seals

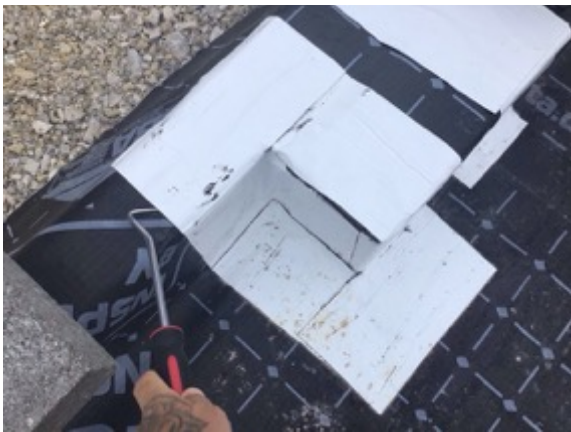
Plot 10 testing threshold detailing

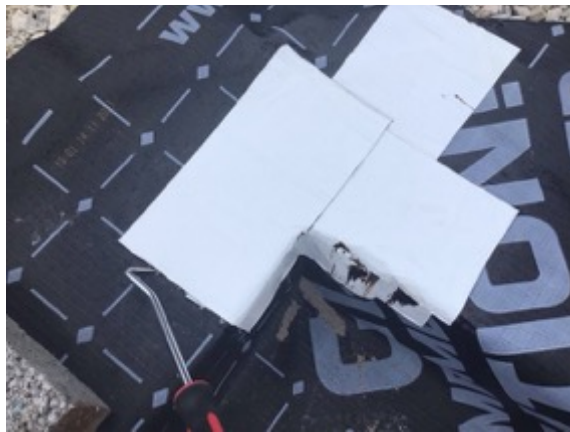
Plot 10 testing corner detailing

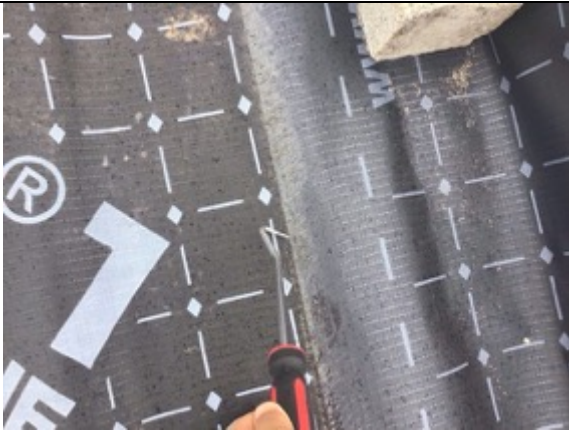
Plot 11 testing hand welded membrane lap joint

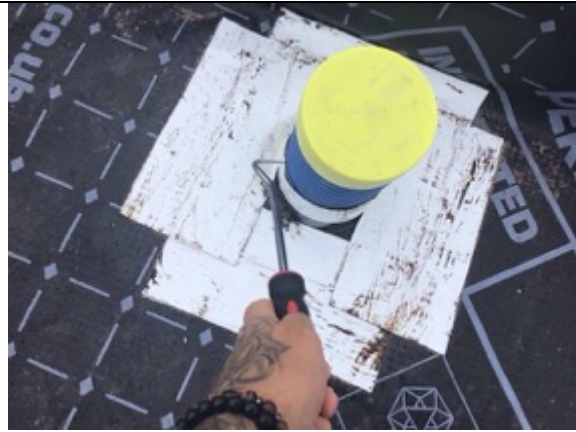
Plot 11 testing pipe seals

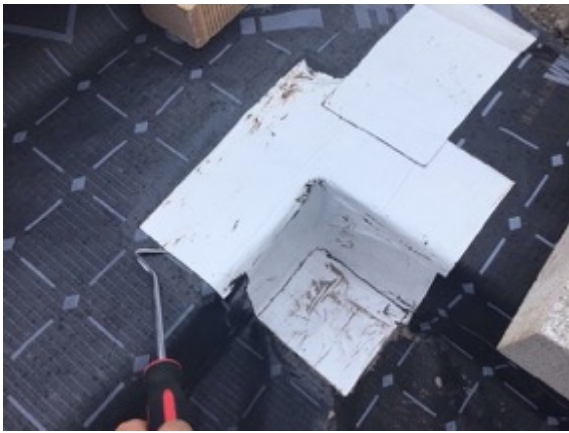
Plot 11 testing corner detailing

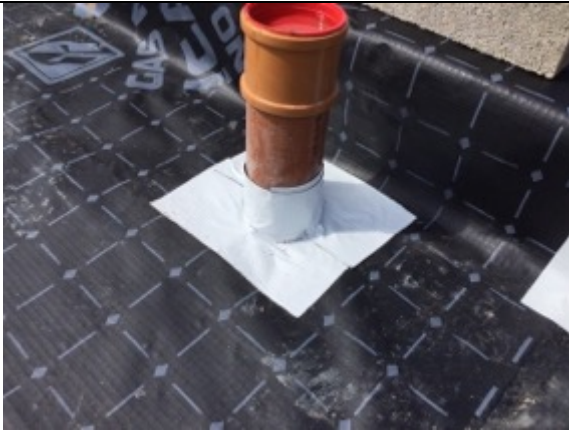
Close up of the pipe penetration detail sealed.

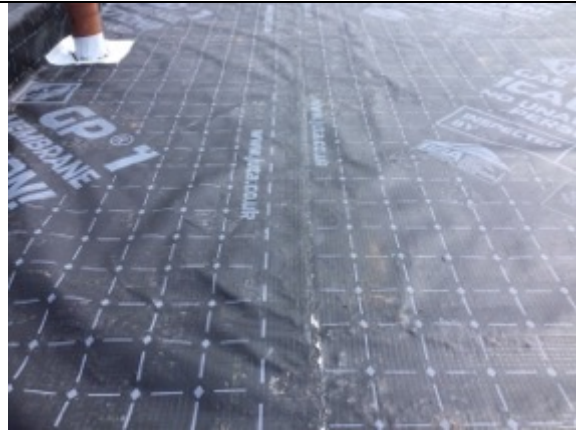
Overview looking down the hand welded lap joint.

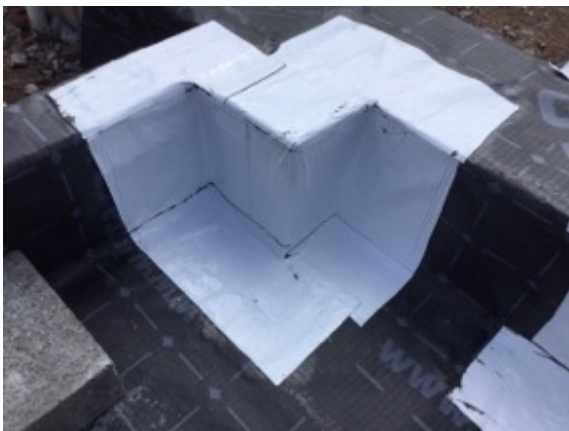
Internal corner and threshold detail sealed to Block 1.

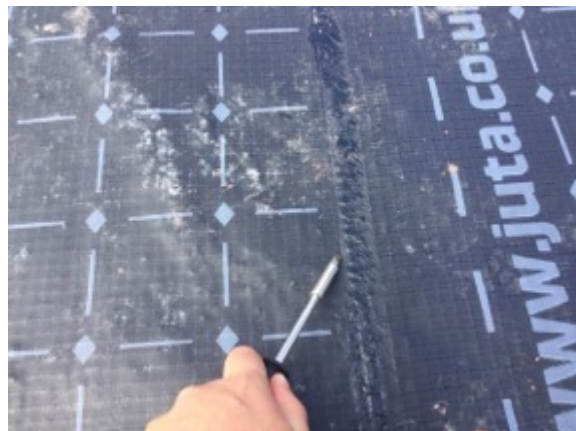
Pick testing along the welded lap joint.

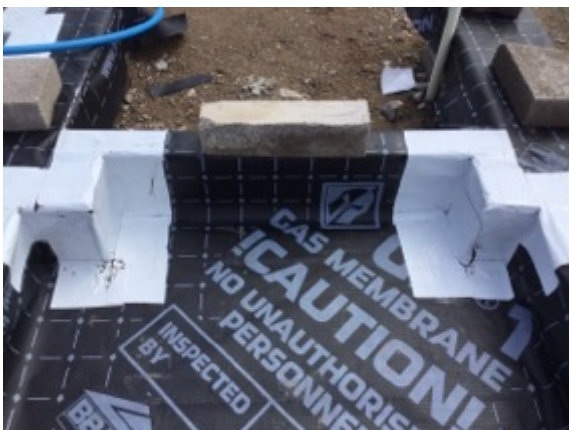
Completed threshold detail within Block 1.

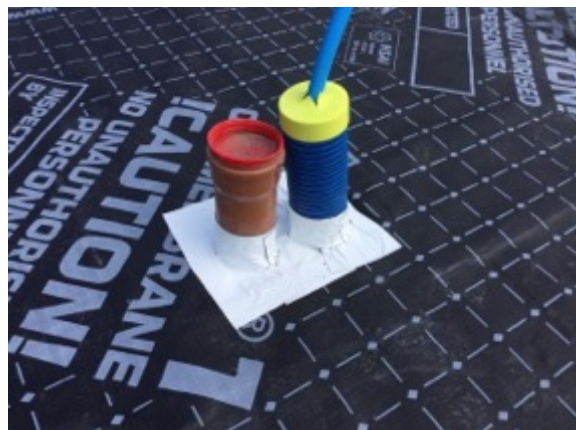
Two pipe penetration details sealed

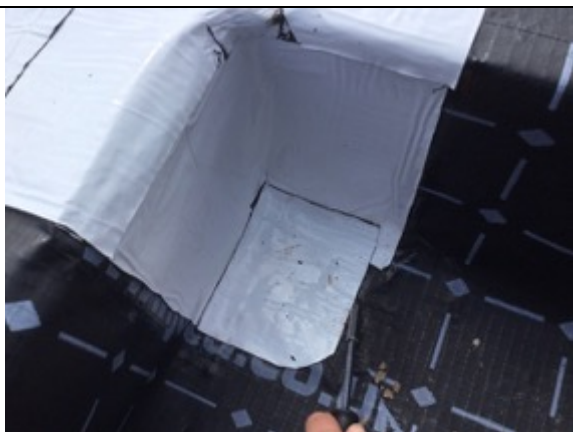
Pick testing to the sealed corner detail.

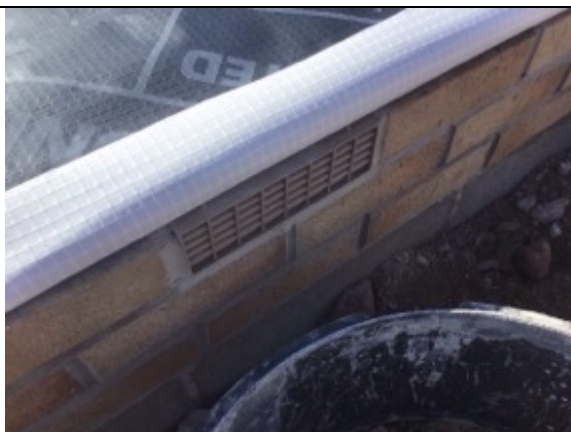
Air brick installed under the perimeter cavity membrane

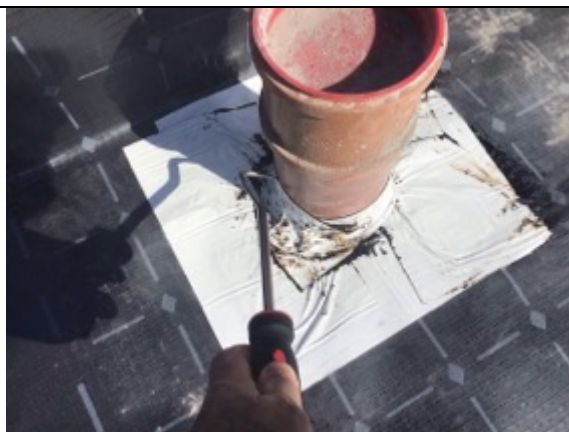
Testing sealed pipe detailing

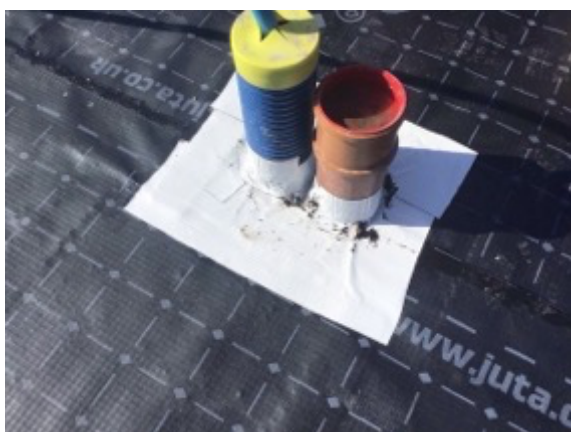
Sealed pipe penetrations

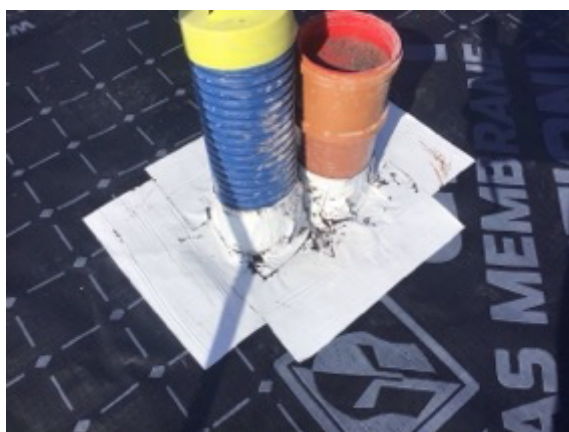
Sealed pipe penetrations

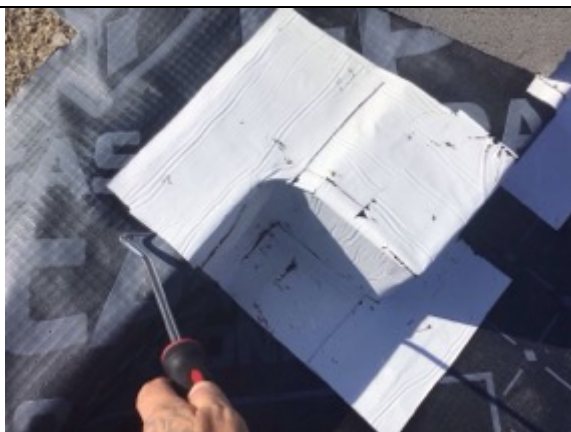
Testing threshold detailing

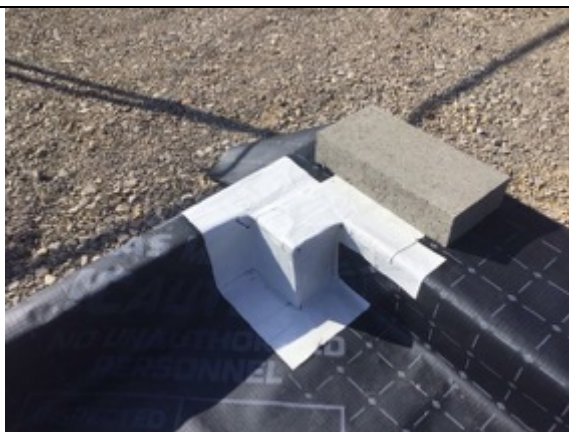
Sealed corner and threshold detailing

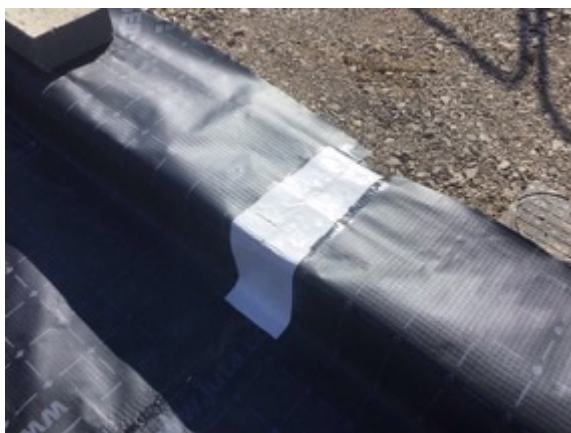
GP SAM used to strengthen the perimeter corner welding

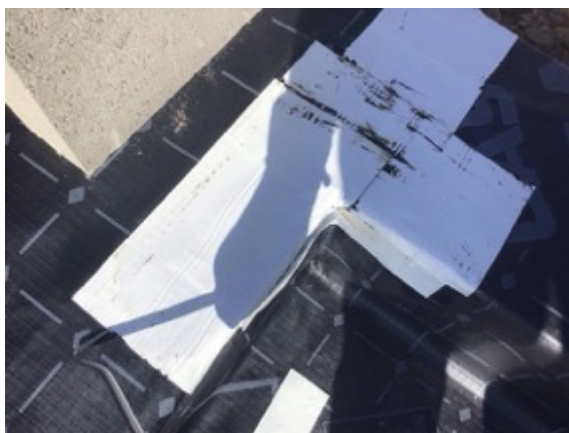
Testing corner detailing

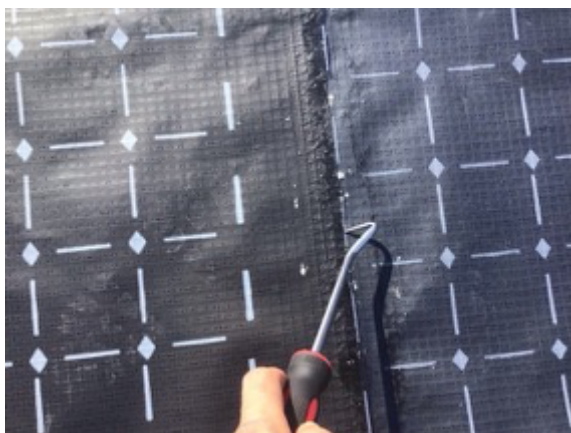
Testing hand welded membrane lap joints

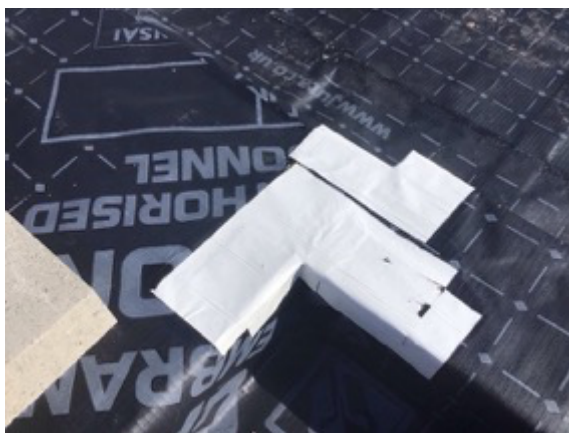
Sealed corner detailing
