## Level 2 - Tree Survey, Condition and Management Report

Morris Feinmann  
178 Palatine Road  
Didsbury  
Manchester  
M20 2UW

BE.240581.R

10<sup>th</sup> December 2024

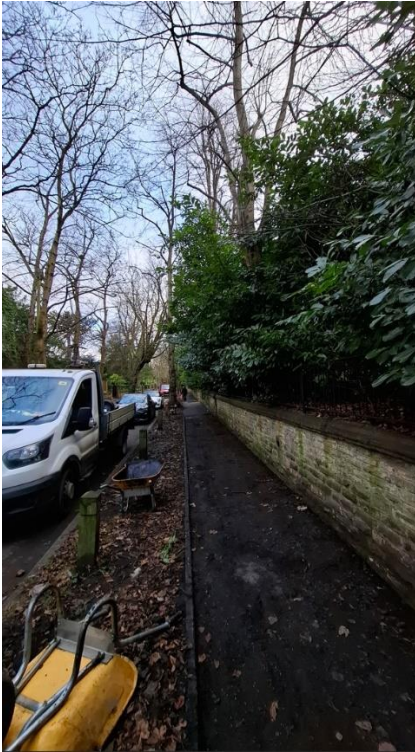
- 3.0.6 Group 764 consists of over 20 mature Laurel bushes, these look to have originally been maintained as a 2-3 m tall hedge but do not look to have been maintained in many years (historic google street view indicate not cut since before 2008). While not required for safety I have recommended these bushes are coppiced at approximately 1 m. These will sprout from this point and a hedge can then be re-established.

*Fig 1. Group 764*

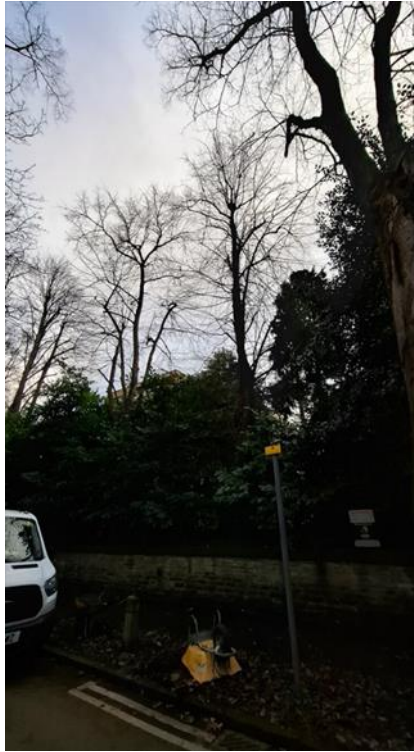
*Fig 2. Trees 771 & 777*

| Tree No. | Species | DBH (mm) | Height (m) | Crown Spread (m) | Age | Vitality | Condition | Works Required | Time Scale | Risk Factor | Re-Survey |
|---|---|---|---|---|---|---|---|---|---|---|---|
| 777 | Common Lime | 660 | 18 | 7 | M | Fair | <ul style="list-style-type: none"> <li>Fair</li> <li>No FFB observed</li> <li>Epicormic growth at base</li> <li>Solid tones when sounded with mallet to 2 m AGL</li> <li>Co-dominant stem from 1.5 m</li> <li>Soil filled pocket between co-dominant stems probed down to depth of 100 mm</li> <li>Historic pollard at 5 m AGL</li> <li>Multiple stems from pollard point with tight forks</li> <li>Decay likely at this point</li> <li>Large 200mm diameter limbs rubbing at 7 m AGL</li> <li>Significant deadwood in crown</li> <li>Reduced at 15 m AGL</li> </ul> | <ul style="list-style-type: none"> <li>Crown reduce by 3m</li> </ul> | 3 years | Low | Three years |

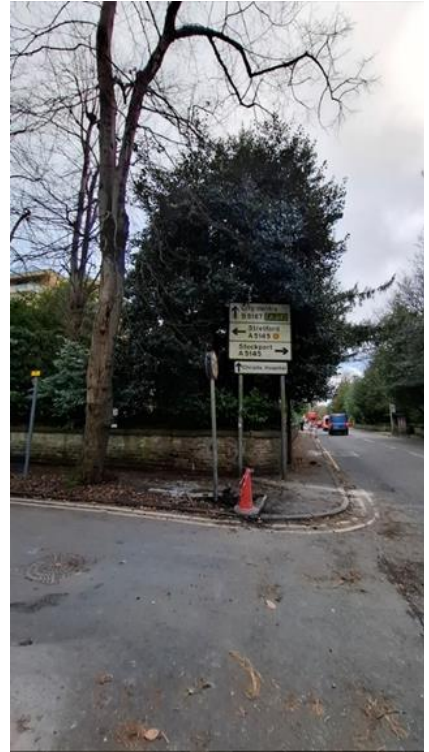
*Fig 3. Tree 783*

| Tree No. | Species | DBH (mm) | Height (m) | Crown Spread (m) | Age | Vitality | Condition | Works Required | Time Scale | Risk Factor | Re-Survey |
|---|---|---|---|---|---|---|---|---|---|---|---|
| 783 | Common Holly | 339 | 9 | 5 | M | Good | <ul style="list-style-type: none"> <li>Good</li> <li>No D3 or FFB observed</li> <li>Solid tones when sounded with mallet to 2 m AGL</li> <li>Multiple stems from 3.5 m</li> <li>Obscuring Road sign</li> </ul> | <ul style="list-style-type: none"> <li>Clear road sign by 1m</li> <li>Crown lift to 3m over footpath</li> </ul> | 1 year | Low | Three years |

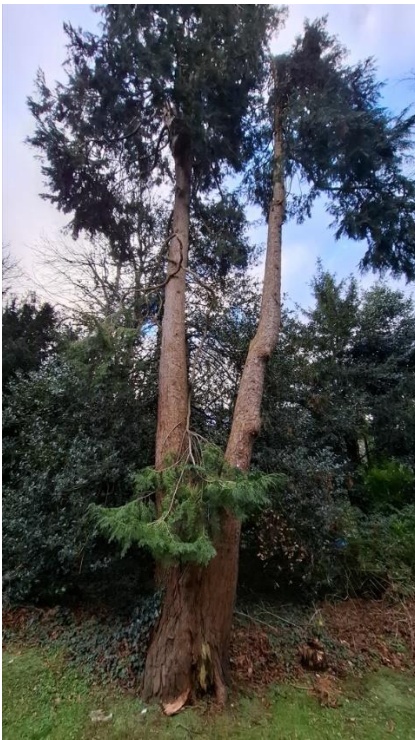
- 3.0.4 Two trees (787 & 789) are in a poor structural condition and I have recommended that they are removed. The Lime tree 789 is in a particularly poor condition, with black exudate indicating the presence of *Phytophthora* and mycelium mats and rhizomorph bootlaces indicating the presence of Honey Fungus. While the crown looks to be in a fair condition *Phytophthora* and Honey Fungus can both lead to stem and root problems leading to root and basal failure.

*Fig 4. Tree 787*

| Tree No. | Species | DBH (mm) | Height (m) | Crown Spread (m) | Age | Vitality | Condition | Works Required | Time Scale | Risk Factor | Re-Survey |
|---|---|---|---|---|---|---|---|---|---|---|---|
| 787 | Lawson Cypress | 460 | 13 | 6 | M | Fair | <ul style="list-style-type: none"> <li>• Poor</li> <li>• Damage on south west aspect at ground level</li> <li>• Triangle of decay 300 mm wide at base extending 750 mm AGL on stem</li> <li>• Twin stem at 1.5 m with 380mm sub dominant stem to south, included bark union with poor attachment to dominant stem</li> <li>• Clear stem to 6 m Tree has become exposed by removal of tree directly to east</li> <li>• Main stem bifurcates at 7 m Western stem turns at right angle before turning upwards with swollen compensatory growth</li> <li>• 75mm diameter branch snapped out at 9 m AGL on north west aspect</li> </ul> | <ul style="list-style-type: none"> <li>• Remove to stump</li> </ul> | 1 year | Moderate | Three years |

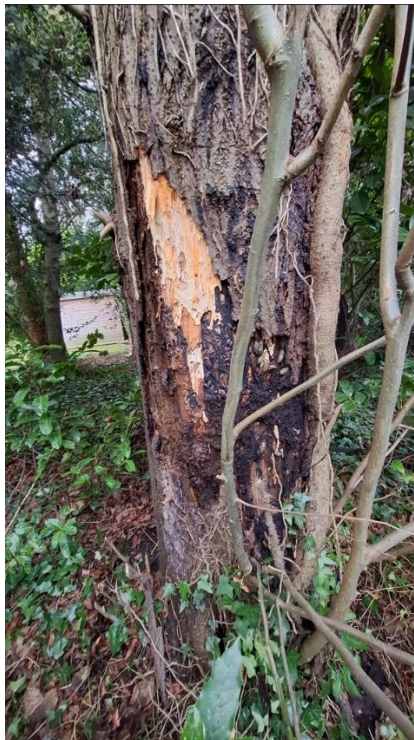
*Fig 5. Tree 789*

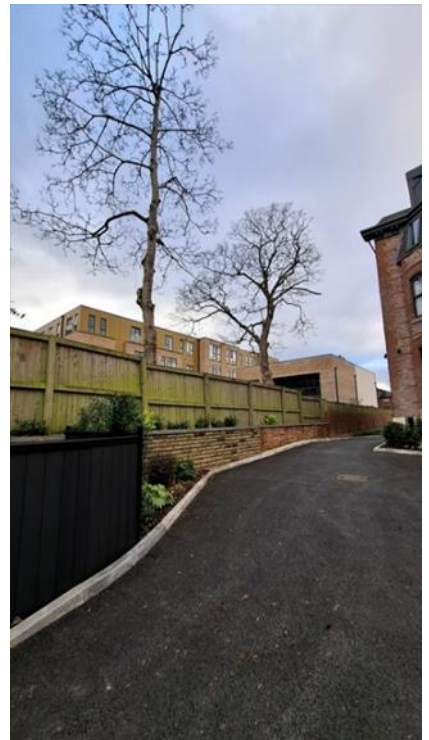
- 3.0.5 All of the individual trees were considered to be in a good or fair physiological condition. However several of the Sycamore trees (767, 796 & 797) look to be declining. The reduction in health of trees 796 and 797 is likely to be a result of construction on the neighbouring property. A decline in tree health can be due to any combination of factors revolving around their growing environment and conditions, as well as previous tree management. In some instances, the decline in health can be addressed, and potentially reversed, by tree health care and cultural practices. Basal bark sprays of Potassium Phosphite (Silvanus) has been recommended. Potassium Phosphite can improve plant health by enhancing their defence systems (See Research Laboratory Technical Report, Attachment 4).

*Fig 6. Trees 796 & 797*

| Tree No. | Species | DBH (mm) | Height (m) | Crown Spread (m) | Age | Vitality | Condition | Works Required | Time Scale | Risk Factor | Re-Survey |
|---|---|---|---|---|---|---|---|---|---|---|---|
| 796 | Sycamore | 340 | 10 | 3 | EM | Fair | <ul style="list-style-type: none"> <li>Fair – declining</li> <li>Little evidence of root buttresses soil levels</li> <li>Suspected of soil level being raised</li> <li>No D3 or FFB observed</li> <li>Solid tones when sounded with mallet to 2 m AGL</li> <li>Tree has been excessively crown lifted to 6 m AGL</li> <li>150mm diameter limbs removed at 4 and 5 m AGL on south aspect</li> <li>Crown looks thin</li> <li>Evidence of recent ground work by neighbours may have adversely impacted tree</li> </ul> | <ul style="list-style-type: none"> <li>Root Collar Excavation to establish correct soil levels at the base of the tree</li> <li>Apply potassium phosphite basal bark spray</li> </ul> | 1 year | Low | Three years |
| 797 | Sycamore | 359 | 8 | 3 | EM | Fair | <ul style="list-style-type: none"> <li>Fair - declining</li> <li>No D3 or FFB observed</li> <li>Solid tones when sounded with mallet to 2 m AGL</li> <li>Tree has been excessively crown lifted to 5 m AGL</li> <li>150mm diameter limbs removed at 3.5 and 4.5 m AGL on south and west aspect</li> <li>Crown looks thin</li> <li>Evidence of recent ground work by neighbours may have adversely impacted tree</li> </ul> | <ul style="list-style-type: none"> <li>Apply potassium phosphite basal bark spray</li> </ul> | 1 year | Low | Three years |

- 4.2.2 I recommend a basal bark spray of Potassium Phosphite for the following trees; 767, 796 and 797, as described below and in Appendix 4.
- 4.2.3 Potassium Phosphite: Phosphites stimulate tree vitality leading to root development and development of new tissue. Phosphite based fertilisers have been shown to enhance a tree's defence system which can improve disease resilience and response to fungal pathogens. Phosphites are easily absorbed and moved to all areas of the plant as they are usually formulated as a liquid.
