## SIM, Combined Projects – Gantry Repairs Methodology – Rev E 21.03.25

### Repair 1

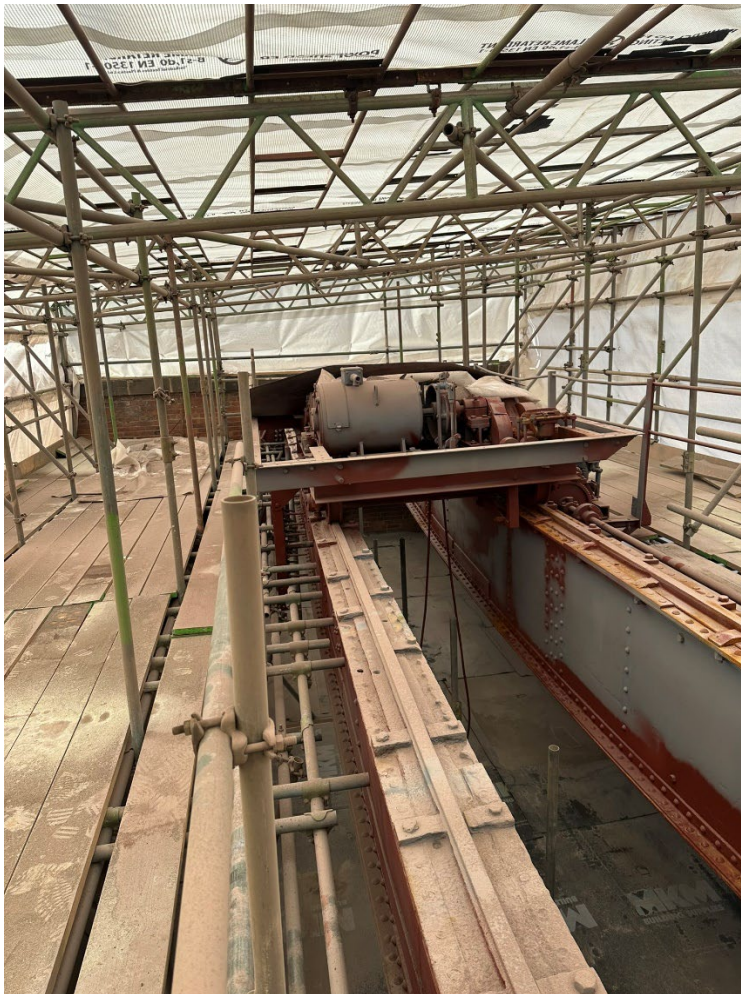
See below photo as an example of repair 1 location:

1. Temporary propping installed to centre of beam prior to works commencing.
2. Cut top of existing rivet head off with an angle grinder to create flat surface for mag drill.
3. Setup mag drill over rivets to be removed.
4. Drill out existing rivets. 4no at a time.
5. De mount mag drill.
6. Install dome headed bolts from underside of top flange. Bolts will be M24 x 40 or 50mm. Sized to match existing bolts.
7. Install nut from top of side of flange.
8. Install dummy dome head to bolt and nut on top side of flange so it appears to be a rivet.

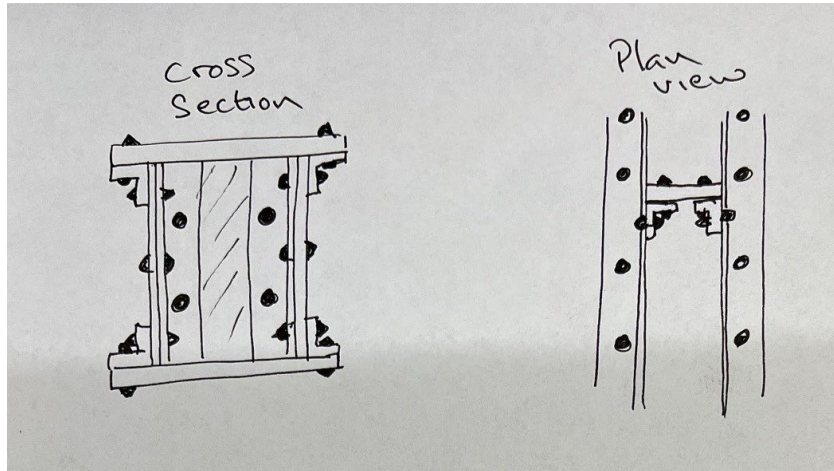
Existing detail of gantry steel sections:

1. Temporary propping installed to centre of beam prior to works commencing.
2. Carefully remove steel c-section to make repair more accessible. Store for reinstall once repair works are completed. See photo 2e showing the non-original and non-structural C section.
3. Identify extent of corroded steel by cutting back and using calipers to find where the steel thickness is matching the existing steel thickness.
4. Produce plate to match extent of steel removed. This will be fabricated off site.
5. Lay in the replacement steel plate into the section previously removed and fully weld the plate. See below sketch.

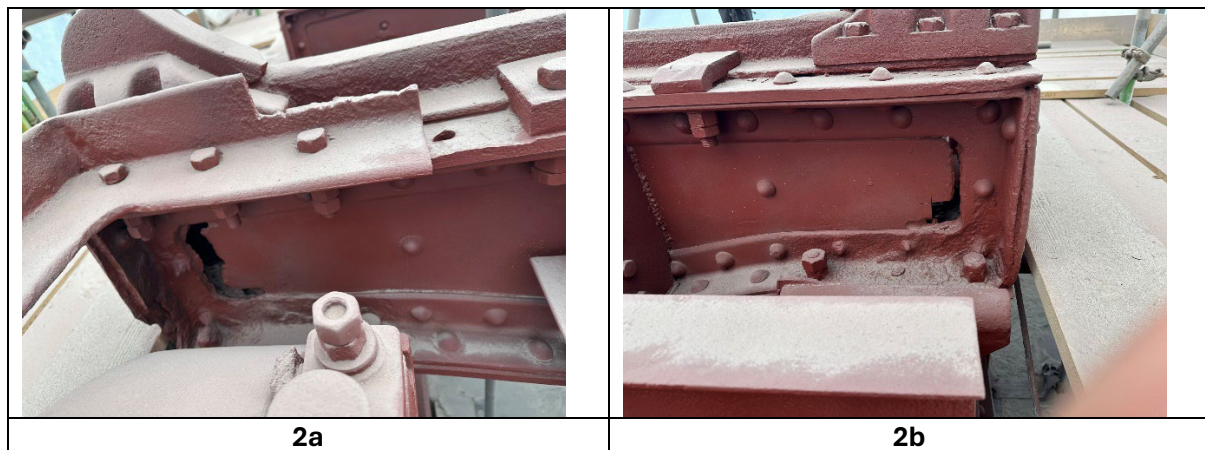
See below photos of the repair 2 locations identified:

7. All rivets in this location will be replaced with dome headed bolts and made to look like a dummy rivet. Bolts will be M24 x 40 or 50mm.
8. Where the angle is also corroded this will also be cut out and an additional steel welded to the face of the replacement plate and then fully welded to the in-situ. Again, dome headed bolts will be installed as dummy rivets.
9. The previously removed steel c-section will be reinstalled in its original configuration.
10. 12mm hole drilled through bottom flange of steel beam at lowest point between each vertical stiffener to allow water to escape all voids.

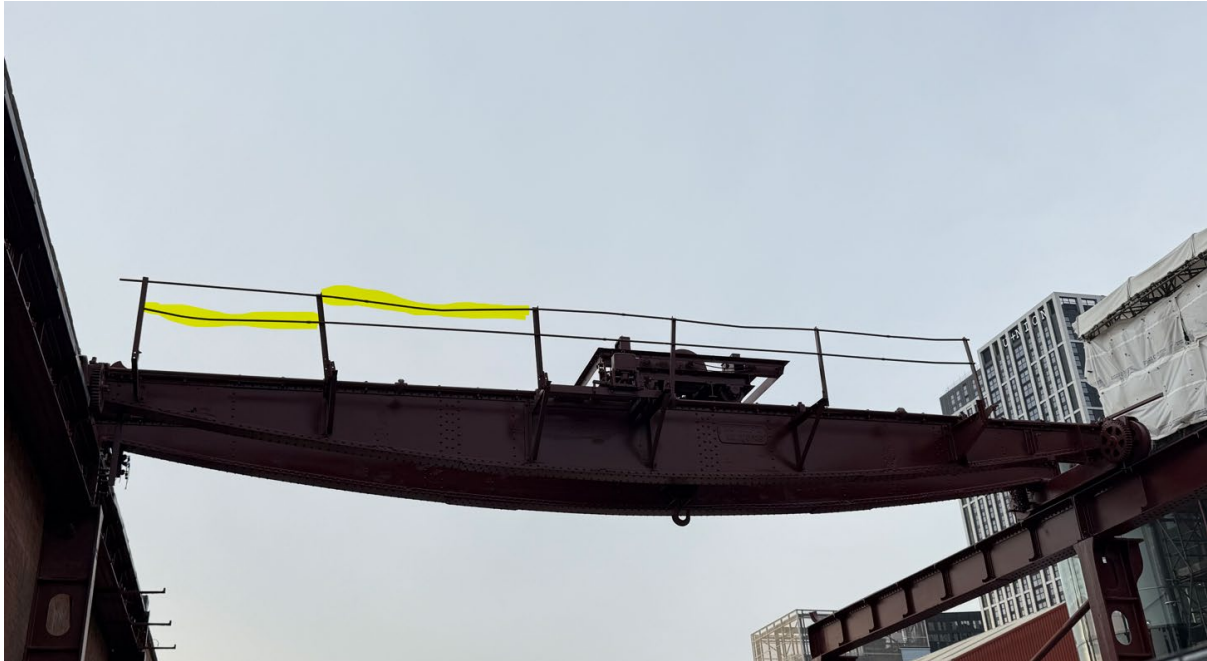
### West Crane Beam

Sections of handrail highlighted in yellow to have metal bars replaced with new. See below images for the west and east crane beams.

Highlighted sections to be cut out and then new sections of metal bar installed in its place.

This is to be welded in place in-situ.
