**Valley Beam report Gridlines J-L**

**New Warehouse SIM Liverpool Road Manchester**

**Ref WS/22702/SIM/12-11-2024**

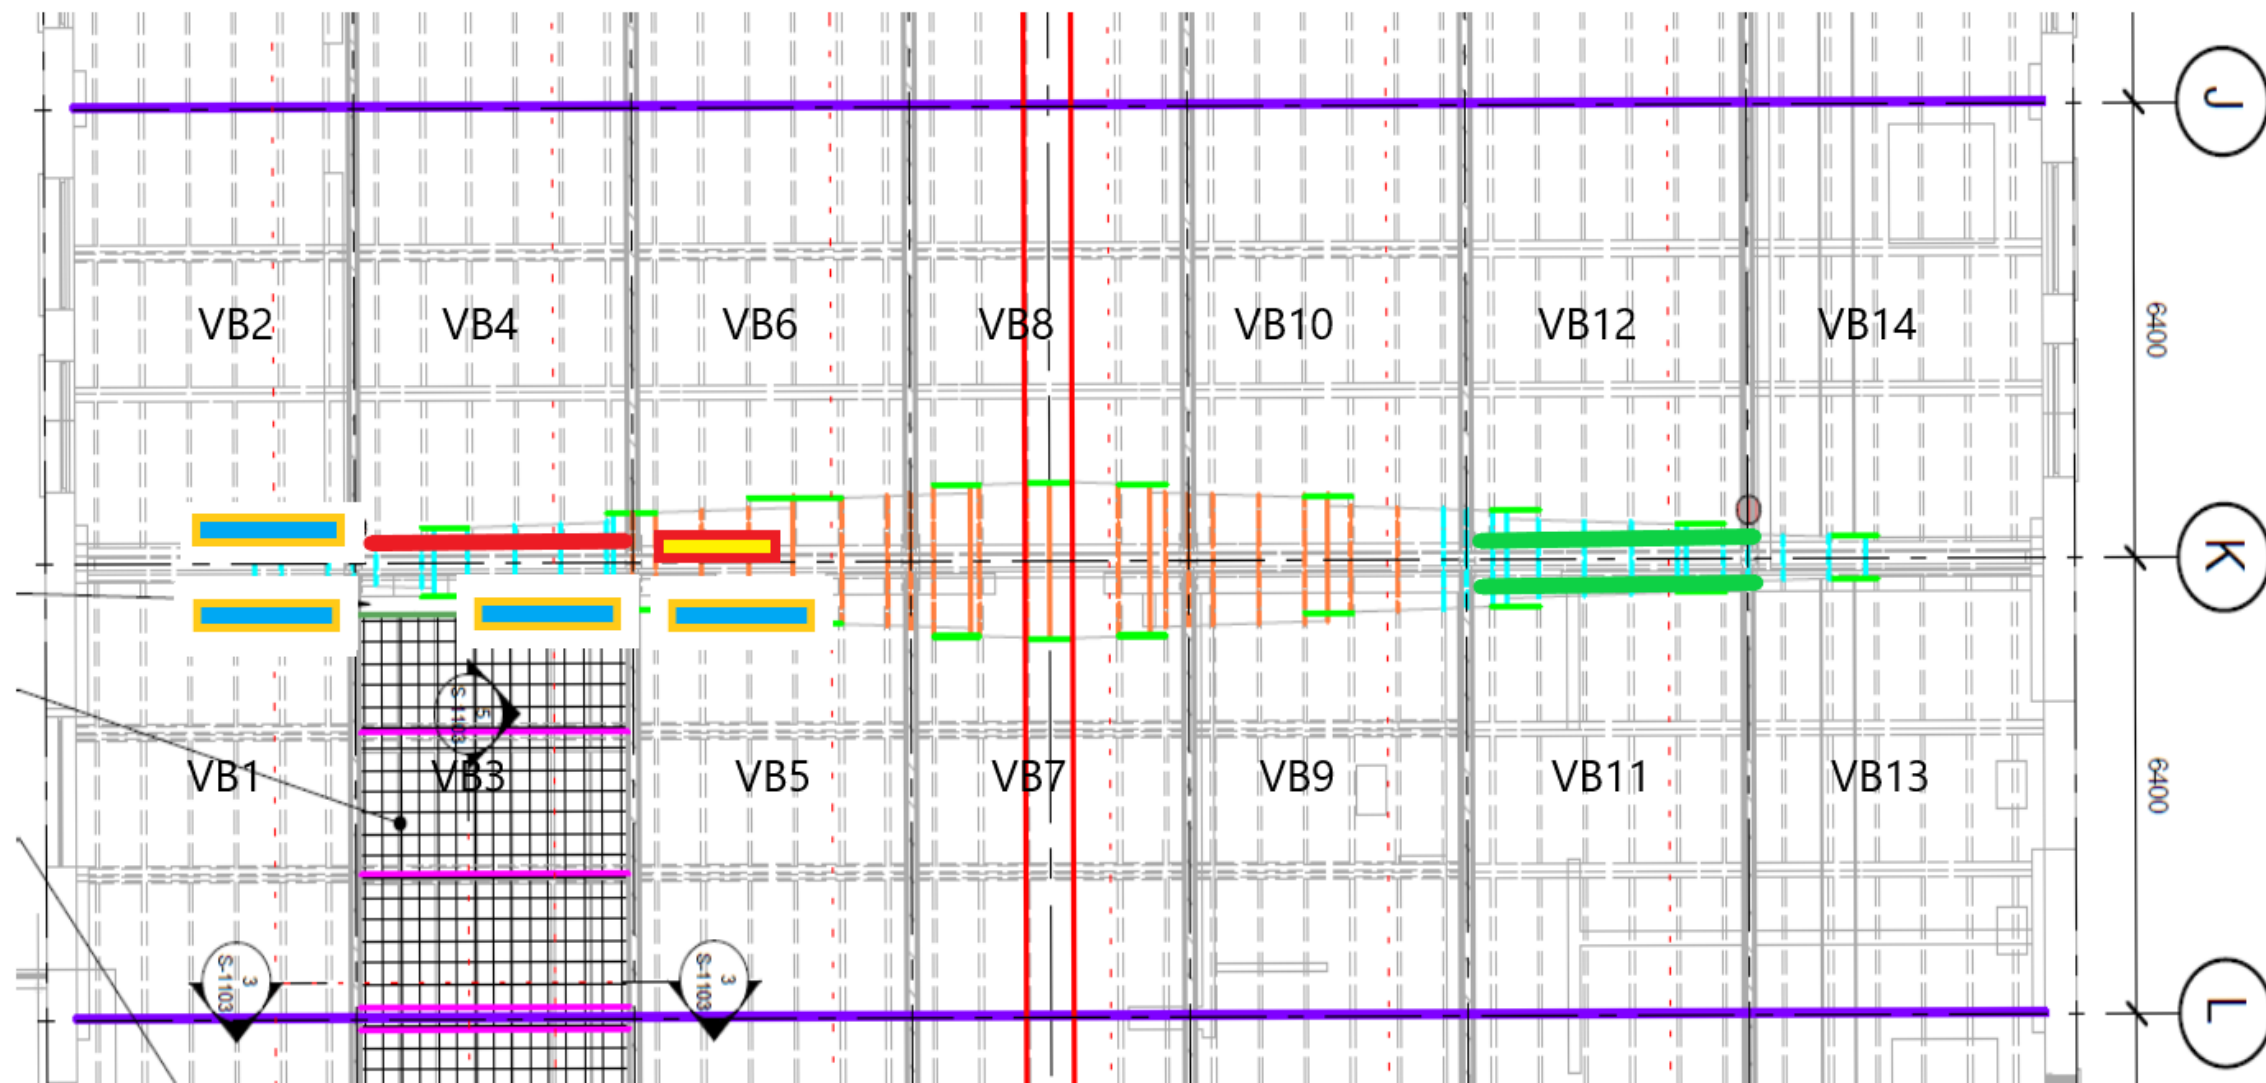
**Defrass decay from beam (Subject to SE ) and treat with Wykamol 10.1 fungicide gel**

**Cut out decay and splice new section of wood to beam**

**Renew beam full length using C24 treated Douglas fir**

**Steel flitch repair as per WML specifications and drawing**
