## Fenton House, Higher Ardwick, Manchester.

### Further information on Condition Compliance Details.

[response to Manchester City Council email – 05/06/2023]

Response revised – 27 09 2023

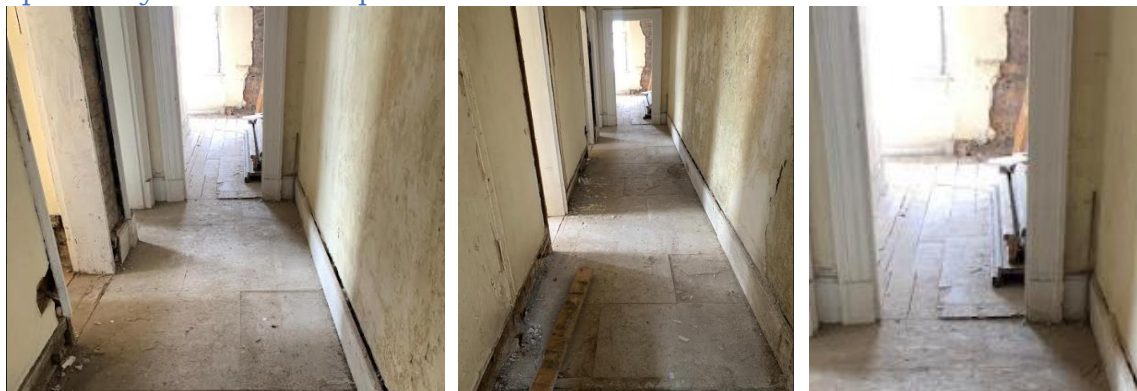
10.1 **Response** – The owner has revisited this part of the building and has confirmed that the location of the proposed new south storeroom [Ground floor room GF 03] is made up of timber floorboards laid on timber under floor joists. There are no underlying stone flags in this area. [see photographs on the following page]

10.2 This was a mistaken assumption made by the conservation adviser at the time of inspection. There is consequently no conservation reason to alter the existing proposed layout in this respect.

Looking east along the upper ground floor corridor with Room GF 03 shown at its eastern end.

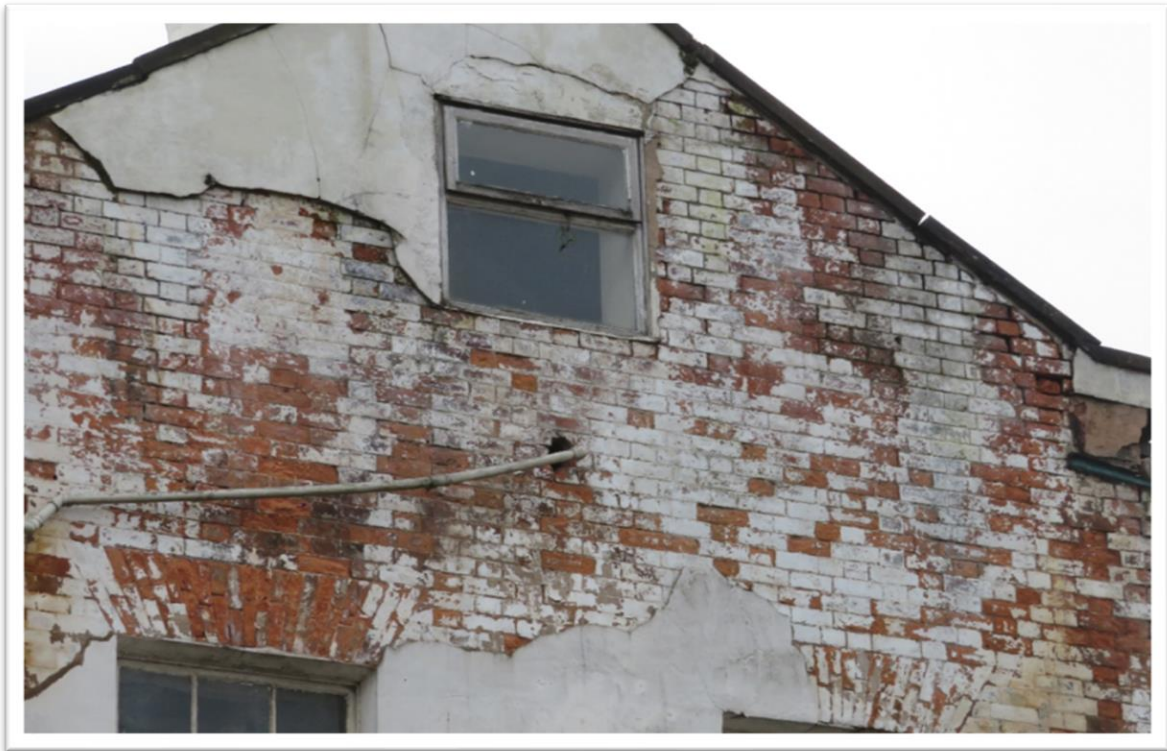
4. A final method statement of the resulting treatment decided in condition 15c).
- Photographs of parts of the elevations show the condition of the underlying bricks, [See **Appendix A**] and we suspect that the moisture ingress in the existing bricks and their condition was the reason for the application of the render in the first instance. There is evidence from an inspection of the exposed brickwork on the Harkness Street elevation that the brickwork was painted prior to rendering. A photograph on page 14 of Document EN shows the upper floor of the property rendered with ashlar etching even at that time. The projecting right hand bay also showed extensive brick replacements at this time.

- We agree with the approach outlined in condition 15, however, there is consensus now that the render cannot be removed satisfactorily whilst also avoiding significant and widespread damage to the underlying bricks. Experience of other similar cases of hard cementitious render have led us to conclude that attempts to remove the existing render by mechanical means would severely damage the faces/arises of the underlying bricks that would result in a decision to re-render the walls. Nevertheless Documents 5, and 6C and Drawings 6A and 6B give details of the owner's approach, which generally follows the Council's four part condition 15.

*The Harkness Street gable elevation showing widespread severely spalled and damaged bricks. Also, evidence of painted brickwork beneath the present render layer. [It should be noted that this is an area of render that has fallen off; other areas of remaining cement render may be significantly more difficult to remove]*

**4.2** Subject to prompt agreement on the above, the proposed patch repair of missing or defective existing render can be removed and the sound render retained.

The patch repair render will be a lime mix with a bagged/sponged finish that matches the texture of the present sound render. [as indicated by the photograph included in **Appendix B**] All the render will be as specified in Document 5 pages 11 and 12 and have an off-white colour\*. [nearest RAL – 9001]

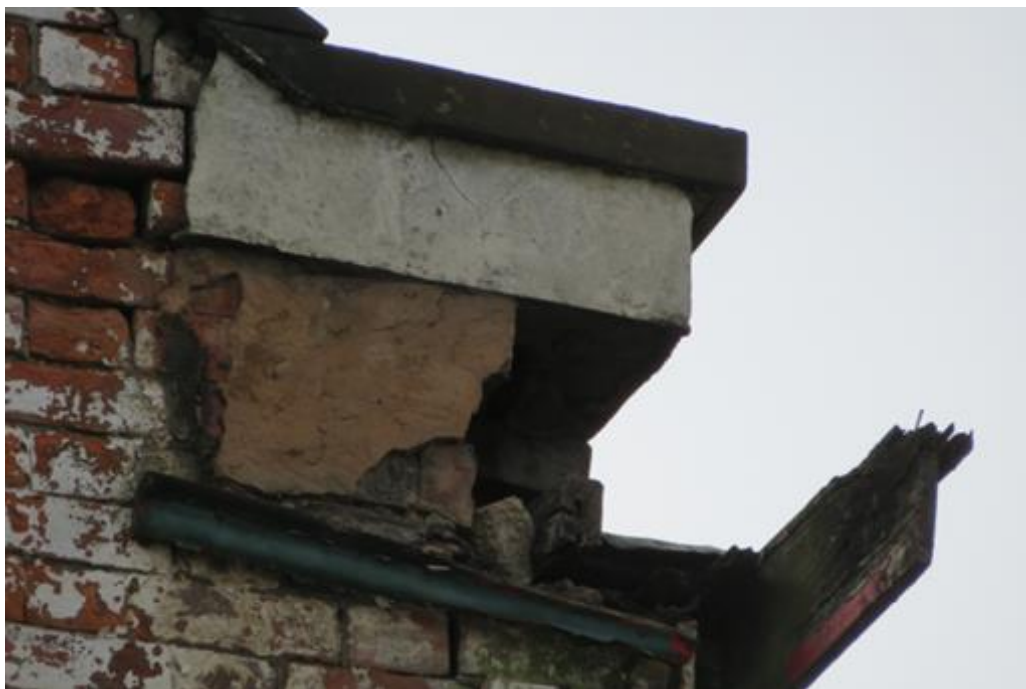
*Detail of the underlying condition of the brickwork on the Harkness Street upper elevation  
**Above:** Severely damaged faces to the brickwork near to the eaves and front gutter return.*

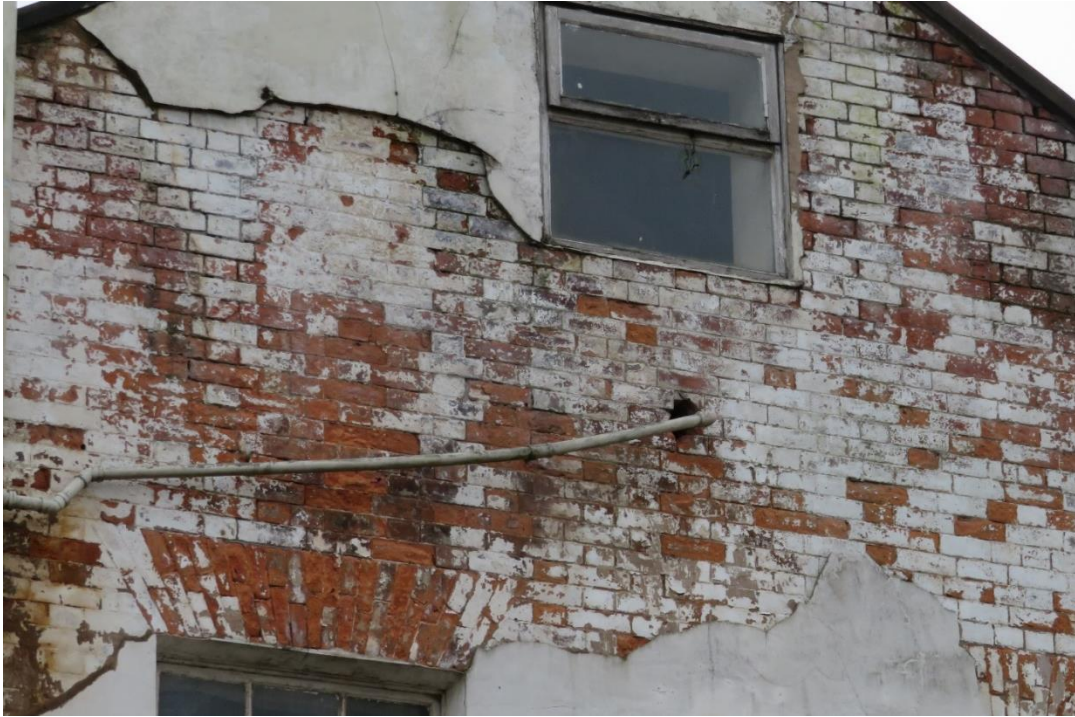
*Close-up of damaged faces to the voussoirs and bricks above the first floor window and at eaves level.*

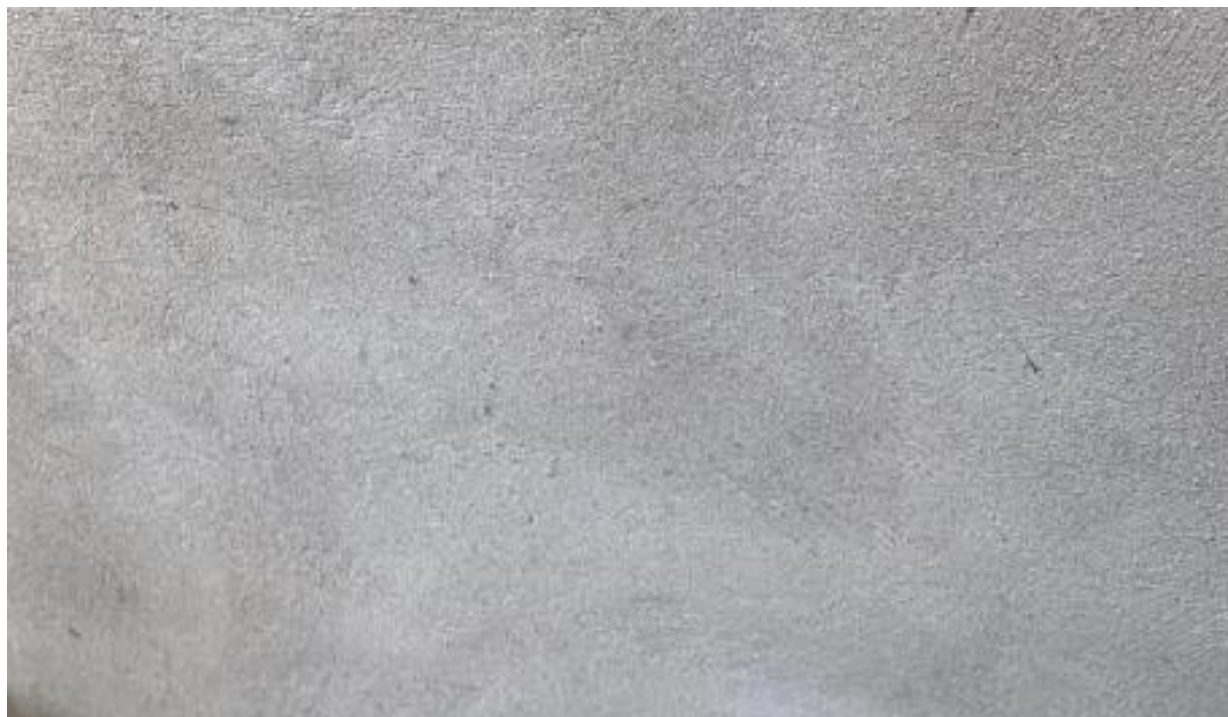
Photograph of Render Panel to Replicate the Existing Render Finish

- The owner has provided a photograph of an existing repaired patch of render. [This is included in **Appendix B**] I would be grateful if you could consider this as a sample that will be matched in the event that it is agreed that the existing render is to be retained and repaired?
