# Arboricultural Consultancy for Aviva - Commercial

| Insured | Mayfield Road Management Company Limited | Address | Flat 1-6, 14 Mayfield Road, Whalley Range, Manchester, M16 8FT | | |
| Client | Subsidence Management Services | Contact | Alun Dwyer | Claim No. | IFS-AVI-SUB-24-0113675 |

## 2. Property and Damage Description

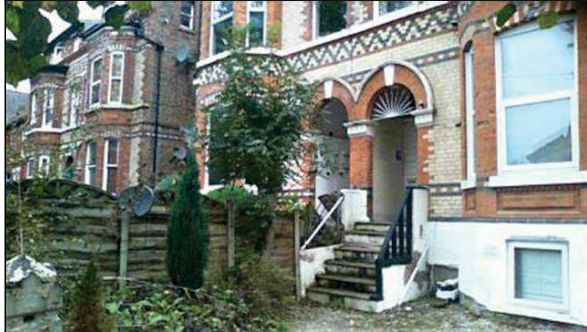
T3 - Ash

With due regards to species profile, size and proximity, the Ash (T3), the Cypress trees (T1 & T2) and the Hydrangea (S1) are considered the dominant features proximate to the focal area(s) of movement and accordingly, where vegetation is confirmed as being causal, we have identified them as the primary cause of the current subsidence damage.

| Tree No. | Species | Age Cat | Approx. Height (m) | Distance to Building (m) * | Ownership | Action | Requirement |
|---|---|---|---|---|---|---|---|
| T3 | Ash | 1 | 5.1 | 2.8 | A - Third Party | Remove | Remove close to ground level and treat stump to inhibit regrowth. |

Consequently, we have advocated the complete removal of the Ash (T3), the Cypress trees (T1 & T2) and the Hydrangea (S1) as it will offer the most certain arboricultural solution likely to restore long-term stability.

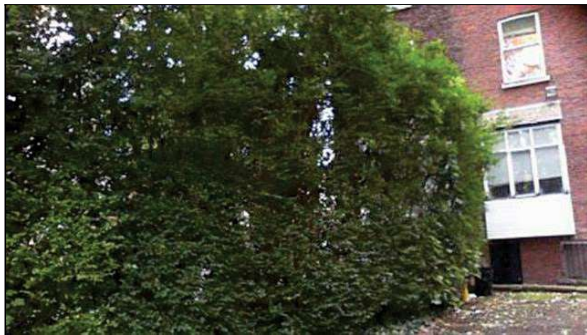
H1 - Privet

| Tree No. | Species | Age Cat | Approx. Height (m) | Distance to Building (m) * | Ownership | Action | Requirement |
|---|---|---|---|---|---|---|---|
| H1 | Privet | 1 | 4.8 | 4.8 | C - Insured | Action to avoid future risk | Maintain at, or below current dimensions by way of regular pruning. |

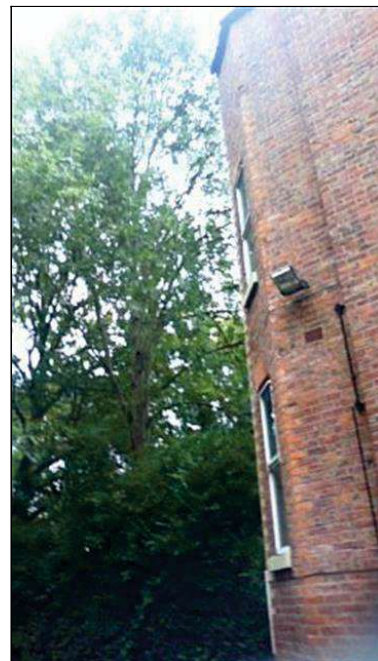
T6 - Ash

| Tree No. | Species | Age Cat | Approx. Height (m) | Distance to Building (m) * | Ownership | Action | Requirement |
|---|---|---|---|---|---|---|---|
| T6 | Ash | 1 | 24 | 8.2 | E - Boundary Veg (ownership to be confirmed) | Action to avoid future risk | Crown reduce overall canopy by 30% (minimum) to achieve a crown volume reduction in line with BRE IP7/06. Maintain at reduced dimensions by re-pruning back to points of previous reduction on a 3 year (max) cycle. |

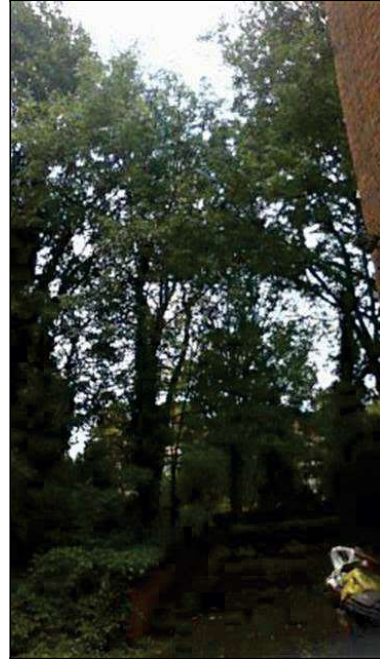
T7 - Ash

| Tree No. | Species | Age Cat | Approx. Height (m) | Distance to Building (m) * | Ownership | Action | Requirement |
|---|---|---|---|---|---|---|---|
| T7 | Ash | 1 | 13.2 | 7.5 | A - Third Party | Action to avoid future risk | Crown reduce overall canopy by 30% (minimum) to achieve a crown volume reduction in line with BRE IP7/06. Maintain at reduced dimensions by re-pruning back to points of previous reduction on a 3 year (max) cycle. |

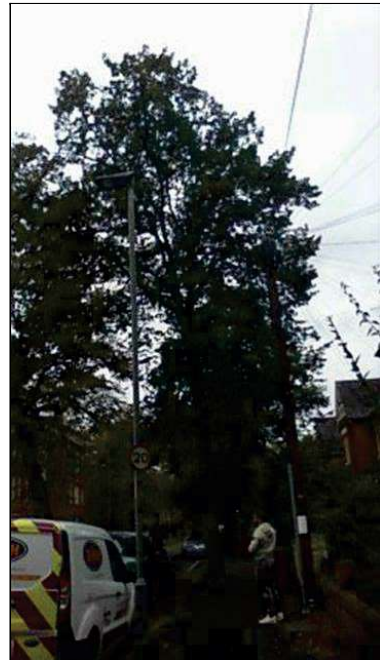
T4 - Lime

| Tree No. | Species | Age Cat | Approx. Height (m) | Distance to Building (m) * | Ownership | Action | Requirement |
|---|---|---|---|---|---|---|---|
| T4 | Lime | 1 | 16.3 | 11.25 | B - Local Authority | Action to avoid future risk | Recently reduced; maintain in line with BRE IP7/06 by re-pruning back to points of previous reduction on a 3 year (max) cycle. |

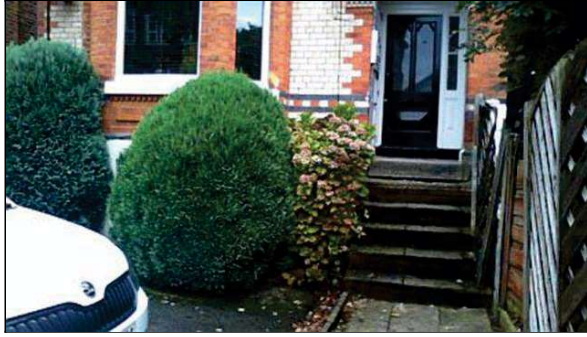
S1 - Hydrangea

| Tree No. | Species | Age Cat | Approx. Height (m) | Distance to Building (m) * | Ownership | Action | Requirement |
|---|---|---|---|---|---|---|---|
| S1 | Hydrangea | 1 | 1.8 | 0.25 | C - Insured | Remove | Remove close to ground level and treat stump to inhibit regrowth. |

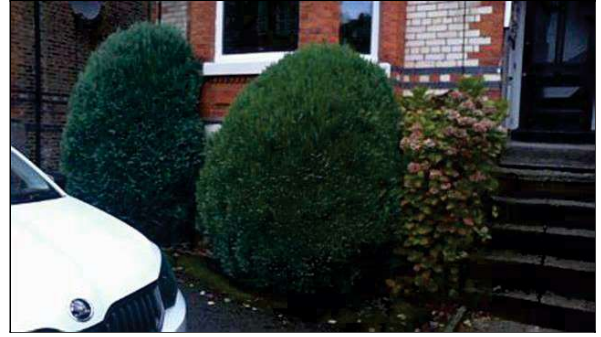
T2 - Cypress

| Tree No. | Species | Age Cat | Approx. Height (m) | Distance to Building (m) * | Ownership | Action | Requirement |
|---|---|---|---|---|---|---|---|
| T2 | Cypress | 1 | 2 | 0.25 | C - Insured | Remove | Remove close to ground level. |

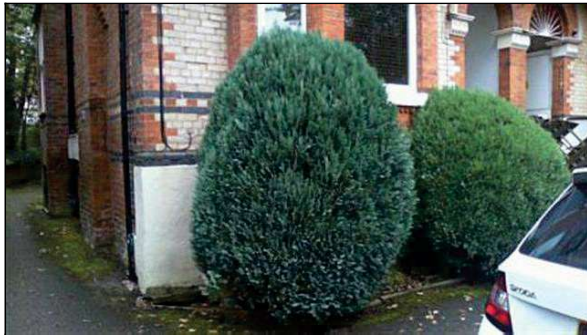
T1 - Cypress

| Tree No. | Species | Age Cat | Approx. Height (m) | Distance to Building (m) * | Ownership | Action | Requirement |
|---|---|---|---|---|---|---|---|
| T1 | Cypress | 1 | 2.4 | 1 | C - Insured | Remove | Remove close to ground level. |

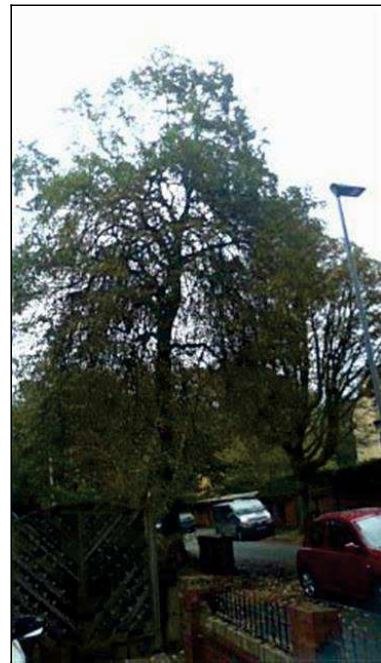
T5 - Lime

| Tree No. | Species | Age Cat | Approx. Height (m) | Distance to Building (m) * | Ownership | Action | Requirement |
|---|---|---|---|---|---|---|---|
| T5 | Lime | 1 | 17.4 | 12.25 | B - Local Authority | Action to avoid future risk | Recently reduced; maintain in line with BRE IP7/06 by re-pruning back to points of previous reduction on a 3 year (max) cycle. |
