**Project Name:** British Legion Site  
**Project Description:** CCTV Survey  
**Project Number:** 21678  
**Project Status:** Processing  
**Project Date:** 26/06/2024  
**Inspection Standard:** MSCC5 Sewers & Drainage GB (SRM5 Scoring)

**Company:** Rowlinson Construction Ltd  
**Description:** Construction  
**Contact:** Mark Frain  
**Street:** 118b Gatley Road  
**Town or City:** Cheadle  
**Post Code:** SK8 4AU

**Company:** British Legion Site  
**Street:** Woodhouse Lane  
**Town or City:** Wythenshawe  
**County:** Manchester  
**Post Code:** M22 9TF

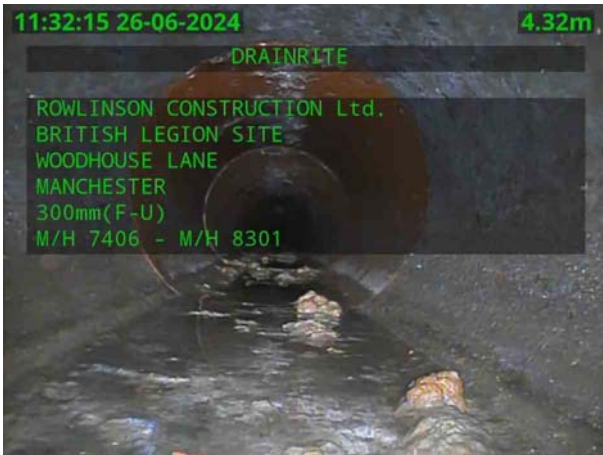
MH  
8301X\_02c3f772-0e43-413c-a2cc-759969f5926e\_20240626\_1  
44012\_201.jpg, 0.00 m  
Water level, 10% of the vertical dimension

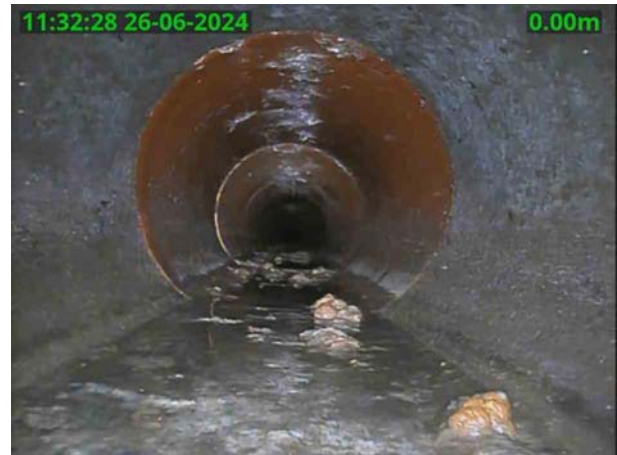
MH  
8301X\_0366b74d-69e5-4719-b16e-dea494ff9b71\_20240626\_1  
44101\_190.jpg, 00:00:15, 0.00 m  
Settled deposits, fine, 10% cross-sectional area loss, start

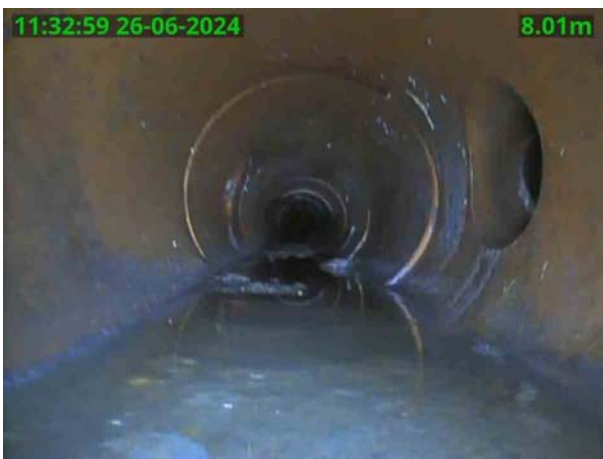
MH  
8301X\_142bd1e8-ace7-47c7-bdfa-450c50568fd0\_20240626\_1  
44218\_195.jpg, 00:00:46, 8.01 m  
Junction at 3 o'clock, 150mm dia

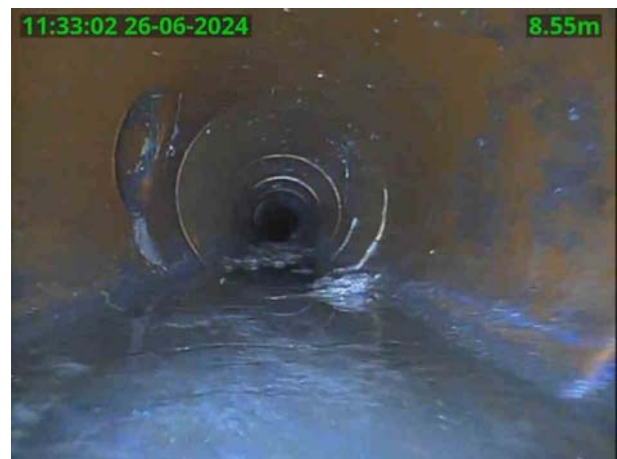
MH  
8301X\_e796bcff-1260-436c-b779-d81b2cfa5fdb\_20240626\_14  
4302\_287.jpg, 00:00:49, 8.55 m  
Junction at 9 o'clock, 150mm dia

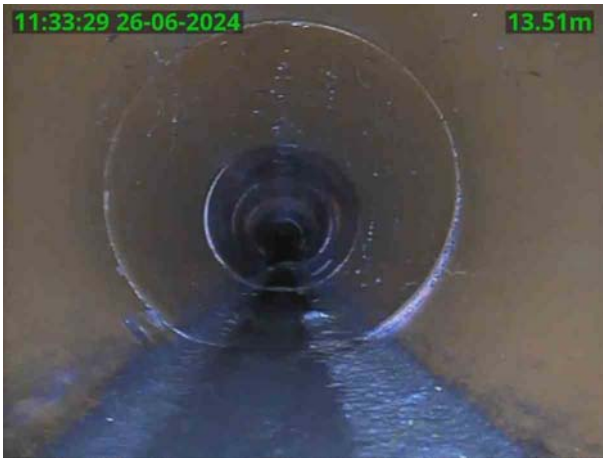
| Scale: | 1:398 | Position [m] | Code | Observation | MPEG | Photo | Grade |
|---|---|---|---|---|---|---|---|
| | 13.51 | F01 | DES | Settled deposits, fine, 10% cross-sectional area loss, finish | 00:01:16 | MH<br>8301X_d7<br>274702-45 | 3 |

MH  
8301X\_d7274702-4543-4502-8448-ebef90335ff\_20240626\_1  
44349\_534.jpg, 00:01:16, 13.51 m  
Settled deposits, fine, 10% cross-sectional area loss, finish

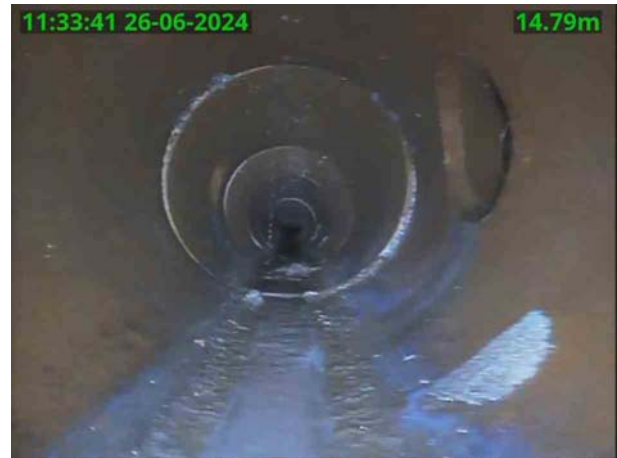
MH  
8301X\_4e61f0c1-8992-4472-8420-84c78c71e576\_20240626\_  
144427\_700.jpg, 00:01:28, 14.79 m  
Junction at 3 o'clock, 150mm dia

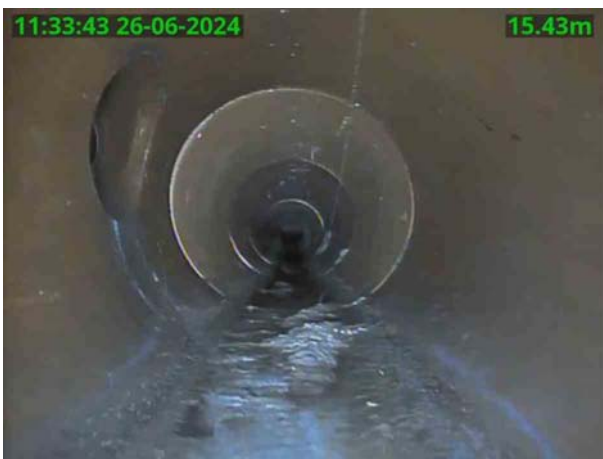
MH  
8301X\_9846d641-6b70-48dd-9cdb-c5113f770cc4\_20240626\_  
144455\_462.jpg, 00:01:30, 15.43 m  
Junction at 9 o'clock, 150mm dia

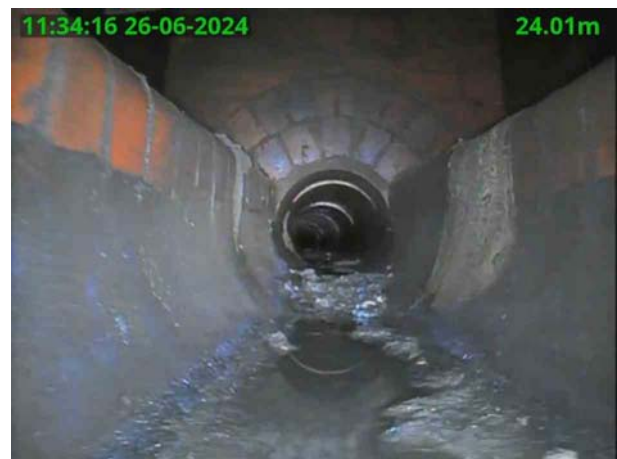
MH  
8301X\_e2bffc1c-c488-4d4a-a761-1ca0d67be1db\_20240626\_1  
44622\_777.jpg, 00:02:03, 24.01 m  
General remark, MH NO REF ON DRAWING

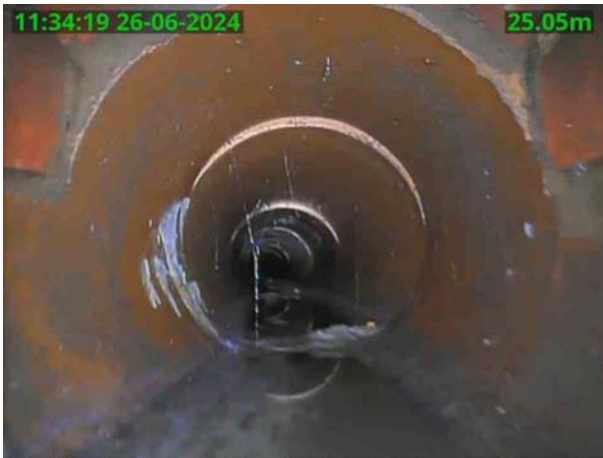
MH  
8301X\_5f8237f5-9584-41bc-8471-d31ab0e967a0\_20240626\_1  
44711\_189.jpg, 00:02:06, 25.05 m  
Pipe size changes, new size(s), 300mm high

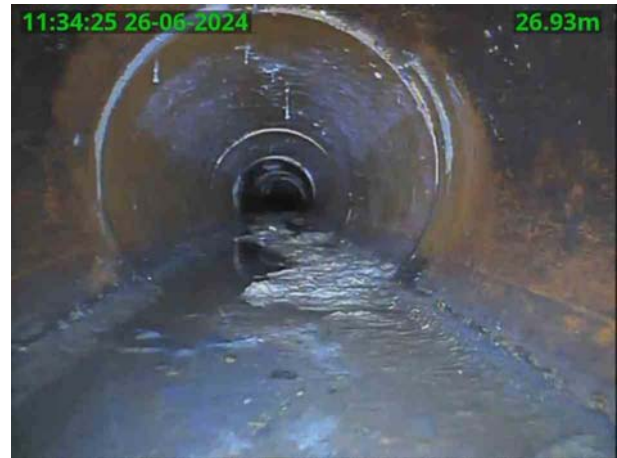
MH  
8301X\_57444b3b-2df2-4a46-a43f-daa3cc96a4d9\_20240626\_1  
44747\_748.jpg, 00:02:12, 26.93 m  
Settled deposits, fine, 10% cross-sectional area loss, start

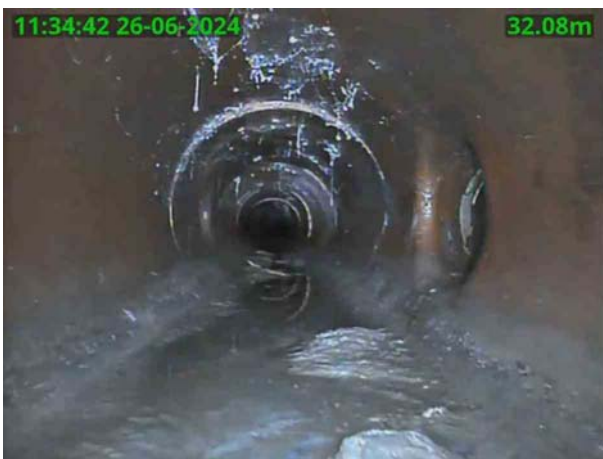
MH  
8301X\_4c0a1c7c-b223-409e-a920-30bd46e6bb73\_20240626\_  
144835\_838.jpg, 00:02:29, 32.08 m  
Junction at 3 o'clock, 150mm dia

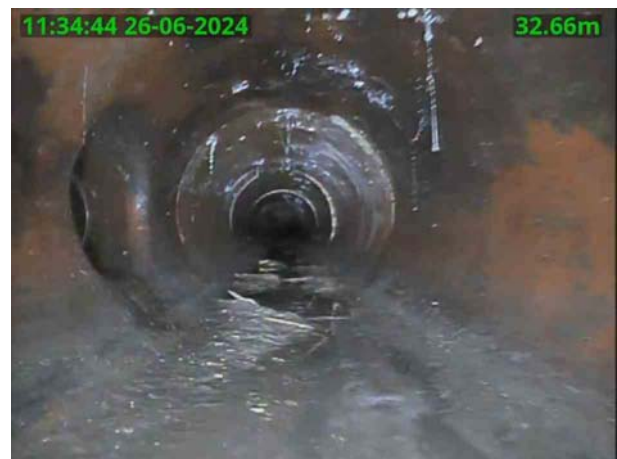
MH  
8301X\_cbe1a71a-553f-446a-a8bf-4aec8d82de09\_20240626\_1  
44906\_702.jpg, 00:02:31, 32.66 m  
Junction at 9 o'clock, 150mm dia

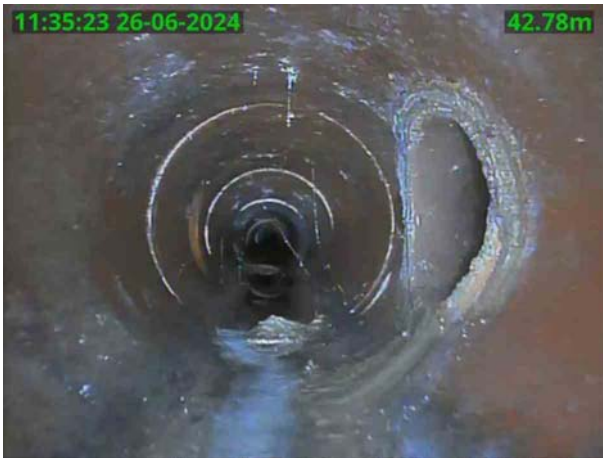
MH  
8301X\_c62f1032-655e-40e3-b64c-382543fe9a78\_20240626\_1  
45043\_752.jpg, 00:03:10, 42.78 m  
Connection other than junction at 3 o'clock, 150mm dia

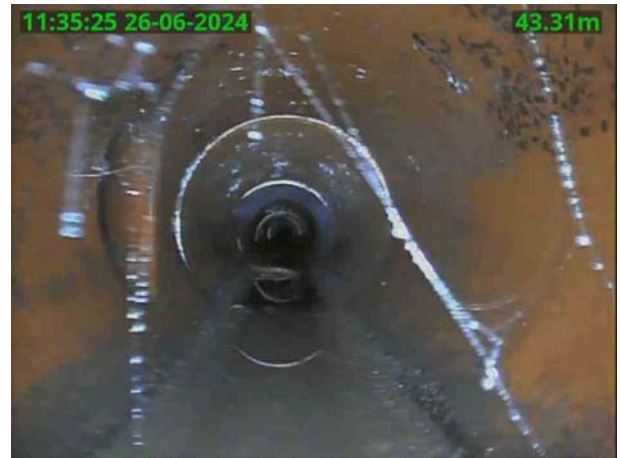
MH  
8301X\_1a69736d-cd99-4ada-a9fc-5bb92a38fcf8\_20240626\_1  
45111\_172.jpg, 00:03:12, 43.31 m  
Junction at 9 o'clock, 150mm dia

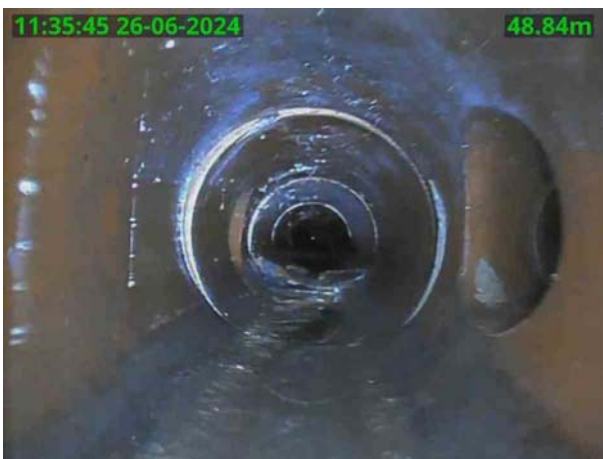
MH  
8301X\_00de4aff-2cc9-42d3-b5c9-598e5489bd0c\_20240626\_1  
45200\_154.jpg, 00:03:32, 48.84 m  
Junction at 3 o'clock, 150mm dia

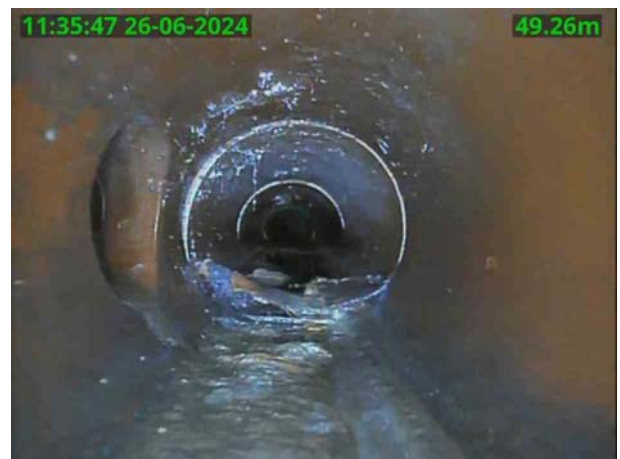
MH  
8301X\_57bca2c4-0a31-49cc-b1bd-21747c1f46ba\_20240626\_1  
145236\_788.jpg, 00:03:34, 49.26 m  
Junction at 9 o'clock, 150mm dia

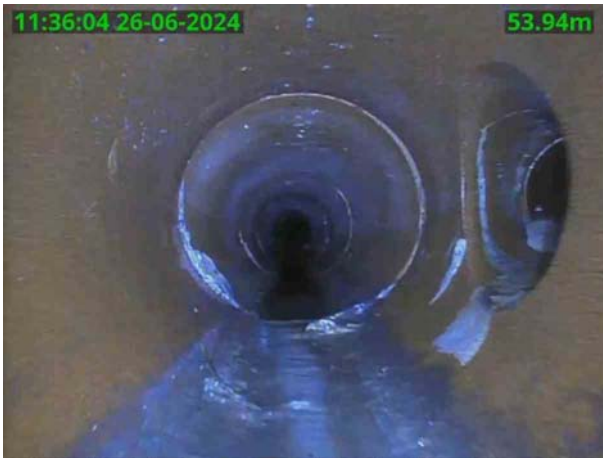
MH  
 8301X\_1d406252-4052-49da-b57a-9a0b02d84696\_20240626\_145352\_648.jpg, 00:03:51, 53.94 m  
 Junction at 3 o'clock, 150mm dia

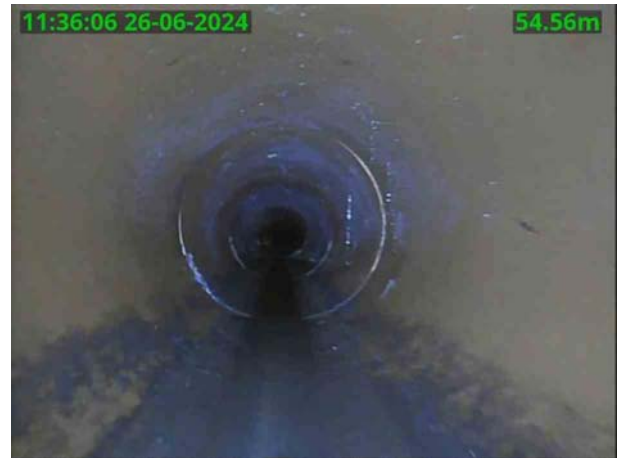
| Scale: | 1:398 | Position [m] | Code | Observation | MPEG | Photo | Grade | | |
|---|---|---|---|---|---|---|---|---|---|
| | | 54.56 | F02 DES | Settled deposits, fine, 10% cross-sectional area loss, finish | 00:03:53 | MH<br>8301X_34<br>cd5b4f-5b | 3 | | |

MH  
 8301X\_34cd5b4f-5b8b-4c72-8450-9d3462c29043\_20240626\_145415\_879.jpg, 00:03:53, 54.56 m  
 Settled deposits, fine, 10% cross-sectional area loss, finish

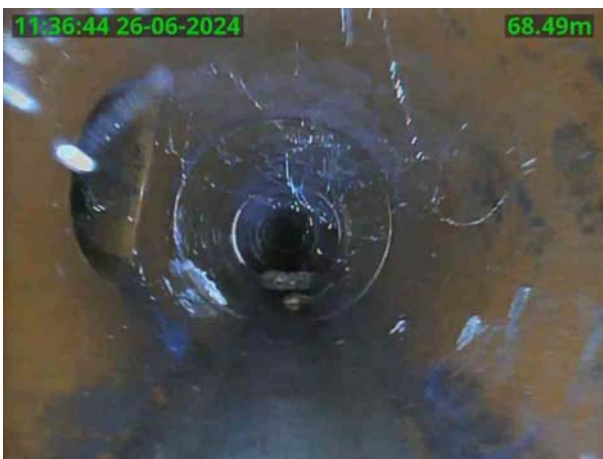
MH  
 8301X\_fb132325-d32f-4a74-a2f1-678e4e2ca0ab\_20240626\_145525\_565.jpg, 00:04:31, 68.49 m  
 Junction at 9 o'clock, 150mm dia

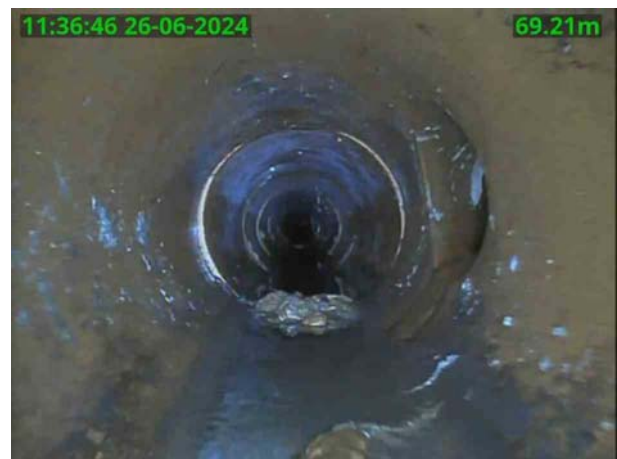
MH  
 8301X\_14b84926-f9e4-4074-9350-39fd3f18fa27\_20240626\_145624\_617.jpg, 00:04:33, 69.21 m  
 Junction at 3 o'clock, 150mm dia

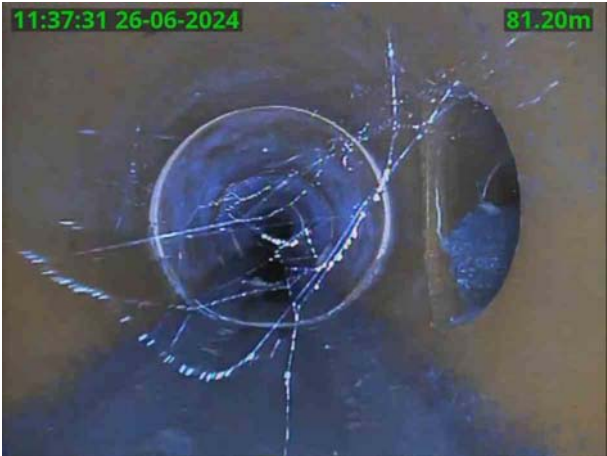
8301X\_3881f1fd-5daf-41cb-85b6-0ad9ba793248\_20240626\_145755\_496.jpg, 00:05:18, 81.20 m

Junction at 3 o'clock, 150mm dia

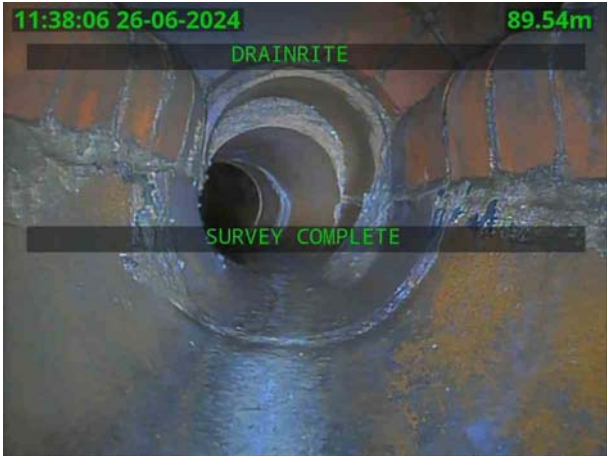
8301X\_245511b9-d425-449c-9e82-7af805317fe1\_20240626\_145849\_728.jpg, 00:05:53, 89.54 m

Finish node, manhole, reference: MH 8301

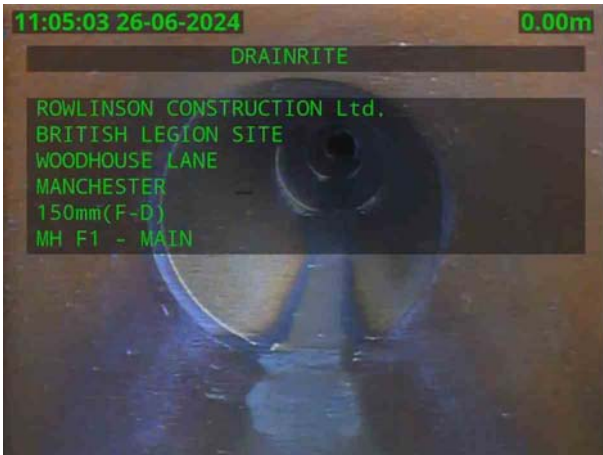
MH  
F1X\_1064993f-67e4-46de-a96f-b0556a0be1ad\_20240626\_15  
0049\_124.jpg, 0.00 m  
Water level, 0% of the vertical dimension

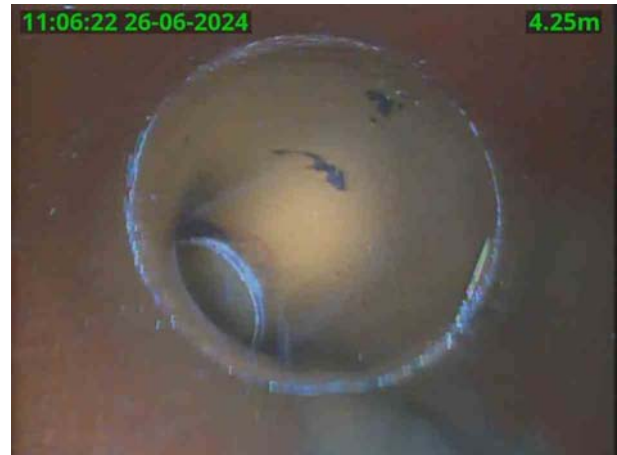
MH  
F1X\_a8ce3e10-c9cc-40ed-a451-680f2b5ee1b9\_20240626\_15  
0229\_752.jpg, 00:01:21, 4.25 m  
Line deviates left

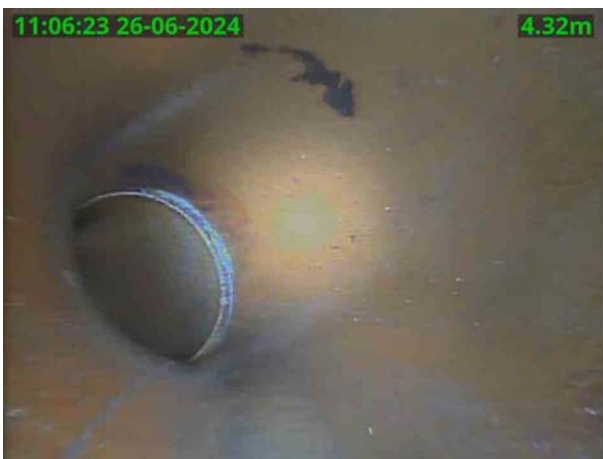
MH  
F1X\_2b94b9bf-0f11-4e16-8521-3a30e24cab4a\_20240626\_15  
0252\_061.jpg, 00:01:22, 4.32 m  
Line deviates down

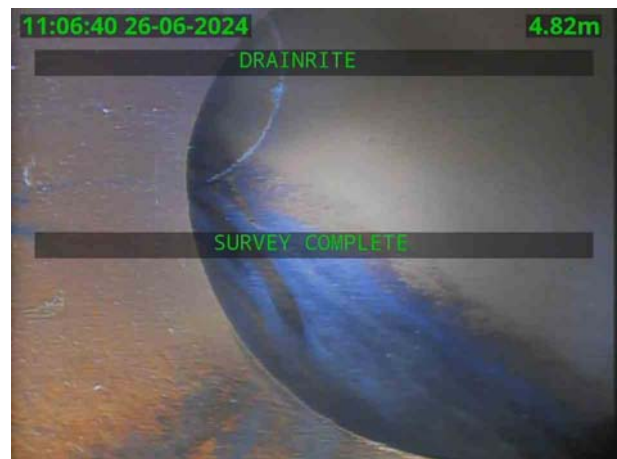
MH  
F1X\_c3397df3-4d91-4727-aa5e-cf349abf8ae6\_20240626\_150  
334\_906.jpg, 00:01:39, 4.82 m  
Finish node, manhole, reference: MAIN
