# Asbestos Refurbishment Survey Report

Job Ref No: **581081**, Account Ref No: **1550**, Contract Ref No: **98086**

## Victoria Baths, Hathersage Road, Manchester, M13 0FE

| Contract Title | (CL/45355) Victoria Baths, Hathersage Road, Manchester, M13 0FE - Fire Alarm System - Pre refurbishment Survey |

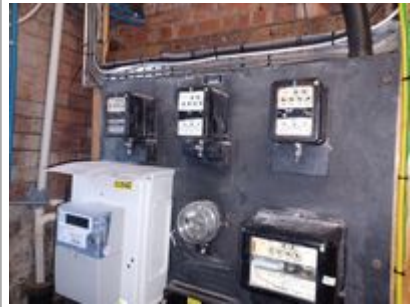
| Building | Level | Location | Item / Product Examined | Sample No. | Material Description | Fibre Type | Material Score | Extent | Risk Level Assessment | Initial Control Recommendation | Photograph |
|---|---|---|---|---|---|---|---|---|---|---|---|
| Victoria Baths, Hathersage Road, Manchester, M13 0FE | -1 | B01/B1-003-electrics | Panel to electrics | 581081-7 | Asbestos-containing composite | Chrysotile | 3 | 1 Sqm. | R3 | Remove if likely to be disturbed by proposed works | |

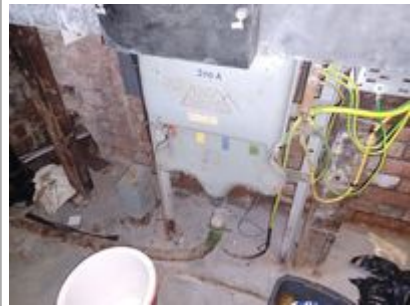
| Building | Level | Location | Item / Product Examined | Sample No. | Material Description | Fibre Type | Material Score | Extent | Risk Level Assessment | Initial Control Recommendation | Photograph |
|---|---|---|---|---|---|---|---|---|---|---|---|
| Victoria Baths, Hathersage Road, Manchester, M13 0FE | -1 | B01/B1-003-electrics | Electric intake | | Asbestos-containing woven product | Presume Chrysotile | 5 | 1 No. | R3 | Remove if likely to be disturbed by proposed works | |

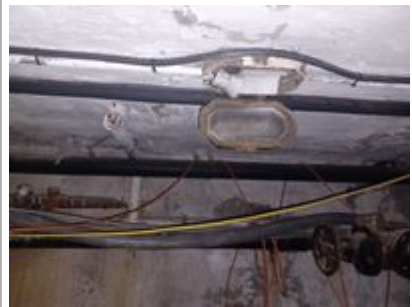
| Building | Level | Location | Item / Product Examined | Sample No. | Material Description | Fibre Type | Material Score | Extent | Risk Level Assessment | Initial Control Recommendation | Photograph |
|---|---|---|---|---|---|---|---|---|---|---|---|
| Victoria Baths, Hathersage Road, Manchester, M13 0FE | -1 | B01/B1-006 | Seal to light on ceiling | 581081-34 | Asbestos-containing mastic | Chrysotile | 3 | 0.5 Lm. | R3 | Remove if likely to be disturbed by proposed works | |

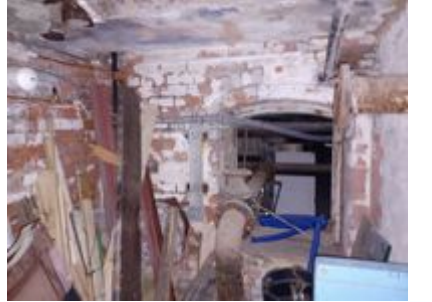
| Building | Level | Location | Item / Product Examined | Sample No. | Material Description | Fibre Type | Material Score | Extent | Risk Level Assessment | Initial Control Recommendation | Photograph |
|---|---|---|---|---|---|---|---|---|---|---|---|
| Victoria Baths, Hathersage Road, Manchester, M13 0FE | -1 | B01/B1-014 | Residues to walls | 581081-10 | Asbestos-containing insulation | Chrysotile | 8 | Not Quantifiable | R2 | Prohibit/restrict access to area pending removal or remediation of item/material | |

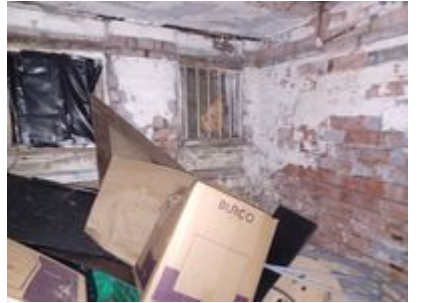
| Building | Level | Location | Item / Product Examined | Sample No. | Material Description | Fibre Type | Material Score | Extent | Risk Level Assessment | Initial Control Recommendation | Photograph |
|---|---|---|---|---|---|---|---|---|---|---|---|
| Victoria Baths, Hathersage Road, Manchester, M13 0FE | -1 | B01/B1-014 | Residues to walls 2 | 581081-11 | Asbestos-containing insulation | Chrysotile | 8 | Not Quantifiable | R2 | Prohibit/restrict access to area pending removal or remediation of item/material | |

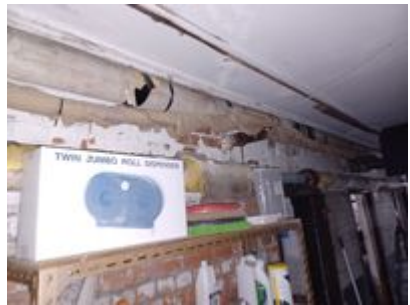
| Building | Level | Location | Item / Product Examined | Sample No. | Material Description | Fibre Type | Material Score | Extent | Risk Level Assessment | Initial Control Recommendation | Photograph |
|---|---|---|---|---|---|---|---|---|---|---|---|
| Victoria Baths, Hathersage Road, Manchester, M13 0FE | -1 | B01/B1-030 | Residues to pipe and brackets | 581081-13 | Asbestos-containing insulation | Chrysotile | 10 | 1 Lm. | R1 | Prohibit/restrict access to area pending removal or remediation of item/material | |

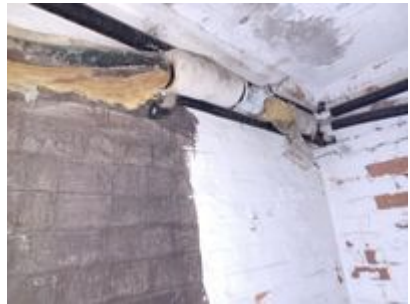
| Building | Level | Location | Item / Product Examined | Sample No. | Material Description | Fibre Type | Material Score | Extent | Risk Level Assessment | Initial Control Recommendation | Photograph |
|---|---|---|---|---|---|---|---|---|---|---|---|
| Victoria Baths, Hathersage Road, Manchester, M13 0FE | -1 | B01/B1-031 | Residues to wall behind pipework | 581081-12 | Asbestos-containing insulation | Chrysotile | 8 | Not Quantifiable | R2 | Prohibit/restrict access to area pending removal or remediation of item/material | |

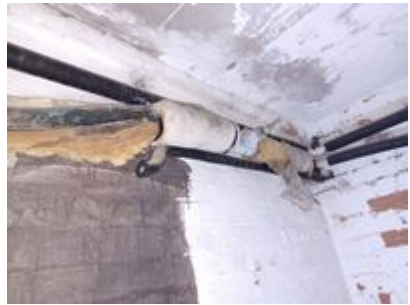
| Building | Level | Location | Item / Product Examined | Sample No. | Material Description | Fibre Type | Material Score | Extent | Risk Level Assessment | Initial Control Recommendation | Photograph |
|---|---|---|---|---|---|---|---|---|---|---|---|
| Victoria Baths, Hathersage Road, Manchester, M13 0FE | -1 | B01/B1-031 | Residues to pipe and brackets | 581081-13 | Asbestos-containing insulation | Chrysotile | 10 | 1 Lm. | R1 | Prohibit/restrict access to area pending removal or remediation of item/material | |

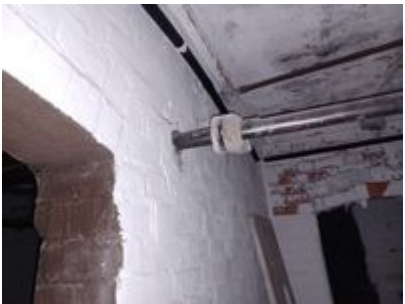
| Building | Level | Location | Item / Product Examined | Sample No. | Material Description | Fibre Type | Material Score | Extent | Risk Level Assessment | Initial Control Recommendation | Photograph |
|---|---|---|---|---|---|---|---|---|---|---|---|
| Victoria Baths, Hathersage Road, Manchester, M13 0FE | -1 | B01/B1-032 | Residues to wall behind pipework | 581081-12 | Asbestos-containing insulation | Chrysotile | 8 | Not Quantifiable | R2 | Prohibit/restrict access to area pending removal or remediation of item/material | |

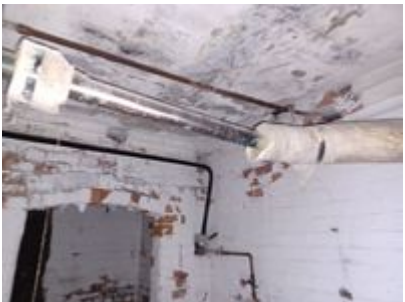
| Building | Level | Location | Item / Product Examined | Sample No. | Material Description | Fibre Type | Material Score | Extent | Risk Level Assessment | Initial Control Recommendation | Photograph |
|---|---|---|---|---|---|---|---|---|---|---|---|
| Victoria Baths, Hathersage Road, Manchester, M13 0FE | -1 | B01/B1-032 | Residues to pipe and brackets | 581081-13 | Asbestos-containing insulation | Chrysotile | 10 | 1 Lm. | R1 | Prohibit/restrict access to area pending removal or remediation of item/material | |

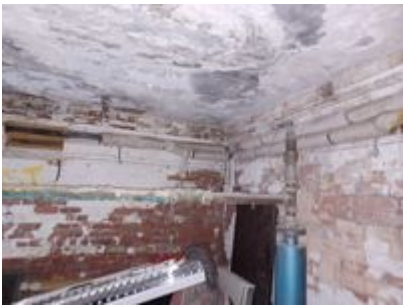
| Building | Level | Location | Item / Product Examined | Sample No. | Material Description | Fibre Type | Material Score | Extent | Risk Level Assessment | Initial Control Recommendation | Photograph |
|---|---|---|---|---|---|---|---|---|---|---|---|
| Victoria Baths, Hathersage Road, Manchester, M13 0FE | -1 | B01/B1-034 | Residues to pipe and brackets | 581081-13 | Asbestos-containing insulation | Chrysotile | 10 | 1 Lm. | R1 | Prohibit/restrict access to area pending removal or remediation of item/material | |

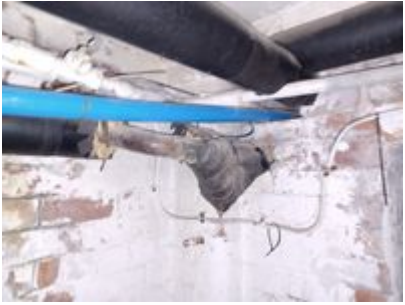
| Building | Level | Location | Item / Product Examined | Sample No. | Material Description | Fibre Type | Material Score | Extent | Risk Level Assessment | Initial Control Recommendation | Photograph |
|---|---|---|---|---|---|---|---|---|---|---|---|
| Victoria Baths, Hathersage Road, Manchester, M13 0FE | -1 | B01/B1-035-basement around female swimming pool | Residues to wall behind pipework and wall penetrations | 581081-15 | Asbestos-containing insulation | Chrysotile | 8 | Not Quantifiable | R2 | Prohibit/restrict access to area pending removal or remediation of item/material | |

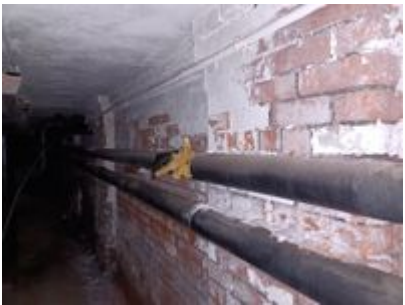
| Building | Level | Location | Item / Product Examined | Sample No. | Material Description | Fibre Type | Material Score | Extent | Risk Level Assessment | Initial Control Recommendation | Photograph |
|---|---|---|---|---|---|---|---|---|---|---|---|
| Victoria Baths, Hathersage Road, Manchester, M13 0FE | -1 | B01/B1-035-basement around female swimming pool | Residues to walls on right corridor | 581081-19 | Asbestos-containing insulation | Chrysotile | 10 | Not Quantifiable | R1 | Prohibit/restrict access to area pending removal or remediation of item/material | |

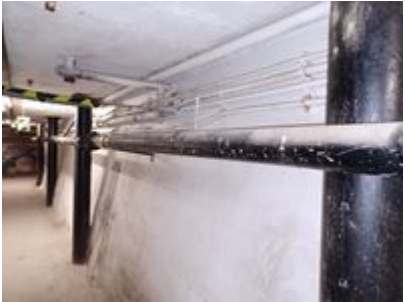
| Building | Level | Location | Item / Product Examined | Sample No. | Material Description | Fibre Type | Material Score | Extent | Risk Level Assessment | Initial Control Recommendation | Photograph |
|---|---|---|---|---|---|---|---|---|---|---|---|
| Victoria Baths, Hathersage Road, Manchester, M13 0FE | -1 | B01/B1-037-basement of males 1st class swimming pool | Pipe | 581081-29 | Asbestos-containing cement | Amosite, Chrysotile | 5 | 150 Lm. | R3 | Remove if likely to be disturbed by proposed works | |

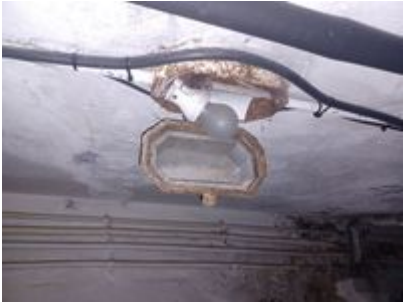
| Building | Level | Location | Item / Product Examined | Sample No. | Material Description | Fibre Type | Material Score | Extent | Risk Level Assessment | Initial Control Recommendation | Photograph |
|---|---|---|---|---|---|---|---|---|---|---|---|
| Victoria Baths, Hathersage Road, Manchester, M13 0FE | -1 | B01/B1-037-basement of males 1st class swimming pool | Seal to light on ceiling | 581081-34 | Asbestos-containing mastic | Chrysotile | 4 | 0.5 Lm. | R3 | Remove if likely to be disturbed by proposed works | |

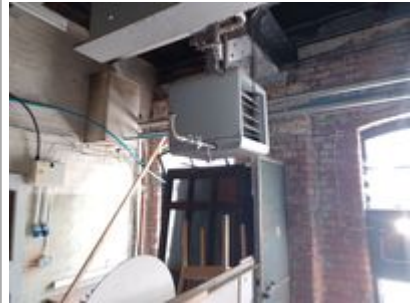
| Building | Level | Location | Item / Product Examined | Sample No. | Material Description | Fibre Type | Material Score | Extent | Risk Level Assessment | Initial Control Recommendation | Photograph |
|---|---|---|---|---|---|---|---|---|---|---|---|
| Victoria Baths, Hathersage Road, Manchester, M13 0FE | 0 | B02/ GF-005-Elecrician store | Heater | | Asbestos-containing woven product | Presume Chrysotile | 5 | 1 No. | R3 | Remove if likely to be disturbed by proposed works | |

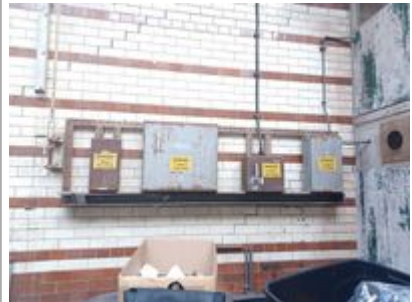
| Building | Level | Location | Item / Product Examined | Sample No. | Material Description | Fibre Type | Material Score | Extent | Risk Level Assessment | Initial Control Recommendation | Photograph |
|---|---|---|---|---|---|---|---|---|---|---|---|
| Victoria Baths, Hathersage Road, Manchester, M13 0FE | 0 | B03/ GF-001-Laundry | Electrics | | Asbestos-containing woven product | Presume Chrysotile | 5 | 4 No. | R3 | Remove if likely to be disturbed by proposed works | |

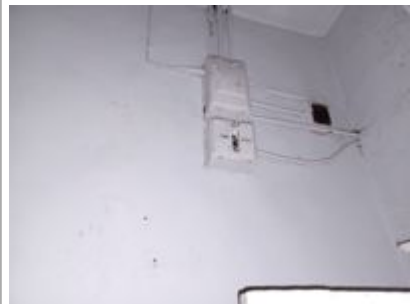
| Building | Level | Location | Item / Product Examined | Sample No. | Material Description | Fibre Type | Material Score | Extent | Risk Level Assessment | Initial Control Recommendation | Photograph |
|---|---|---|---|---|---|---|---|---|---|---|---|
| Victoria Baths, Hathersage Road, Manchester, M13 0FE | 1 | B01/01-012 | Wall | | Asbestos-containing electrics | Presume Chrysotile | 5 | 2 No | R3 | Remove if likely to be disturbed by proposed works | |

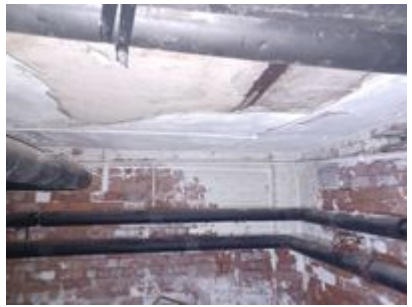
| Building | Level | Location | Item / Product Examined | Accessibility | Access Comments | Photograph |
|---|---|---|---|---|---|---|
| Victoria Baths, Hathersage Road, Manchester, M13 0FE | -1 | B01/B1-035- basement around female swimming pool | <b>Entire Location</b> | Limited Access | concrete damage to ceiling | |
