## 38 to 42 Mosley Street Paint Analysis

### Report on Findings Report No HPM88MS01

ISSUE 01– 22/12/2024

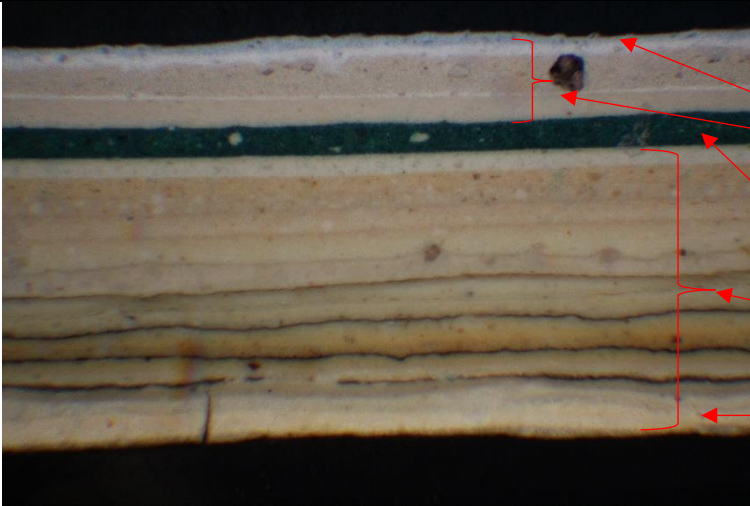
| Sample Ref: 01 | Location: 38 to 42 Mosley Street |
|---|---|
| | <p><b>X50 Magnification –</b><br/> Current visible paint scheme (Blue).<br/> 4No White / off white paint layers.<br/> Single green paint scheme.<br/> 16 white / off white paint layers.<br/> Earliest decorative colour.</p> |
| <p>Early schemes tested for lead</p> <p>Yes – evidence early lead based paints present.</p> <p>(Lead bearing paint layers noted in black).</p> <p>The first 11 paint layers are based on lead carbonate.</p> | |

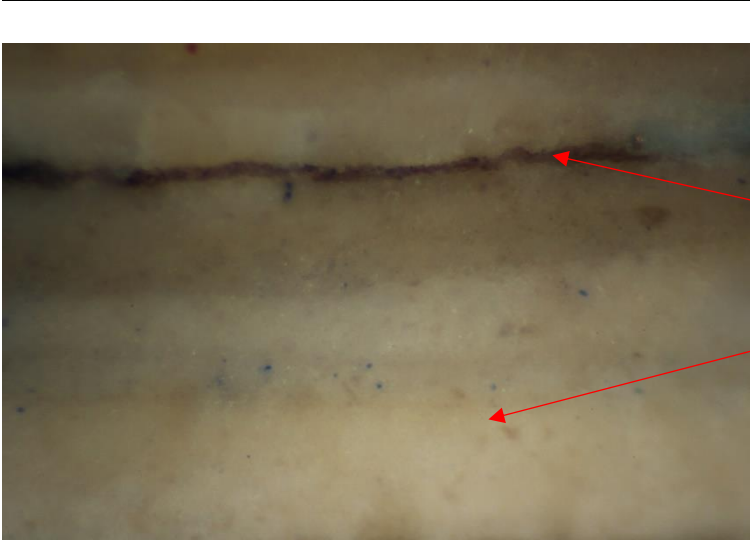
| Sample Ref: 01 | Location: 38 to 42 Mosley Street |
|---|---|
| | <p><b>X400 Magnification -</b><br/> Earliest paint layers.</p> <p>Thick layer of dirt on 4<sup>th</sup> paint layer</p> <p>Earliest paint scheme – white oil paint based on lead carbonate.</p> |

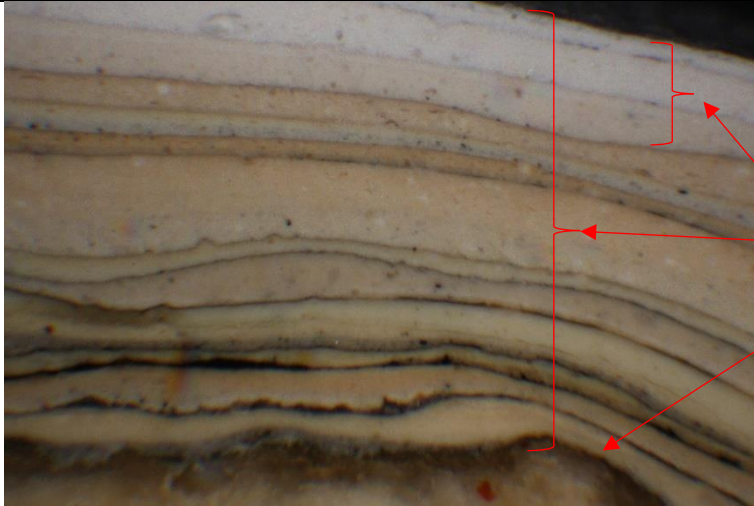
| Sample Ref: 02 | Location: 38 to 42 Mosley Street |
|---|---|
| | <p><b>X50 Magnification –</b><br/>Current visible paint scheme (white).</p> <p>Modern Titanium white paint layers.</p> <p>25 white and off-white paint layers.</p> <p>Earliest decorative paint layers</p> |
| <p>Early schemes tested for lead</p> <p>Yes – evidence early lead based paints present.</p> <p>(Lead bearing paint layers noted in black).</p> <p>The first 10 paint layers are based on Lead Carbonate.</p> | |

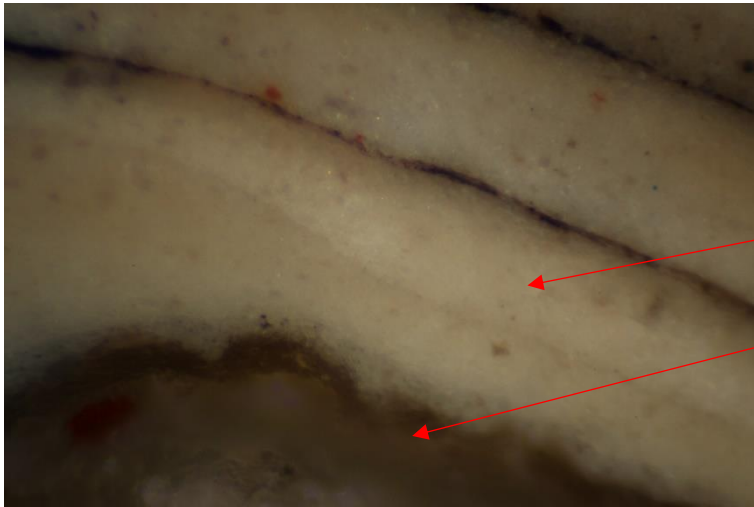
| Sample Ref: 02 | Location: 38 to 42 Mosley Street |
|---|---|
| | <p><b>X400 Magnification -</b><br/>Earliest paint layers.</p> <p>Earliest paint scheme – white paint based on lead carbonate.</p> <p>Possible distemper paint layers (not fully removed).</p> |

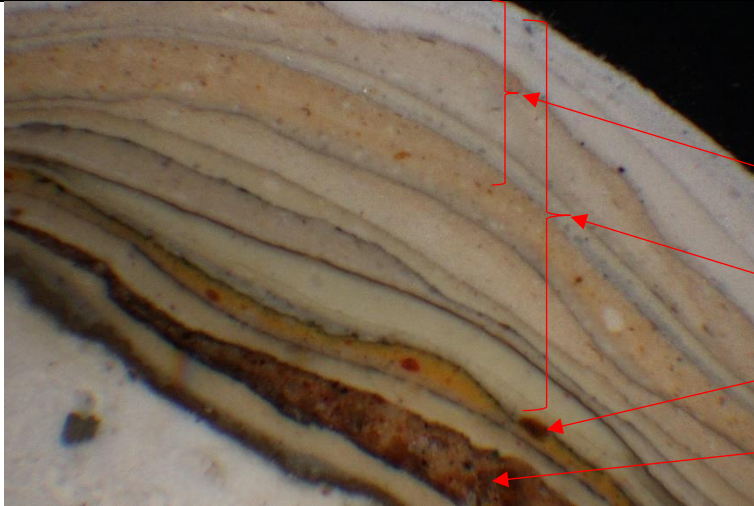
| Sample Ref: 03 | Location: 38 to 42 Mosley Street |
|---|---|
| | <p><b>X50 Magnification –</b><br/>Current visible paint scheme.</p> <p>9No modern paint layers based on Titanium white.</p> <p>17No white / off-white paint schemes.</p> <p>Single yellow paint scheme</p> <p>Single brown paint scheme</p> |
| <p>Early schemes tested for lead</p> <p>Yes – evidence early lead based paints present.</p> <p>(Lead bearing paint layers noted in black).</p> <p>8 out of 10 of the first paint layers are based on lead carbonate.</p> | |

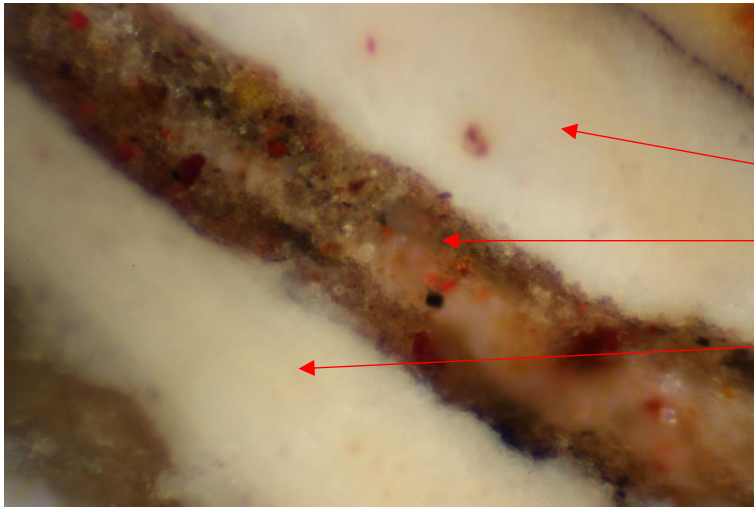
| Sample Ref: 03 | Location: 38 to 42 Mosley Street |
|---|---|
| | <p><b>X400 Magnification -</b><br/>Earliest paint layers.</p> <p>Third Decorative scheme - white</p> <p>Second decorative scheme – red / brown.</p> <p>Earliest paint scheme – white oil paint based on lead carbonate.</p> |

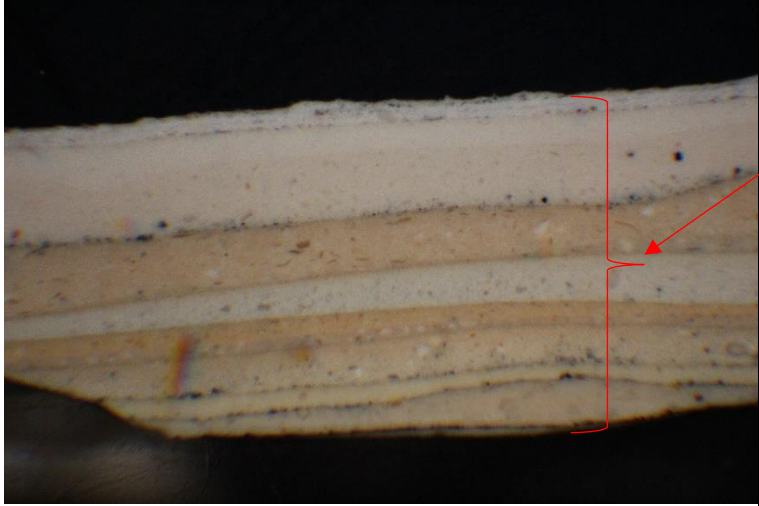
| Sample Ref: 04 | Location: 38 to 42 Mosley Street |
|---|---|
| | <p><b>X50 Magnification –</b><br/>Current visible paint scheme (white).</p> <p>12No layers of white / off white paints.</p> <p>Note: Sample does not have the earliest paint schemes present in other samples – possible repair or later detail.</p> |

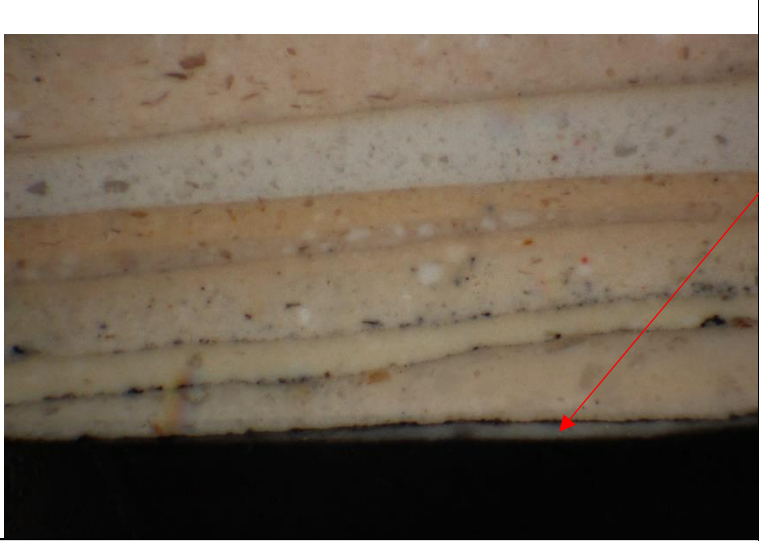
| Sample Ref: 04 | Location: 38 to 42 Mosley Street |
|---|---|
| | <p><b>X400 Magnification -</b><br/>Earliest paint layers.</p> <p>Earliest paint scheme – white paint based on lead carbonate.</p> |

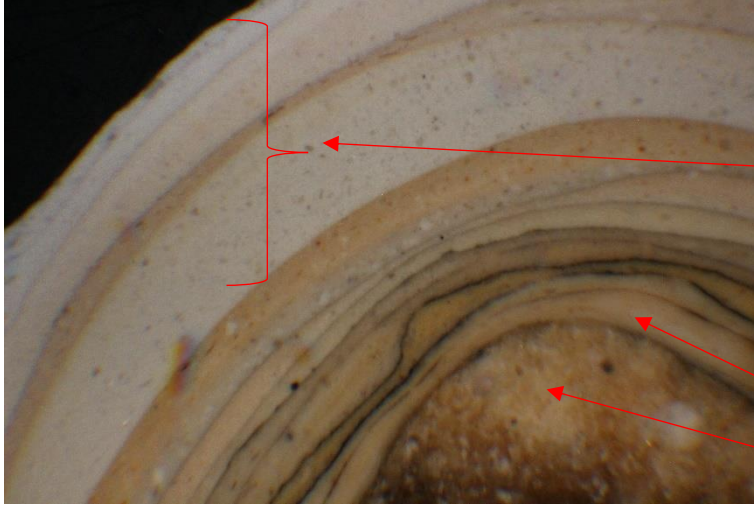
| Sample Ref: 05 | Location: 38 to 42 Mosley Street |
|---|---|
| | <p><b>X50 Magnification –</b><br/>Current visible paint scheme (white).</p> <p>6No modern white paint layer based on Titanium white.</p> <p>22 separate white / off white / light stone paint layers.</p> <p>Earliest paint layers</p> <p>Plaster</p> |

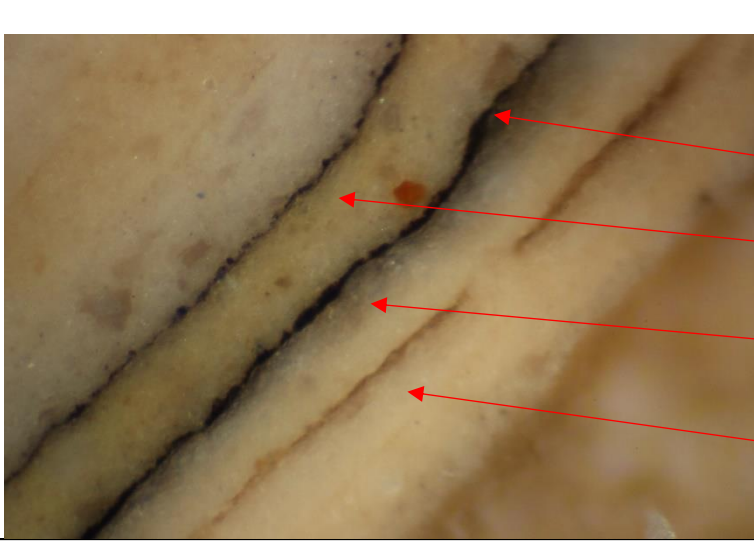
| Sample Ref: 05 | Location: 38 to 42 Mosley Street |
|---|---|
| | <p><b>X400 Magnification -</b><br/>Earliest paint layers.</p> <p>Thick dirt layers</p> <p>Third paint scheme – off white (yellow).</p> <p>Second paint scheme – off white (grey)</p> <p>Earliest paint scheme – white oil paint based on lead carbonate.</p> |

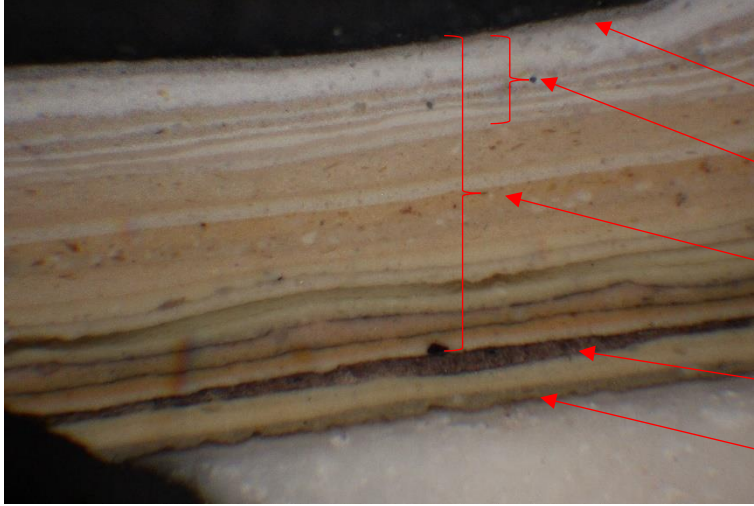
| Sample Ref: 06 | Location: 38 to 42 Mosley Street |
|---|---|
| | <p><b>X50 Magnification –</b></p> <p>Current visible paint scheme (grey).</p> <p>7 No Modern paint layers based on Titanium white.</p> <p>27 white / off white paint layers.</p> <p>Single brown decorative scheme.</p> <p>Earliest paint layers.</p> |
| <p>Early schemes tested for lead</p> <p>Yes – evidence early lead based paints present.</p> <p>(Lead bearing paint layers noted in black).</p> <p>The first 12 layers are based on lead carbonate.</p> | |

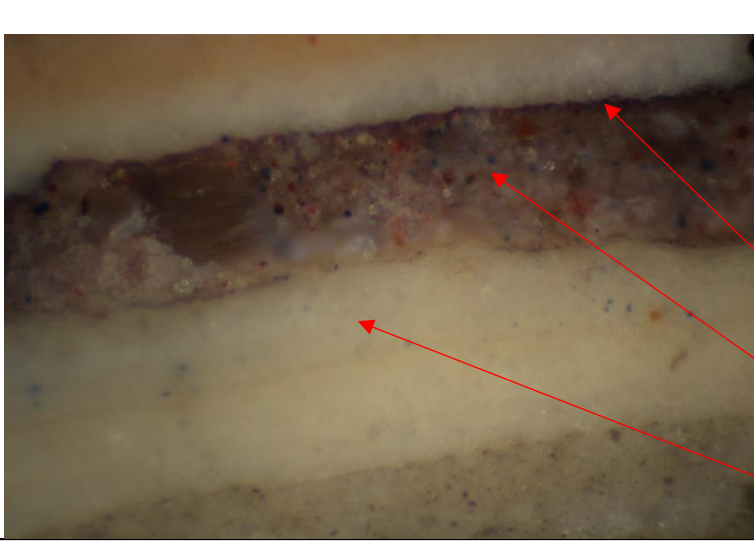
| Sample Ref: 06 | Location: 38 to 42 Mosley Street |
|---|---|
| | <p><b>X400 Magnification -</b></p> <p>Earliest paint layers.</p> <p>Thick dirt of surface of paintwork.</p> <p>Later brown decorative scheme (layer 5).</p> <p>Earliest paint layers – white oil paint based on lead carbonate.</p> |

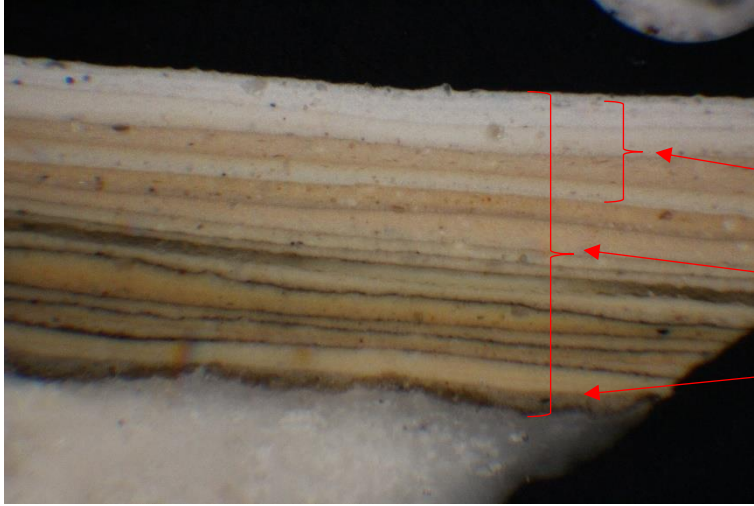
| Sample Ref: 07 | Location: 38 to 42 Mosley Street |
|---|---|
| | <p><b>X50 Magnification –</b><br/>Current visible paint scheme (white).</p> <p>Modern paint layers based on Titanium white</p> <p>25 separate white / off white paint layers.</p> <p>Earliest paint layers.</p> |

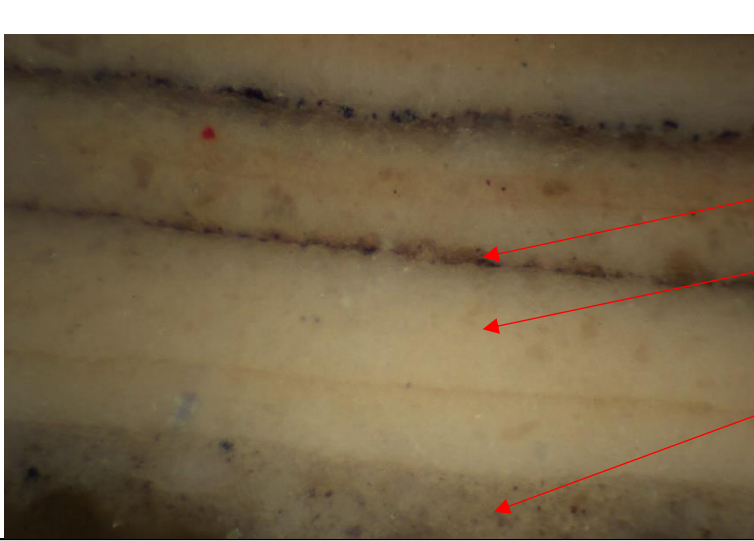
| Sample Ref: 07 | Location: 38 to 42 Mosley Street |
|---|---|
| | <p><b>X400 Magnification -</b><br/>Earliest paint layers.</p> <p>Dirt on surface of paintwork.</p> <p>Earliest paint schemes – white oil paint based on lead carbonate.</p> <p>Temporary distemper paint layers – not fully removed.</p> |
| <p>Early schemes tested for lead</p> <p>Yes – evidence early lead based paints present.</p> <p>(Lead bearing paint layers noted in black).</p> <p>The earliest 10 layers are based on lead carbonate.</p> | |

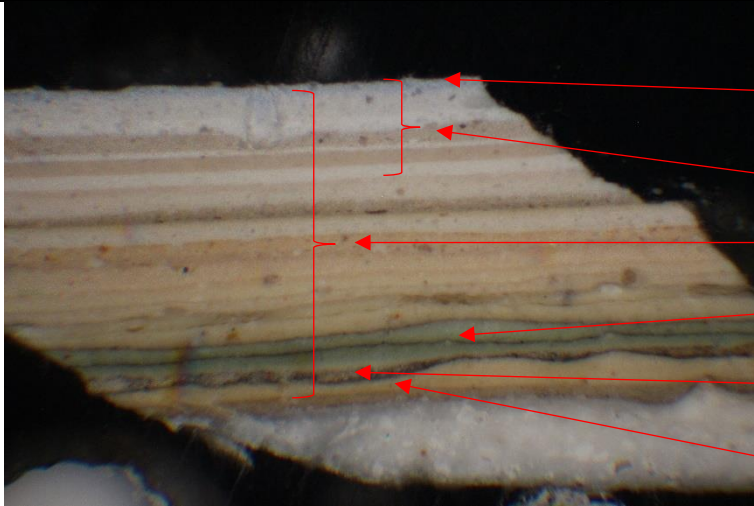
| Sample Ref: 08 | Location: 38 to 42 Mosley Street |
|---|---|
| | <p><b>X50 Magnification –</b></p> <p>Current visible paint scheme (blue).</p> <p>Modern Titanium white paint layers.</p> <p>22 white / off white paint layers.</p> <p>Two light green paint schemes (tints).</p> <p>Light brown paint scheme</p> <p>Earliest paint layers.</p> |

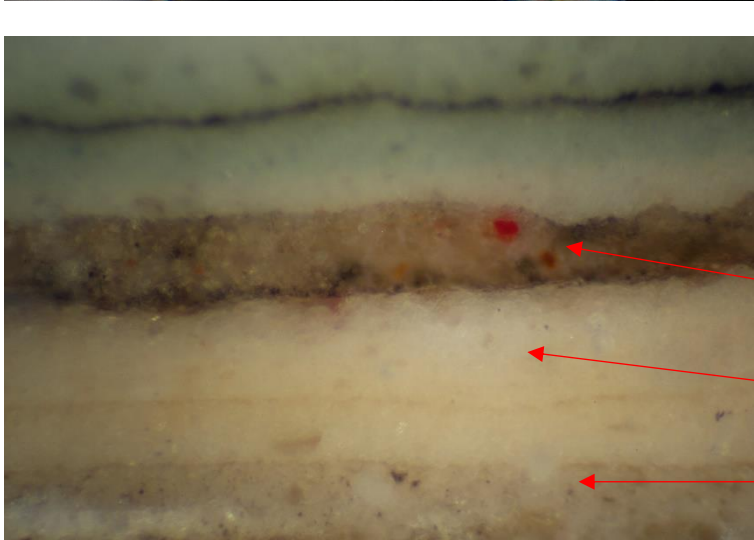
| Sample Ref: 08 | Location: 38 to 42 Mosley Street |
|---|---|
| | <p><b>X400 Magnification -</b></p> <p>Earliest paint layers.</p> <p>Light brown / stone coloured paint scheme (layer 5).</p> <p>Earliest decorative scheme – white oil paint based on lead carbonate.</p> <p>Temporary distemper paint layers – not fully removed.</p> |

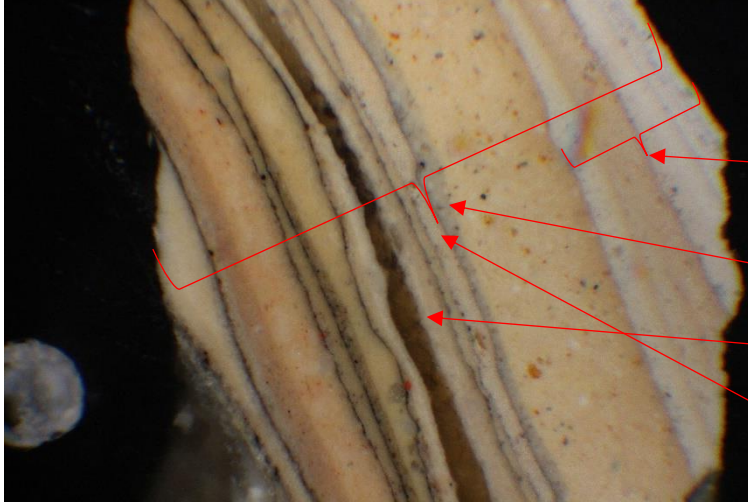
| Sample Ref: 09 | Location: 38 to 42 Mosley Street |
|---|---|
| | <p><b>X50 Magnification –</b><br/>Current visible paint scheme (white).</p> <p>Modern paint layers based on Titanium white.</p> <p>Single light grey paint layer.</p> <p>Single clear varnish layer (tarnished).</p> <p>20 separate white and off-white paint layers.</p> |

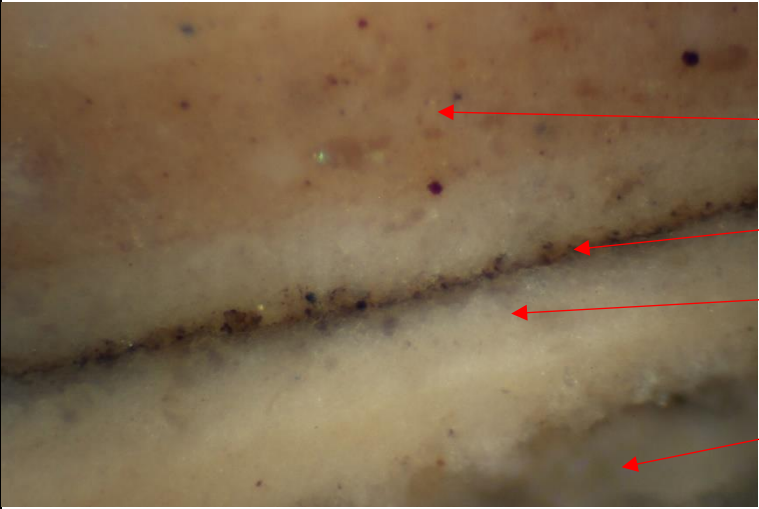
| Sample Ref: 09 | Location: 38 to 42 Mosley Street |
|---|---|
| | <p><b>X400 Magnification -</b><br/>Earliest paint layers.</p> <p>Later off white (light stone) paint layer</p> <p>Dirt on surface of paintwork.</p> <p>Earliest paint scheme – white paint based on lead carbonate.</p> <p>Temporary distemper paint layers – not fully removed.</p> |

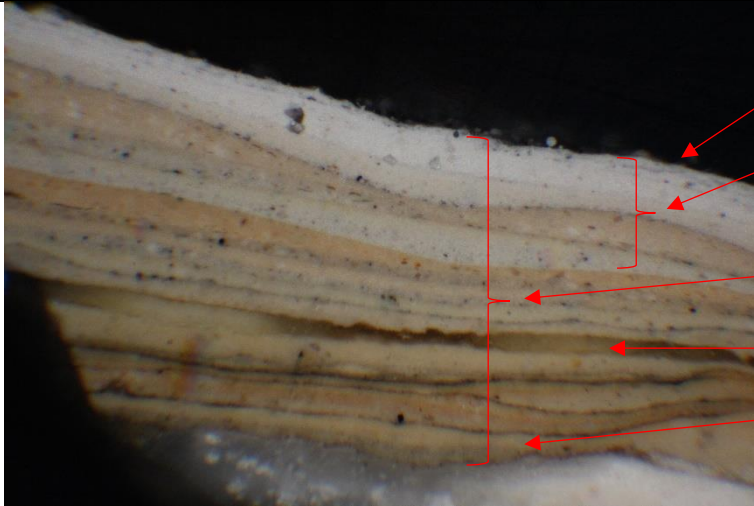
| Sample Ref: 10 | Location: 38 to 42 Mosley Street |
|---|---|
| | <p><b>X50 Magnification –</b></p> <p>Current visible paint scheme (white.</p> <p>Modern paint layers based on Titanium white.</p> <p>21 white / off white paint layers.</p> <p>Single clear varnish layer (tarnished)</p> <p>Earliest paint layers.</p> |

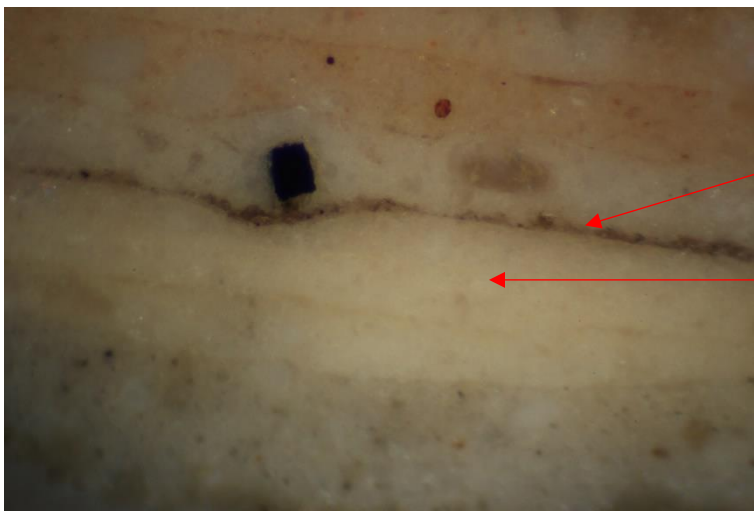
| Sample Ref: 10 | Location: 38 to 42 Mosley Street |
|---|---|
| | <p><b>X400 Magnification -</b></p> <p>Earliest paint layers.</p> <p>Dirt on surface of paintwork.</p> <p>Earliest paint scheme – white paint based on lead carbonate.</p> |

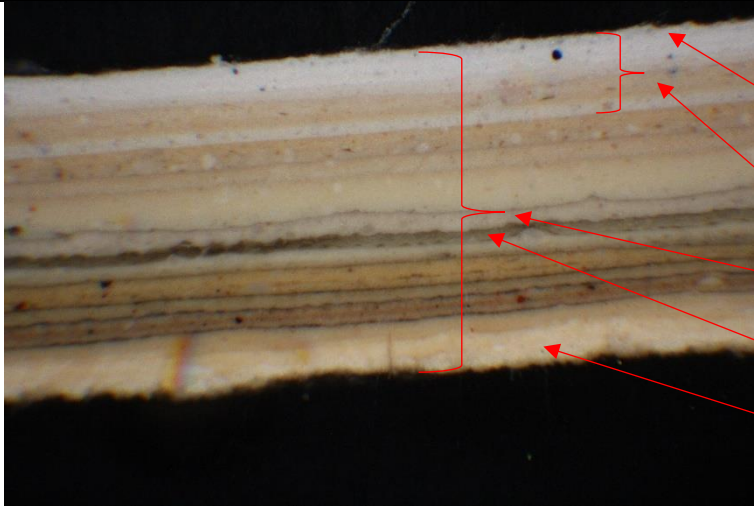
| Sample Ref: 11 | Location: 38 to 42 Mosley Street |
|---|---|
| | <p><b>X50 Magnification –</b><br/>Current visible paint scheme (white).</p> <p>Modern paint layers based on Titanium white.</p> <p>22 white / off white paint layers.</p> <p>Single clear varnish layer (tarnished).</p> <p>Earliest paint coatings.</p> |

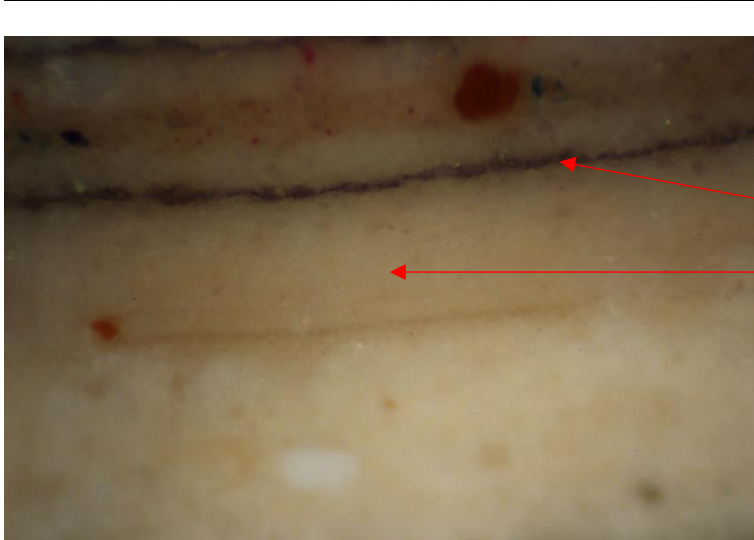
| Sample Ref: 11 | Location: 38 to 42 Mosley Street |
|---|---|
| | <p><b>X400 Magnification -</b><br/>Earliest paint layers.</p> <p>Dirt on surface of the paintwork.</p> <p>Earliest paint scheme – white oil paint based on lead carbonate.</p> |

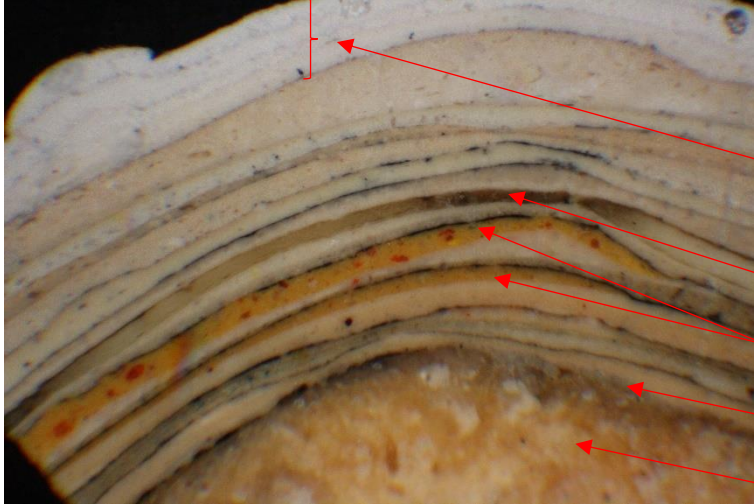
| Sample Ref: 12 | Location: 38 to 42 Mosley Street |
|---|---|
| | <p><b>X50 Magnification –</b><br/>Current visible paint scheme (white).</p> <p>Modern paint layers based on Titanium white.</p> <p>Single clear varnish layer (tarnished).</p> <p>2 No yellow decorative schemes.</p> <p>Earliest paint layers.</p> <p>Plaster</p> |

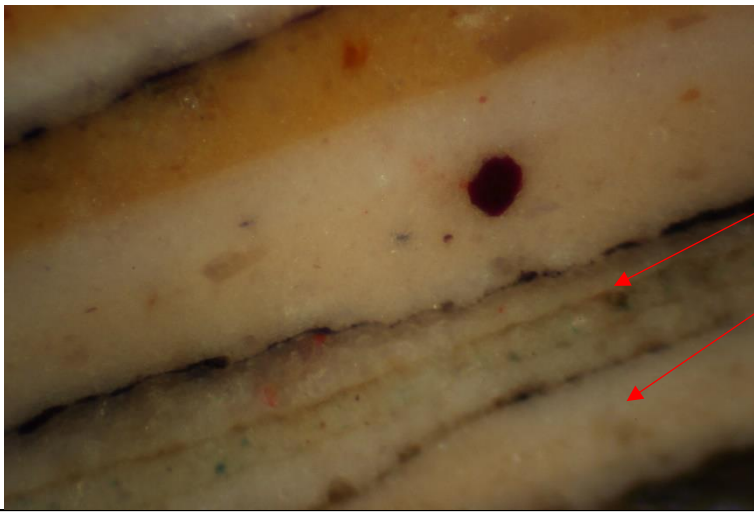
| Sample Ref: 12 | Location: 38 to 42 Mosley Street |
|---|---|
| | <p><b>X400 Magnification -</b><br/>Earliest paint layers.</p> <p>Later off-white paint layers (slightly green).</p> <p>Earliest paint scheme – white paint based on lead carbonate.</p> |

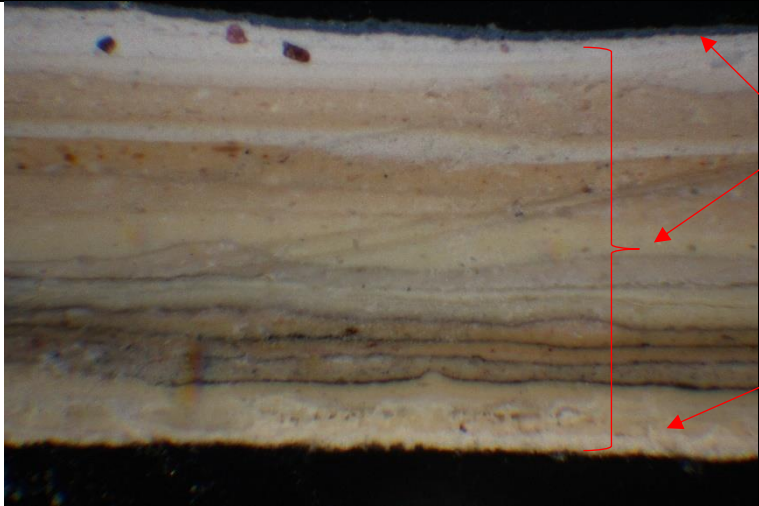
| Sample Ref: 13 | Location: 38 to 42 Mosley Street |
|---|---|
| | <p><b>X50 Magnification –</b><br/>Current visible paint scheme (blue).</p> <p>20 separate white / off white paint layers.</p> <p>Earliest paint layers.</p> |

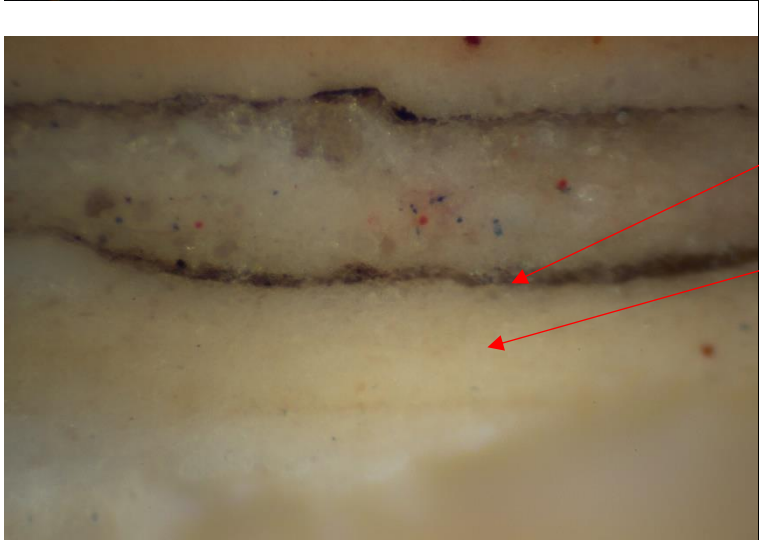
| Sample Ref: 13 | Location: 38 to 42 Mosley Street |
|---|---|
| | <p><b>X400 Magnification -</b><br/>Earliest paint layers.</p> <p>Thick dirt layer on paintwork.</p> <p>Earliest paint scheme – white oil paint based on lead carbonate.</p> |

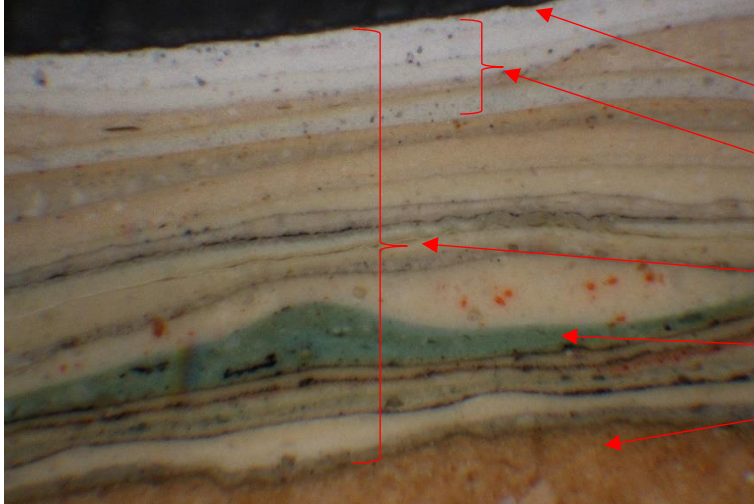
| Sample Ref: 14 | Location: 38 to 42 Mosley Street |
|---|---|
| | <p><b>X50 Magnification –</b></p> <p>Current visible paint scheme (white).</p> <p>Modern paint layers based on Titanium white.</p> <p>21 white / off white paint schemes.</p> <p>Single green paint layer.</p> <p>Plaster</p> |

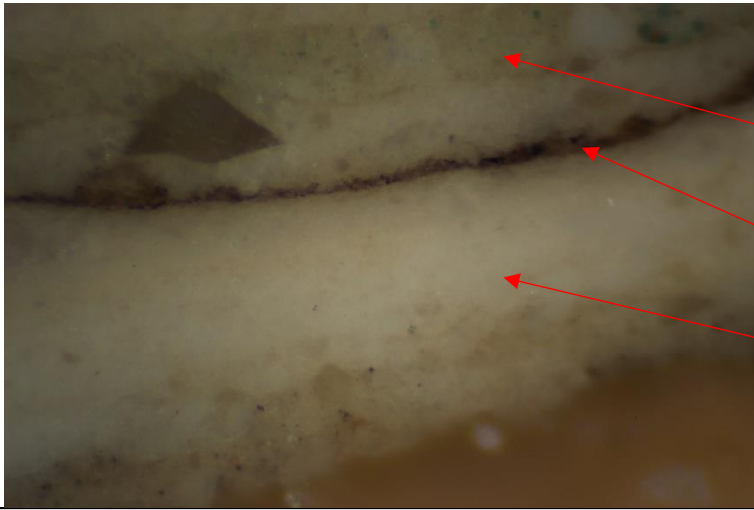
| Sample Ref: 14 | Location: 38 to 42 Mosley Street |
|---|---|
| | <p><b>X400 Magnification -</b></p> <p>Earliest paint layers.</p> <p>Later paint scheme off-white (green).</p> <p>Dirt on surface of paintwork.</p> <p>Earliest paint scheme – white paint based on lead carbonate.</p> |

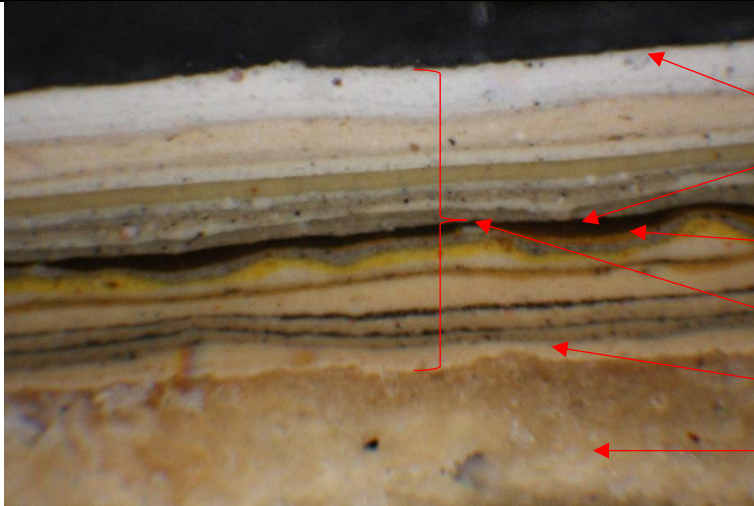
| Sample Ref: 15 | Location: 38 to 42 Mosley Street |
|---|---|
| | <p><b>X50 Magnification –</b><br/>Current visible paint scheme (white).</p> <p>Single clear varnish layer (tarnished).</p> <p>Yellow paint layers (2No)</p> <p>22 white / off white paint layers.</p> <p>Earliest paint layers.</p> <p>Plaster</p> |

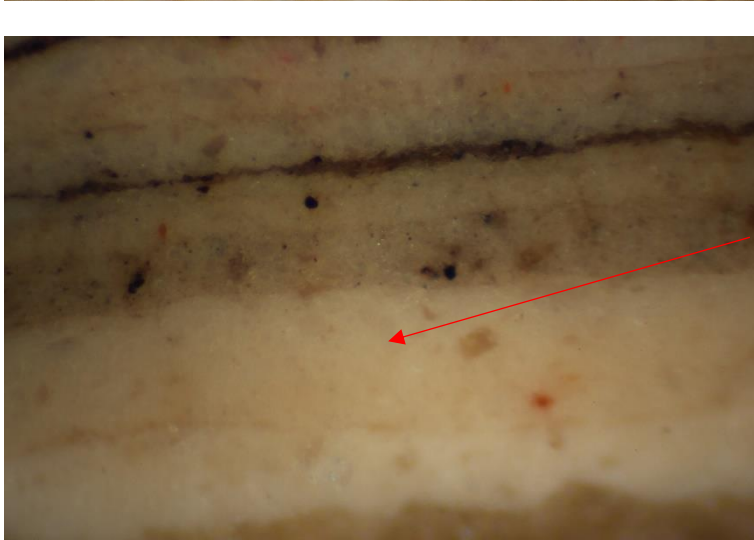
| Sample Ref: 15 | Location: 38 to 42 Mosley Street |
|---|---|
| | <p><b>X400 Magnification -</b><br/>Earliest paint layers.</p> <p>Earliest paint scheme – white oil paint based on lead carbonate.</p> |

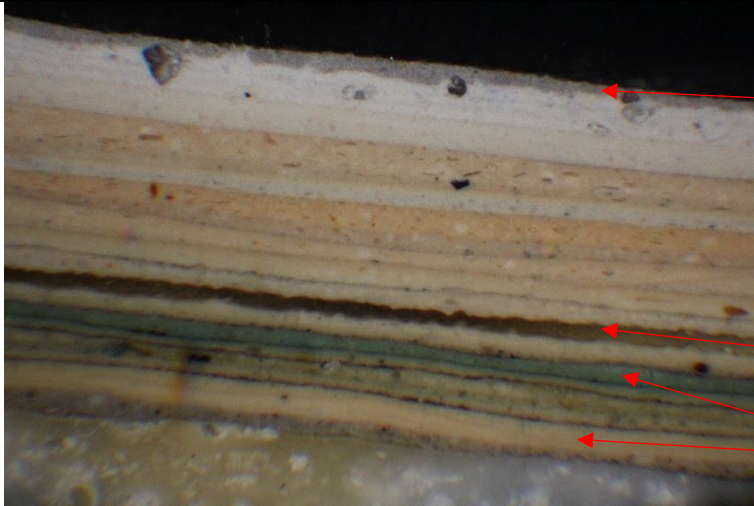
| Sample Ref: 16 | Location: 38 to 42 Mosley Street |
|---|---|
| | <p><b>X50 Magnification –</b><br/>Current visible paint scheme (grey).</p> <p>Single clear varnish layer.</p> <p>Single green paint layer.</p> <p>Earliest paint layers.</p> |

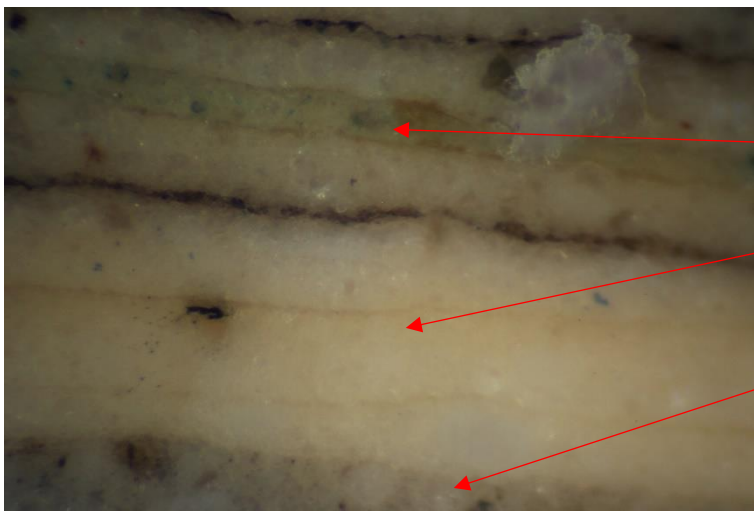
| Sample Ref: 16 | Location: 38 to 42 Mosley Street |
|---|---|
| | <p><b>X400 Magnification -</b><br/>Earliest paint layers.</p> <p>Later off-white paint layers (green tint).</p> <p>Earliest paint scheme – white oil paint based on lead carbonate.</p> <p>Temporary distemper paint layers – not fully removed.</p> |

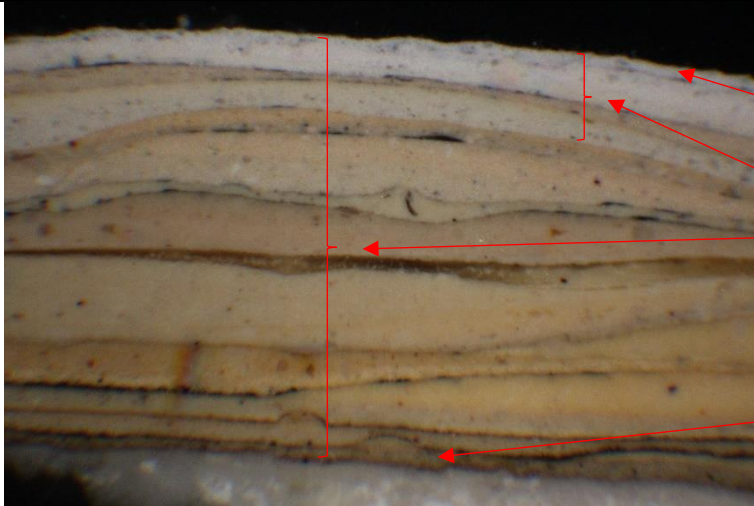
| Sample Ref: 17 | Location: 38 to 42 Mosley Street |
|---|---|
| | <p><b>X50 Magnification –</b></p> <p>Current visible paint scheme (white).</p> <p>Modern Titanium white paint layers.</p> <p>22 white and off white paint layers.</p> <p>Earliest paint layers.</p> |

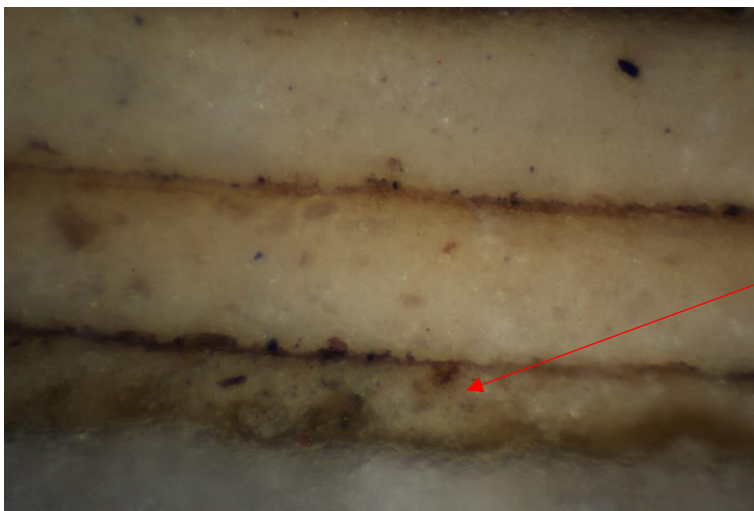
| Sample Ref: 17 | Location: 38 to 42 Mosley Street |
|---|---|
| | <p><b>X400 Magnification -</b></p> <p>Earliest paint layers.</p> <p>Earliest paint scheme – white paint based on lead carbonate.</p> |

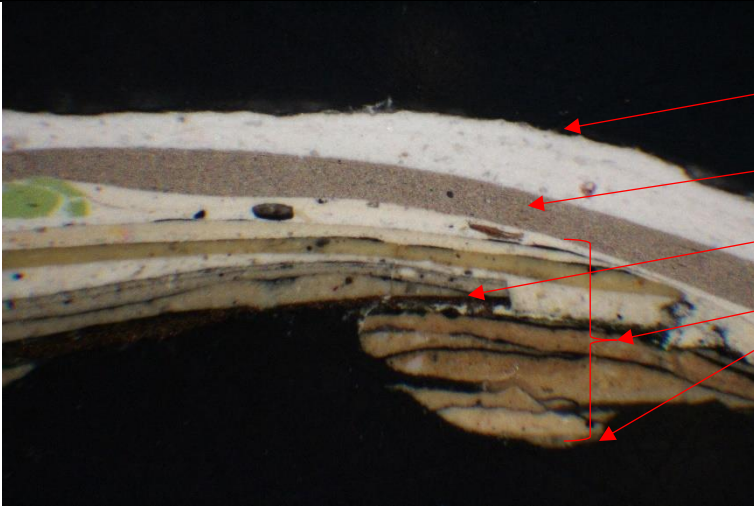
| Sample Ref: 18 | Location: 38 to 42 Mosley Street |
|---|---|
| | <p><b>X50 Magnification –</b><br/>Current visible paint scheme (white).</p> <p>Single brown paint layer.</p> <p>Single brown paint layer.</p> <p>17 No layers of white / off white paint.</p> <p>Earliest paint layers</p> |

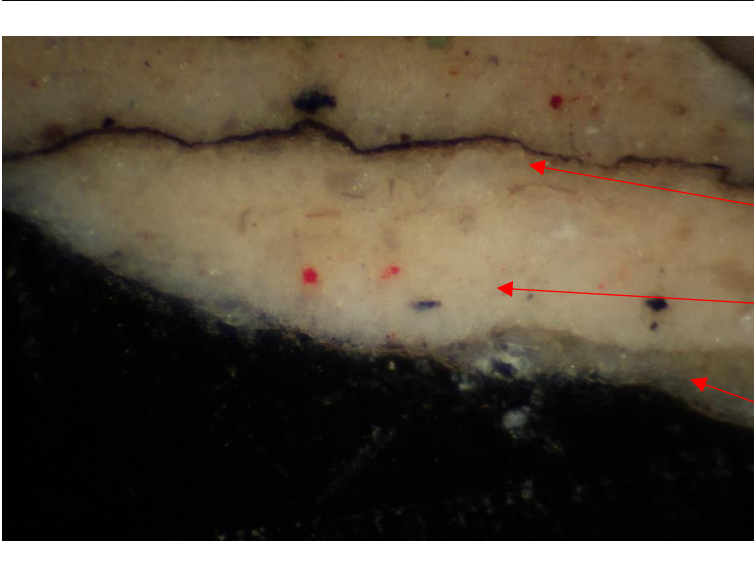
| Sample Ref: 18 | Location: 38 to 42 Mosley Street |
|---|---|
| | <p><b>X400 Magnification -</b><br/>Earliest paint layers.</p> <p>Thick dirt layer on surface of paintwork.</p> <p>Earliest paint scheme – white paint based on lead carbonate.</p> <p>Primer layer</p> |

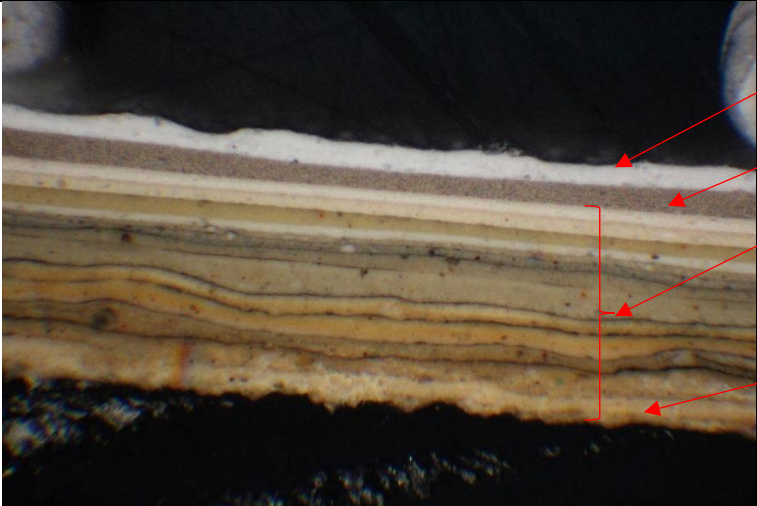
| Sample Ref: 19 | Location: 38 to 42 Mosley Street |
|---|---|
| | <p><b>X50 Magnification –</b><br/>Current visible paint scheme (white).</p> <p>Single brown paint layer</p> <p>20 off white and light stone paint layers</p> <p>Earliest paint layers</p> |

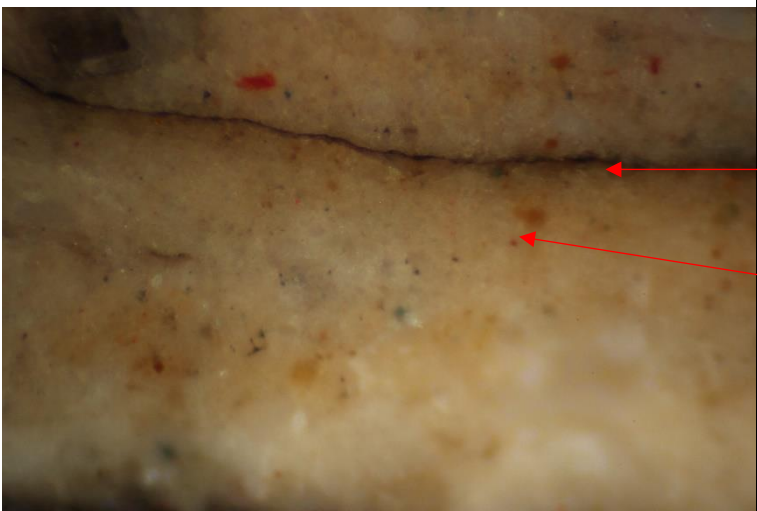
| Sample Ref: 19 | Location: 38 to 42 Mosley Street |
|---|---|
| | <p><b>X400 Magnification -</b><br/>Earliest paint layers.</p> <p>Dirt on surface of paintwork.</p> <p>Earliest paint scheme – off white or light stone coloured oil paint based on lead carbonate.</p> |

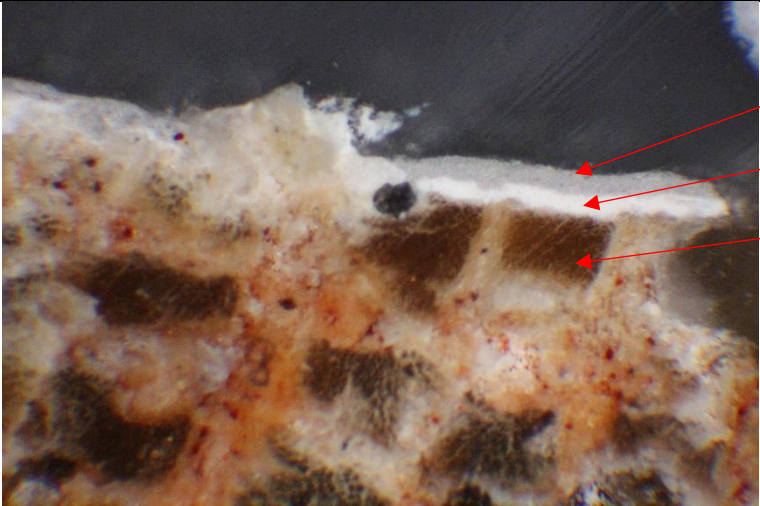
Infill panel to pilaster (sample 20) – The sample taken from this element indicated that the panel had been replaced or covered with a plywood panel. Only 2 separate paint layers were present with the earliest of these being a Titanium white (possibly primer) followed by the current grey paintwork. It is unclear why the panels have been replaced.

| Sample Ref: 20 | Location: 38 to 42 Mosley Street |
|---|---|
| | <p><b>X50 Magnification –</b></p> <p>Current visible paint scheme (grey).</p> <p>Single modern white paint layer.</p> <p>Plywood.</p> |
| | <p><b>X400 Magnification -</b></p> <p>Earliest paint layers.</p> <p>Earliest paint scheme – white paint based on Titanium white.</p> <p>Note: The white may be a primer layer with the grey being the only decorative colour applied. It is likely that the plywood covers the original panelling.</p> |

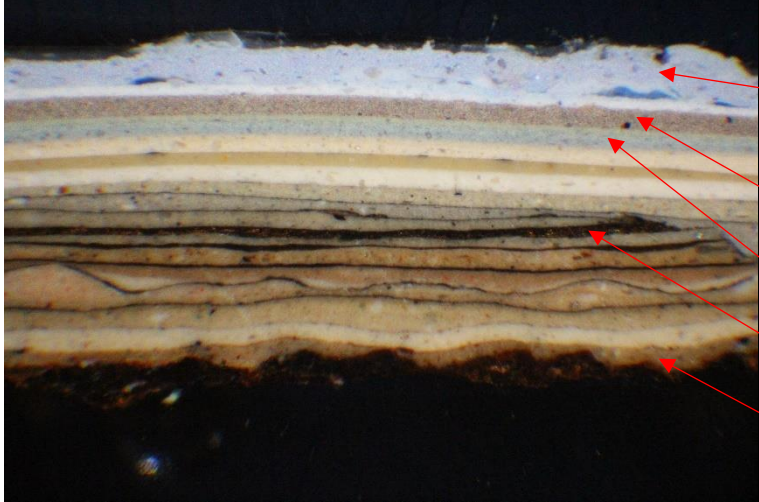
| Sample Ref: 21 | Location: 38 to 42 Mosley Street |
|---|---|
| | <p><b>X50 Magnification –</b></p> <ul style="list-style-type: none"> <li>Current visible paint scheme (blue Portafleck paint).</li> <li>Single brown paint layer.</li> <li>Earlier blue paint layer.</li> <li>Gold paint layer (layer 12).</li> <li>Earliest paint layers.</li> </ul> |

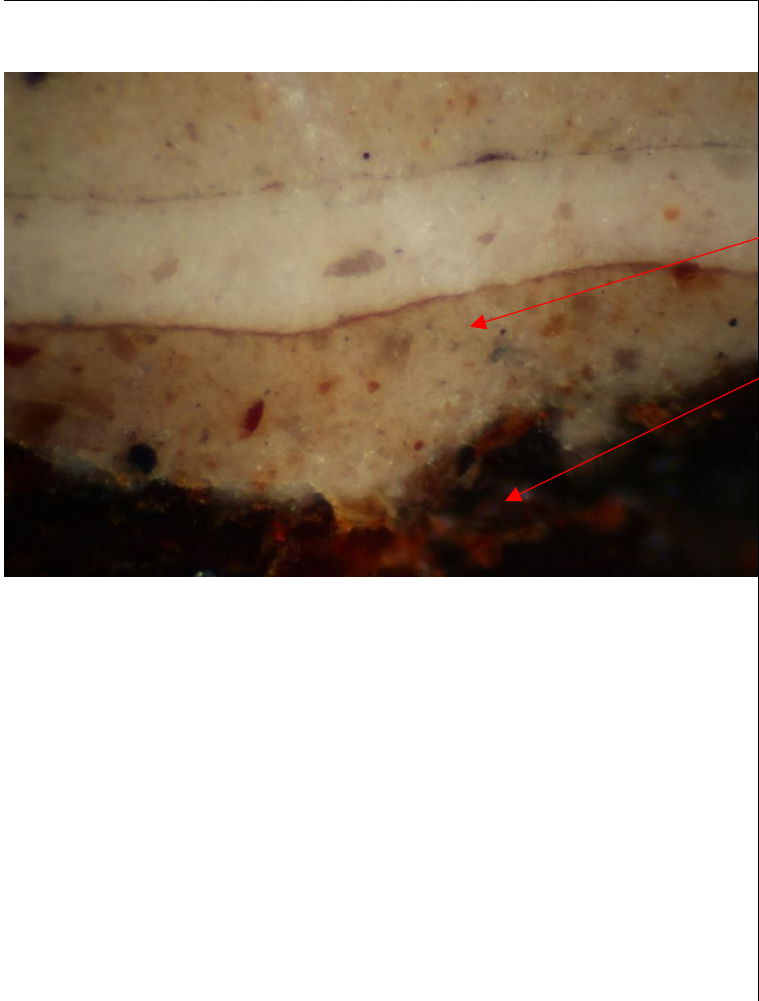
| Sample Ref: 21 | Location: 38 to 42 Mosley Street |
|---|---|
| | <p><b>X400 Magnification -</b></p> <ul style="list-style-type: none"> <li>Earliest paint layers.</li> <li>Earliest paint scheme – off white oil paint based on lead carbonate.</li> <li>Corrosion on surface of the column.</li> </ul> |

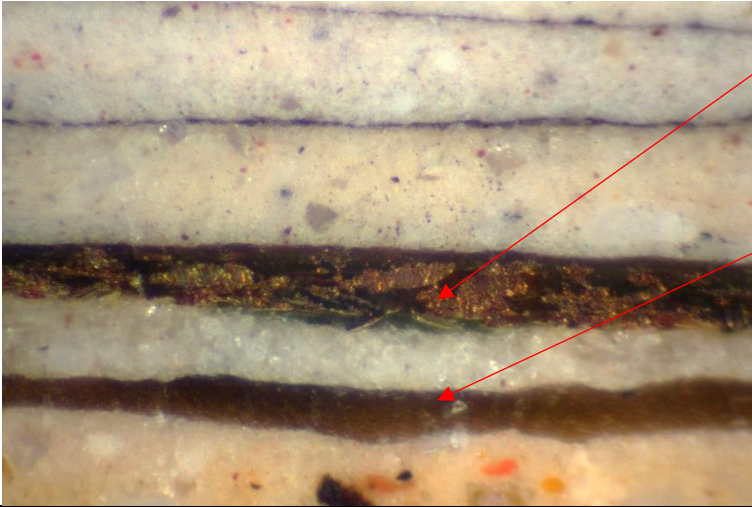
| | <p><b>Detail – 400x Magnification.</b></p> <p>Gold Paint - particles of gold flake within resin (not gilding).</p> <p>Varnish layer on surface of layer 7 – providing a gloss finish.</p> |

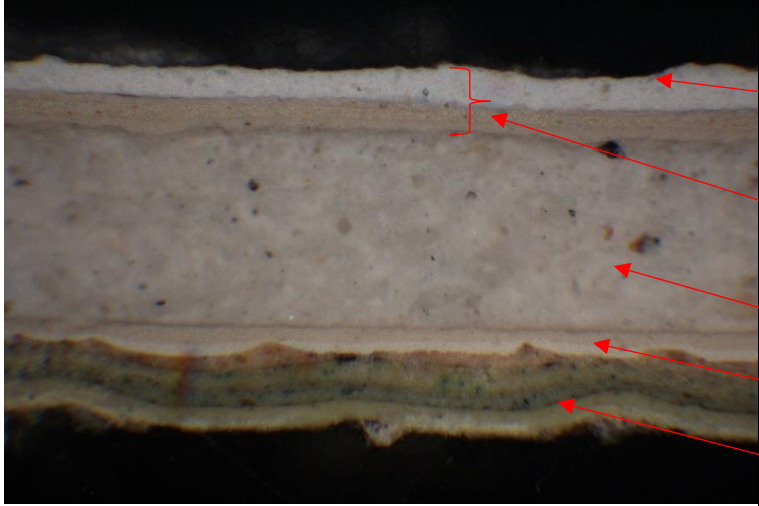
| Sample Ref: 22 | Location: 38 to 42 Mosley Street |
|---|---|
| | <p><b>X50 Magnification –</b></p> <p>Current visible paint scheme (white Portafleck paint).</p> <p>4No modern white and off-white paint layers.</p> <p>Filler</p> <p>2No modern off white paint layers.</p> <p>Earlier decorative schemes</p> |

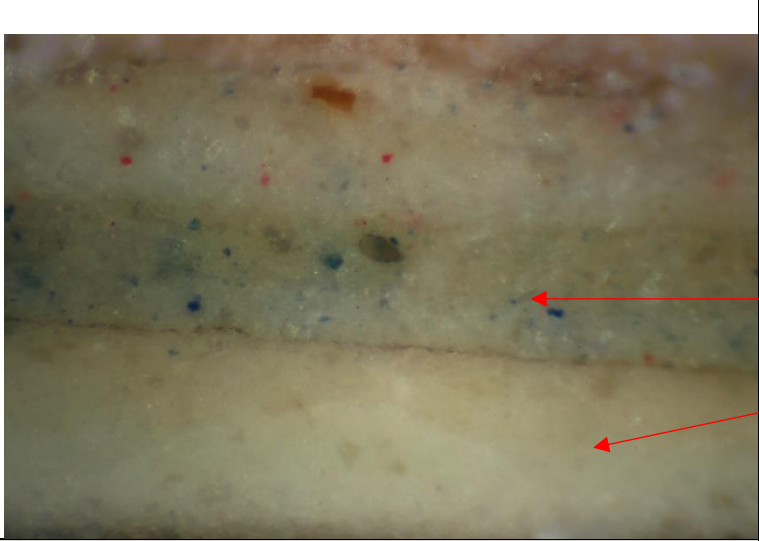
| Sample Ref: 22 | Location: 38 to 42 Mosley Street |
|---|---|
| | <p><b>X400 Magnification -</b></p> <p>Earliest paint layers.</p> <p>Later off-white schemes with blue / green tint.</p> <p>Earliest paint scheme – white paint based on lead carbonate.</p> |

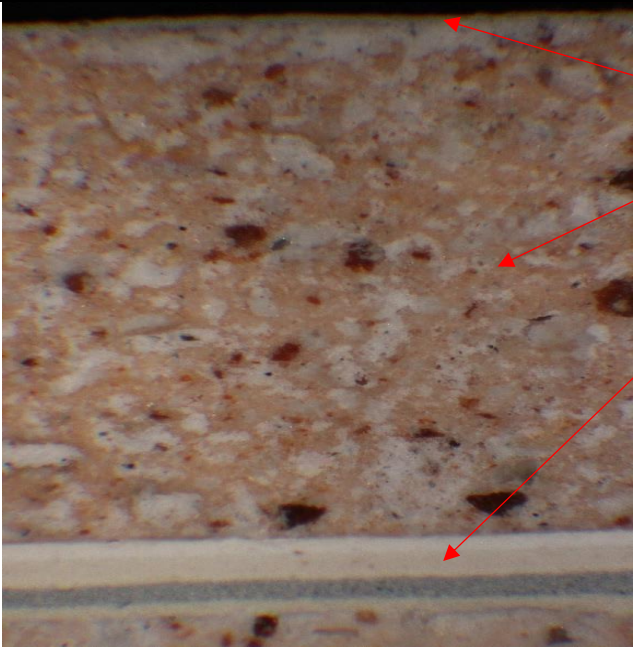
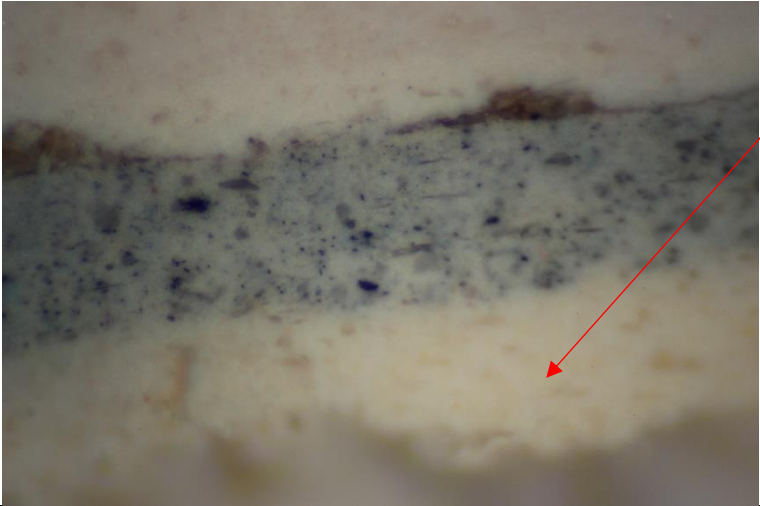
| Sample Ref: 23 | Location: 38 to 42 Mosley Street |
|---|---|
| <br> | <p><b>X50 Magnification –</b><br/>Current visible paint scheme (blue).</p> <p>Modern Gypsum plaster</p> <p>Earlier paint layers – these are all modern and based on Titanium whites.</p> <p>No historic paint layers present.</p><br><p><b>X400 Magnification -</b><br/>Earliest paint layers.</p> <p>Earliest paint scheme – white paint based on Titanium white.</p> |
