## 38 to 42 Mosley Street Paint Analysis

### Report on Findings Report No HPM88MS01

ISSUE 01– 22/12/2024

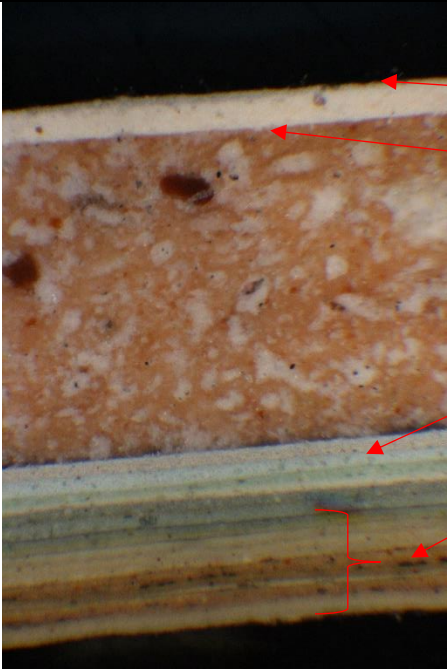
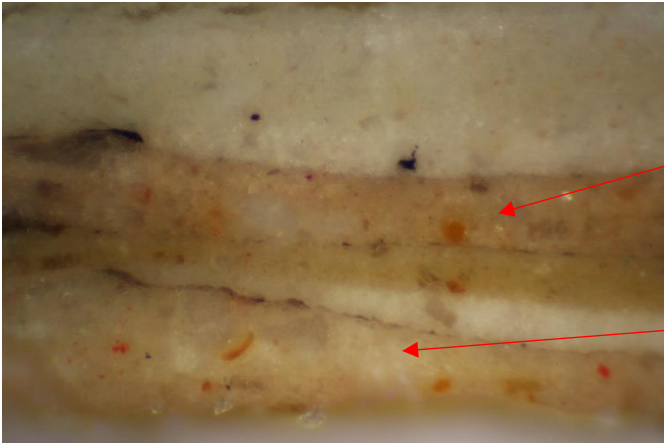
| Sample Ref: 24 | Location: 38 to 42 Mosley Street |
|---|---|
| <br> | <p><b>X50 Magnification –</b><br/>Current visible paint scheme (blue).</p> <p>2No modern paint layers over Gypsum plaster.</p> <p>Modern blue / off-white paint layers based on Titanium white.</p> <p>Historic paint layers.</p><br><p><b>X400 Magnification -</b><br/>Earliest paint layers.</p> <p>Later off white / light stone coloured paint layers.</p> <p>Earliest paint scheme – off white oil paint based on lead carbonate.</p> |

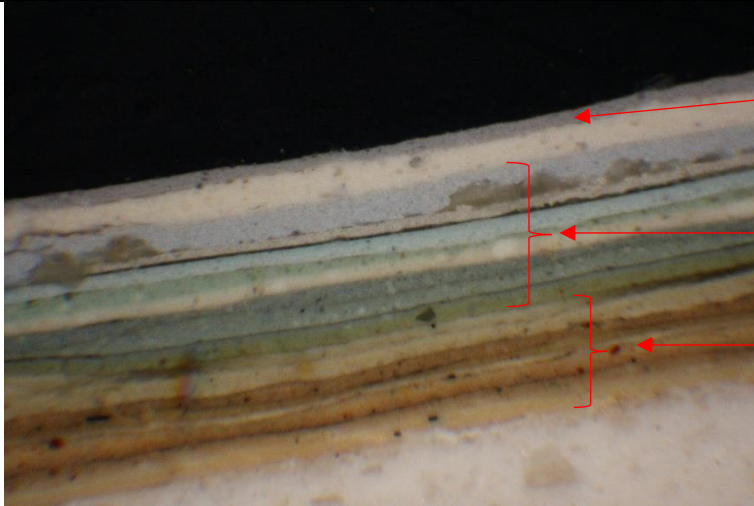
| Sample Ref: 25 | Location: 38 to 42 Mosley Street |
|---|---|
| | <p><b>X50 Magnification –</b><br/>Current visible paint scheme (blue).</p> <p>8 separate blue / green paint layers.</p> <p>Earliest paint layers all based on lead carbonate. Off white oil paint.</p> |

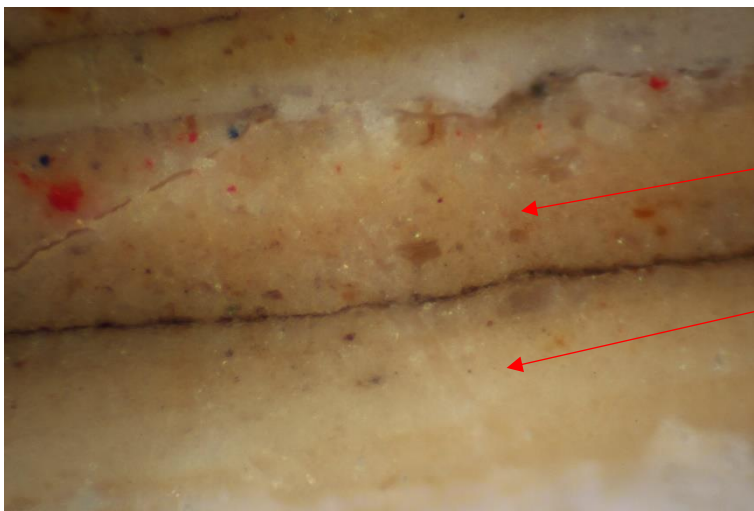
| Sample Ref: 25 | Location: 38 to 42 Mosley Street |
|---|---|
| | <p><b>X400 Magnification -</b><br/>Earliest paint layers.</p> <p>Later off white scheme.</p> <p>Earliest paint scheme – off white / light stone oil paint based on lead carbonate.</p> |

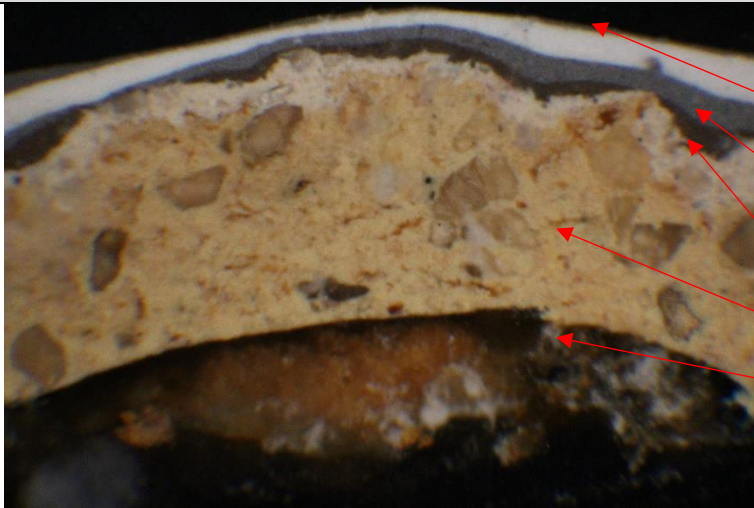
| Sample Ref: 26 | Location: 38 to 42 Mosley Street |
|---|---|
| | <p><b>X50 Magnification –</b></p> <ul style="list-style-type: none"> <li>Current visible paint scheme (grey).</li> <li>Earlier grey paint layer.</li> <li>Dark brown paint layer</li> <li>Granular coating (shelter coat)</li> <li>Tinted resin over stonework.</li> </ul> |
| | <p><b>X400 Magnification -</b></p> <p>Earliest paint layers.</p> <p>Earliest paint scheme – resin / varnish over stonework to base of column.</p> <p>Note: The shelter coating and subsequent paint layers are modern. The roughness of the shelter coating provided a textured look to the column base.</p> |

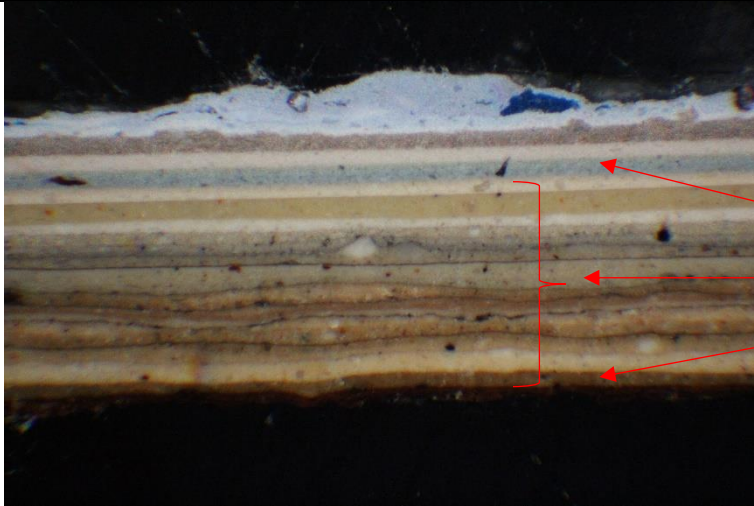
| Sample Ref: 27 | Location: 38 to 42 Mosley Street |
|---|---|
| | <p><b>X50 Magnification –</b><br/>Current visible paint scheme (blue Portafleck paint).</p> <p>Single blue paint layer.</p> <p>17 off-white / stone coloured paint layers.</p> <p>Earliest paint layers.</p> |

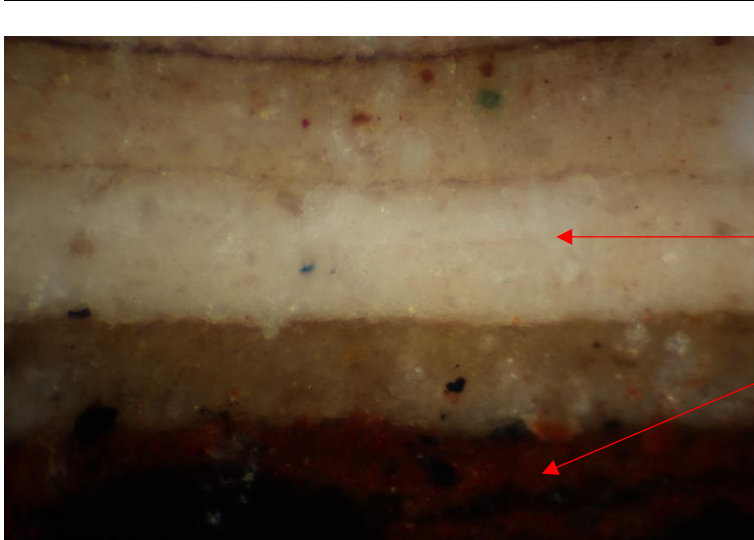
| Sample Ref: 27 | Location: 38 to 42 Mosley Street |
|---|---|
| | <p><b>X400 Magnification -</b><br/>Earliest paint layers.</p> <p>Earliest paint scheme – white paint based on lead carbonate.</p> <p>Corrosion on surface of iron column.</p> |

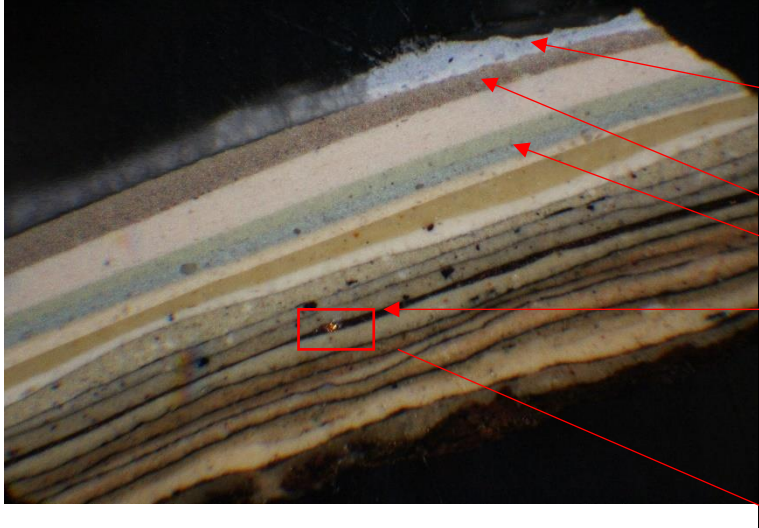
| Sample Ref: 28 | Location: 38 to 42 Mosley Street |
|---|---|
| | <p><b>X50 Magnification –</b></p> <p>Current visible paint scheme (blue Portafleck paint).</p> <p>Single brown paint layer.</p> <p>Single green and blue paint layers</p> <p>Gold paint layer.</p> <p>15 white / off white historic paint layers (lead carbonate based) some with varnish finish.</p> |

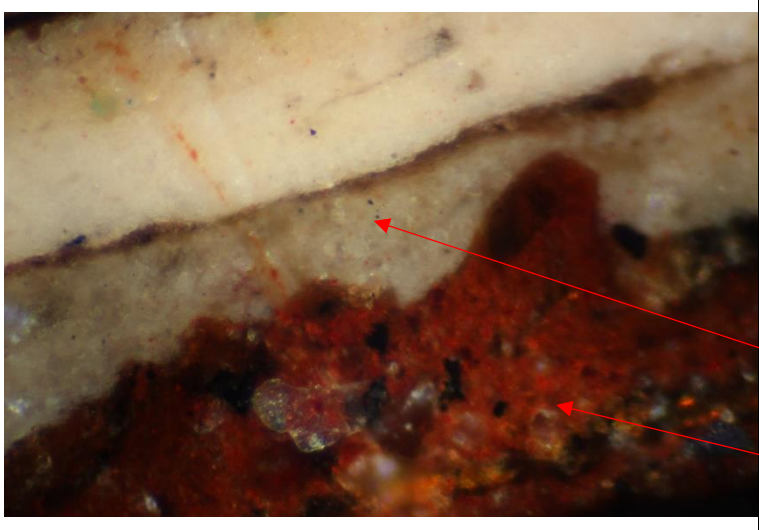
| Sample Ref: 28 | Location: 38 to 42 Mosley Street |
|---|---|
| | <p><b>X400 Magnification -</b></p> <p>Earliest paint layers.</p> <p>Earliest paint scheme – white oil paint based on lead carbonate.</p> <p>Iron oxide paint layer over iron corrosion.</p> |
| <p>Early schemes tested for lead</p> <p>Yes – evidence early lead based paints present.</p> <p>(Lead bearing paint layers noted in black).</p> <p>12 of the 13 earliest paints are based on lead carbonate.</p> | |

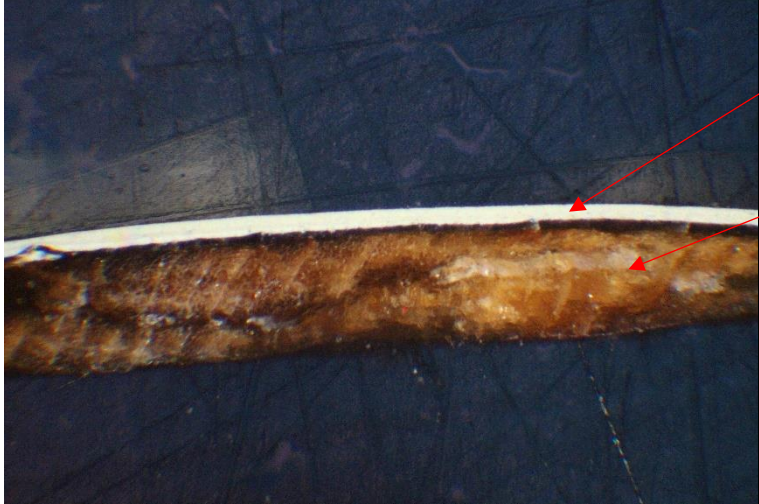
| Sample Ref: 29 | Location: 38 to 42 Mosley Street |
|---|---|
| | <p><b>X50 Magnification –</b><br/>Current visible paint scheme (light green).</p> <p>Timber panel.</p> <p>Note: The timber panel was originally varnished but this has been overcoated with a modern light green alkyd paint system.</p> |
| | <p><b>X400 Magnification -</b><br/>Earliest paint layers.</p> <p>2No Modern light green paint layers based on Titanium white.</p> <p>White primer.</p> <p>Tinted varnish over timberwork.</p> |

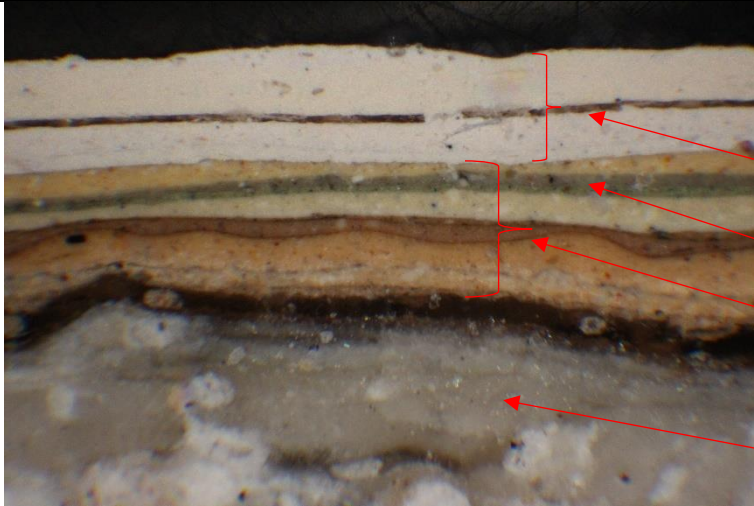
Stair wall brickwork (sample 30) – The brickwork wall was originally decorated in white lime washes. It is difficult to determine the exact number of coats that were applied as lime is particularly unstable especially in slightly damp conditions. 7 separate lime wash coatings are noted in the sample although it is likely that the actual number was greater than this. After the lime washes stone coloured paints were used on three occasions before moving to light green colours. Modern Titanium white paints were then used for the final two decorations.

| Sample Ref: 30 | Location: 38 to 42 Mosley Street |
|---|---|
| | <p><b>X50 Magnification –</b><br/>Current visible paint scheme (off white).<br/>Modern Titanium white paint layers.</p> <p>Single green paint layer.</p> <p>Off white and stone coloured paint layers (majority being lead carbonate based).</p> <p>Early lime wash paint layers (min 7 but likely to be more)</p> |

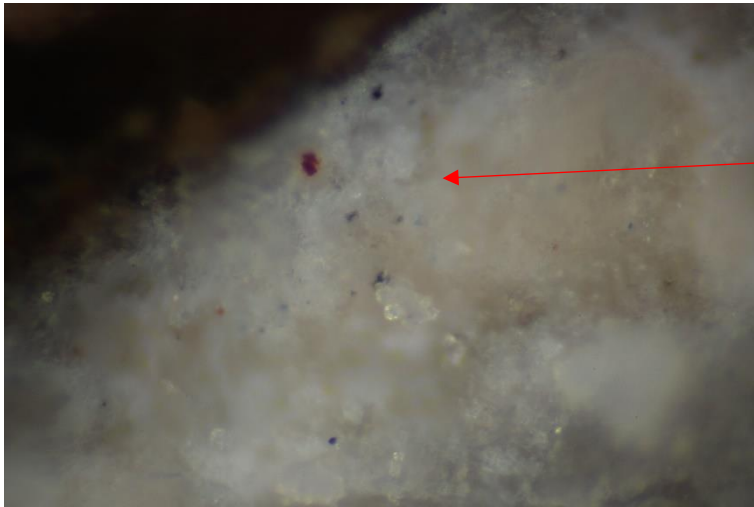
| Sample Ref: 30 | Location: 38 to 42 Mosley Street |
|---|---|
| | <p><b>X400 Magnification -</b><br/>Earliest paint layers.</p> <p>Earliest paint scheme – white lime wash paint coatings.</p> <p>Note: Lime washes were regularly applied and were often unstable so actual number of layers is difficult to determine.</p> |

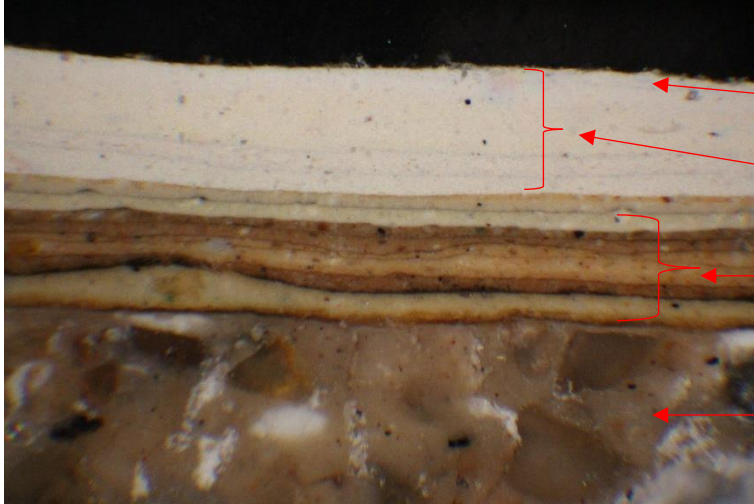
| Sample Ref: 31 | Location: 38 to 42 Mosley Street |
|---|---|
| | <p><b>X50 Magnification –</b></p> <p>Current visible paint scheme (white).</p> <p>4 No modern paint layers based on Titanium white.</p> <p>7 No off white / light stone paint layers based on lead carbonate.</p> <p>Lime plaster</p> |

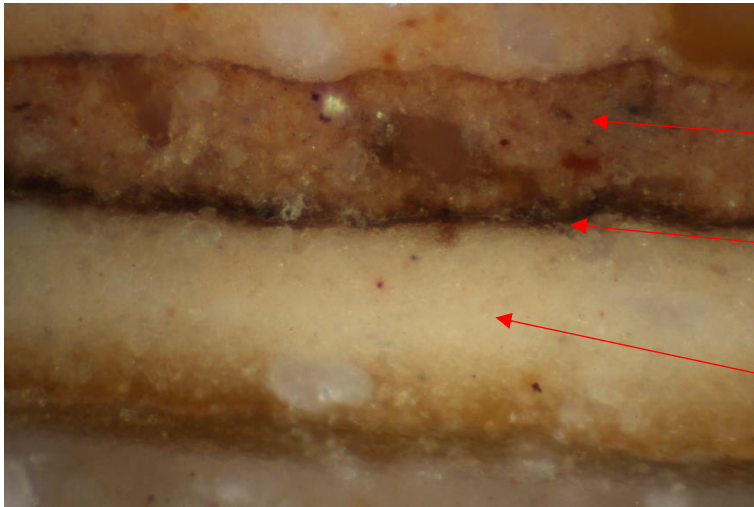
| Sample Ref: 31 | Location: 38 to 42 Mosley Street |
|---|---|
| | <p><b>X400 Magnification -</b></p> <p>Earliest paint layers.</p> <p>Later light stone coloured paint layer.</p> <p>Thick dirt layer on surface of the paintwork.</p> <p>Earliest paint scheme – white paint based on lead carbonate.</p> |

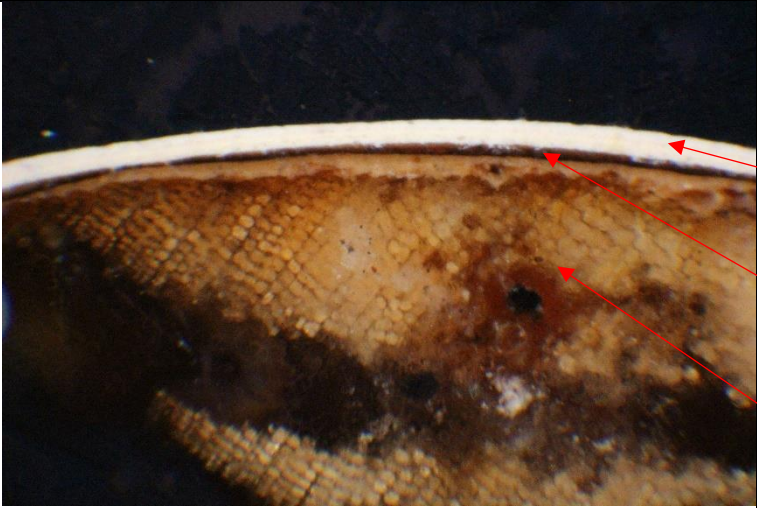
| Sample Ref: 32 | Location: 38 to 42 Mosley Street |
|---|---|
| | <p><b>X50 Magnification –</b><br/>Current visible paint scheme (white).</p> <p>3No layers of modern Titanium white alkyd paints.</p> <p>Tinted resin varnish over stone coloured paint. (providing a timber gaining appearance).</p> <p>Timber</p> |
| | <p><b>X400 Magnification -</b><br/>Earliest paint layers.</p> <p>Earliest paint scheme – tinted varnish over stone coloured paint based on lead carbonate.</p> <p>Note: The original appearance of the timberwork would have been of a slightly grained hardwood.</p> |

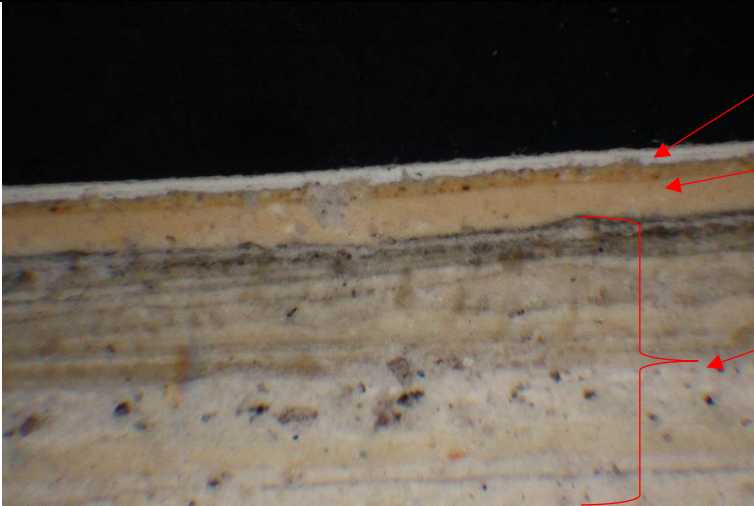
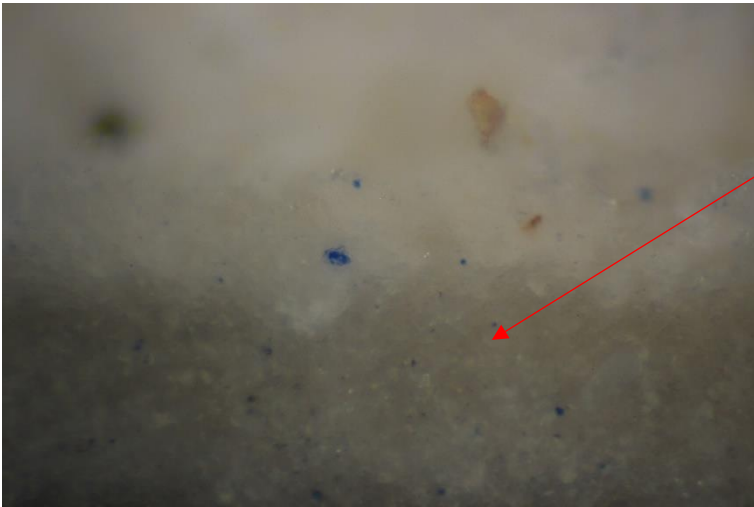
| Sample Ref: 33 | Location: 38 to 42 Mosley Street |
|---|---|
| <br> | <p><b>X50 Magnification –</b><br/>Current visible paint scheme (white).</p> <p>2No stone coloured paint layers.</p> <p>18+ layers of white limewash paint coatings.</p><br><p><b>X400 Magnification -</b><br/>Earliest paint layers.</p> <p>Earliest paint scheme – white lime wash paint.</p> |

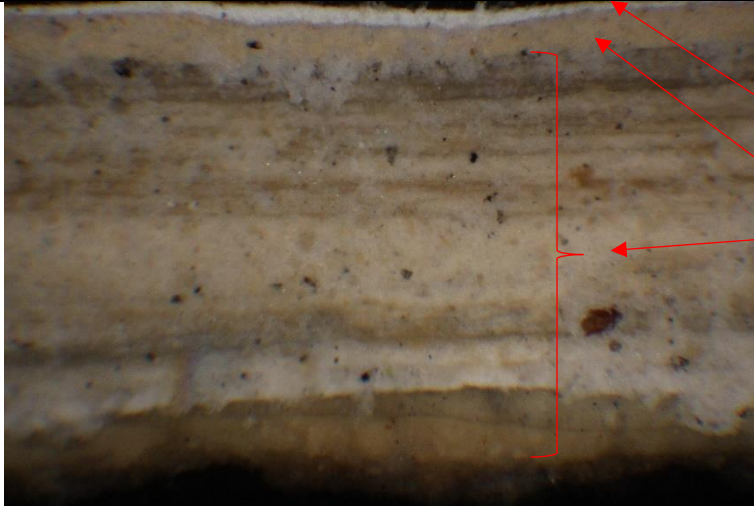
| Sample Ref: 34 | Location: 38 to 42 Mosley Street |
|---|---|
| | <p><b>X50 Magnification –</b><br/>Current visible paint scheme (white).</p> <p>Single stone coloured paint layer.</p> <p>18+ layers of limewash paint coatings.</p> <p>Earliest paint coatings</p> |
| | <p><b>X400 Magnification -</b><br/>Earliest paint layers.</p> <p>Earliest paint scheme – white lime wash.</p> |

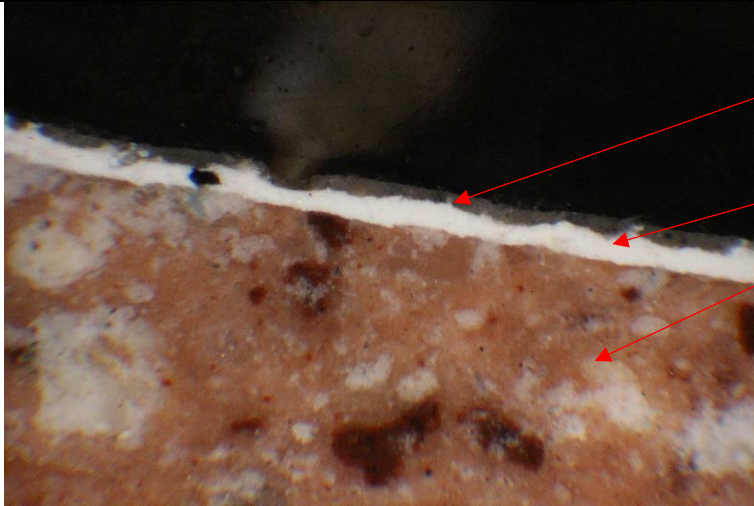
| Sample Ref: 35 | Location: 38 to 42 Mosley Street |
|---|---|
| | <p><b>X50 Magnification –</b><br/>Current visible paint scheme (off white).</p> <p>Modern white paint coating.</p> <p>Modern gypsum plaster.</p> |
| | <p><b>X400 Magnification -</b><br/>Earliest paint layers.</p> <p>Earliest paint scheme – modern white paint based on Titanium white.</p> |

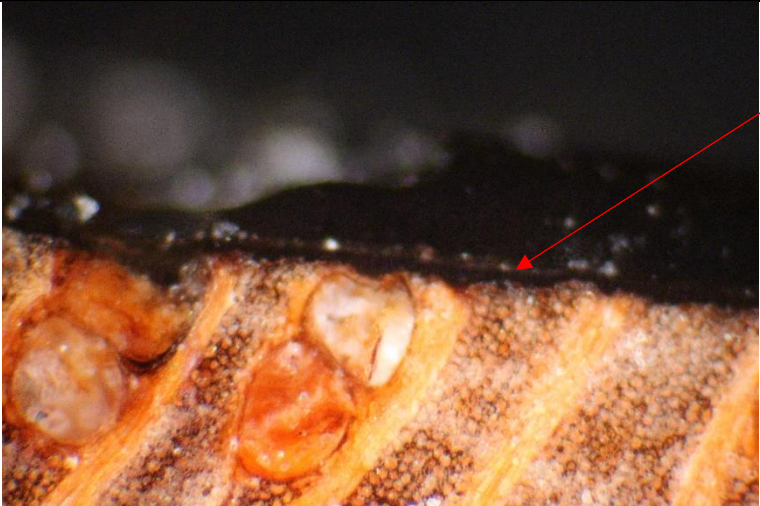
Skirting (sample 36) – A small sample was taken from the timber skirting and this indicated that only one varnish coating had been applied to the skirting element. It is possible that the skirting was also replaced as part of the works to replace the floor structure within the room.

| Sample Ref: 36 | Location: 38 to 42 Mosley Street |
|---|---|
| | <p><b>X100 Magnification –</b><br/>Current visible paint scheme – varnish layer over hardwood timber.</p> <p>Note: This is a single varnish layer over a timber skirting section.</p> |
| | <p><b>X400 Magnification -</b><br/>Earliest paint layers.</p> <p>Earliest decorative scheme – tinted varnish over hardwood timber.</p> |
