| NORTH MANCHESTER GENERAL HOSPITAL | | | | | | |
| FINISHED LEVELS AND EARTHWORK VOLUMES | | | | | | |

EXTERNAL WORKS PLAN

## *Appendix B      Field reconnaissance photographs*

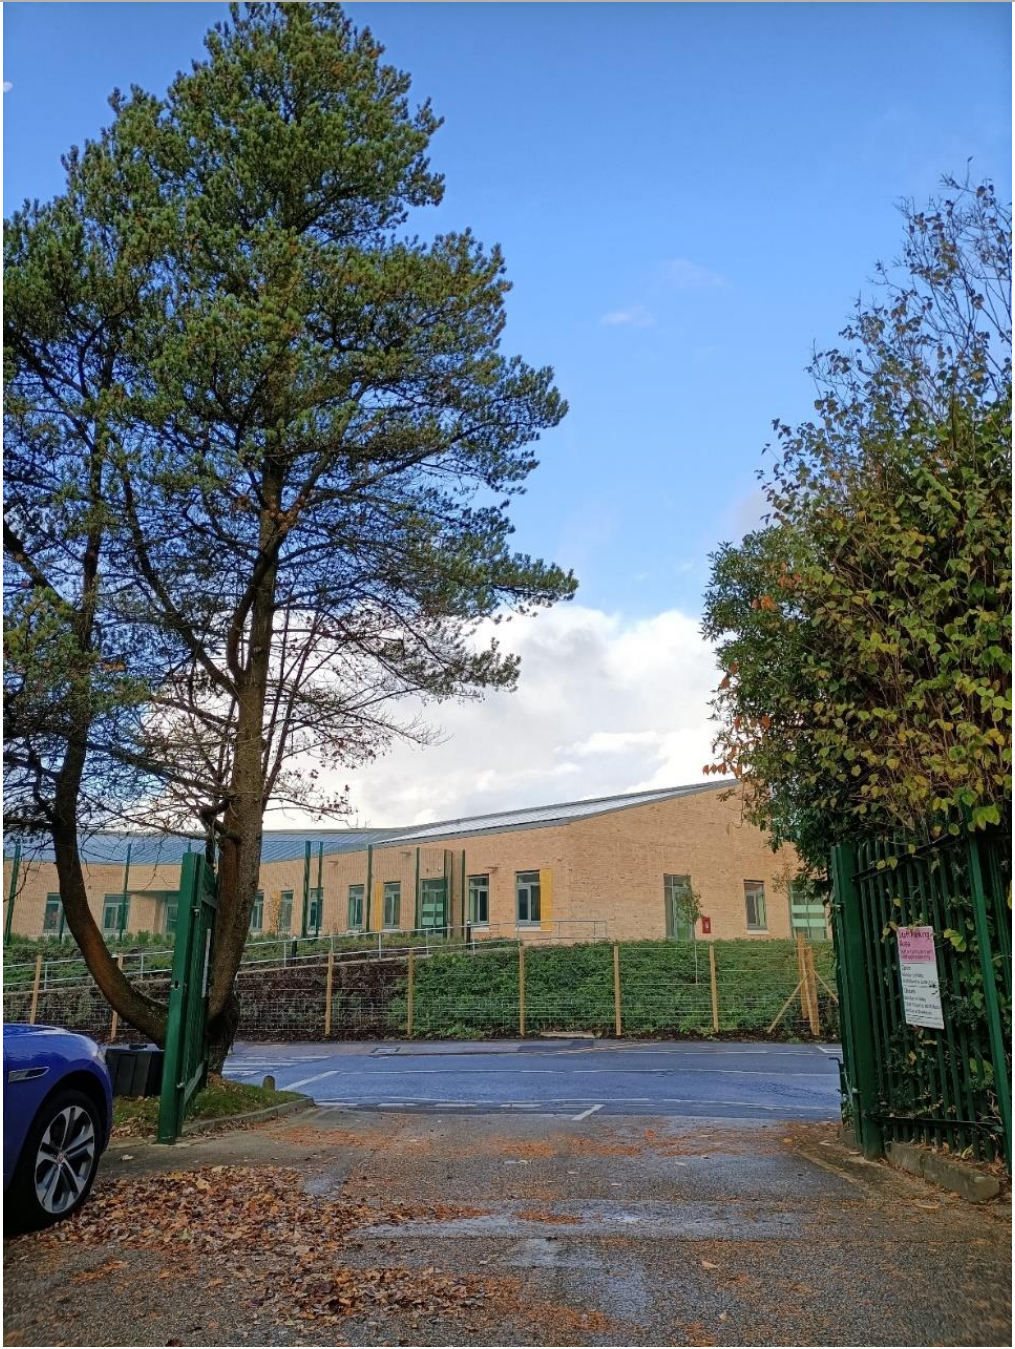
| <b>Photograph 1</b> | |

| <b>Description:</b><br>Access point to<br>car park site from<br>Crescent Drive. | |

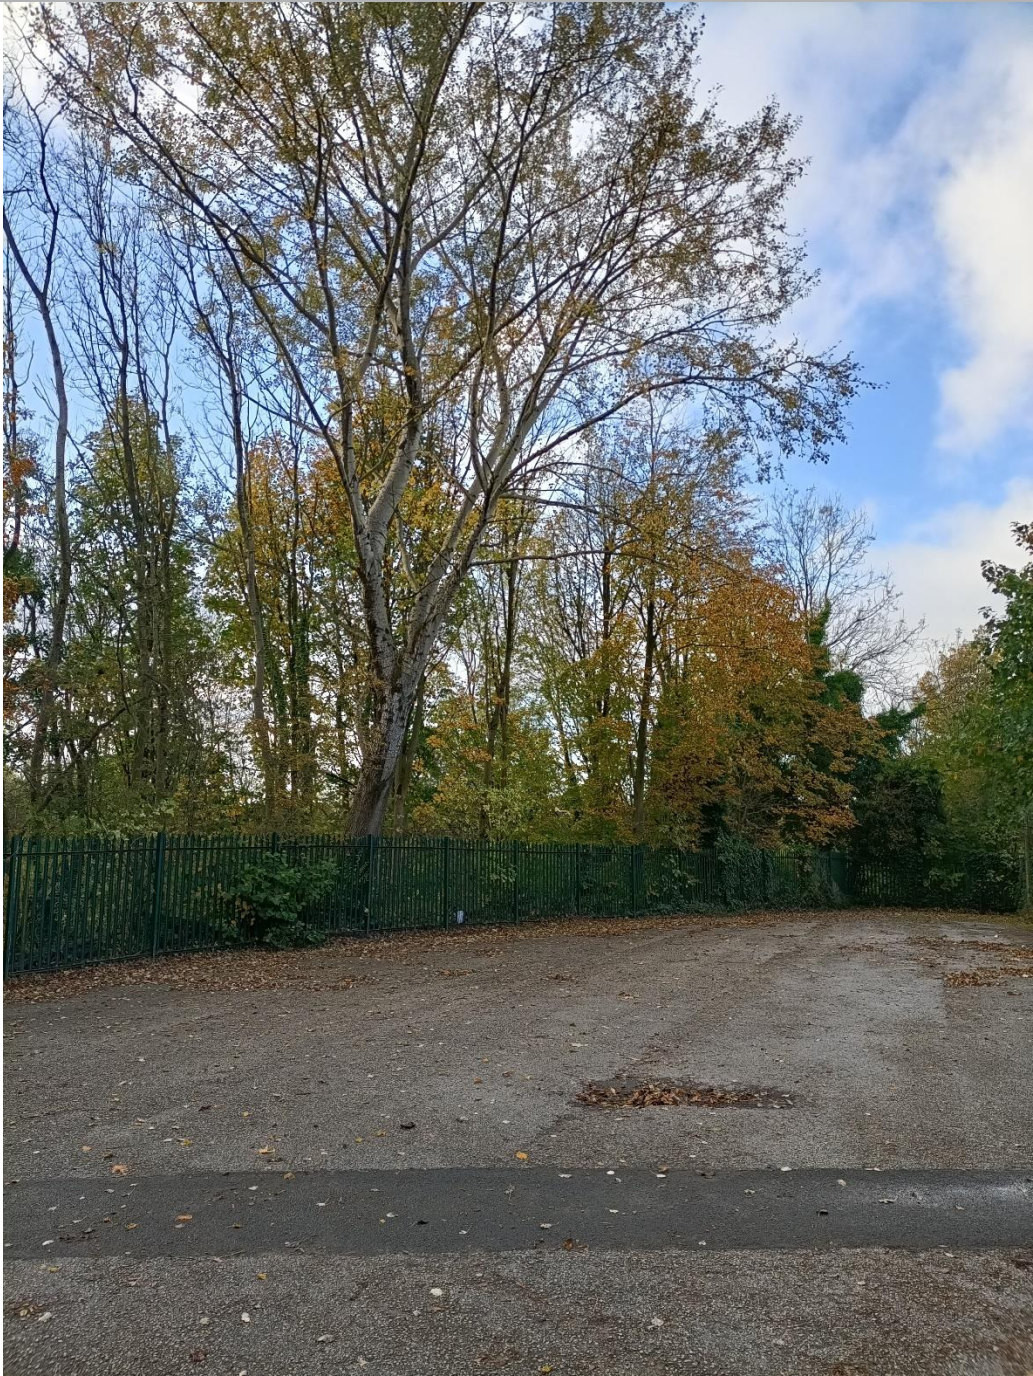
| <b>Photograph 2</b> | |

| <b>Description:</b> Linear scarring in tarmac car park surface suggesting that utilities lie below (assumed gas main, pressure unknown). | |

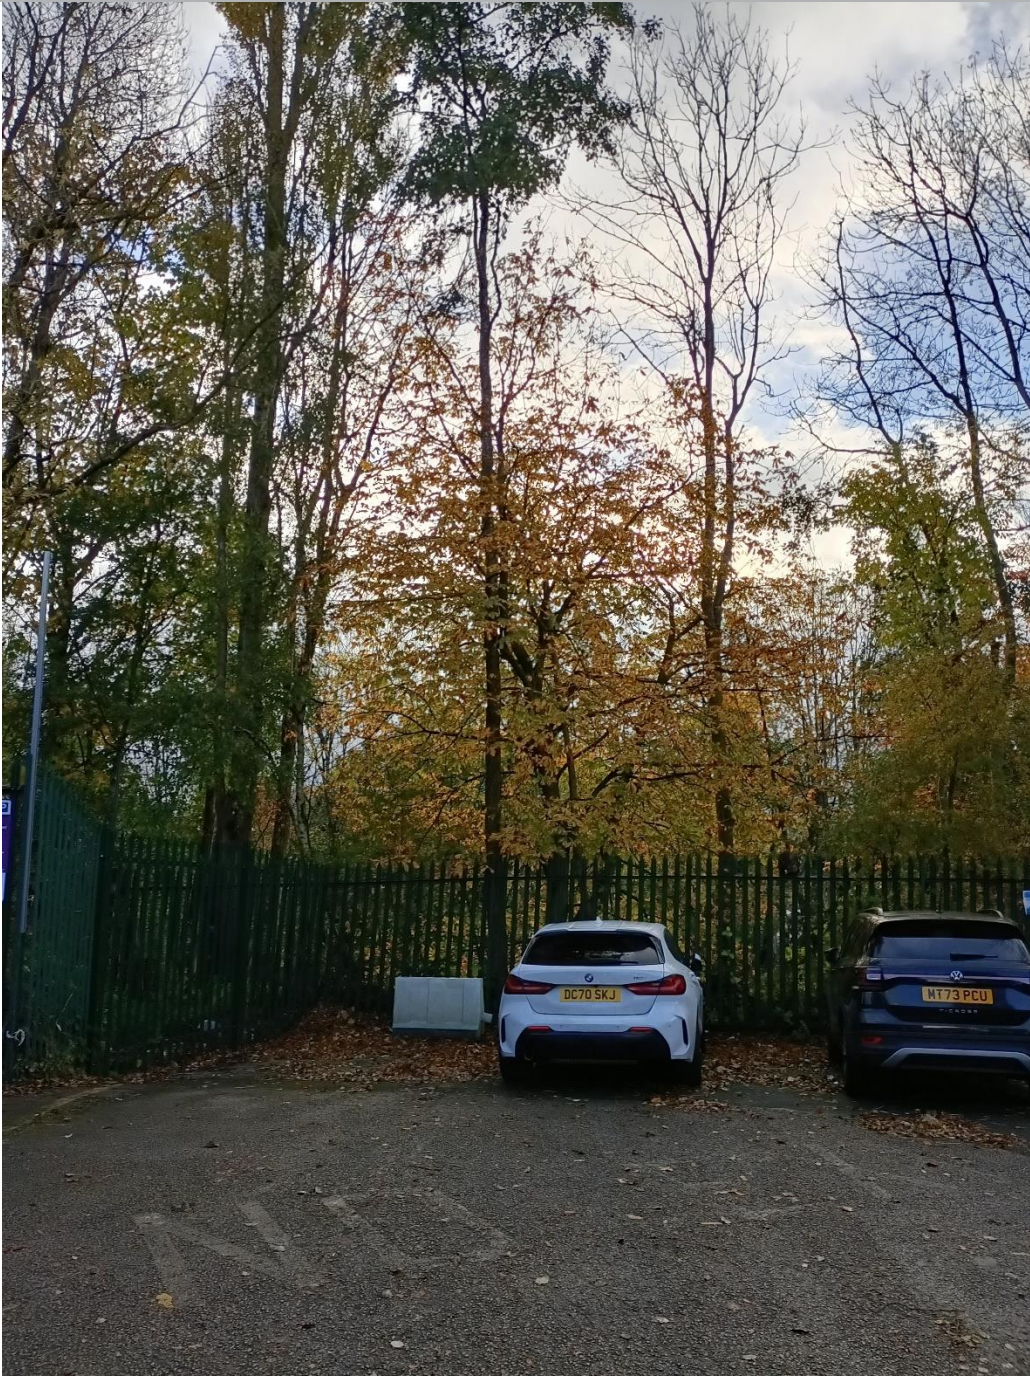
| Photograph 3 | |

| Description:<br>Western car park,<br>surrounded by<br>mature treeline. | |

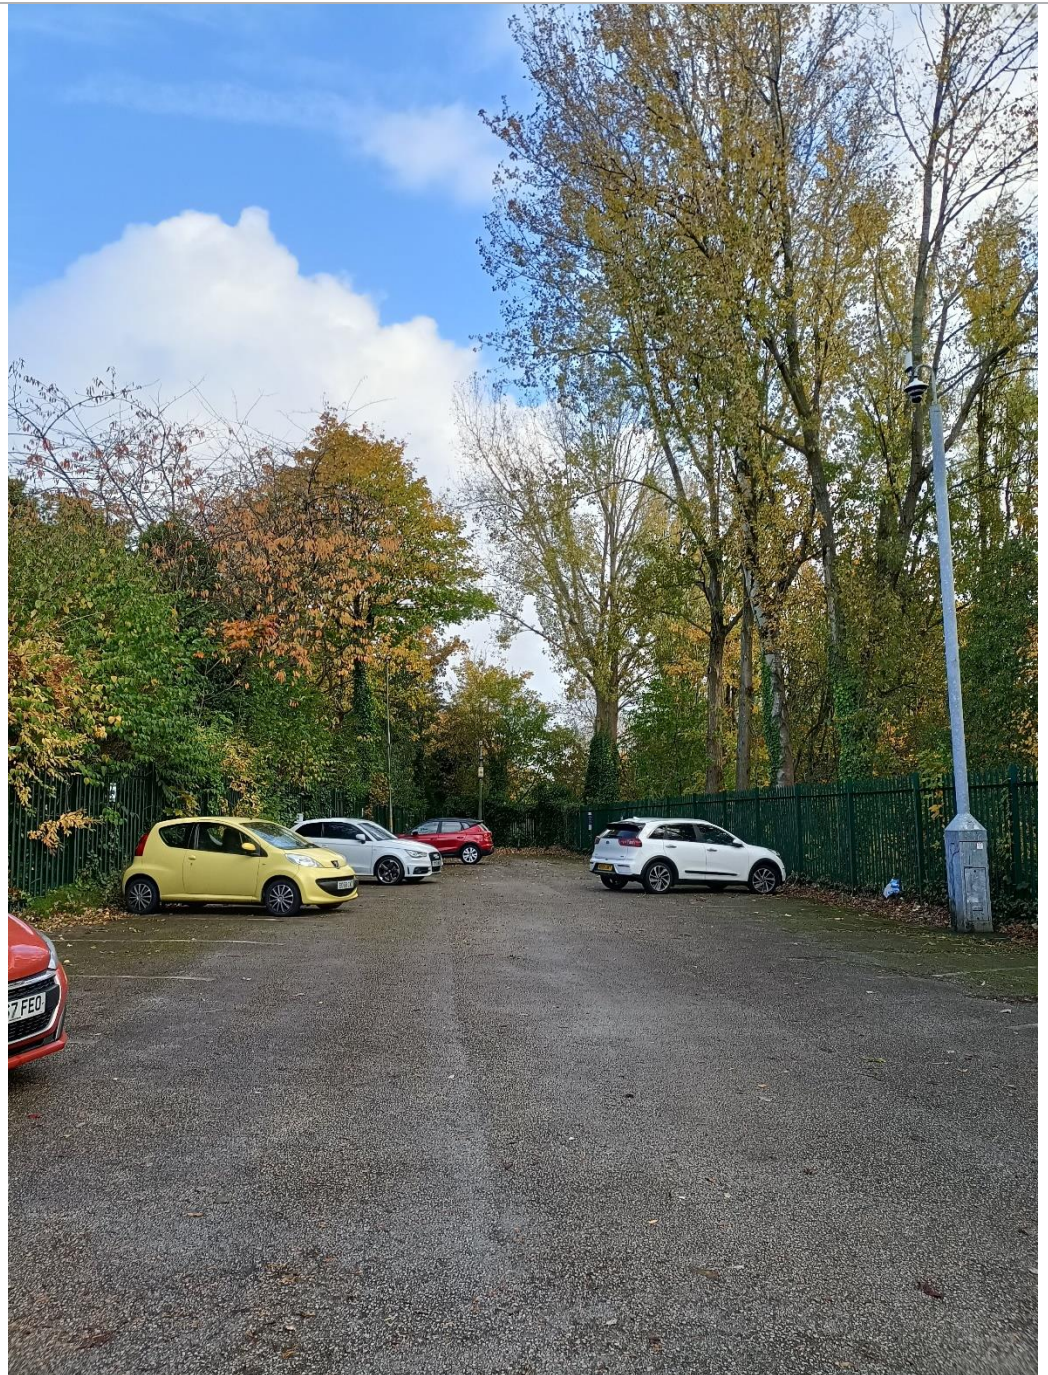
Photograph 4

Description: View  
looking north-east  
across the car  
park adjacent to  
Crescent Drive.

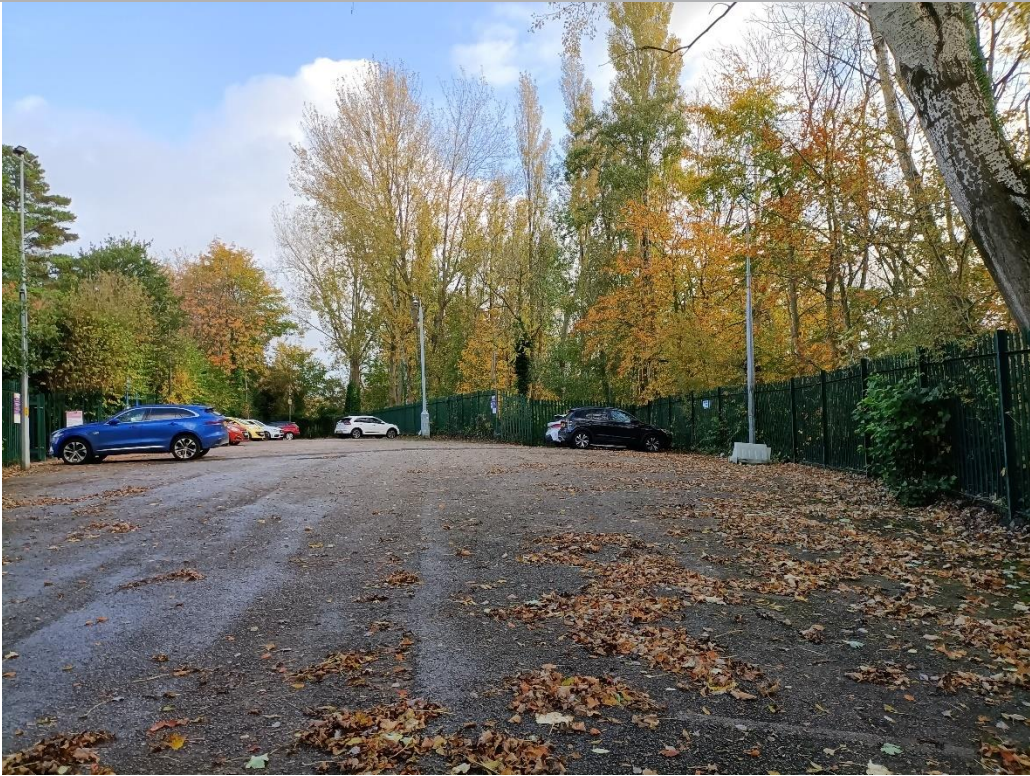
| Photograph 5 | |

| Description: Site<br>levels in the<br>western car park<br>are generally<br>level. | |

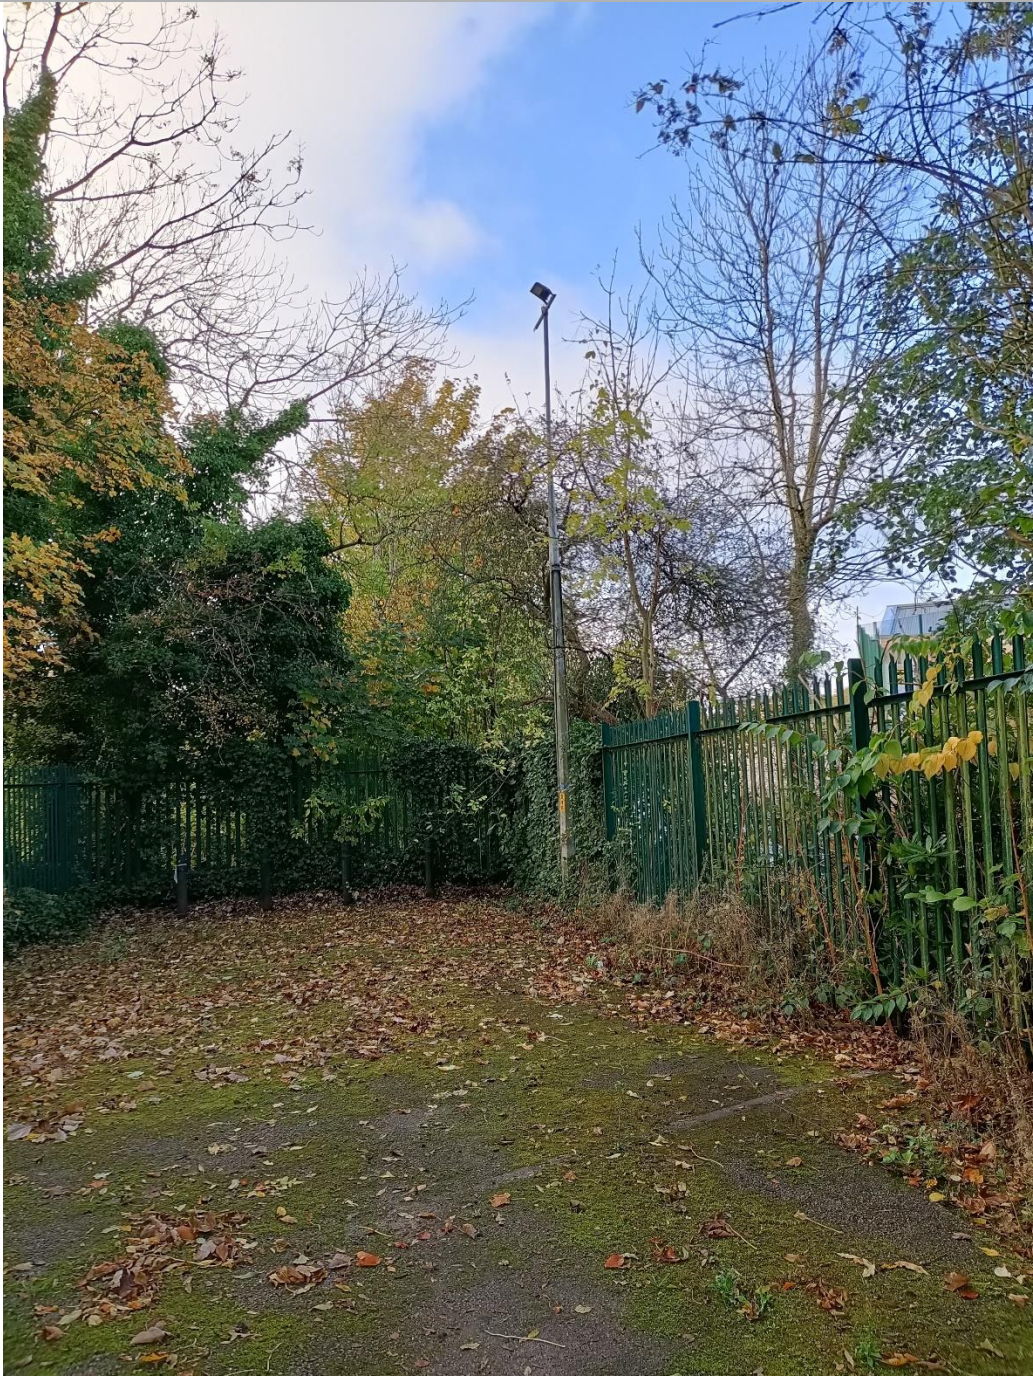
| Photograph 6 | |

| Description:<br>Southern area of<br>car park adjacent<br>to Crescent Drive,<br>surrounded by<br>c.2m high fence<br>line and mature<br>trees. | |

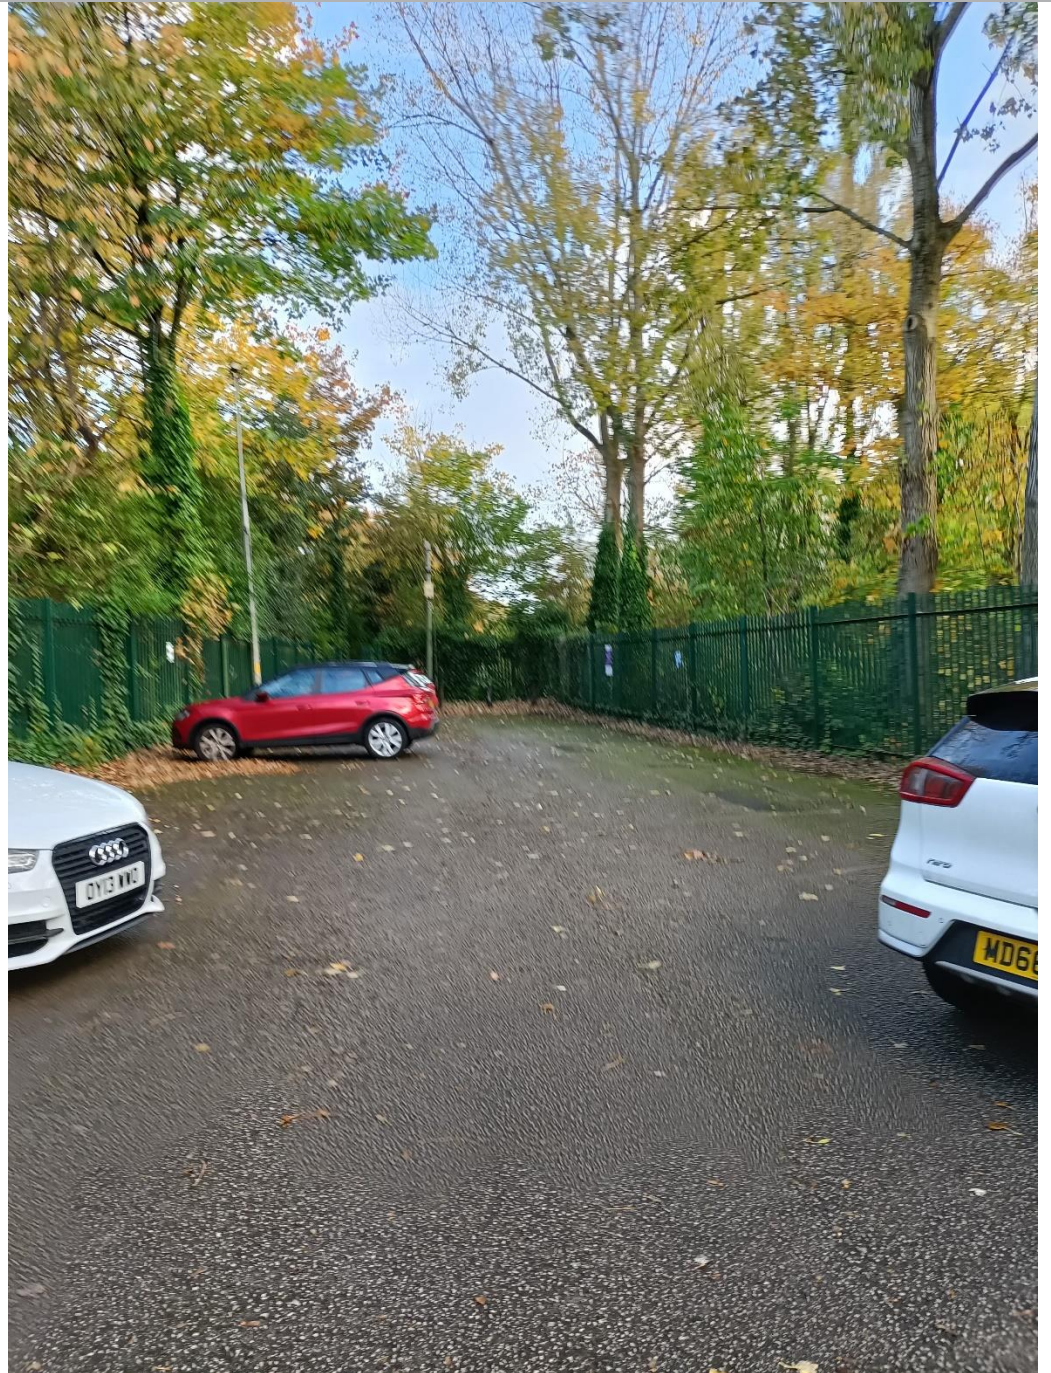
Photograph 7

Description: View  
to the north of the  
car park adjacent  
to Crescent Drive.

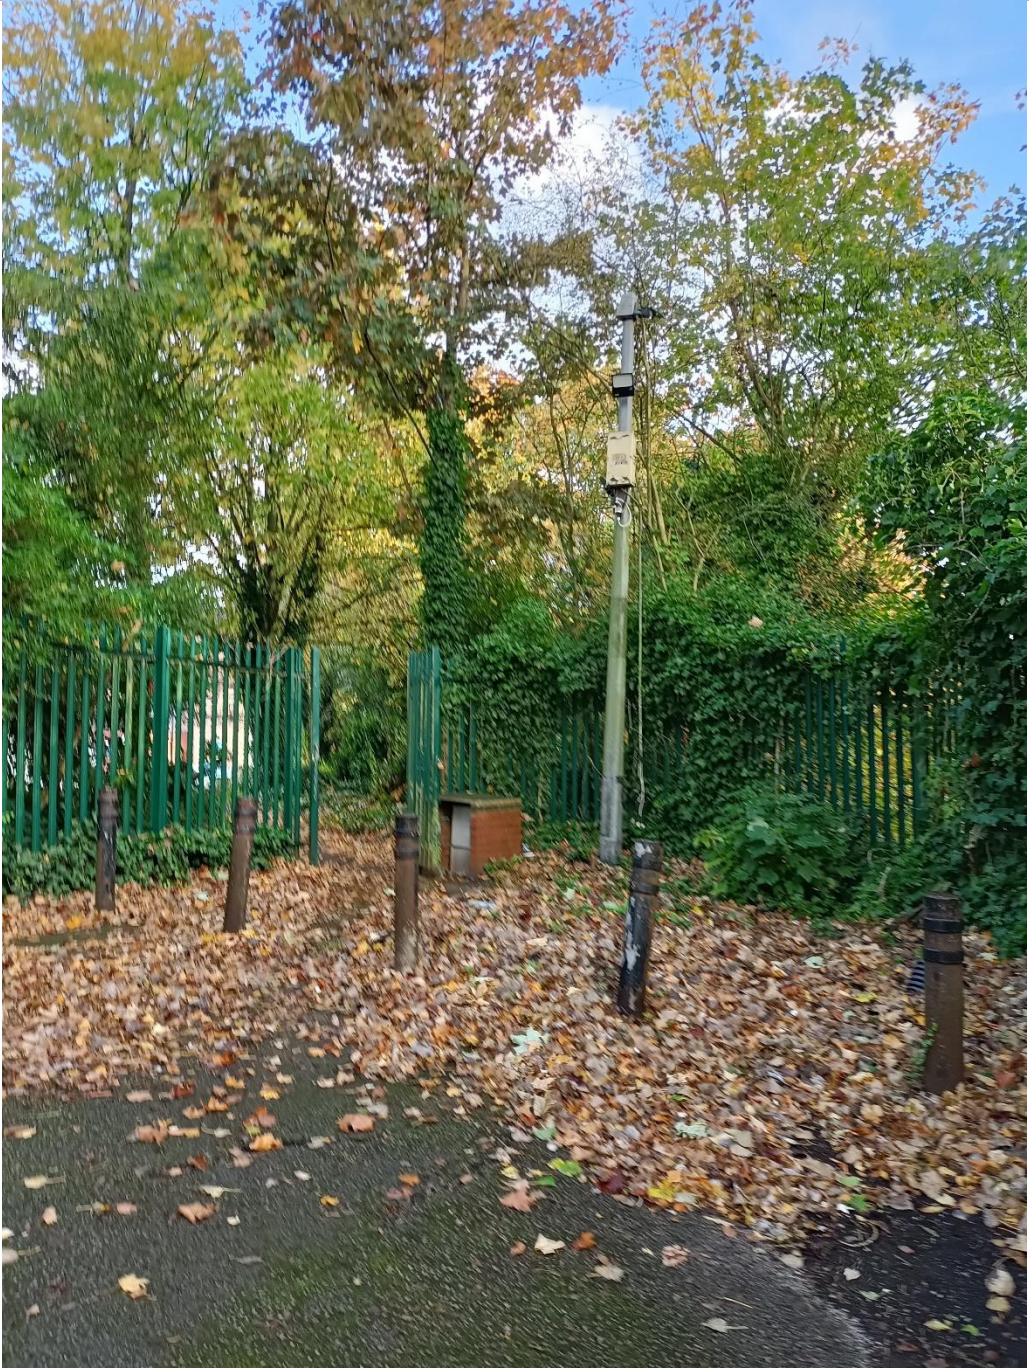
| Photograph 8 | |

| Description:<br>Utilities in the<br>north of the car<br>park. | |

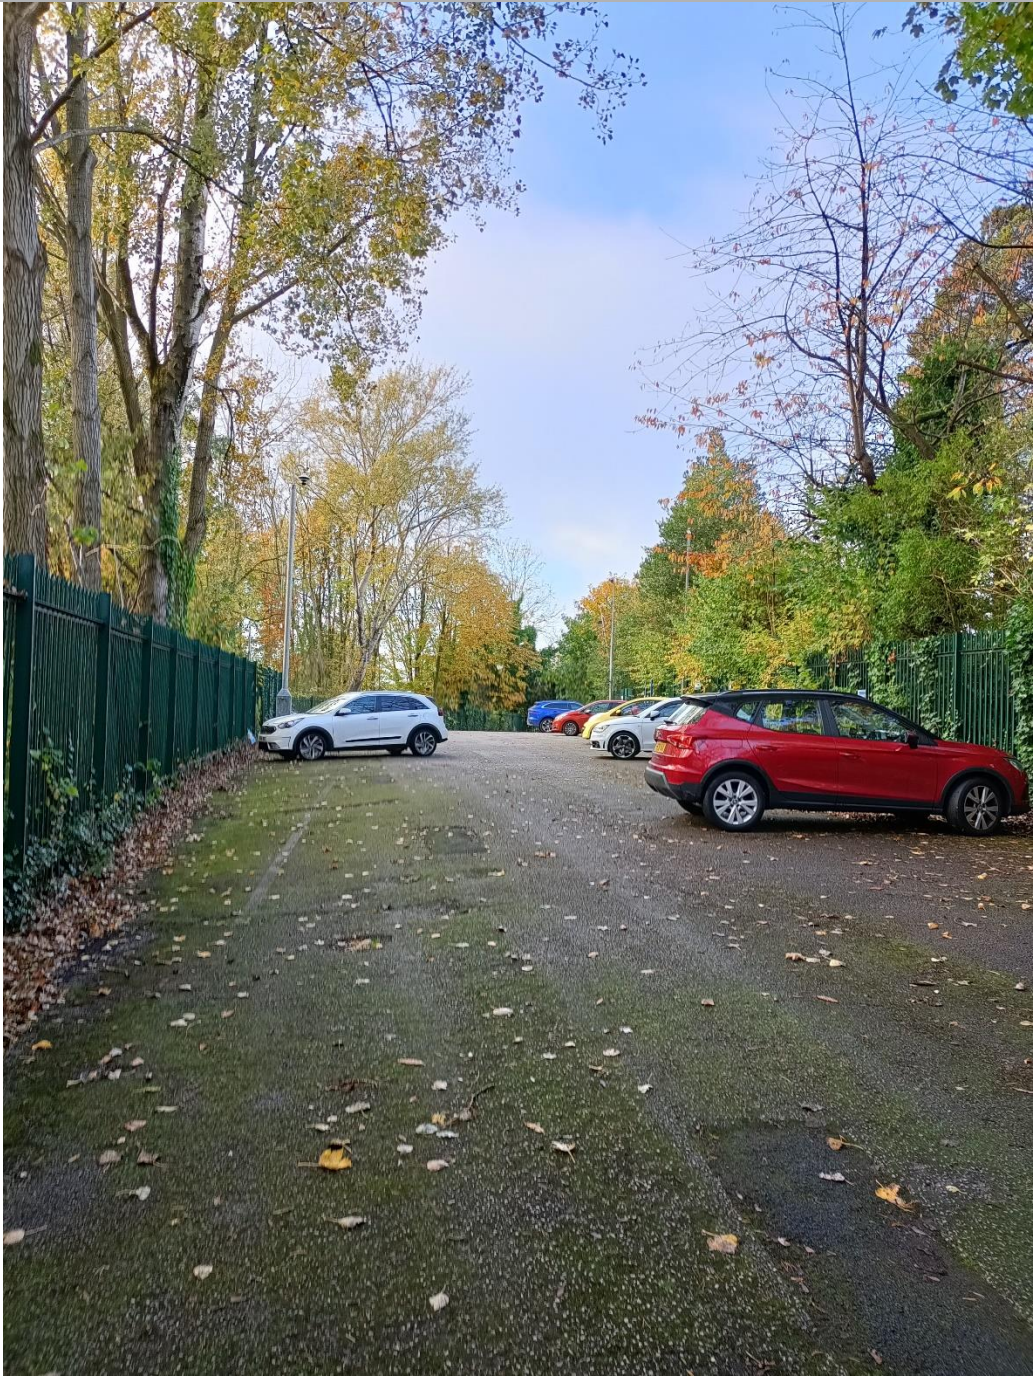
| Photograph 9 | |

| Description:<br>Visible patching of<br>the tarmacadam<br>surface, which is<br>generally in poor<br>condition. | |

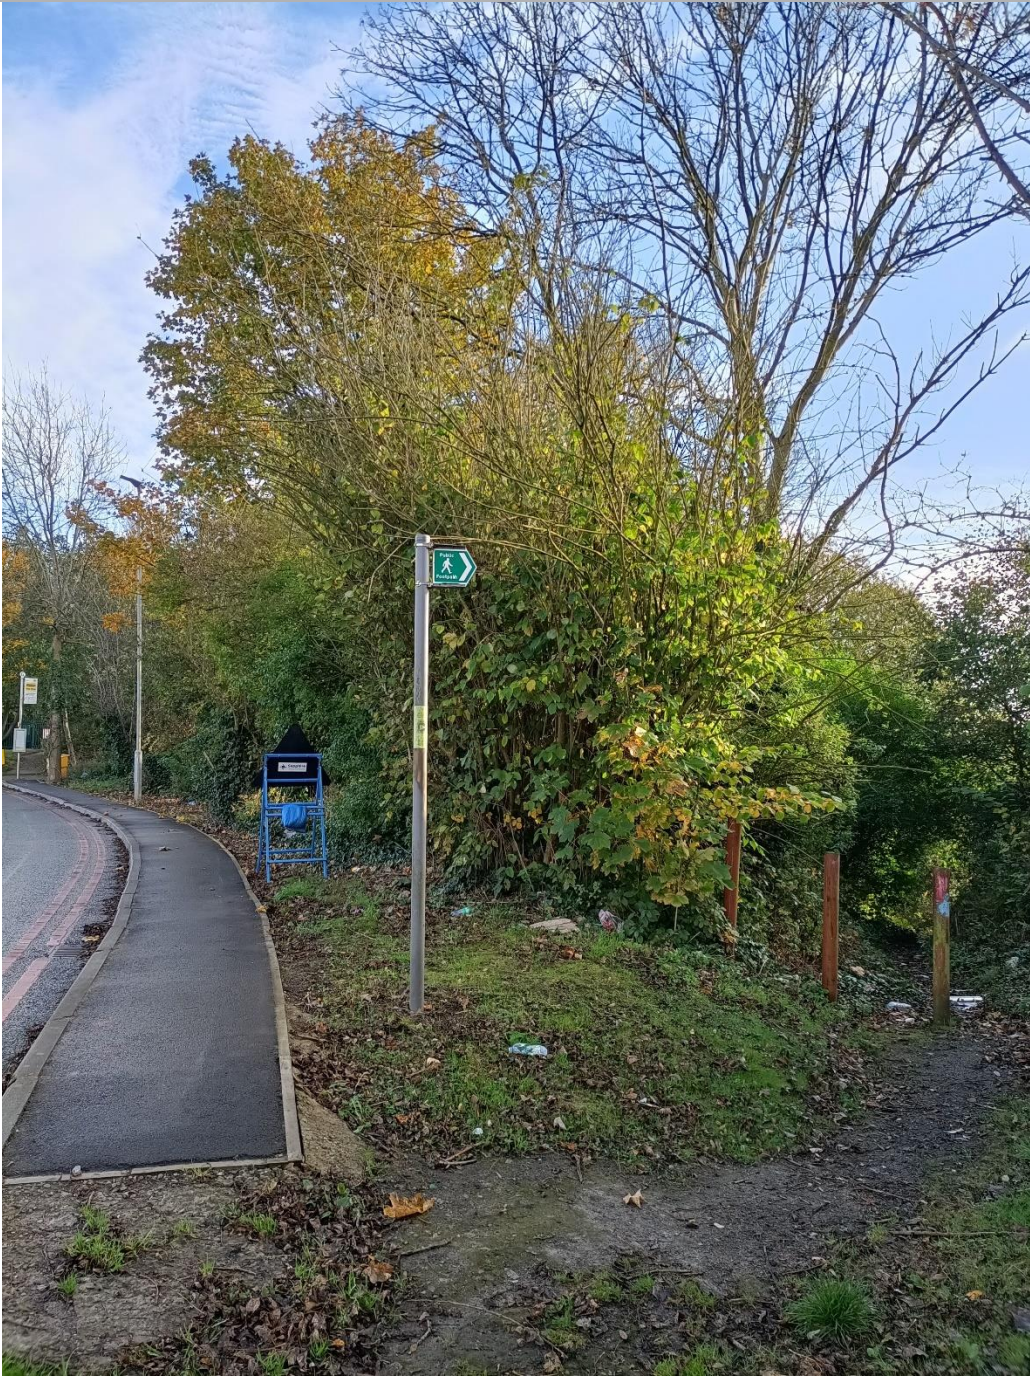
| Photograph 10 | |

| Description: Public<br>footpath that runs<br>adjacent to the<br>wider Ground<br>Investigation site. | |

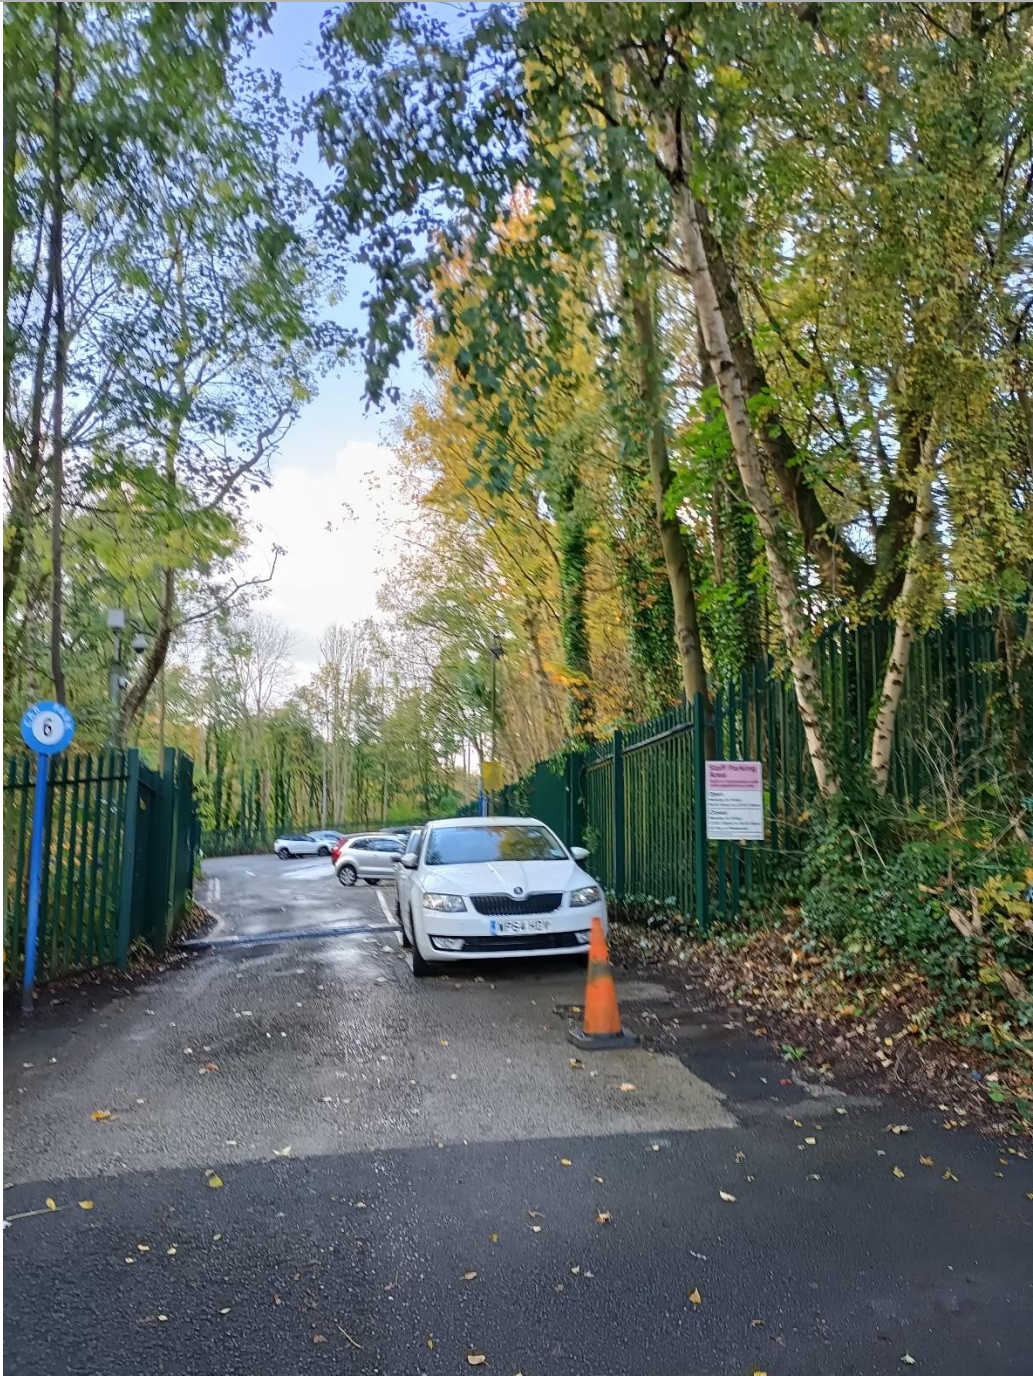
| Description:<br>Entrance to<br>northern car park<br>(east of desk<br>study area). | |

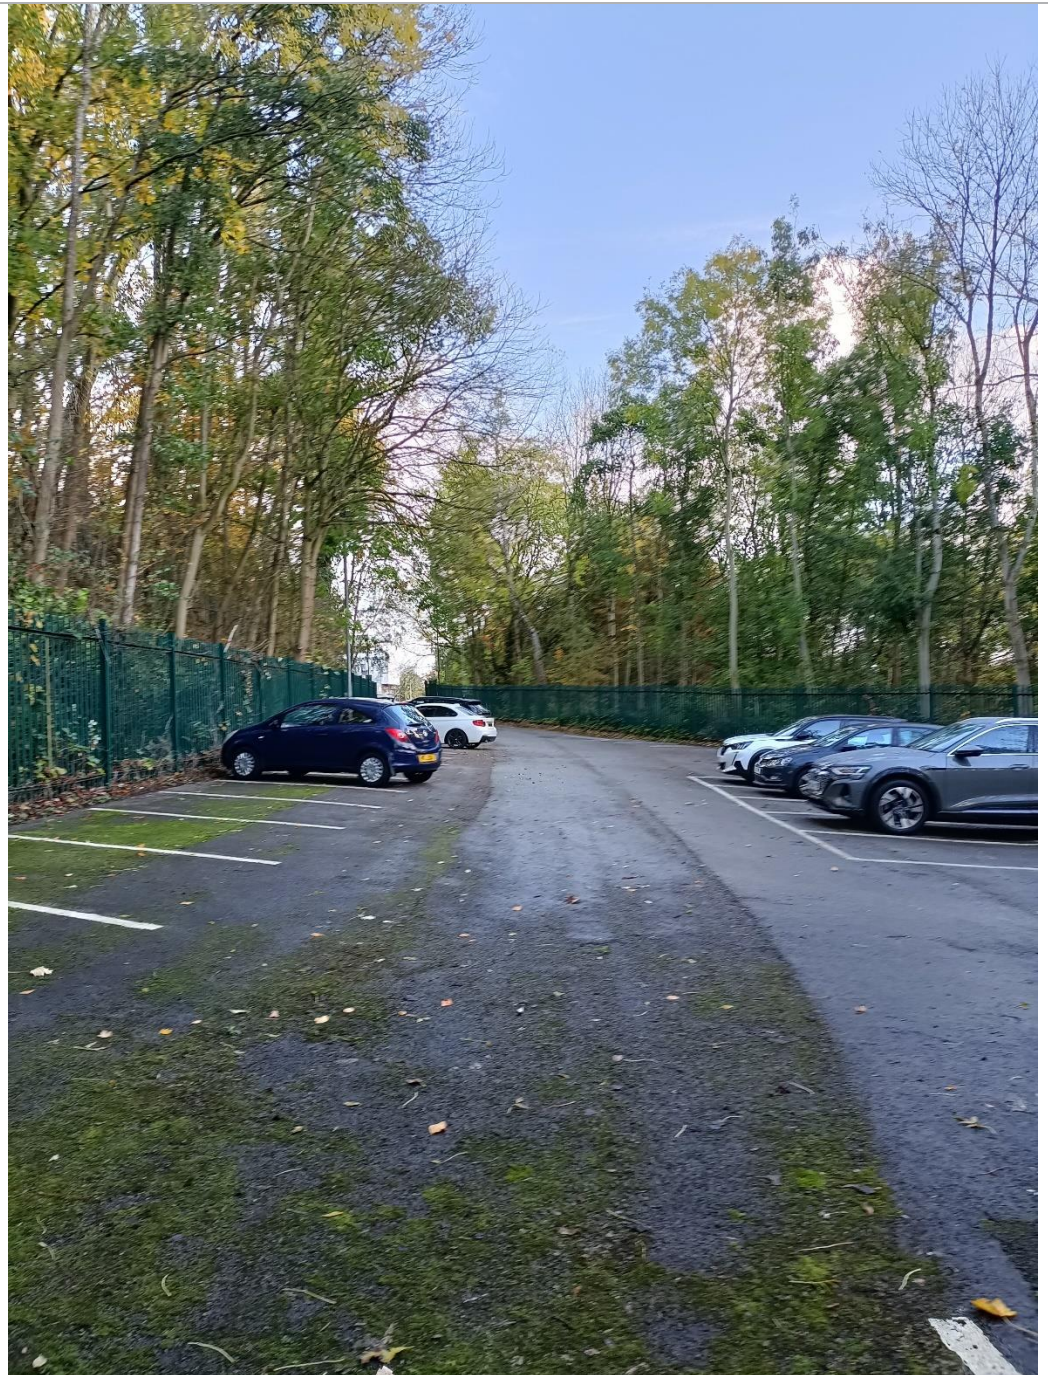
Photograph 12

Description:  
Eastern car park.

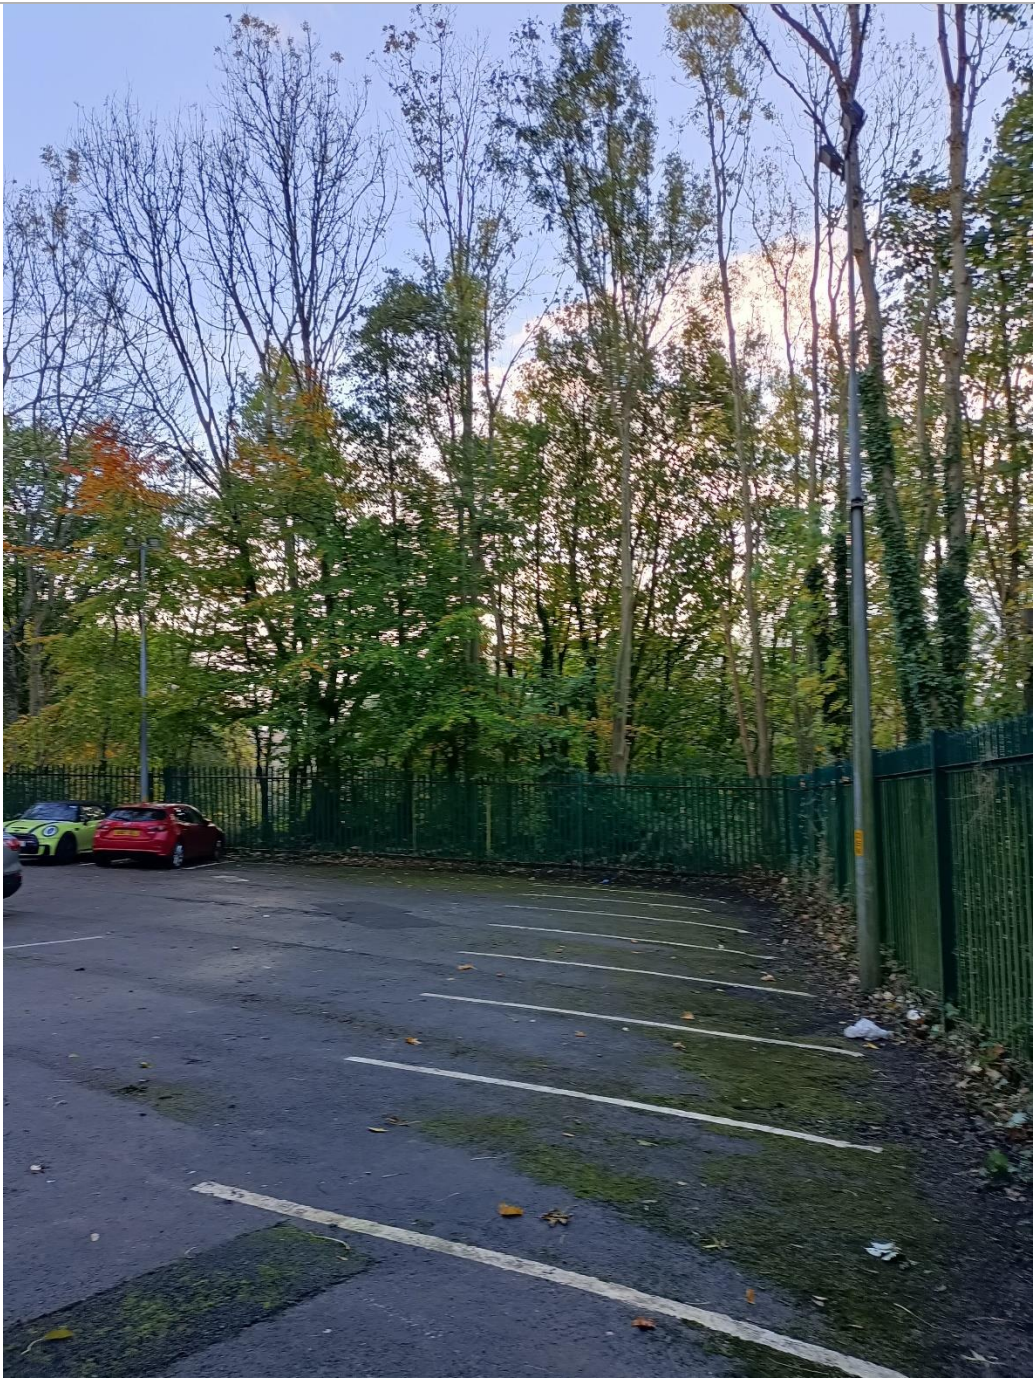
Photograph 13

Description: View  
of eastern car  
park.

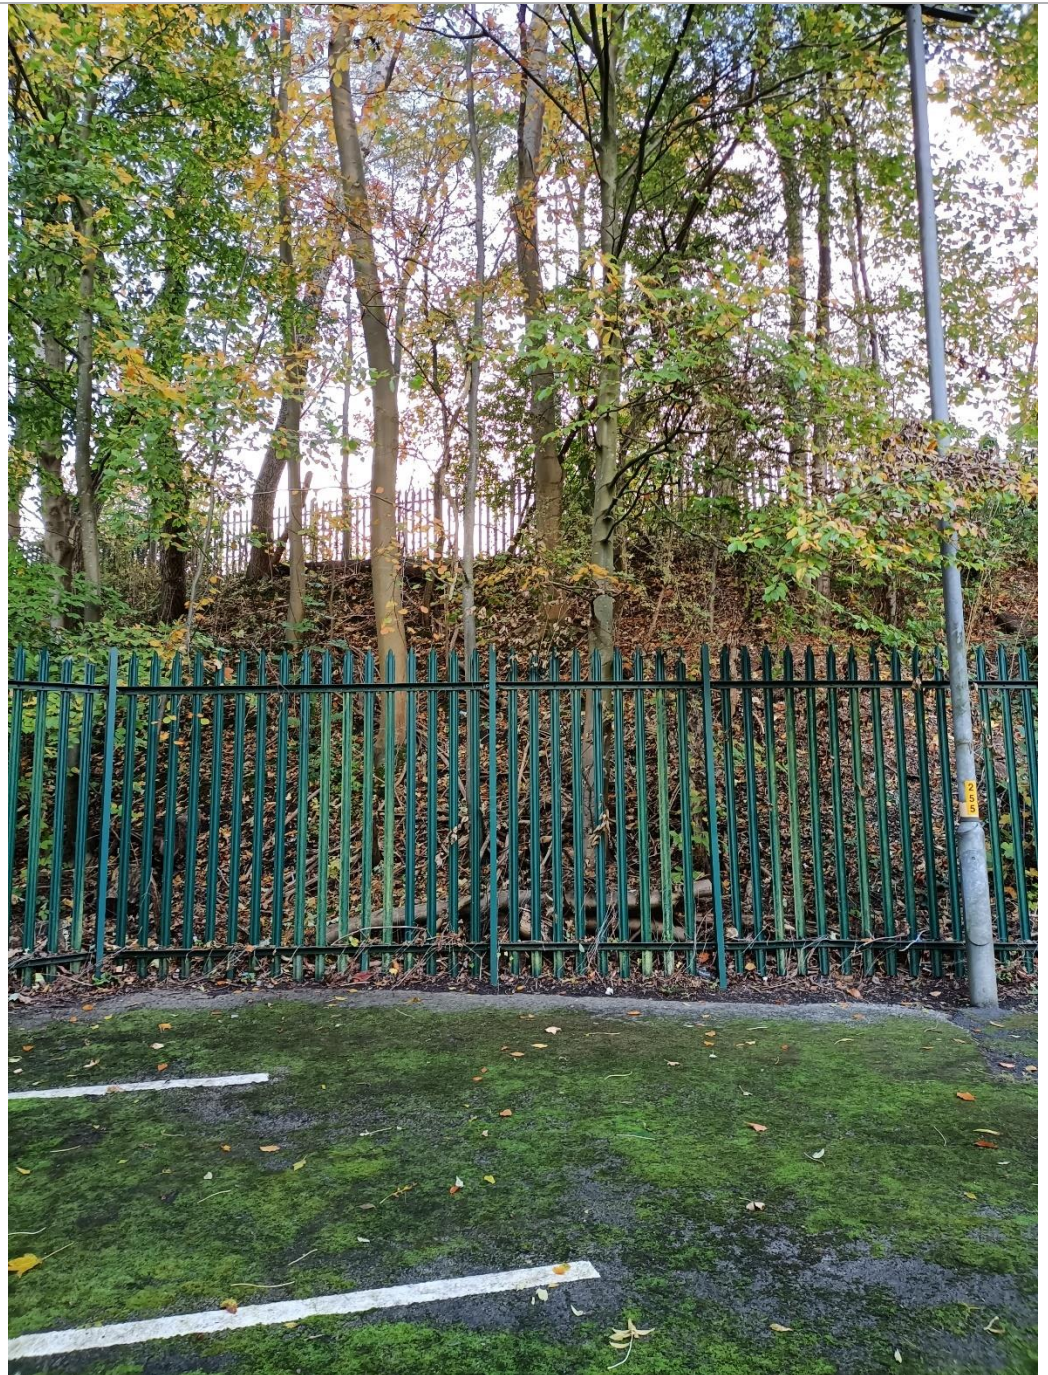
Photograph 14

Description: Steep  
slope to the west  
of the car park.
