**Project: 680 Rylands Building, Manchester**  
**Non-Intrusive Condition Survey**

**Metalwork Surveyor and Conservator – Sam Jacklin & Andrew Chant**  
**Survey Carried Out – Tuesday 19<sup>th</sup> November 2024**

**Calibre Metalwork Limited**

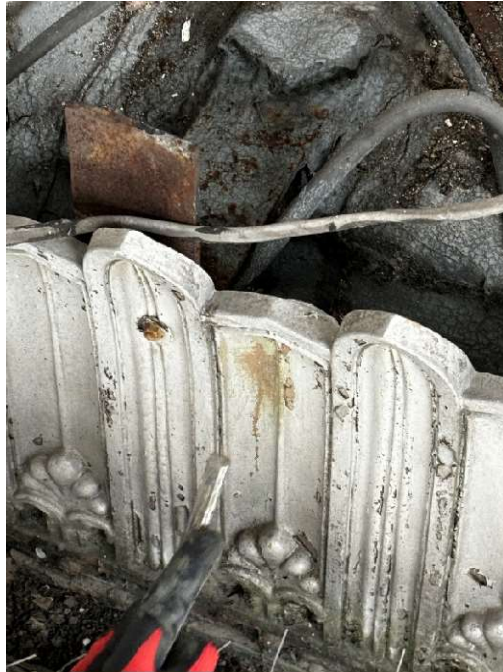
Upon initial inspection and undertaking a scratch test it was apparent that the frieze is constructed from either brass or bronze.

The frieze is fixed with 8no original slot headed screw fixings. In addition, there were found to be 2no recent torx screw non original fixings added.

The frieze panels have been overpainted many times over the years. The existing paintwork is flaking and failing throughout, making the current condition of the frieze difficult to survey in-situ. However, the frieze appears to be in complete condition throughout.

It is our proposal to tag, record and remove each panel / rail and decorative fixings. Sensitively clean, as not to damage the finish of the soft castings, to reveal the true condition of the frieze beneath.

We will then undertake a condition survey to reveal any unforeseen repairs and issue a quotation for your approval.

Following your approval, we will carry out any required repairs and we propose to apply our heritage approved wax to preserve the original material finish and install into original locations.

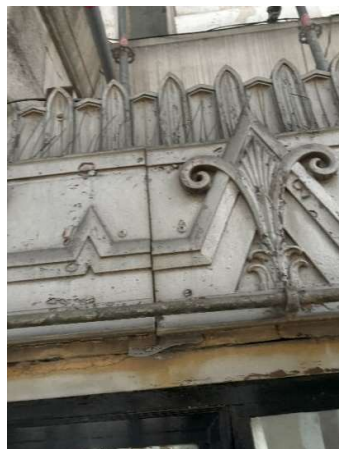
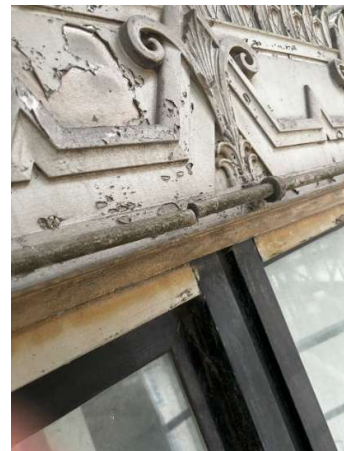
The castings are likely to be secured to a first fix bracket behind, but access prevented inspection. The castings need to be removed to assess these elements.

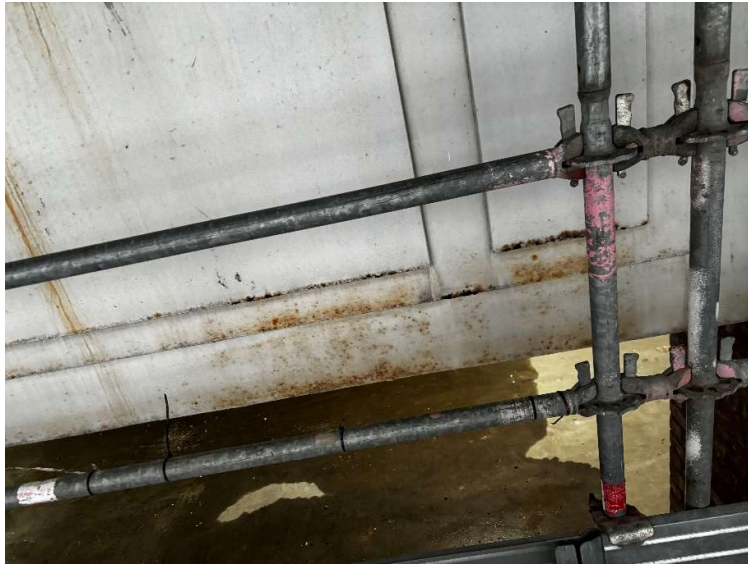
There is localised corrosion apparent on a number of the panels and in many cases, there are casting defects (pits) within the panel. Where the paint has been damaged or lifted, localised corrosion has become apparent.

As per the sample we have already undertaken, we propose to retain as much of the sound paint as possible, treating only corroded areas with the complete removal of paint. Rust would then be abraded to bright metal and converted using our acidic solution and primer applied locally. All other areas would be sanded to provide a key feathering in any edges to existing paint throughout to achieve a smooth finish.

We will apply our own heritage approved paint system by roller / brush.

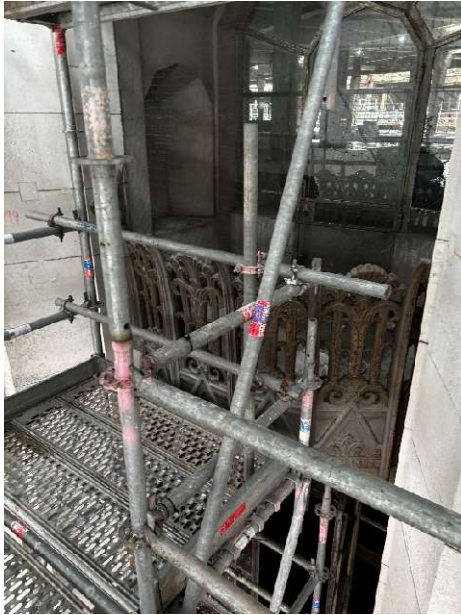
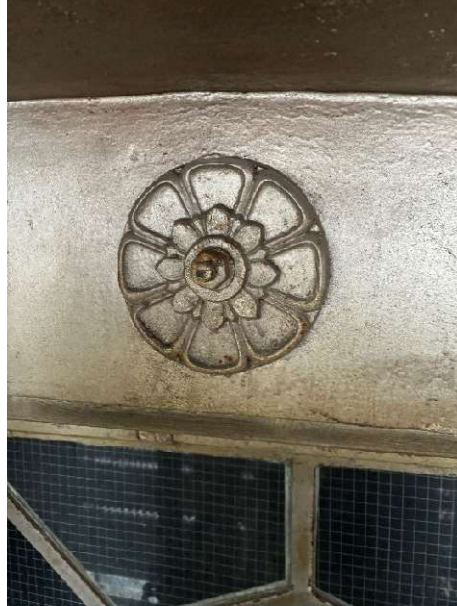
The balconies are constructed of cast iron 5no 'full' decorative panels and 'half' panels at either end. The panels are fixed on an assumed concrete base. The half panels at either end are embedded into the stone with no apparent base fixing visible from the scaffold. The full panels are mechanically fixed via 3no bolt fixings. On the underside of the assumed concrete base there is a decorative iron section that is fixed via 2no bolt fixings with decorative patresses.

The balconies appear to be in complete condition with no visible cracks / defects.

To access all the inaccessible corrosion and to assess the strength and quality of the fixings, we propose to remove the 5no 'full' castings back to our local workshop. Blast clean to SA 2.5 standard to reveal any hidden defects within the casting.

Prior to installation of the 5 removed castings, we propose to carry out an in-situ restoration of the 2no 'half' castings and cast-iron base. We will mechanically clean all accessible iron in-situ. We will remove and treat visible surface rust. It is currently assumed that no repair works will be required. We will finish paint all accessible areas in our heritage approved paint system in a single BS or RAL colour.

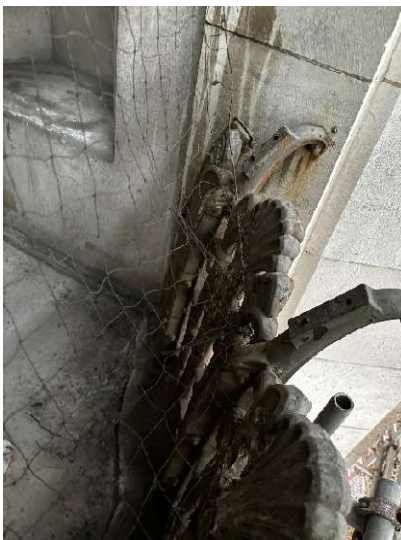
On the top side of the castings there is evidence of some unused original fixing holes and it is assumed that originally the balconies were fitted with a handrail that has since been removed.

Following our finishes being applied we will install all removed castings into original fixing holes, repaired if necessary by others, using new fixings where appropriate.

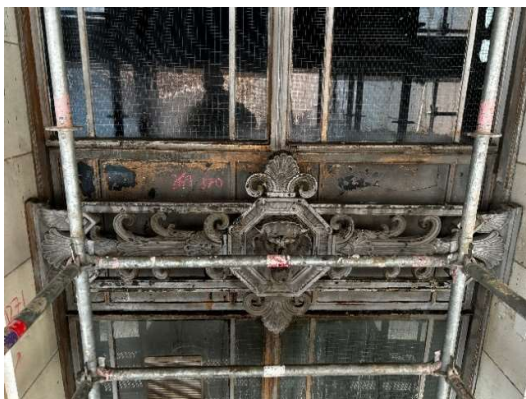
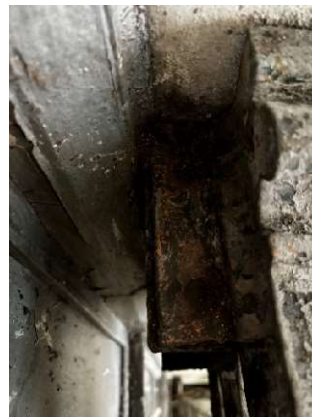
All 6no castings appear to be in complete condition however the fixings are corroded with rust build up on the top side making the visibility and accessibility of the fixings difficult to see / survey. Rust is evident, especially to the rear.

Similarly to the balconies above, we propose to release the central panel from the spigots and transport to our workshop for a full restoration. This will allow the fixings to be assessed for strength and will allow access to the trapped corrosion evident at the fixings.

We propose to remove the central castings back to our local workshop. Blast clean to SA 2.5 standard to reveal any hidden defects within the casting and to handle the old lead based paints in controlled conditions.

As requested by MC we propose to leave the spigots in the stone and carry out an in-situ restoration to the accessible areas. We will manually clean back all accessible areas, removing & treating any surface rust before applying our heritage approved paint system.

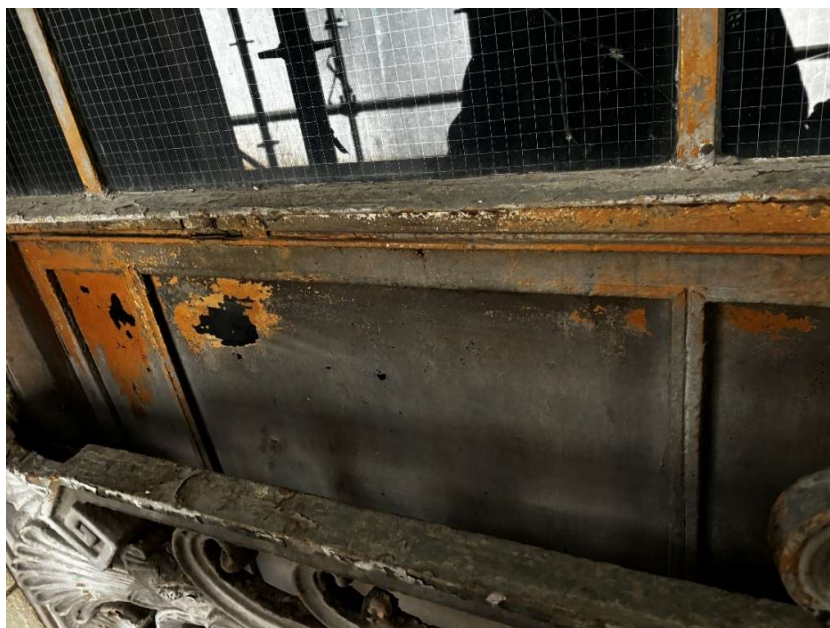
Situated behind each of the decorative spandrel panels mentioned above is an iron framed window with overpainted glazing and not an 'iron window spandrel panel' as was thought previously. We undertook a scratch test to reveal that these were an iron window frame with painted glass.

Access is very limited to the windows due to the scaffolding & the windows being directly behind the iron spandrels however, the iron frames appear to be in complete condition. Constructed of a single outer frame with a larger central window situated between two smaller windows of similar size, dimensions of the glass were unable to be taken due to access but the overall width is approximately 2130 x 1000mm.

Following the removal of the spandrel panels situated in front of the windows, when full access will then be available to the windows. We propose to carefully remove the glass by cutting the putty and releasing the glazing. Following removal of the glass we can determine the fixings in the iron and carefully remove the iron frames back to our local workshop.

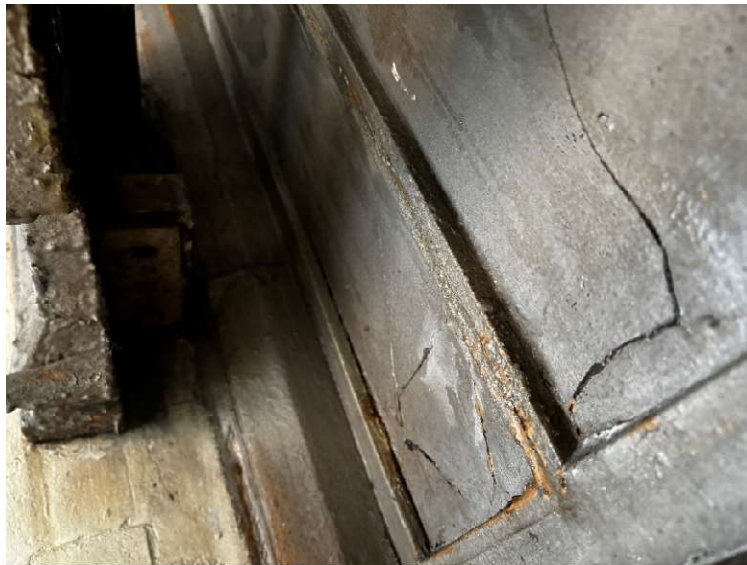
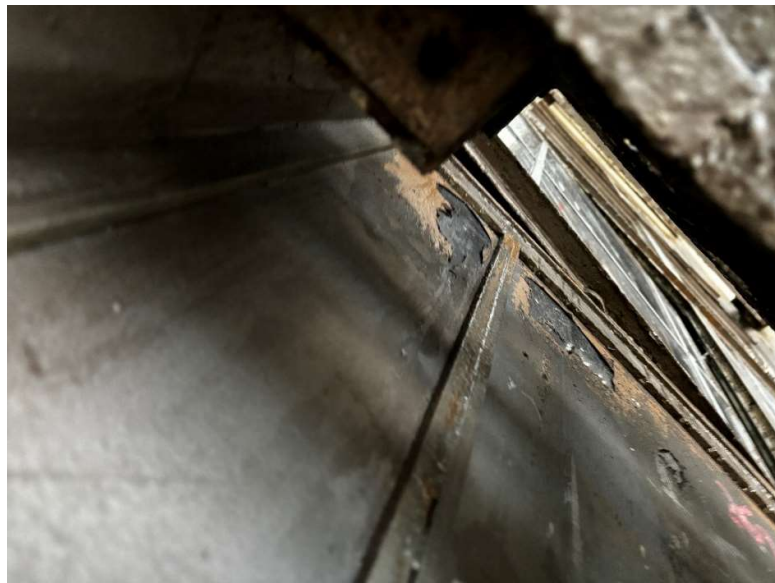
There is corrosion evident in many areas where the paint has failed over the years allowing water to ingress. Where the paint adhesion has failed on the glass and has begun to crack and flake throughout.

Within our workshops, we will blast clean to SA 2.5 standard to reveal the true condition of the ironwork. Once any hidden defects have been revealed we will undertake a priced condition report for your approval.

Using heritage techniques, we will carry out the approved repairs before finishing in a single BS or RAL colour using our heritage approved paint system.

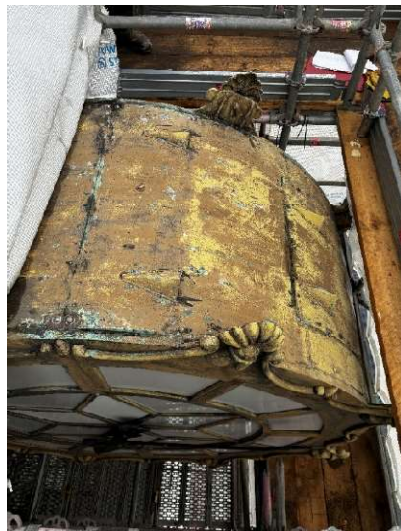
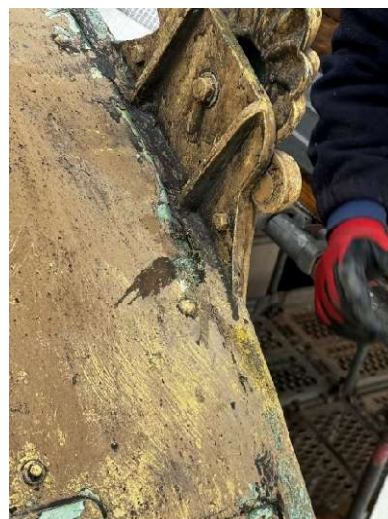
Upon initial inspection it became apparent that the clock is clad with using a mixture of brass or bronze. It is likely, although not proven yet, that the clock structure (hidden) is probably iron and its condition currently unknown. The brass / bronze cladding, probably originally polished and varnished / lacquered has been overpainted over years and this is now failing in many areas.

The clock appears to be in complete condition and constructed in 12no castings on each face with the body of the clock being constructed from brass/bronze with 1no access hatch visible. The decorative section on the 8no decorative sections on each face appear to be castings and are screwed on to the main clock face via 5no fixings.

The glazing on the clock face appears to be in complete condition with no visible cracks.

We propose to tag and record all sections of the clock before carefully dismantling into manageable sections and lowering to the ground via use of the goods lift on site.

Following removal of all the castings back to our workshop, we will suitably clean all sections to reveal the true condition. We will then undertake a priced condition survey, quantifying all required repairs.

Using heritage techniques, we will undertake all approved repairs and suitably finish the clock components (polishing brass / bronze work and painting ironwork).

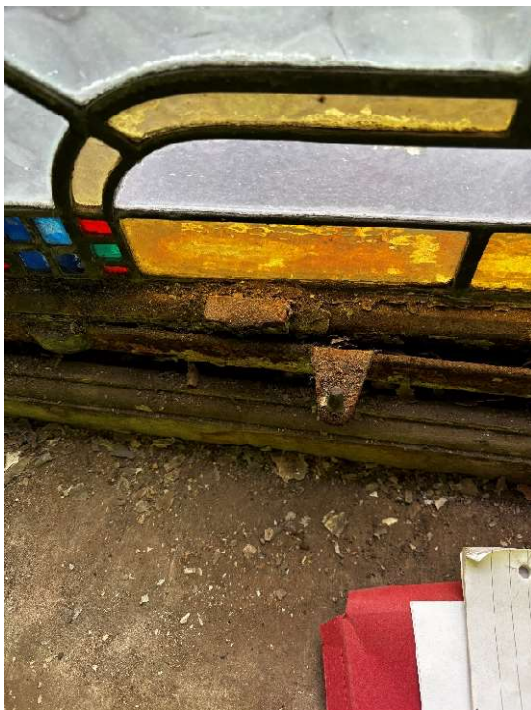
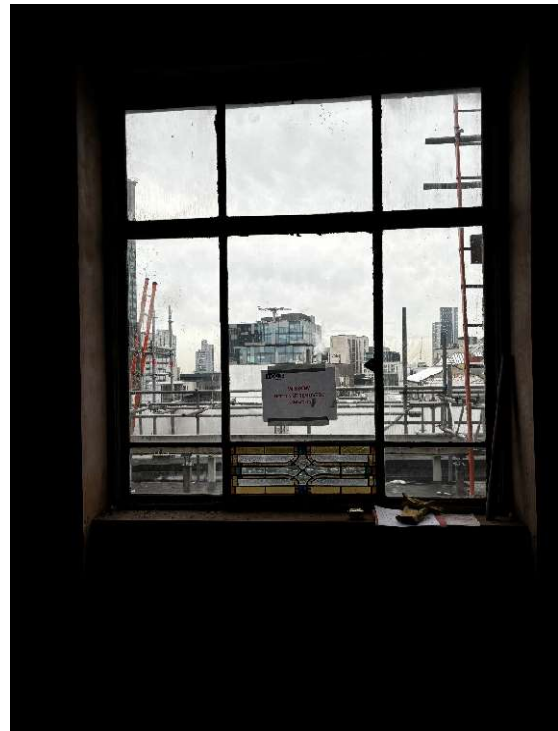
Window 2 has 2no stained glass panels missing. Replaced with a clear pane non original glass of the same size. The 1no stained glass panel left in situ is the central section. There are 3no small breaks apparent within the coloured glass.

The paintwork on the iron is flaking and evidence of rust throughout. The iron stay in the central bottom panel has broken off. The opening light stay appears to complete and in working condition, however the window wasn't opened due to the rust build up around the central brass pivot.

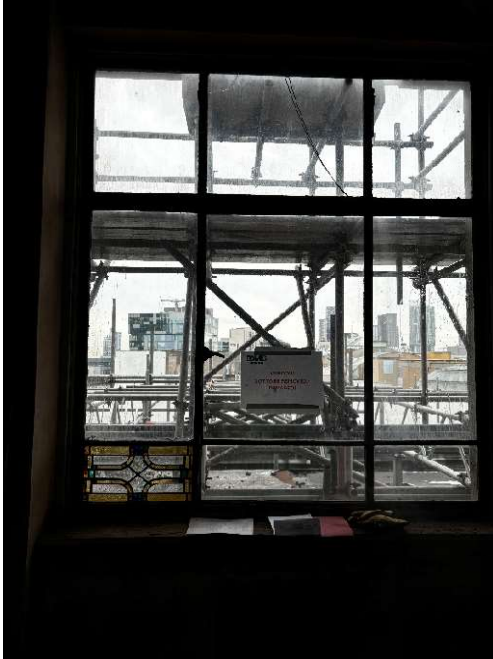
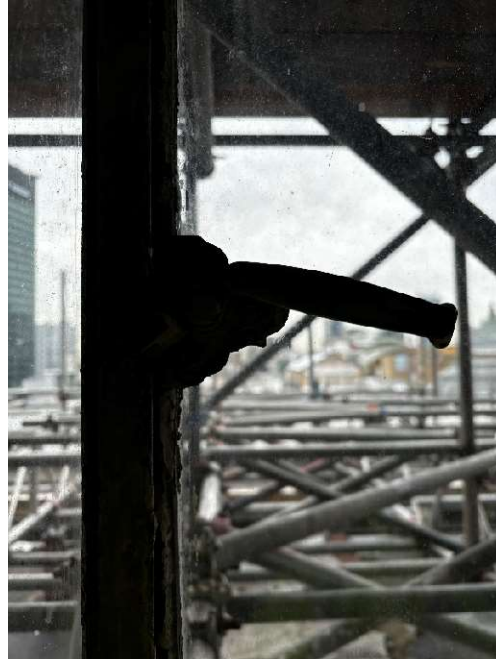
**Window 3 –**

Window 3 has 2no stained glass panels missing. The one stained glass panel left insitu has 3no visible cracks in the smaller coloured panes and 1no crack in the central clear panes.

The paint on the iron frame similar to 'window 2' has failed throughout, due to little/no maintenance and rusting apparent in various locations.

The central stay is missing / broken but the latch is in complete condition.

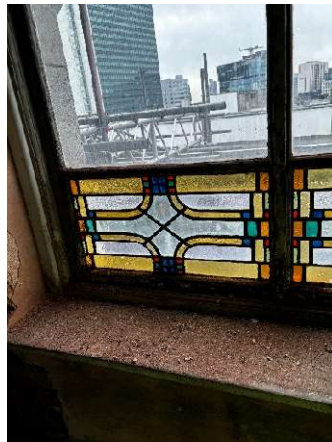
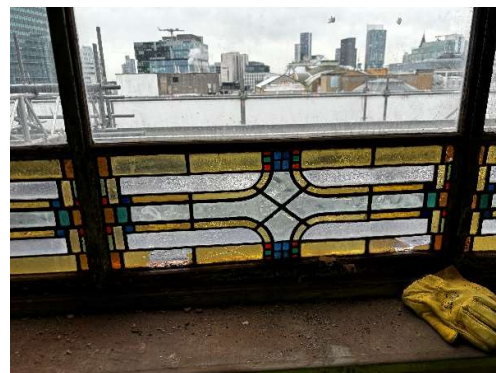
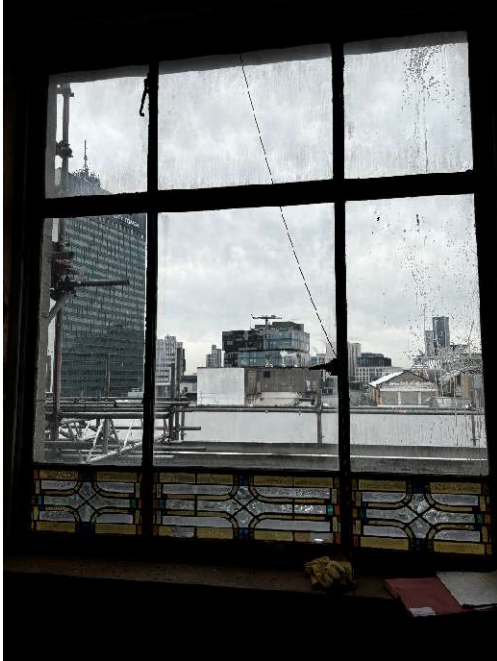
**Window 4 –**

Window 4 has 3no stained glass panels in-situ, the central panel has 7no breaks in both the coloured and the clear panes. The bottom left panel has 4no cracks within the coloured panes.

The iron fixings for the stay within window 4 are still evident, however the stay is missing. Again, as per the previous windows the paintwork has failed with rust evident throughout. The bottom rail of the castings has a slight 'bow'. It is not clear if this was an original casting defect, or created by rust jacking between the outer and inner frames.

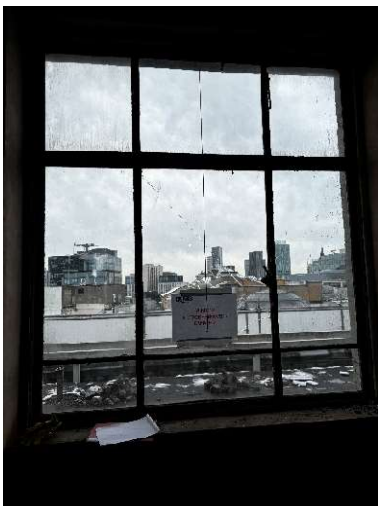
#### **Window 5 -**

Window 5 has all 3no stained glass panels missing. Replaced with non-original clear glass.

The 1no iron stay is missing but the latch appears to be in complete working condition.

The large central pane of 'clear' glass has a large crack from corner to corner.

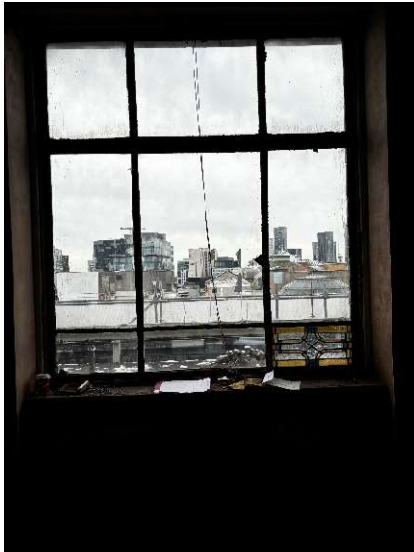
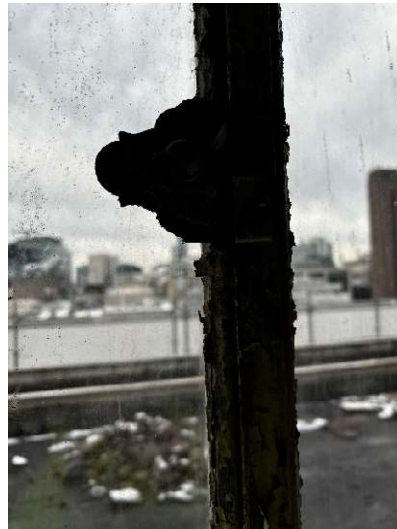
#### **Window 6 -**

Window 6 has 1no stained glass in-situ. There are no visible breaks or cracks within this panel. 2no stained glass panels are missing / replaced with non-original clear glass.

The window stay is missing although the iron fixing lugs are still in-situ.

The iron latch has previously broken and has 1no previous poor repair with a section of folded plate drilled and riveted onto the iron frame.

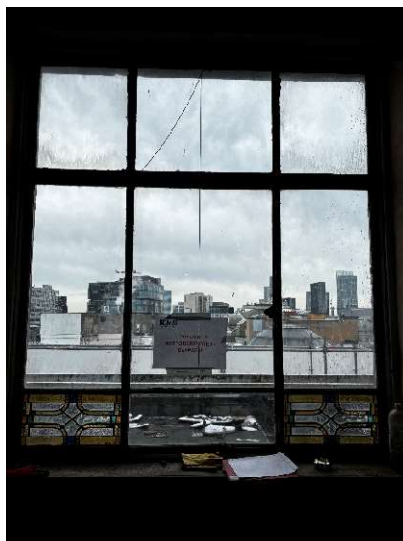
#### **Window 7 –**

Window 7 has 2no stained glass currently in-situ. The central panel is missing / replaced with clear glass. The panel on the RHS has a number of cracks in a single-coloured pane.

The stay is missing and the opener is broken / snapped.

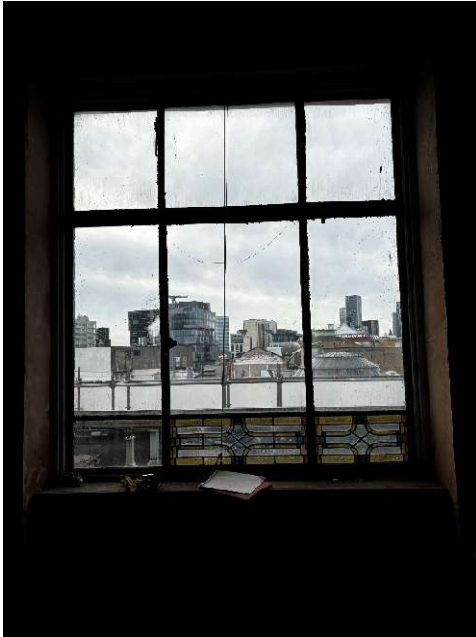
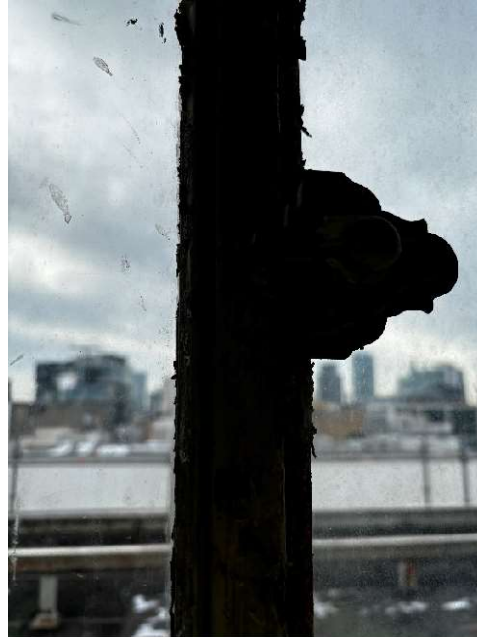
**Window 8 –**

Window 8 has 2no stained glass panels in-situ. There are 4no cracks within these panes. 1no stained glass panel has been removed and replaced with a single clear glass pane.

The latch has had a previous poor repair undertaken with a folded plate drilled and riveted onto the ironwork. The stay is missing, however the iron fixing brackets are in situ.

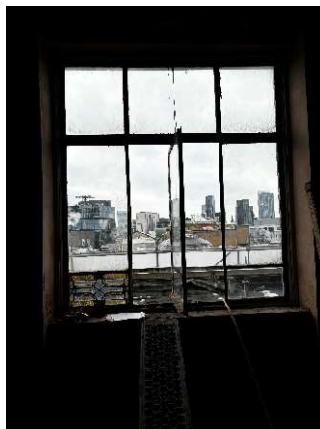
**Window 9 –**

Window 9 has 2no stained glass panels missing / replaced with clear single panes. The 1no stained glass window in-situ has 3no breaks within the panes.

The stay is missing but the iron fixing lugs appear to be in complete condition. The latch appears to be in complete condition.

The window was open, and the operation of the opening light appears to be working with no apparent issues.

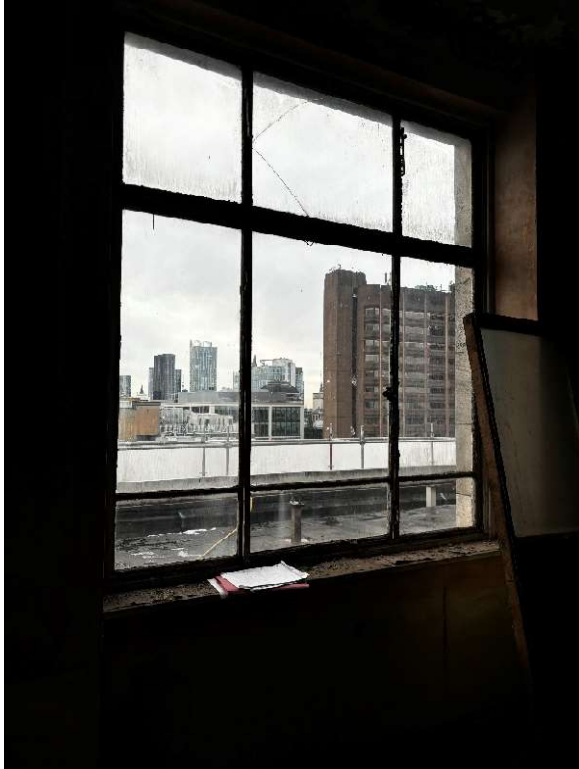
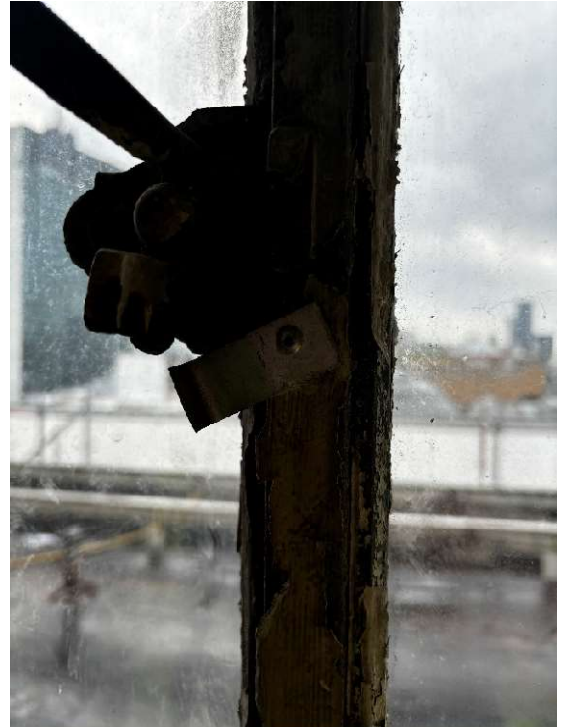
**Window 10 –**

Window 10 is missing all 3 of the original stained-glass panels. The opening light operation was checked and appears to be in full working order.

The window latch has had a previous poor repair with a folded plate drilled and riveted to the iron frame.

The window stay is missing.

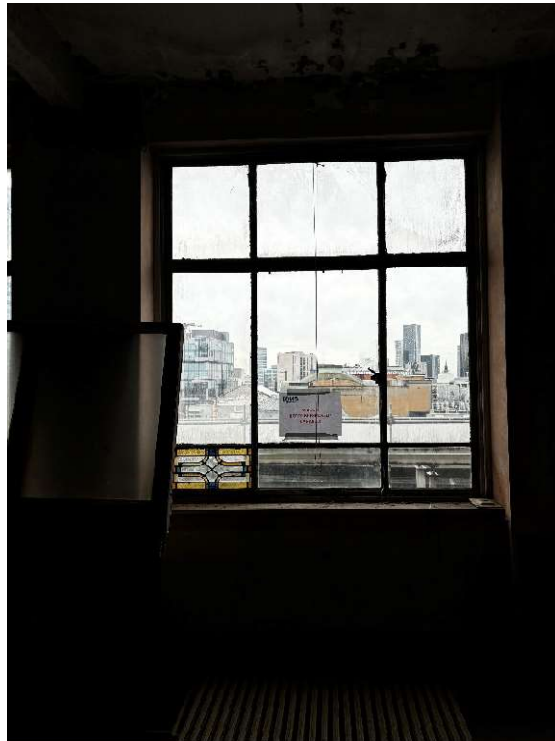
**Window 11 –**

Window 11 has 2no of the stained-glass panels missing and replaced with clear panes.

The stained-glass window left in-situ has 2no visible cracks.

The stay is missing, and the latch has had a previous poor repair similar to those mentioned above.

Due to the failed paintwork, there is significant bowing between the bottom and middle panels. This is believed to be due to 'rust jacking' a build up of rust between these two panels.

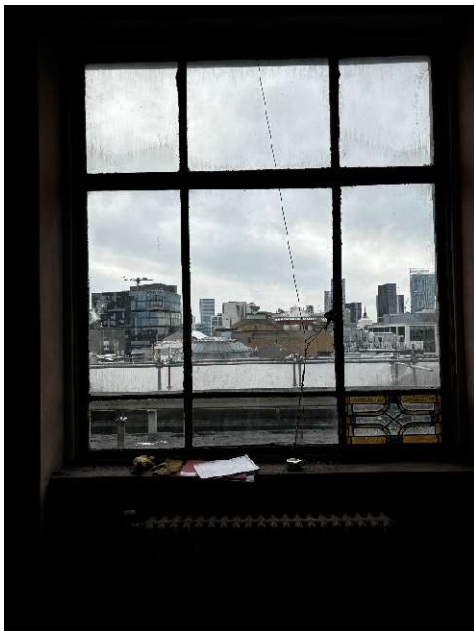
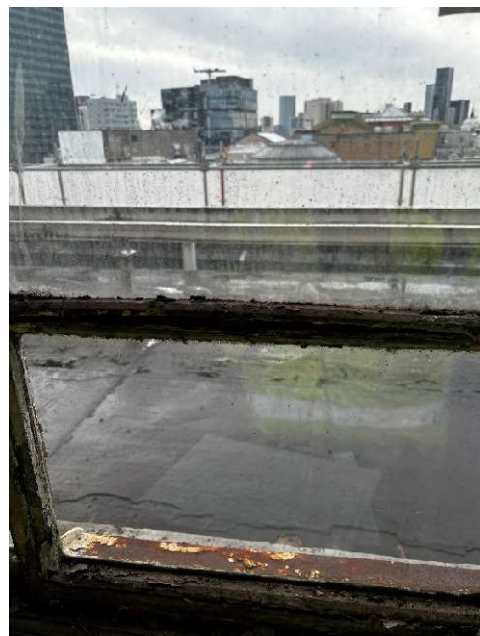
#### Window 12 –

Window 12 has 2no stained glass panels missing / replaced with clear glass panes. 1no stained glass panel has 2no cracks.

The latch in complete condition and appears to be working. The stay is missing.

There is significant bowing between middle panels on 2 sides. This is believed to be due to the paintwork failing and rust jacking between the joints.

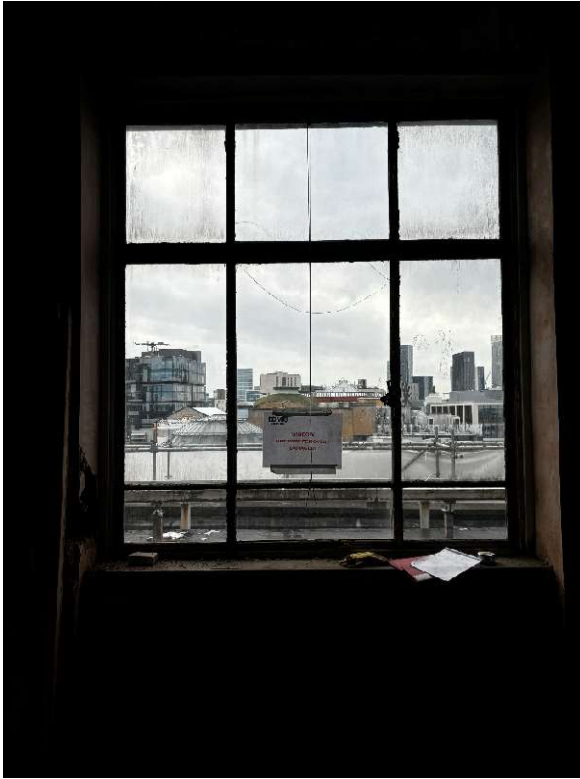
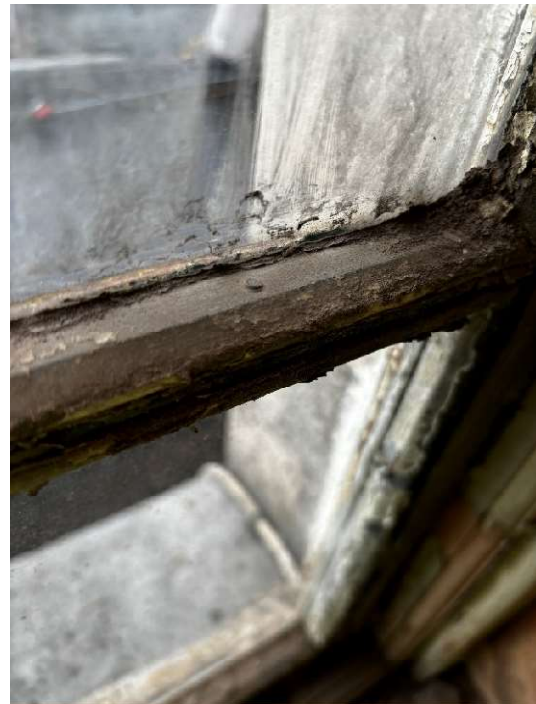
### Window 13

Window 13 has all 3 of the original stained-glass panels missing. These have been replaced with clear panes. The stay is missing, and the latch appears to be in working order.

There is significant rust across on all sides of the frame in particular the bottom of the iron frame.

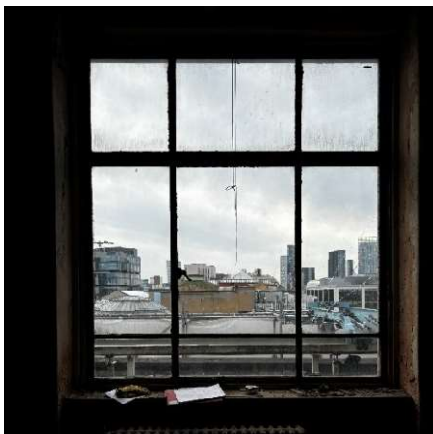
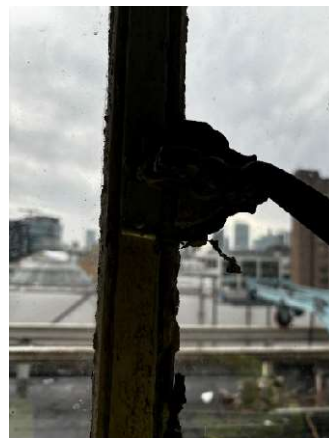
### Window 14 –

Window 14 has 3no stained glass panels missing / replaced with clear panes. There is a large crack on the right middle pane in the clear glass.

There stay is missing and the latch has a previous poor repair similar to those mentioned above.

Taking great care, we will tag and record, then remove the stained-glass panels. We currently assume this to be on a putty bed that can be cut and released from the iron frame. We will suitably pack the stained-glass windows for transportation back to our workshop. Using suitable access provided we will carefully remove the clear glass (from the outside) to reveal the fixings. Once the fixings into the timber subframe have been revealed and all glass removed we will extract the iron frames from sub frame, taking as much care as possible to cause any damage to the timber. (It is assumed that the timber will need replacing however, any original timbers will be useful for replicating as close as possible to the originals).

**Iron Frames** – Within our workshops we will blast clean to SA 2.5 standard enabling us to assess the true condition of the iron frames. Following blast cleaning we will undertake an internal condition survey and using heritage approved techniques we will undertake minimal repairs. Once repairs have been completed, we will finish paint using our heritage approved paint system in a single BS or RAL colour of your choice before installing into existing locations made good by yourselves prior to our site visit.

**Glazing** - Using the stained-glass sample removed from site we will replicate a new stained-glass panel to represent the original in all respects. We will make good the panel by undertaking necessary repairs to the originals. We will glaze the clear glass sections in the closest available modern alternative to closely match the original.

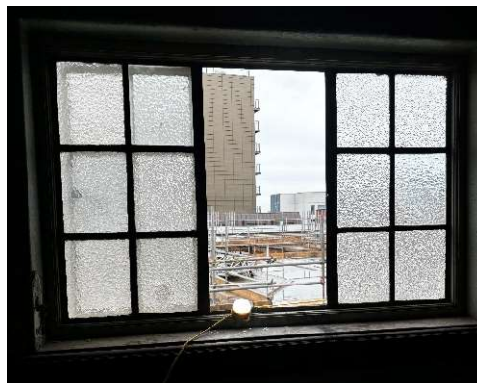
Generally, the ironwork appears to be complete condition, without any obvious defects.

The timber frame in which the iron resides is in poor condition. There is no stay evident but no evidence to say there once was a stay originally.

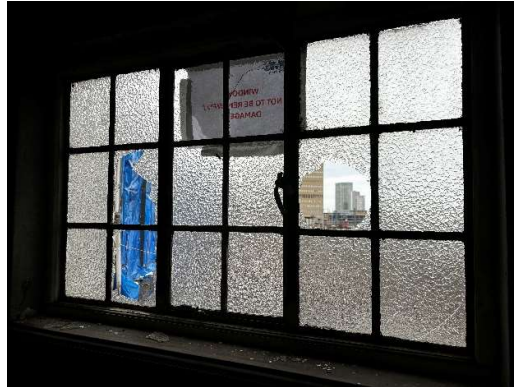
### Window 2

The glazing is broken on 6 no panes, and the iron appears to be in salvageable condition. The paintwork has failed with rust evident throughout.

There is no evidence of the stay, but the latch has had a previous poor repair.

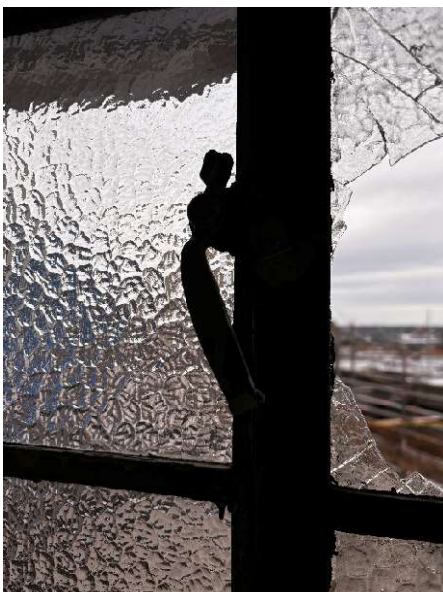
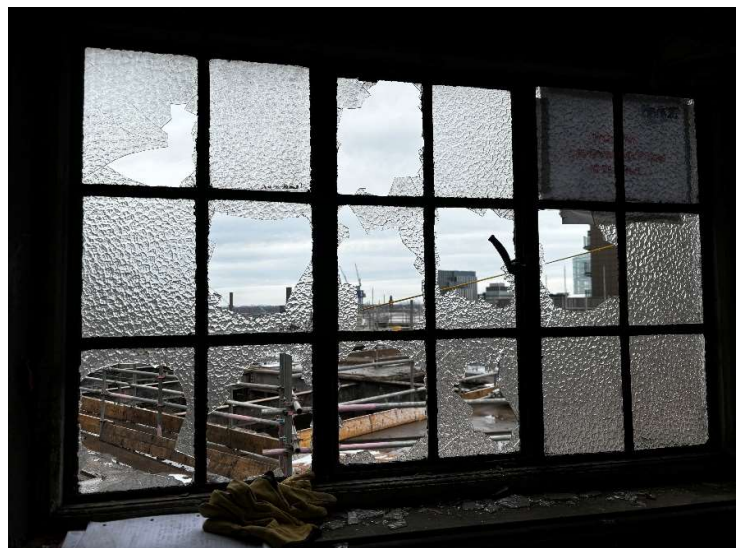
### Window 3

The glass is broken throughout. The stay is missing and there is evidence of a previous poor repair on the latch. The ironwork appears to be in ok condition with evident rust build up due to failed paintwork.

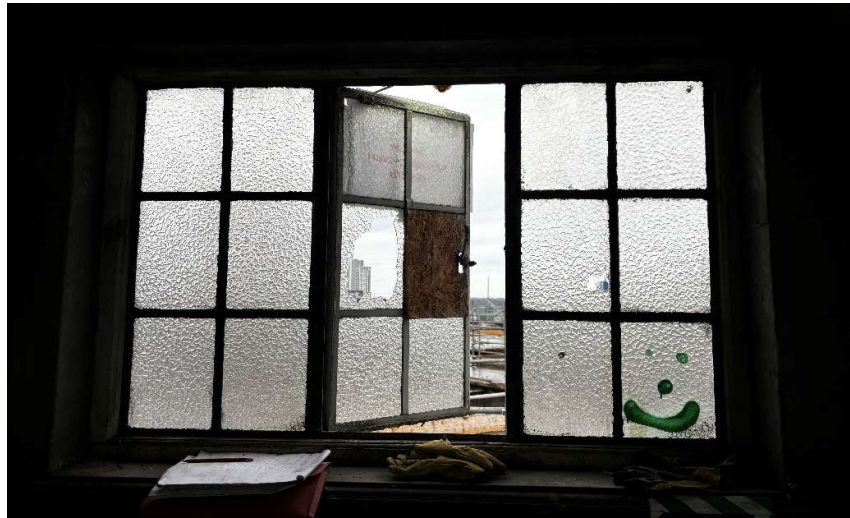
### *Window 4*

There are 4no broken panes. The stay is missing and there is evidence of a previous poor repair on the latch. The ironwork appears to be in ok condition with evident rust build up due to failed paintwork.

Back in our workshop we will blast clean the iron frames to SA 2.5 standard to reveal the condition. Once blast cleaned, we will undertake a priced condition survey and issue for your approval.

Following your approval, we will undertake any required repairs and finish using our heritage approved paint system in a single BS or RAL colour of your choice.

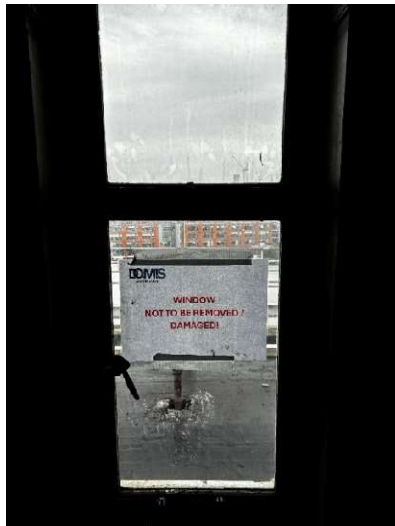
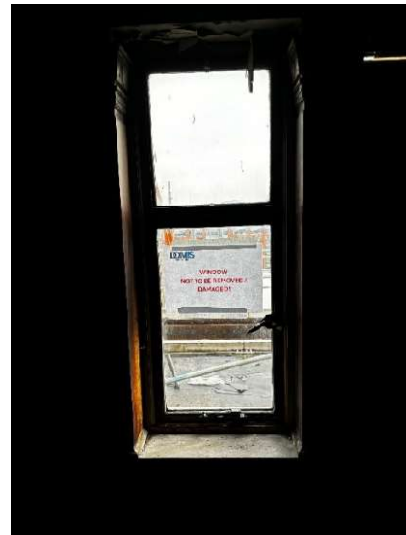
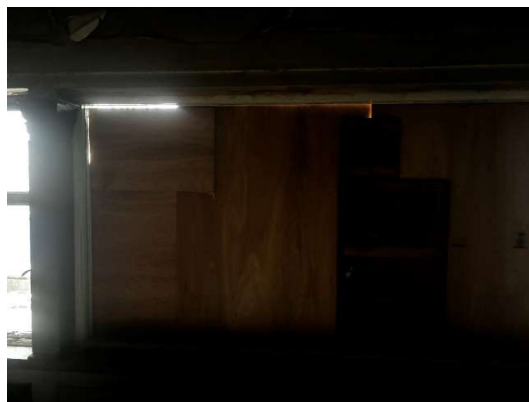
There are 4no stays missing on the 2no windows.

There have been 4no previous poor repairs with a folded plate drilled and riveted to the cast iron frame.

Both bottom opening lights have their stays in-situ and appear to be in full working condition.

The majority of the paintwork on the bottom edging of the ironwork has failed but the iron appears to be sound condition.

The central large window has previously been removed and temporary boarded up. The large opening is 117" x 59".

Within our workshops we will blast clean the iron frames to SA 2.5 standard to reveal the condition. Once blast cleaned, we will undertake a priced condition survey for your approval.

Following your approval, we will undertake any required repairs and finish using our heritage approved paint system in a single BS or RAL colour of your choice.

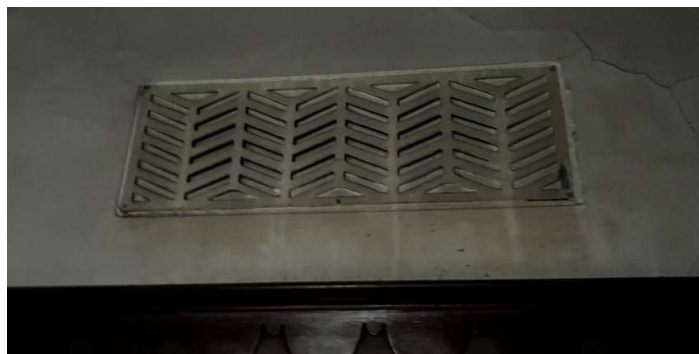
The grills appear to be in ok condition with small areas of paintwork failing.

We propose to carefully remove the 2 no grates from site by removing the 6 no screws / pins. Back at our workshop we will blast clean the grates to SA 2.5 standard to reveal the true condition of the castings.

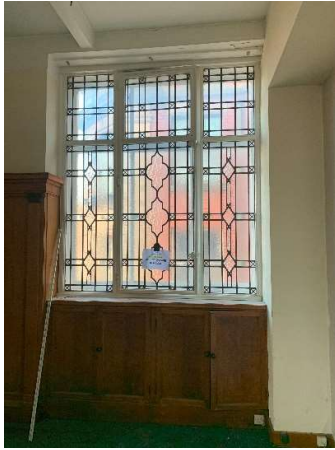
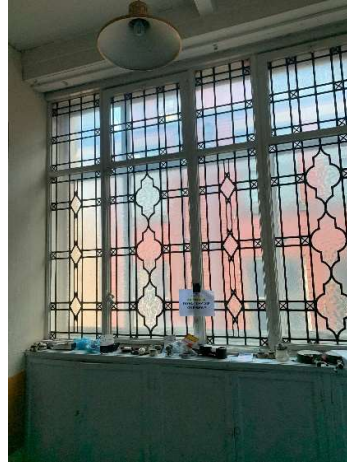
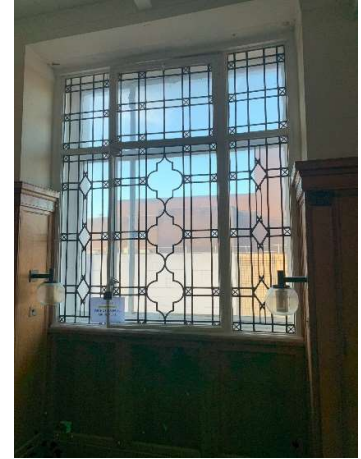
The secondary glazing on level 2 consists of a 1no large leaded light situated within an iron frame. There are 2no frames of the same design (metal casement with higher 'hopper' style opener). Both the iron frame and the leaded lights appear to be in good / fully working condition.

There are no visible cracks / breaks within the glazing and the lead comes appear to be in good condition throughout.

The paintwork has been maintained with no visible rust or cracks within the ironwork.

It is believed that the only reason for the window's being removed is to replace the exterior glazing. Given this, our proposal would be to tag and carefully de-glaze the leaded lights on site before tagging & removing the iron frames. We will lower to ground and transport to our local workshop.

Within our workshops we will then scrape out the remaining putties and glass remnants by hand. Following removal of the putties we will, blast clean all frames to SA 2.5 standard removing all corrosion and old paints in a controlled environment (lead paint assumed).

Once blast cleaned, we will carry out a post blast condition survey, to assess the current condition of each window frame when all the damage is revealed and provide you with a priced report covering any unforeseen repairs and issue for your approval.

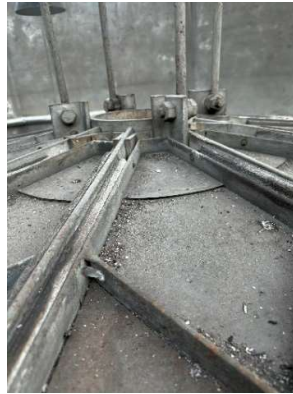
The glazing bars are spaced with timber packers situated between all 'triangular' sections of the laylight.

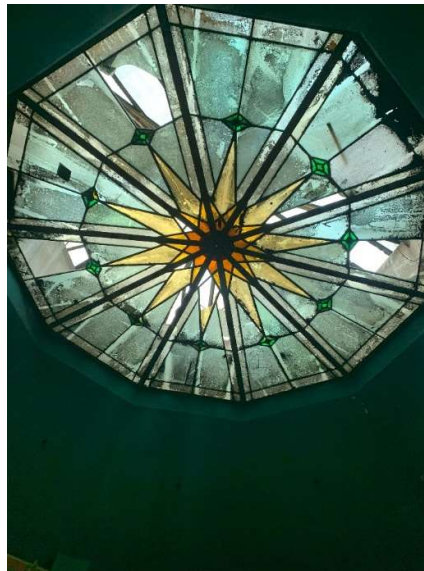
Although access was limited through the previously removed / broken glazed sections, we were able to view much of the ironwork and all appears to be in complete condition with little corrosion evident on the surfaces.

A number of the panes have been broken and previous repairs have been undertaken meaning there are different types of glass present within the lay lights.

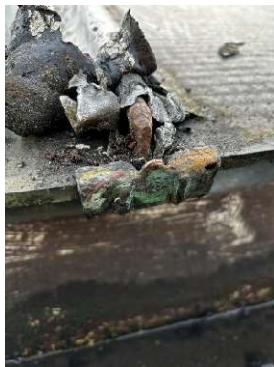
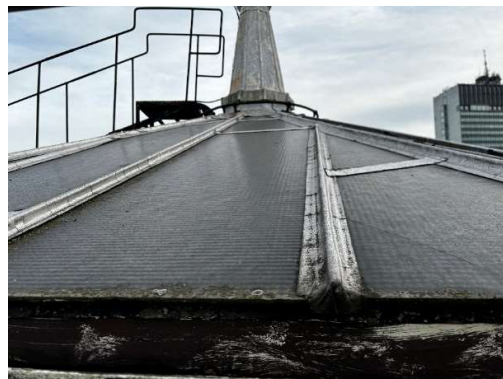
The exterior central hub / spigot was unavailable for survey. Due to the glazing bars being lead wrapped with an exterior lead flashing no fixings could determine.

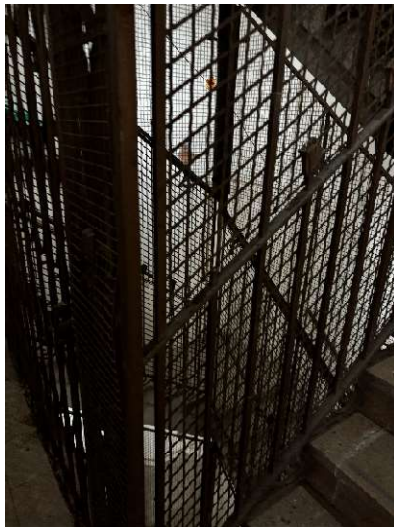
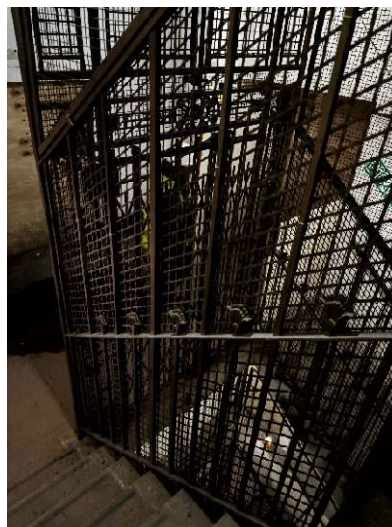
The 'dog bars' are finished with a decorative cast iron finial. There are several of the finials broken / missing across all levels.

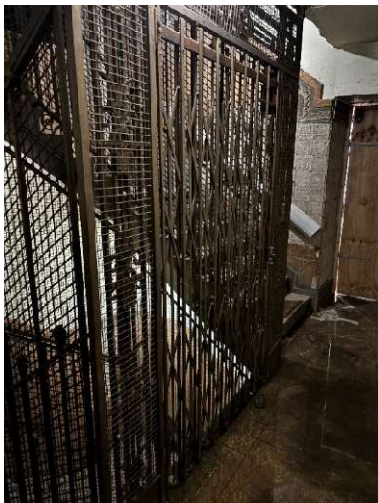
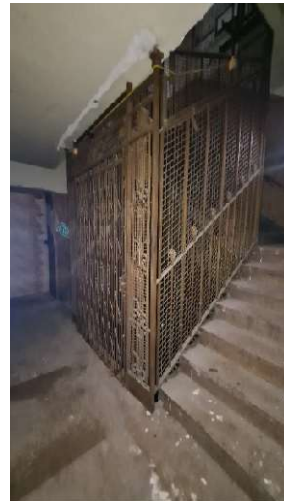
The concertina doors appear to be operational with only 4no of the bars visibly bent / damaged. The decorative iron scroll work situated either side of the concertina doors and on the steps appears to be in complete condition protected over recent more recent times via the addition of the mild steel mesh.

There is a lift call bell to the right-hand side of the lift doors on each landing. Although visible and the buttons working there is no evident power feed so not currently operational.

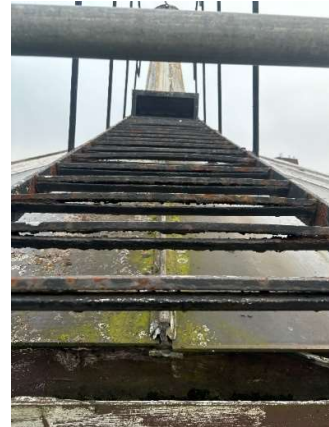
The ironwork generally appears to be in very poor condition.

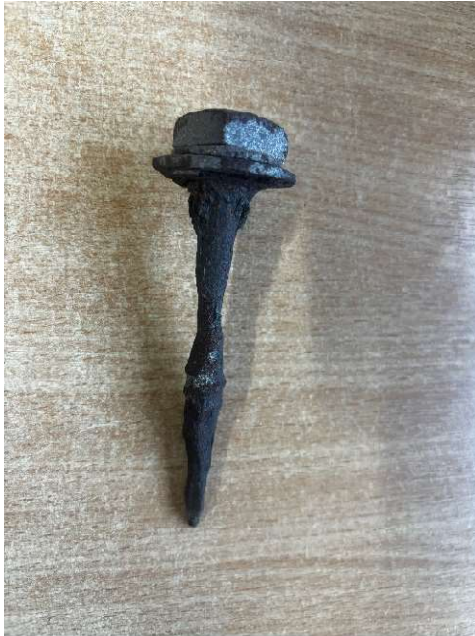
good condition on the exterior, corrosion can be causing difficulties structurally out of sight. Please see below evidence of a failed screw removed from another project we successfully offsite restored. The screw on the exterior appeared to be structurally sound. Because of this, Where practicably we strongly recommend a full off site restoration
