# Cornbrook Culvert Condition Survey

JANUARY 2025

Ref. 222-176

# Bennet Street Culvert Survey- Comprehensive Report and Recommendations

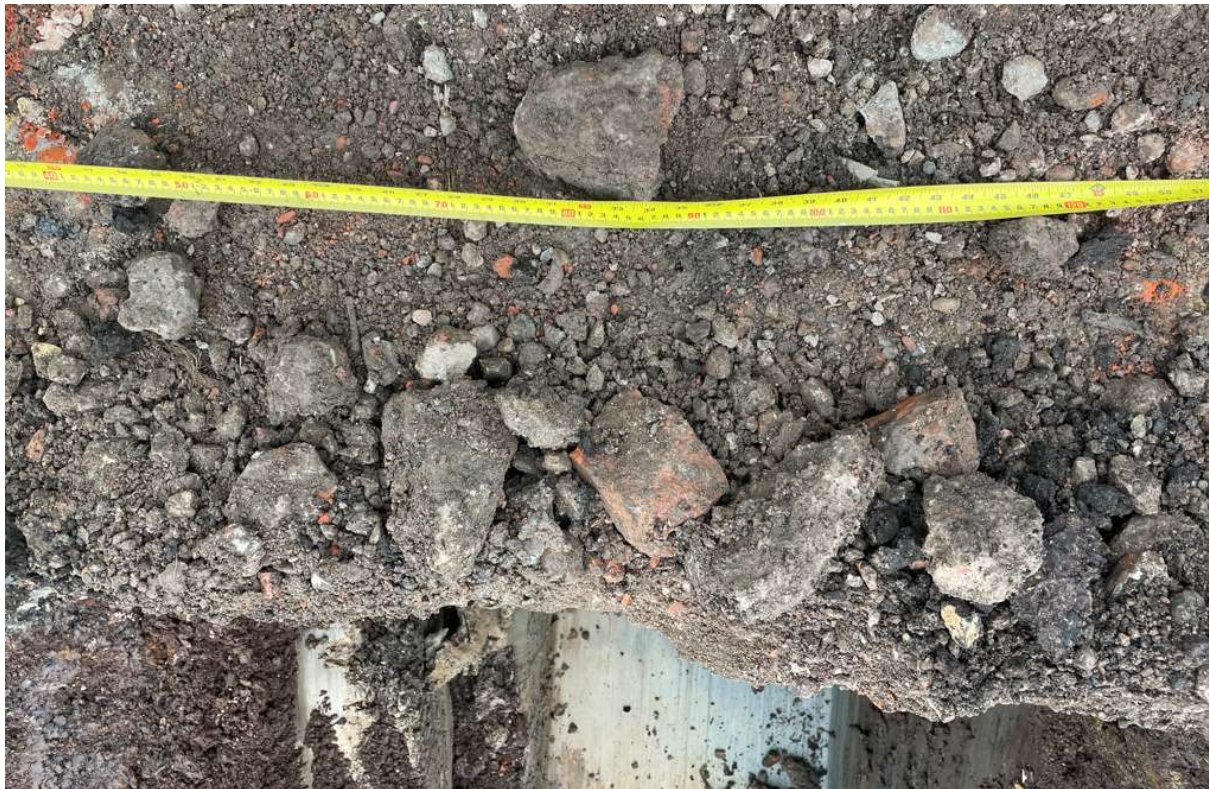
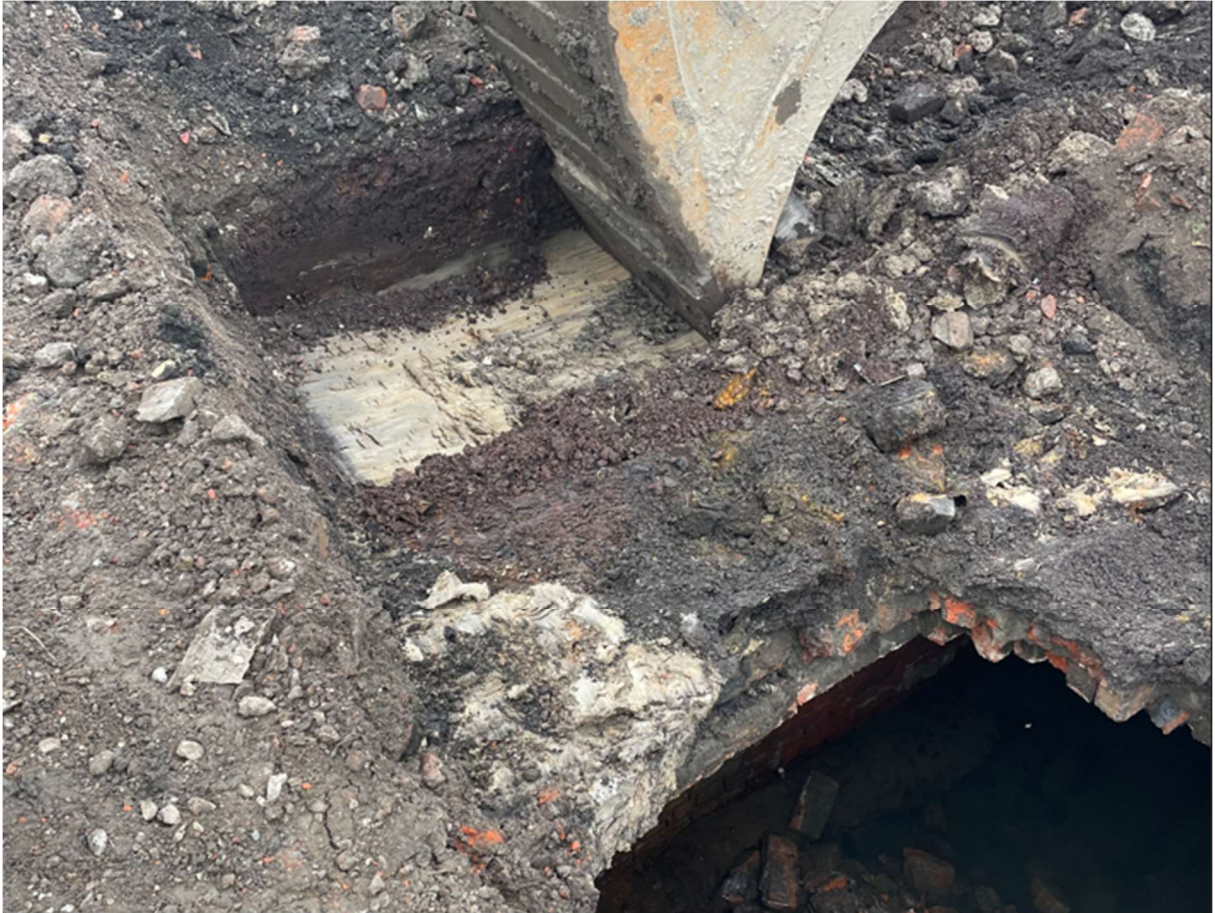
- A partial collapse of the culvert's brick archway was noted, resulting in a 1.5m diameter opening.
- The reduced ground cover above the culvert was identified as a contributing factor to the structural failure, as it limited the arch's capacity to distribute the applied loads.
- Debris and loose bricks were observed within the culvert, but it was confirmed that water flow remained largely unobstructed at the time of inspection.
- Ground investigations revealed a layer of site fill material, approximately 500mm thick, above a stiff clay layer encountered at a depth of approximately 1m. The clay stratum provided sufficient bearing capacity for the proposed remedial measures.

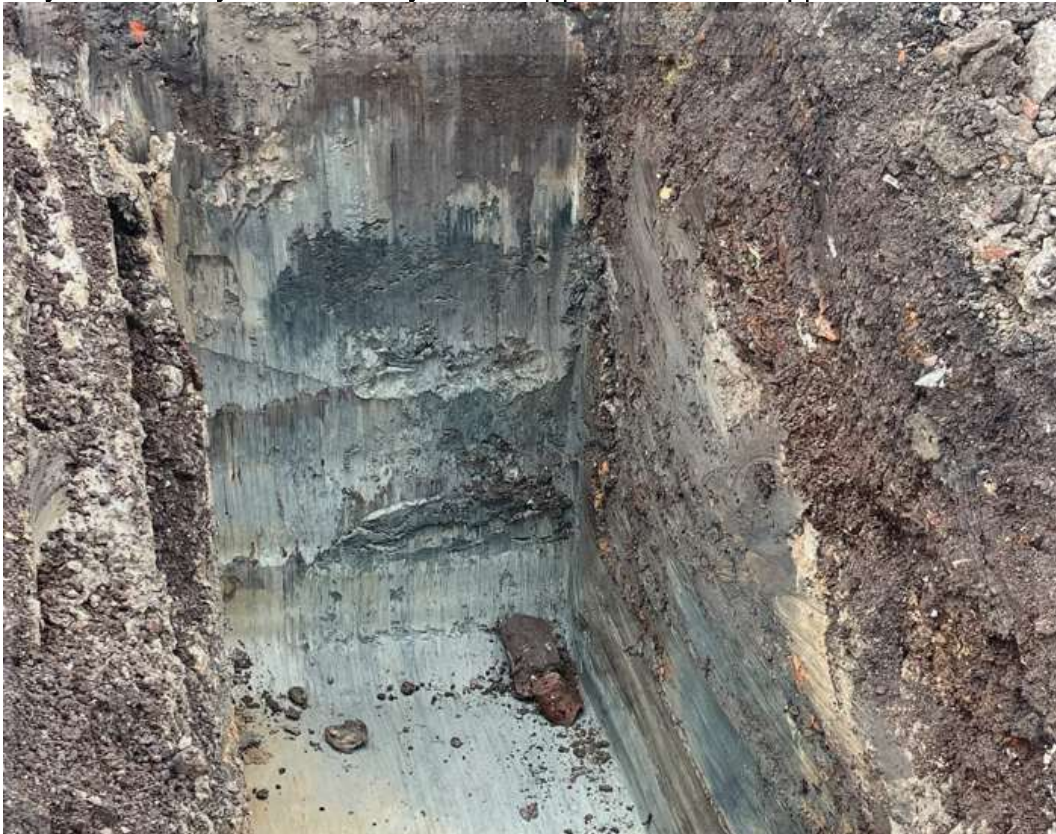
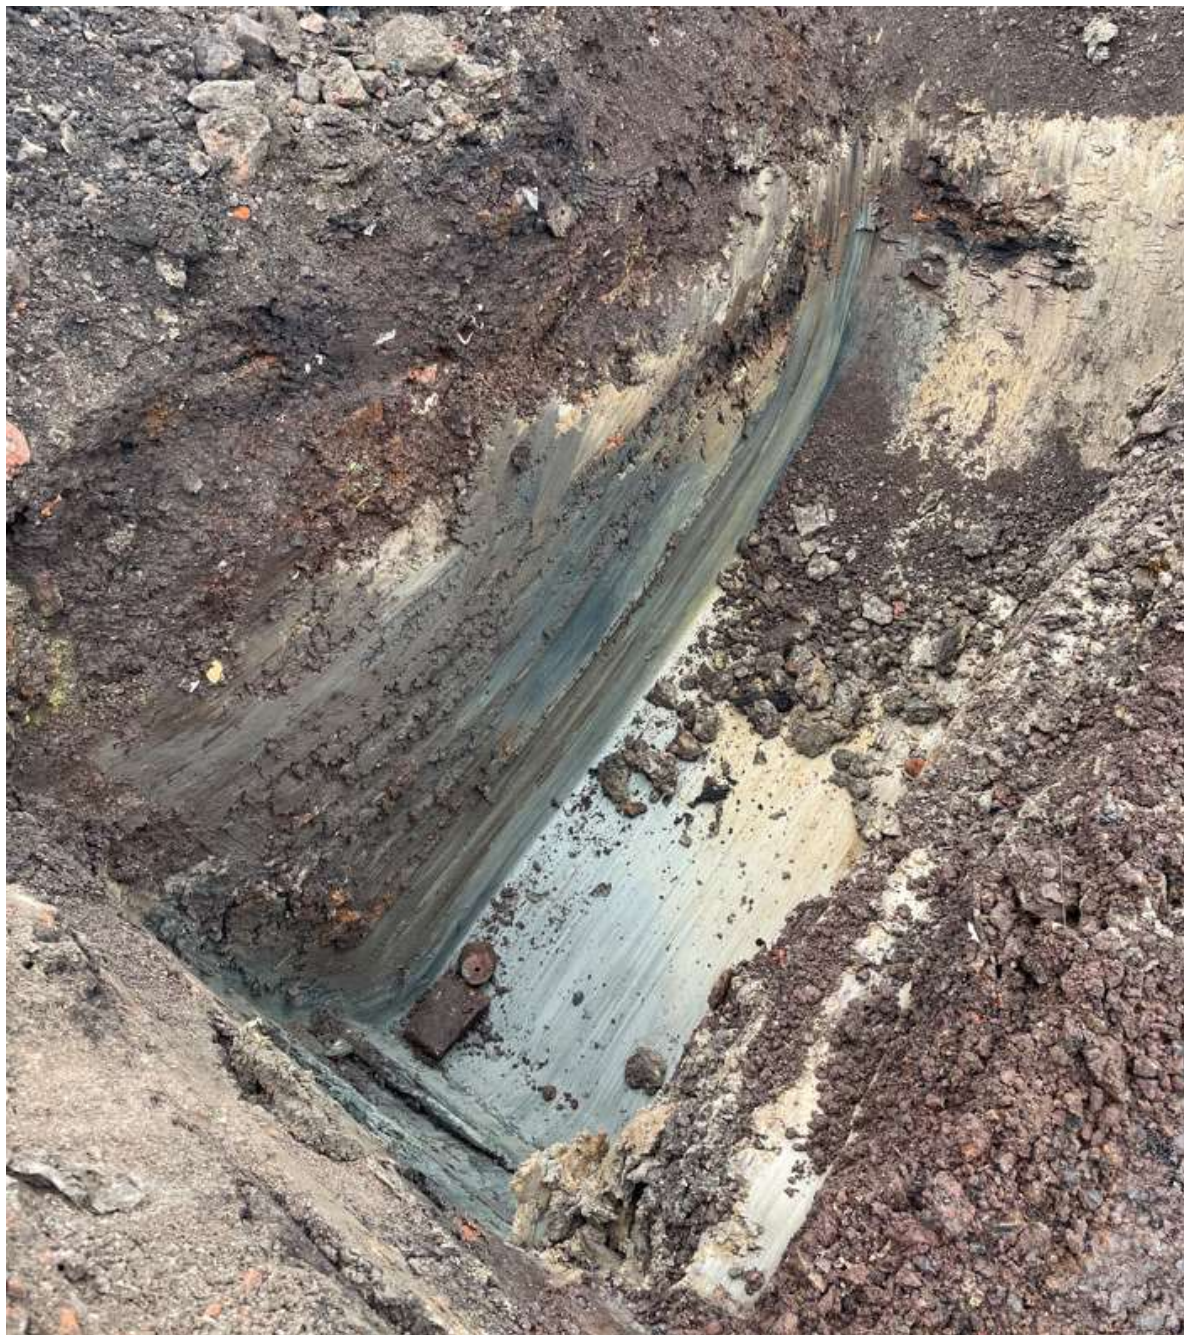
There was approx. 400/500 of existing site fill/stone from E.G.L until we reached the clay strata. Clay become very stiff at approx. 500mm. Approx. 1m total from E.G.L

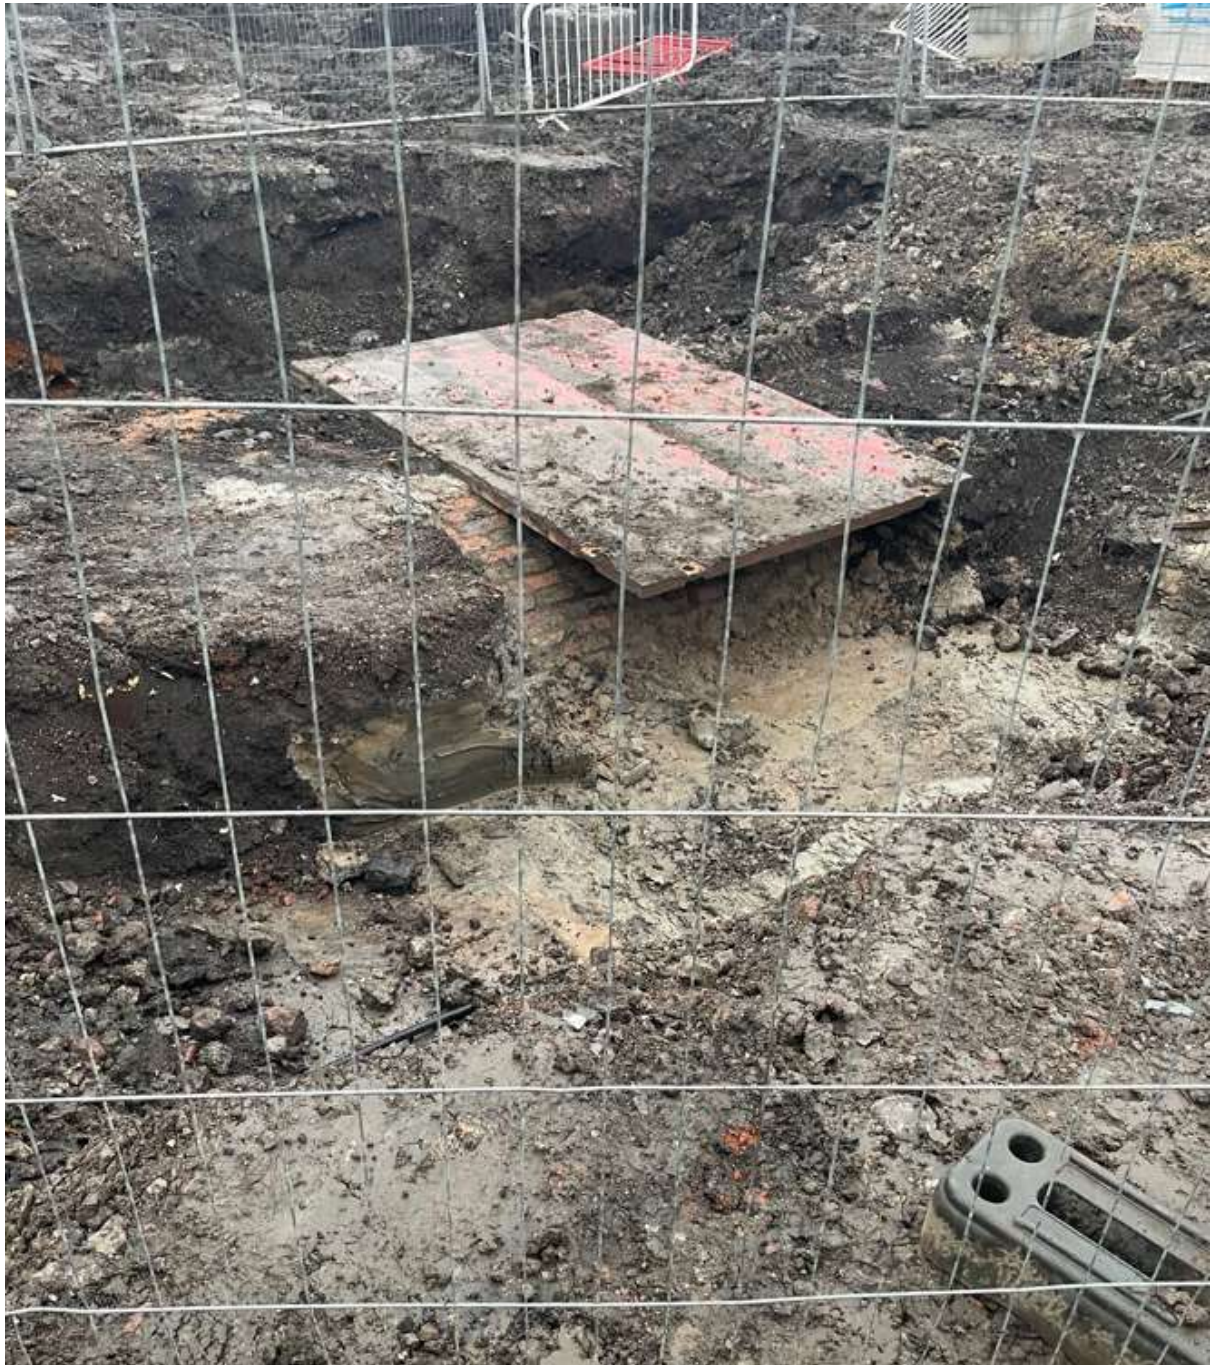
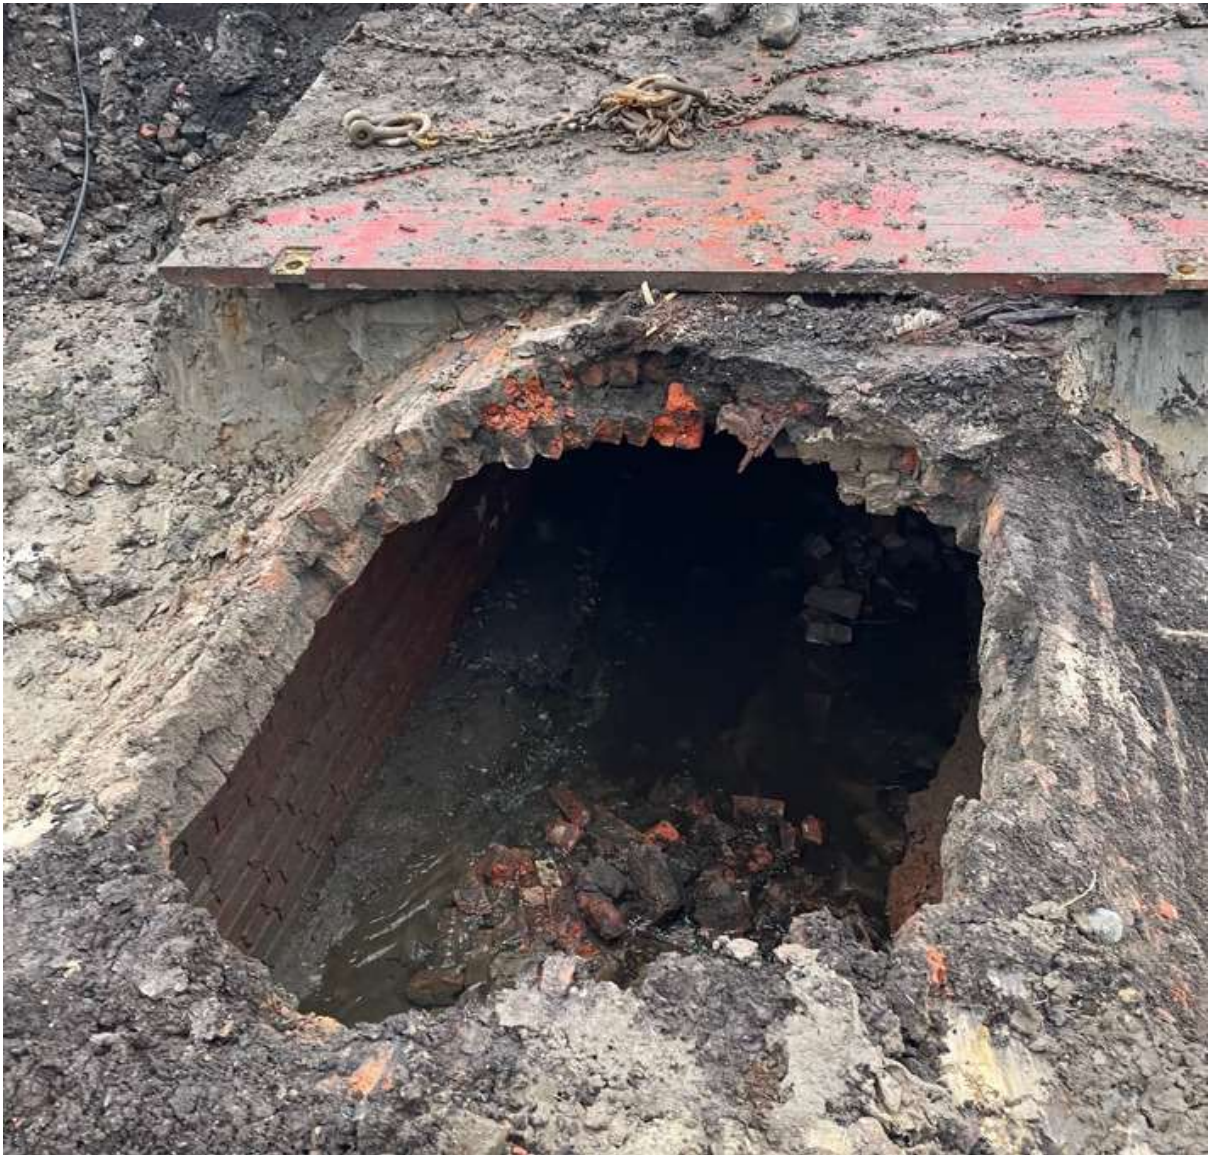
A video can be issue don required which shows the current flow
