An inspection of timber at

CLAYTON HALL, M11 4RU

## INTRODUCTION

Following instructions from Michael Clarkson of Rosslee Construction, I visited the above building on 01.05.24.

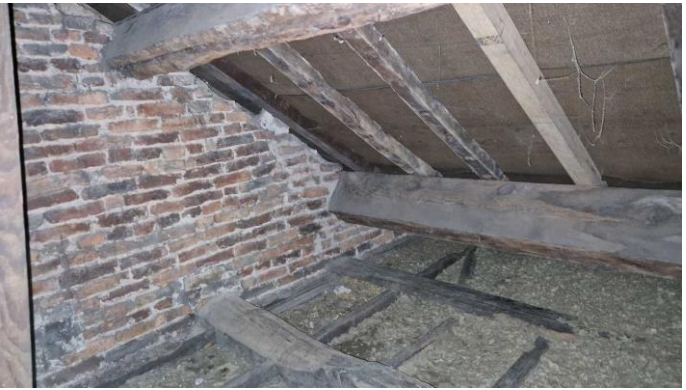
| <p>1</p> <p>Modern felt. Principal timbers with export marks indicating some replacement timber is imported <i>Pinus sylvestris</i>.</p> <p>Some replaced common rafters.</p> | | <p>2</p> <p>General arrangement – no comment.</p> | |

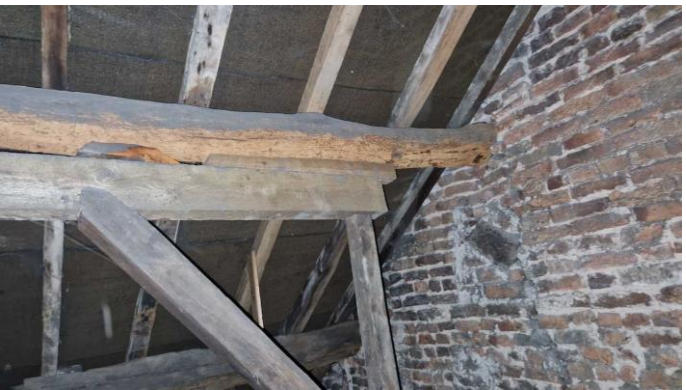
| <p>3</p> <p>Goal post arrangement picking up purlin with reduced section in wall – all historic.</p> | | <p>4</p> <p>General arrangement. See previous photos</p> | |

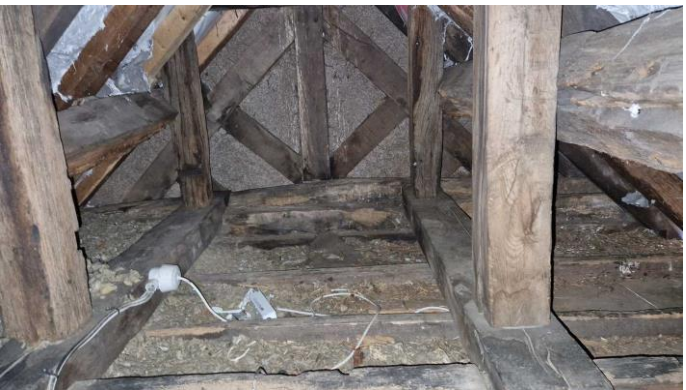
| <p>5</p> <p>General arrangement.</p> | | <p>6</p> <p>Bell turret foundation beams all sound. See previous photos.</p> | |

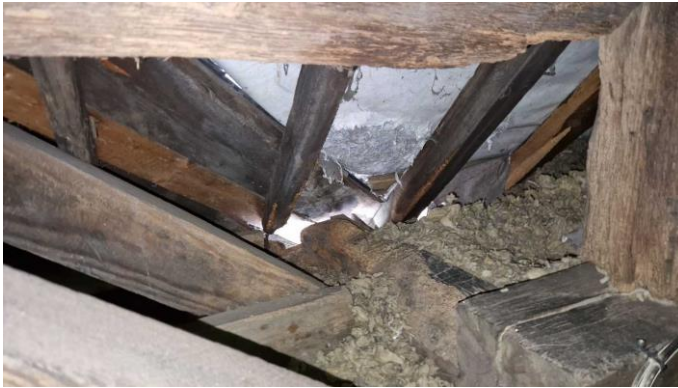
7

Probable entry point for squirrels and birds. No evidence of nesting found.

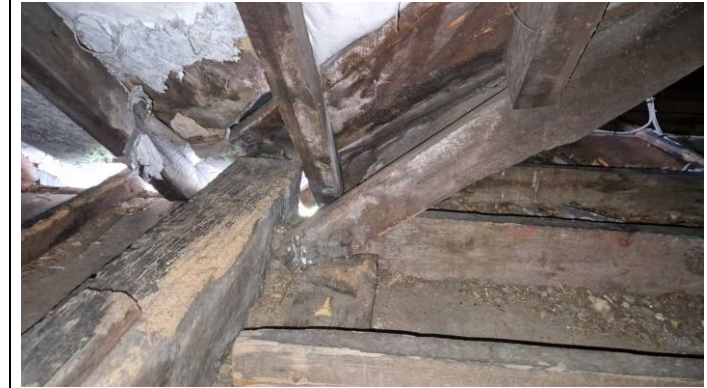
8

Comment as 7.

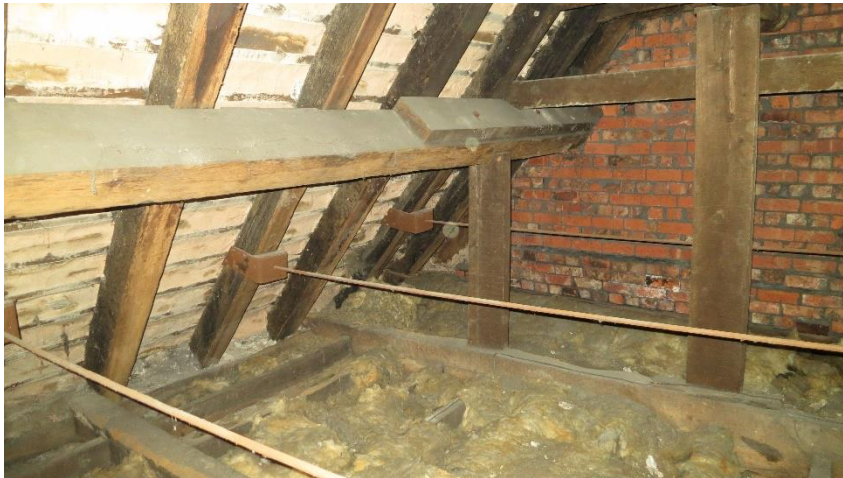
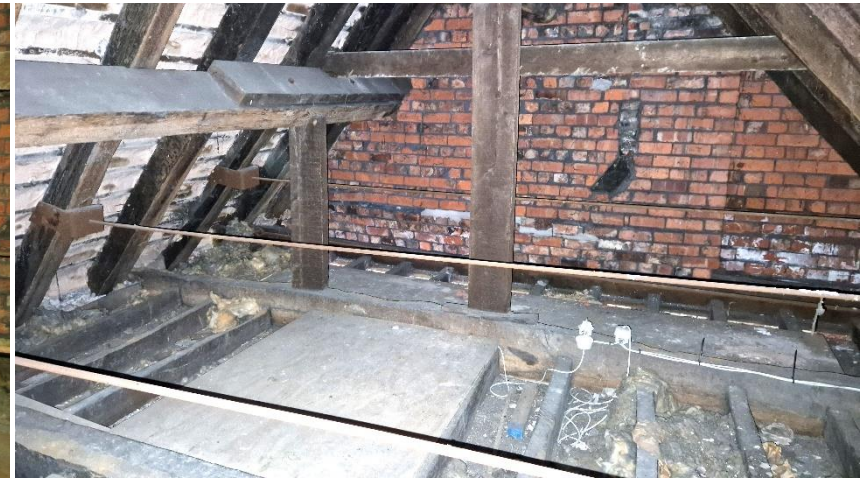
9

The nearest photo shows the detail in 2015. The furthest in 2024. (Resolution good to 300%).

The open brickwork does not seem to have moved significantly since 2015.

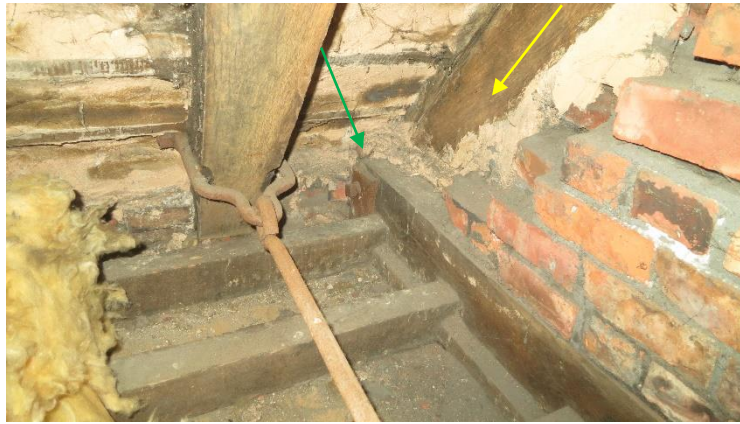
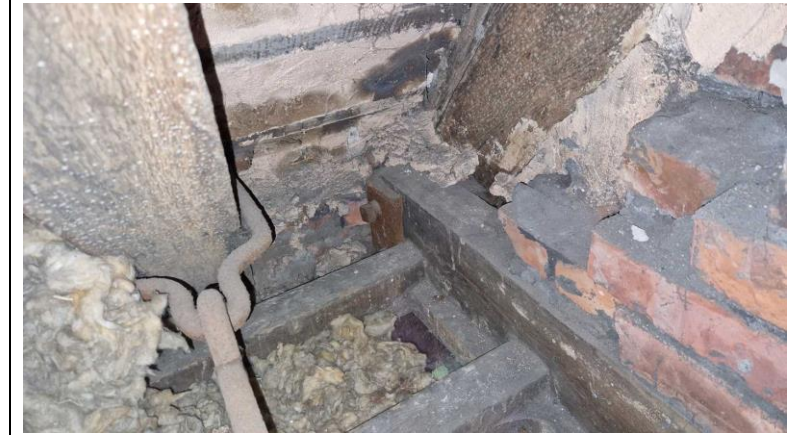
10

The photos – in the same order – also seem to indicate the same – although some loose bricks might have been removed more recently.

The truss is arrowed yellow. An additional (foundation (?)) beam has been planted in front of the tie beam (angle connection onto rafter plate – green arrow) – to support the ceiling and also the masonry skin above.

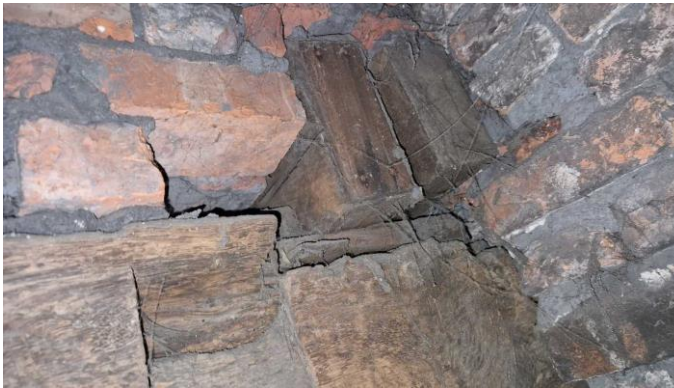
11

Showing the W bearing ends of the tie beam and foundation beam

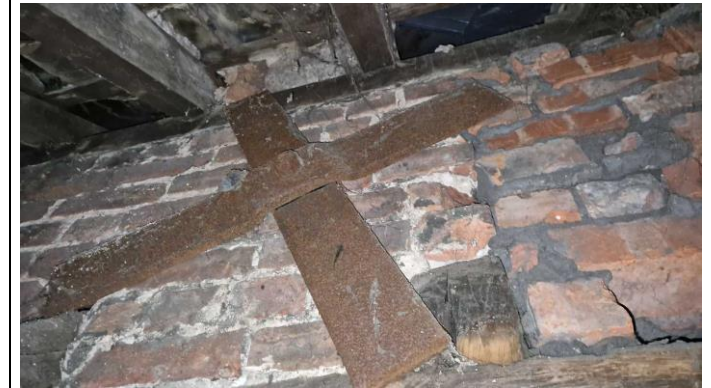
12

W bearing spade end pattress plate for tie beam show in 10.

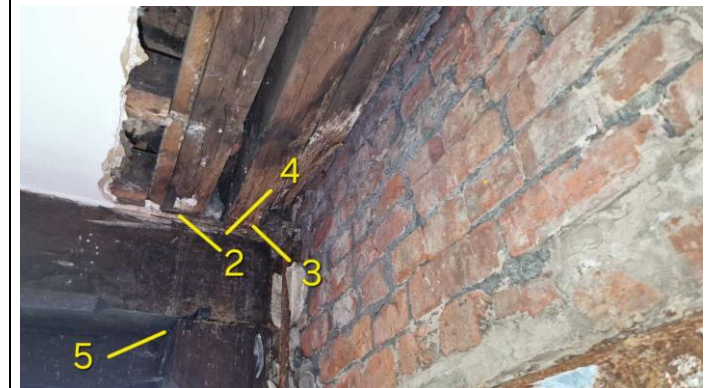
13

The plaster has been stripped around the first floor window on the S wall as part of the works to investigate the movement of the masonry in the S gable. The inner foundation beam has lost some section in the SE corner where it travels over the top of the frame. It was microdrilled (MD 2) and sufficient section was found to remain for the beam to perform. The upper face of the plate was sound at this point also. The bearing of the tie beam was drilled (MD 3) and found to be sound. The top of the frame was microdrilled (MD 4). Drilling showed it has lost some section at its back. This was drilled again (MD 5) and a good trace was obtained from this angle.

The outer timber against the wall seems to be a packer – possibly to pick up the edge of the ceiling. It has previously decayed over the frame.

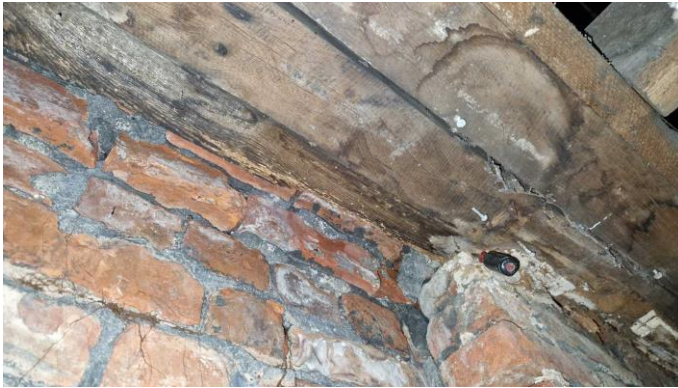
14

The W bearing of the packer (which has no bearing due to previous decay in the SE corner) has decayed over the chimney breast. This decay is of some age.

The packer is in softwood, the tie beam and foundation/ceiling beam are in oak and therefore much more durable.

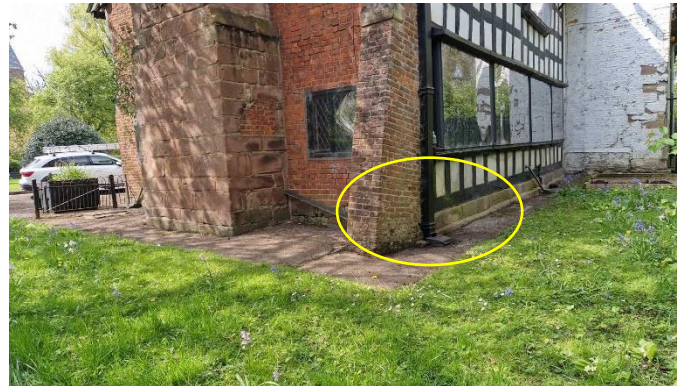
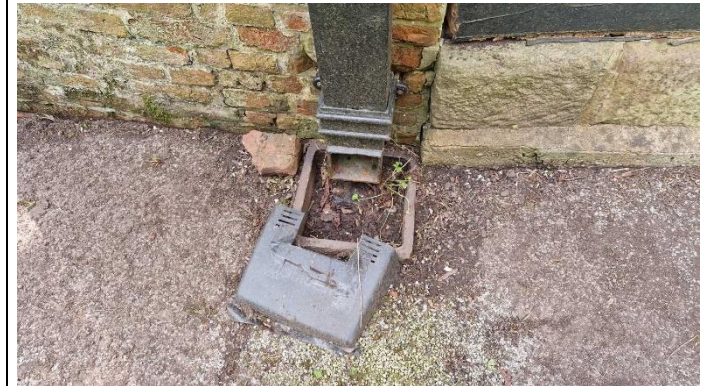
15

The drain for the downpipe in the SE corner of the building is blocked solid – and seems to have been for some time.

Additional perimeter water from the E side of the building will collect and be focused towards this corner.

Also, at its base, the SE corner is very vulnerable to focused wetting – which could result in a degree of subsidence. Although there were no elevated internal timber moisture contents in this corner, the drainage system must be overhauled as a priority – and the external perimeter surface should be profiled to collect and discharge all water clear of the building. From memory after a look below floorboards – there may already have been some relatively recent remedial work carried out at ground floor level in this corner (?)

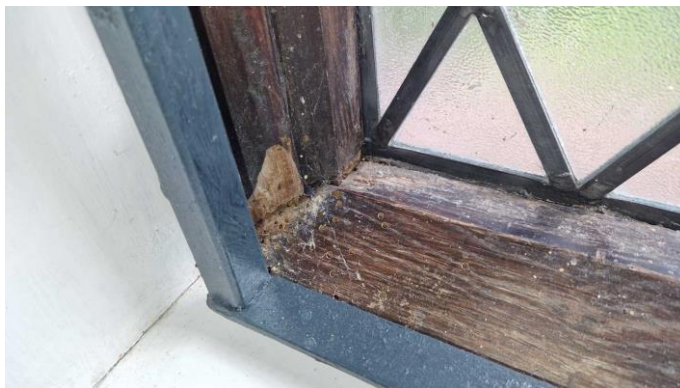
16

There is a very low level of deathwatch beetle activity in the frame of the bathroom window – one beetle found. No action other than to ensure the building envelope remains watertight.

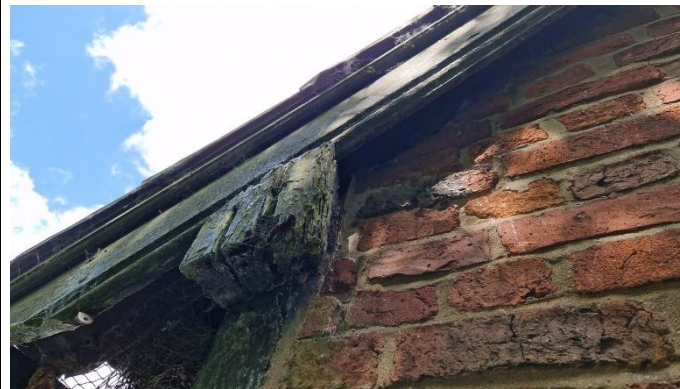
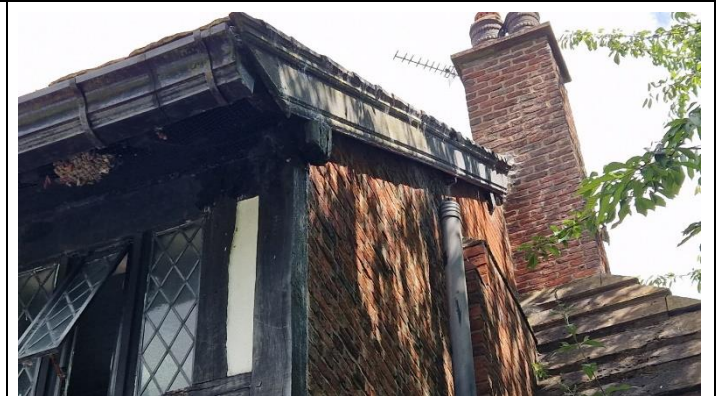
17. Verge board support and bracket require replacement.

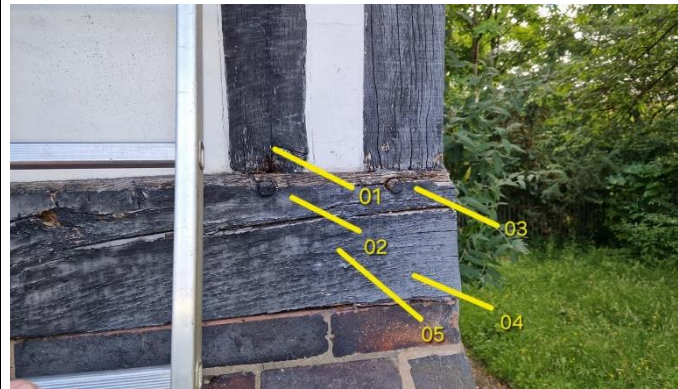
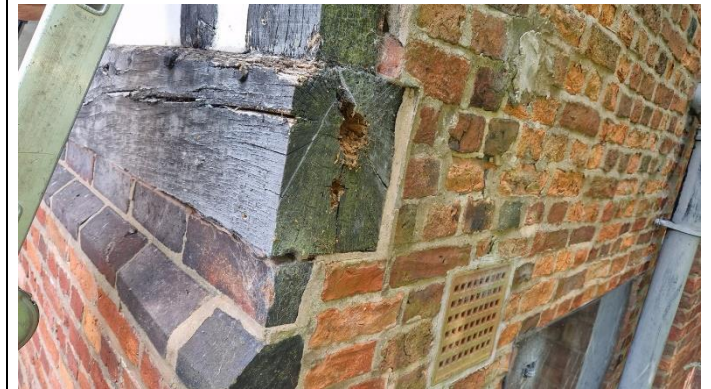
18. Decay to juvenile wood (pith). Micro drilling shows good section remains (MD2 to 5, as marked). MD 1 shows loss of section to post foot - see ob 19 below.

Based on the micodrilling, there has been very little change in the condition of the frame – possibly with the exception of ob 18 – where a cavity in the end grain may have opened up slightly. As such, the original comments from the 2015 survey still apply.

Possibly consider filling the small cavities at end grain for weather proofing.

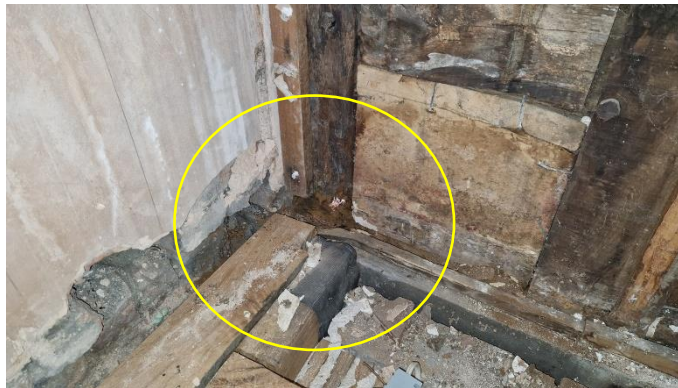
19. Base of wall stud has lost connection, where historic wood borer and possibly decay has caused loss of section to the end of the post and the mortise of the rail. Either replace stud or affect sectional face repair on this side.

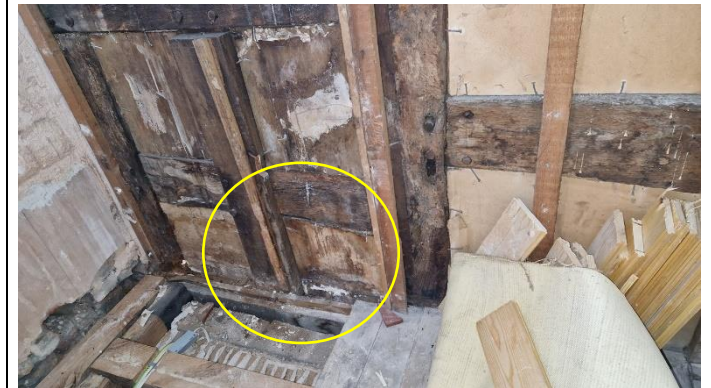
20. Mortise has enlarged historically although connection is still viable. There is some slight instability in the panel which could be improved by stabilising the stud/plate connection.

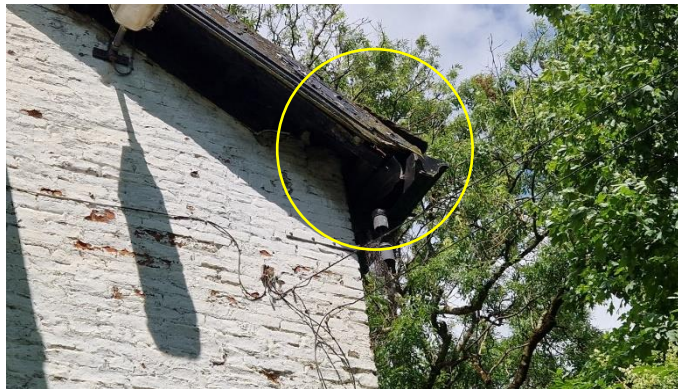
21. The foot of the end rafter, verge board and rafter plate have all lost section historically – presumably due to blocked eaves gutter – and would benefit from local repair.

There is localised decay to timber roof joinery at high level. This will require close platformed access to affect repair. Internally the roof structures are sound.

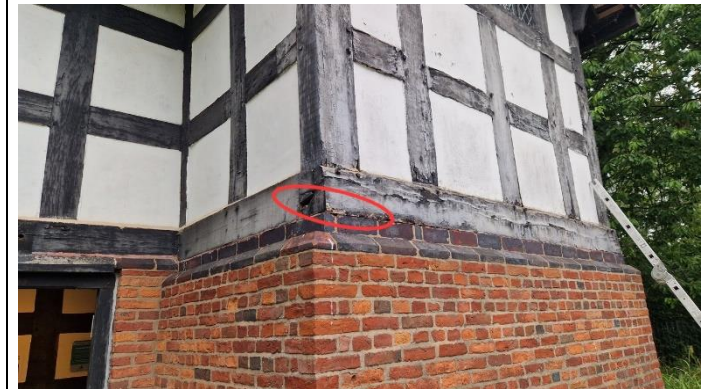
22. Historic decay to end of sole plate – see SP12/13 below.

| SP12/13 | 21 | Trace indicates pocket of decay – probably lower channel has become enlarged.<br><br><b>See discussion.</b> | 19 | Trace indicates a pocket of decay. |

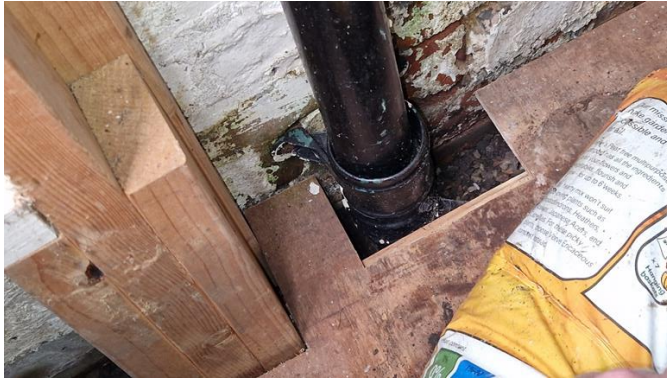
23. It is understood this downpipe is blocked and floods the surrounding area regularly. As with previous comments, the condition of all subsurface drainage is integral to the overall condition of the building.

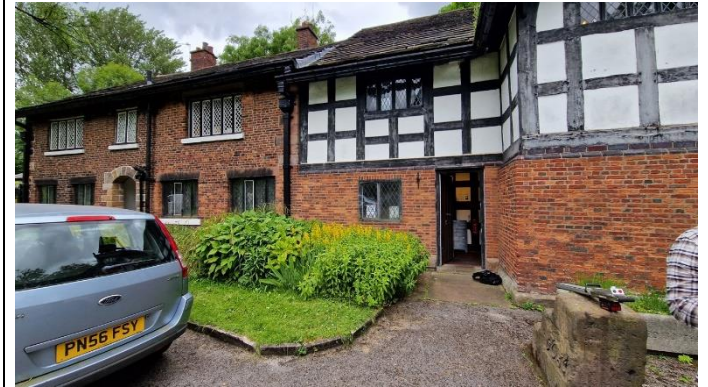
24. Foliage obscured access to downpipe.

Again see comments regarding drainage survey.

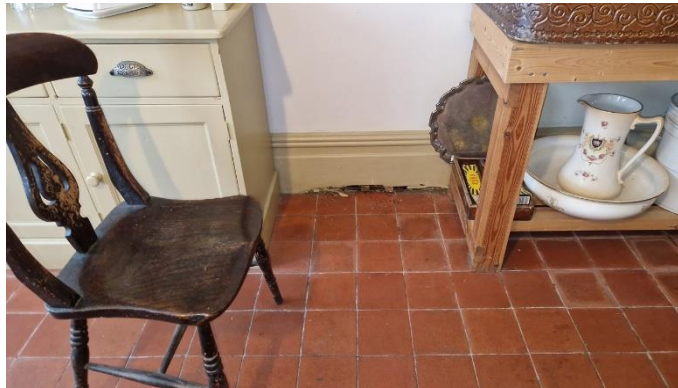
25. Historic (the timber is currently dry) decay to the base of the softwood skirting board which requires replacement.

The damage seen in obs 25 and 26 would seem to be a direct result of the problems with the downpipe in ob 23.

There is some historic decay to the base of the softwood skirting in the kitchen, the result of periodically blocked drains.

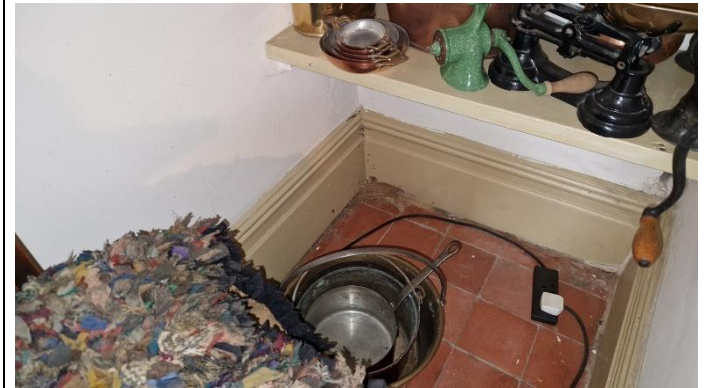
26. Decay to the skirting board, requires replacement.
