## CCTV Inspection Report

**KFC  
BAGULEY  
M23 9TJ**

**14/10/2024**

# UK Drainage Services

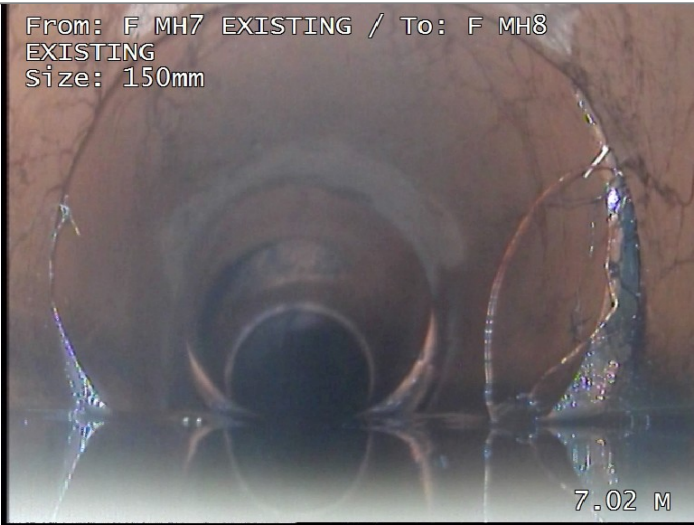
| Start Node Ref:F MH7 EXISTING I/L :mm | | | | Photo | Type/Grade |
|---|---|---|--|---|---|
| 7.02 | JD | Joint displaced 15mm | | 10508700 | Structural / 3 |
| 7.02 | RFJ | Roots fine, at joint | | 10508701 | Service / 2 |

| Job Number | Surveyed by (Operator) | Base Unit | Date |
|---|---|---|---|
| <div> <div> <p>From: F MH7 EXISTING / To: F MH8 EXISTING<br/>Size: 150mm</p> <p>7.02 M</p> <p>Joint displaced 15mm</p> </div> <div> <p>From: F MH7 EXISTING / To: F MH8 EXISTING<br/>Size: 150mm</p> <p>7.40 M</p> <p>Joint displaced 10mm</p> </div> </div> | | | |

| Job Number | Surveyed by (Operator) | Base Unit | Date |
|---|---|---|---|
| <p>3: Constructional deficiencies diminishing static, hydraulic and tightness: Eg. untorched intakes, cracks, minor drainage obstructions such as calcite build ups, protruding laterals, minor damages to pipe wall, individual root penetrations, corroded pipe walls etc.</p> <p>REHABILITATION IS NECESSARY MEDIUM-TERM WITHIN 3 TO 5 YEARS.</p> | | | |

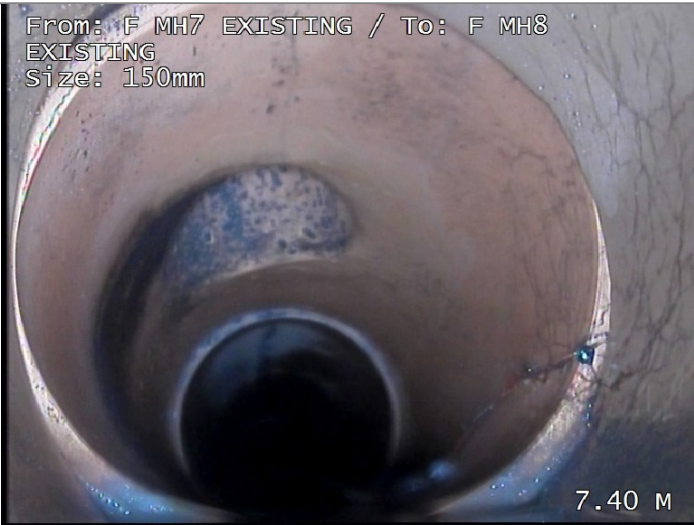
| Start Node Ref:F MH7 EXISTING I/L :mm | | | | Photo | Type/Grade |
|---|---|---|--|---|---|
| 7.40 | JD | Joint displaced 10mm | | 10508706 | Structural / 3 |
