## **Insitu Vs Offsite Restoration**

### ***Rylands Building, Manchester***

## **Project Specific – Rylands Building, Manchester**

### **Clock Restoration Proposal**

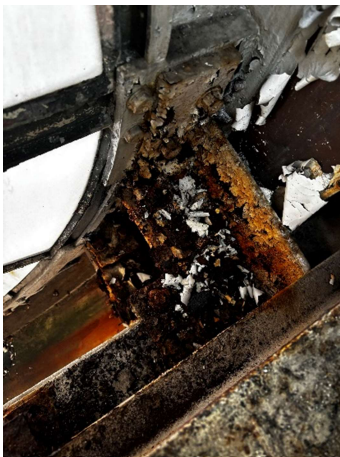
Whilst the clock appears to be in good complete condition externally, our brief site visit including access inside the clock revealed areas of the supporting internal steel framework within that was water logged and heavily corroded in several areas. This poses concerns and doubts as to the condition and its long term structural integrity.

*Figure 1 - Evident corrosion on the internal structure of the clock*

The clock should be carefully surveyed by note and photograph, the components tagged and carefully removed as far as possible to allow the structure to be assessed by a structural engineer and a specification of repair developed. All removed items will be restored offsite and reinstated to their original positions upon installation at a later date. The remaining structural elements remaining on site could then be restored insitu.

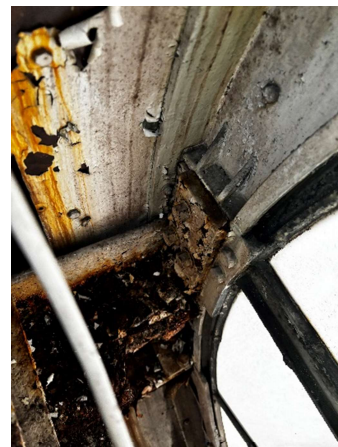
*Figure 2 - Evident corrosion on the internal structure of the clock*

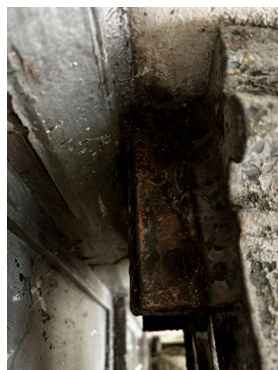
Both the spandrels & balconies appeared complete and in good condition aesthetically (all items appear to be present with no visible damage) however, similarly to those previously mentioned above, there is evident rust build up at the joints / fixings. Corrosion in connections causes pressure to increase over time until eventually the casting or fixing fails to relieve the stress within, potentially allowing heavy components to break away. There are obvious health and safety concerns connected to this that need to be considered.

With both the balconies and corner spandrels being constructed of cast iron, regular maintenance, paint touch up of any damaged is imperative to structural longevity. This has evidently been neglected over the years.

*Figure 3 - Evidence of corrosion & detritus on the connection detail*

Following removal of the panels back to our workshop, we will blast clean to SA 2.5 standard (in controlled conditions due to lead based paint being assumed), undertake a condition survey of all removed items to determine their true condition, carry out any agreed repairs noted, then drill and tap any fixings and make ready for installation, then finish paint using our heritage approved paint system to all areas of the ironwork.

Once fully restored, we will install into the original stubs with new fixings throughout. Providing long lasting paintwork and structural integrity.
