### DECK SURFACE - EXAMPLE PHOTOGRAPHS

Castlefield Viaduct  
Phase 2

Remedials  
Deck Plate

ID CVI-ARUP-ZZ-ZZ-DR-S-4025

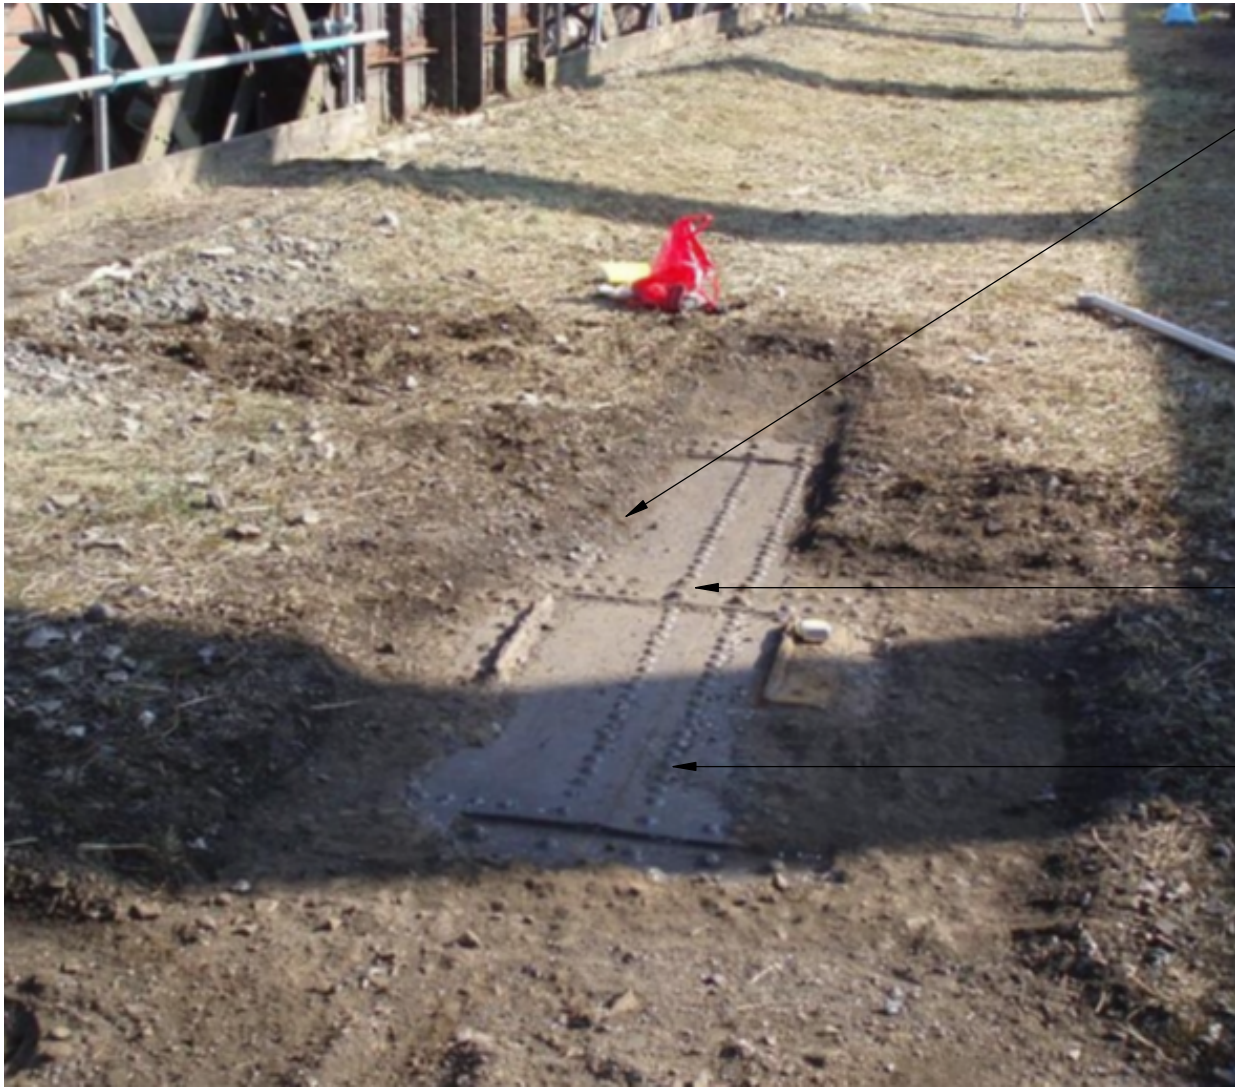
Exposed deck plate and rivets  
- from Balfour 2020 survey  
- location unknown

Exposed deck plate where  
ballast has been removed  
- span 6

Rivet heads from connection  
into transverse beam

Rivet heads from connection  
into longitudinal beam

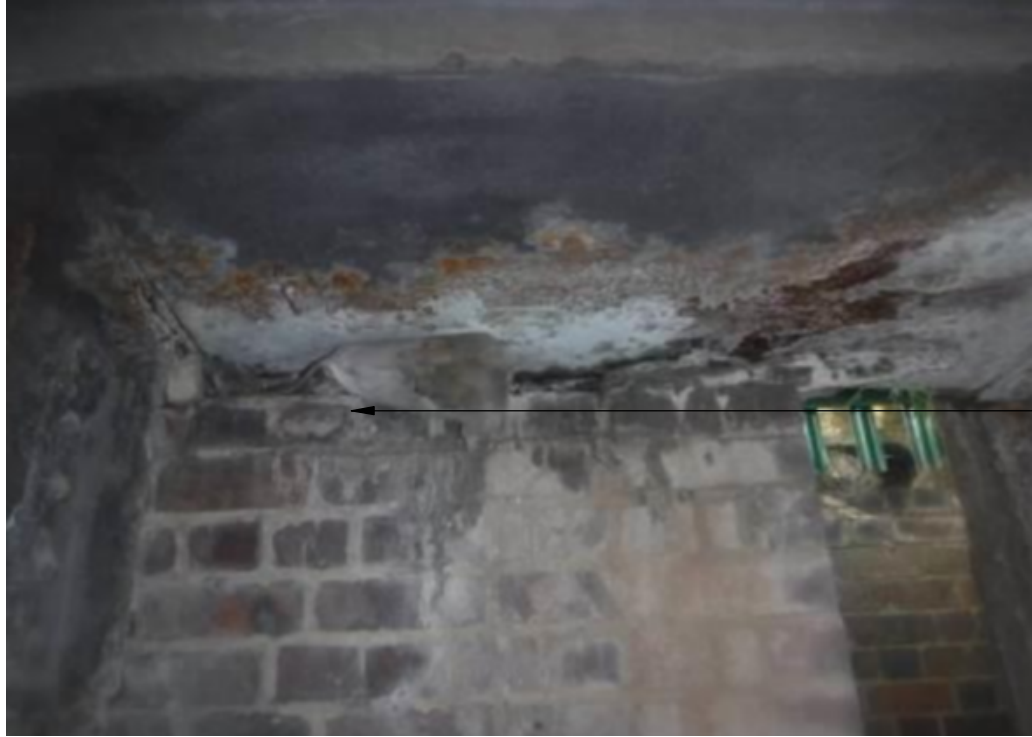
Loss of thickness  
to deck and loose  
debris at span 8

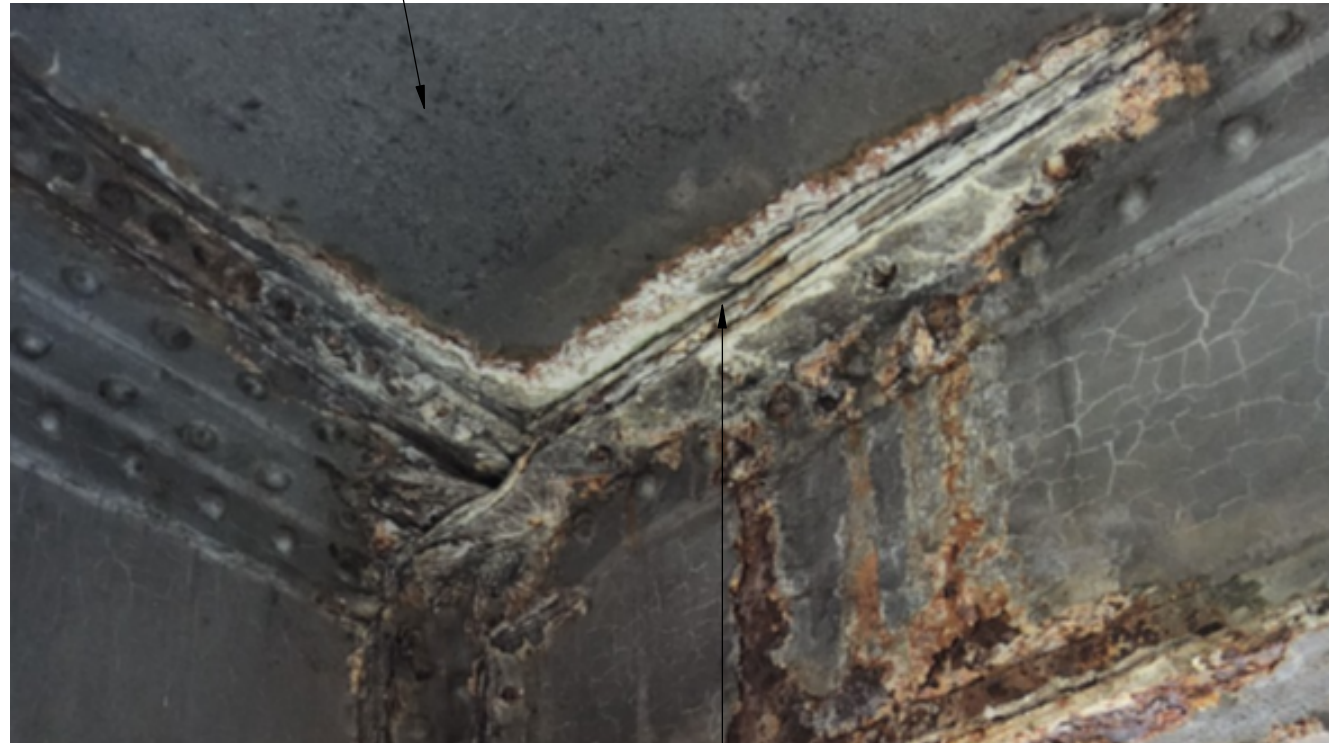
Existing deck plate  
- shown as 3/8"  
(9.5mm) thick on  
archive drawings

Corrosion to longitudinal beam top  
plate  
- plus suspected associated corrosion  
to deck plate  
- location of water ingress through  
waterproofing, span 3

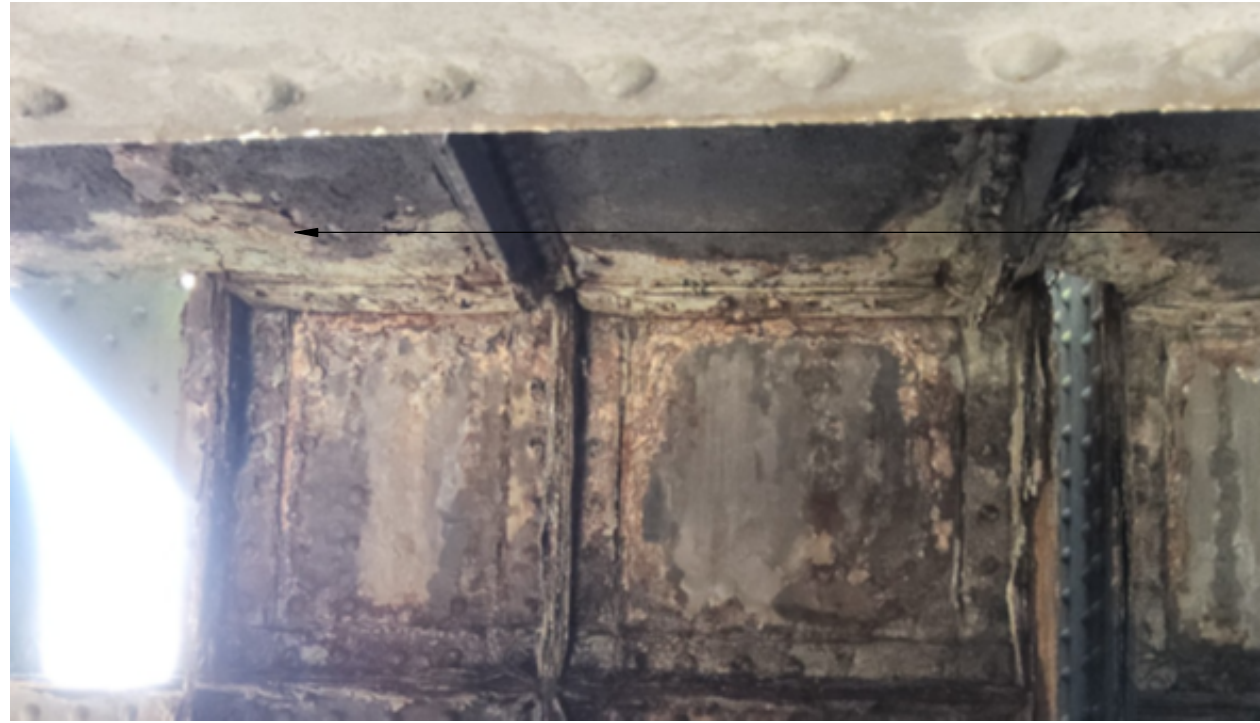
Loss of thickness  
to deck near piers  
- span 3

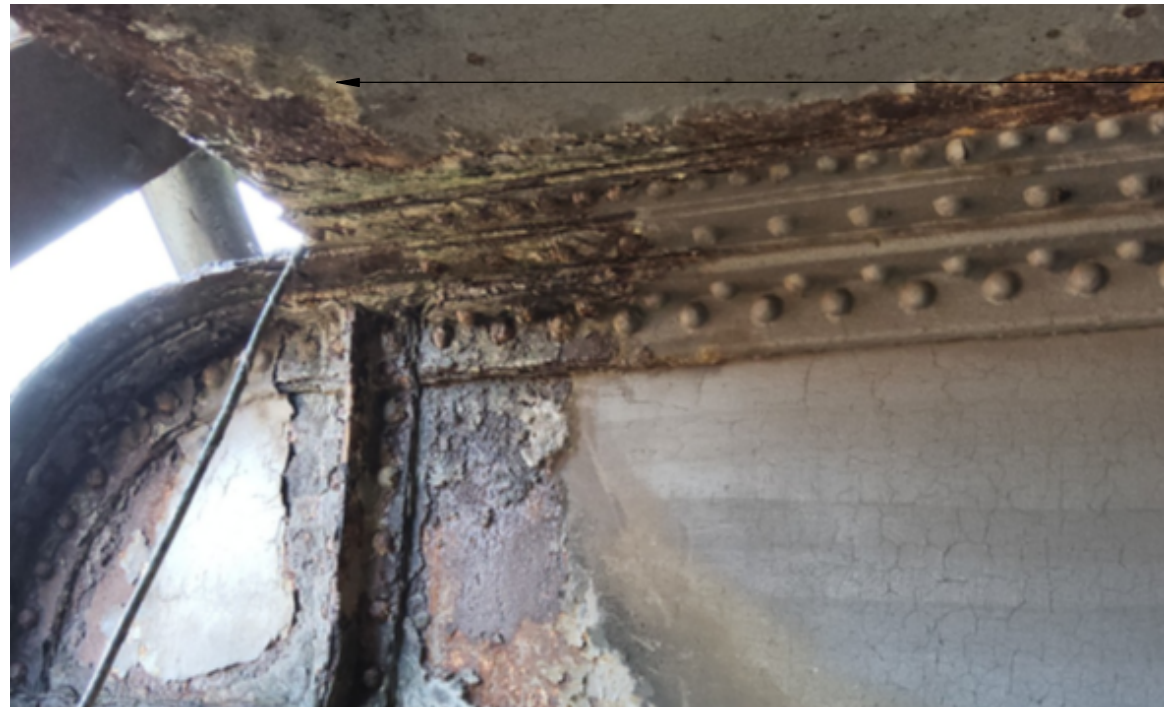
Loss of thickness  
to deck edge  
- span 3

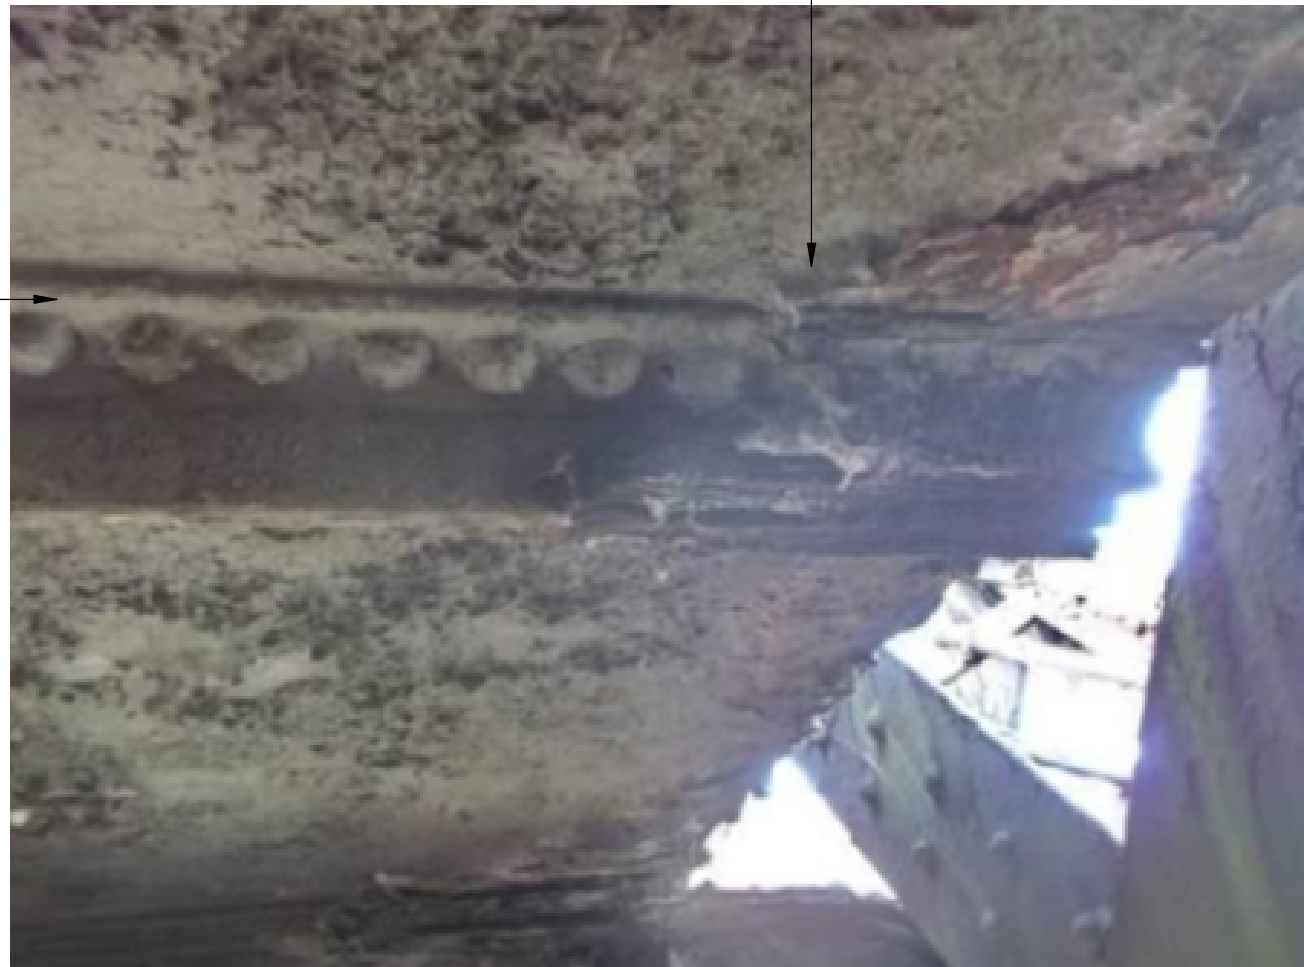
Loss of thickness to  
deck edge and  
stiffener at span 7
