## ASBESTOS REFURBISHMENT SURVEY REPORT

| <b>Site</b> | Brunswick (B Lounge), 97 Piccadilly, Manchester, M1 2DB |
| <b>Date report issued</b> | 6th January 2025 |
| <b>Survey reference</b> | J1104079 |

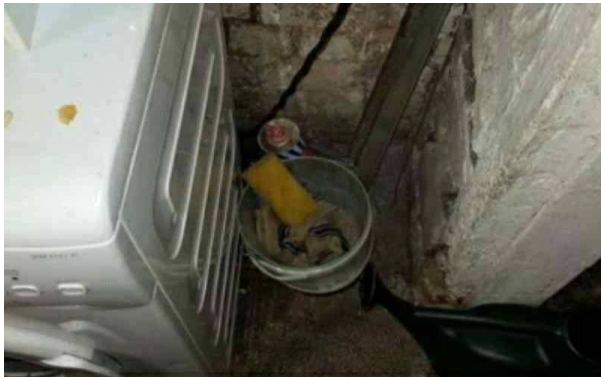
| Item / Inspection Ref: | #2 | Material Assessment | Product type: | 2 | | | |

| Comments: | During the asbestos re-inspection undertaken on 28/07/2023 it was identified that this material has been removed, which is understood to have been completed by iES in July 2022. | | | | | |

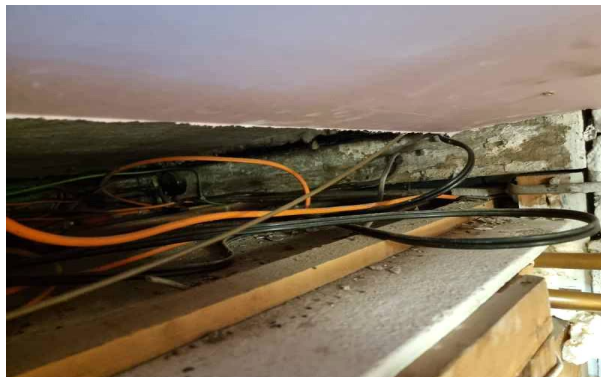
| Comments: | Strongly presumed to be as sample ES/68997/05. This material is presumed to continue throughout the void. On 04/08/2023 ARD Industrial Services Ltd removed the accessible area of this material and enclosed the hole in the ceiling. The ceiling void is contaminated and should not be accessed until removal works have been completed. | | | | | |

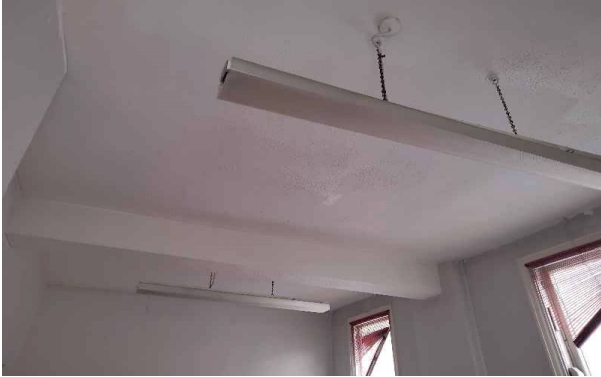
| <b>Item / Inspection Ref:</b> | #8 | <b>Material Assessment</b> | Product type: | 1 | | |

| Comments: | On 04/08/2023 ARD Industrial Services Ltd encapsulated the accessible unsealed areas of this material and enclosed the holes in the suspended ceiling. The ceiling void is contaminated and should not be accessed until removal works have been completed. | | | | | |

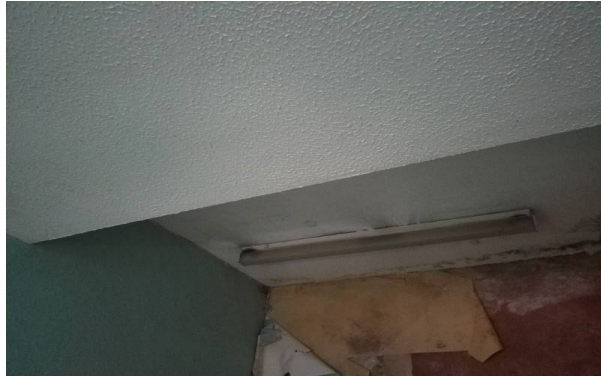
| Comments: | The unsealed areas have been encapsulated by Winsulate on 06/03/2019. This material was overboarded by Winsulate on 29/05/2020. Debris is presumed to be throughout the ceiling void and therefore this area is contaminated and access should be restricted until remedial works have been undertaken. | | | | | |

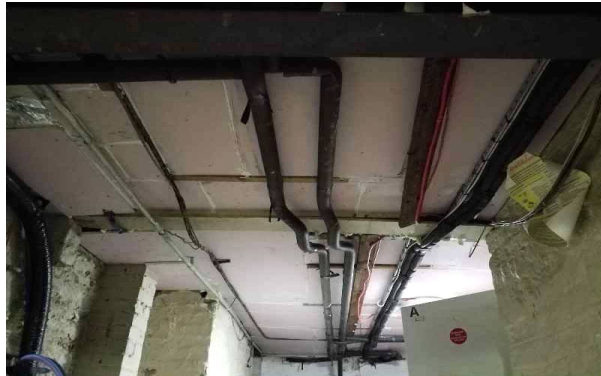
| Comments: | The unsealed areas have been repaired and encapsulated by Winsulate on 06/03/2019. | | | | |

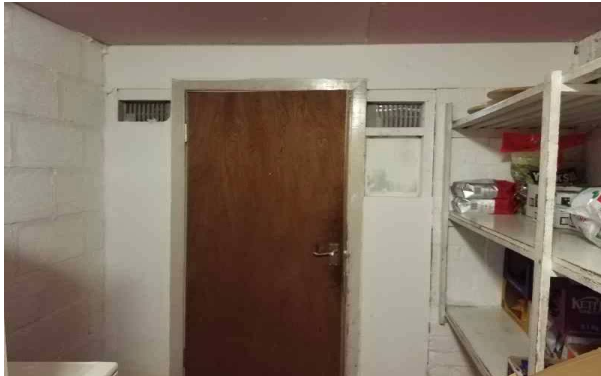
| Comments: | The unsealed areas have been encapsulated by Winsulate on 06/03/2019. This material was overboarded by Winsulate on 29/05/2020. Debris is presumed to be throughout the ceiling void and therefore this area is contaminated and access should be restricted until remedial works have been undertaken. | | | | |

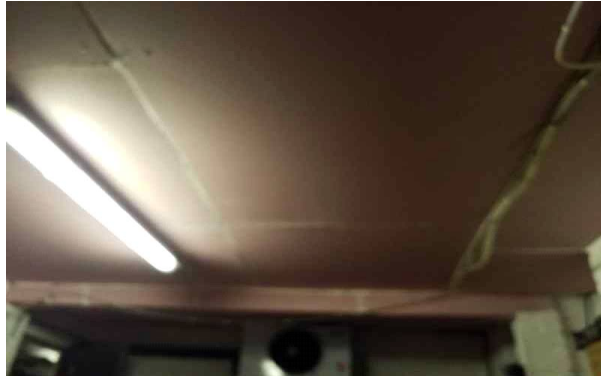
| Item / Inspection Ref: | #21 | Material Assessment | Product type: | 2 | |

| Comments: | This material was overboarded by Winsulate on 29/05/2020. This area is contaminated and therefore access should be restricted until remedial works have been undertaken. | | | | |

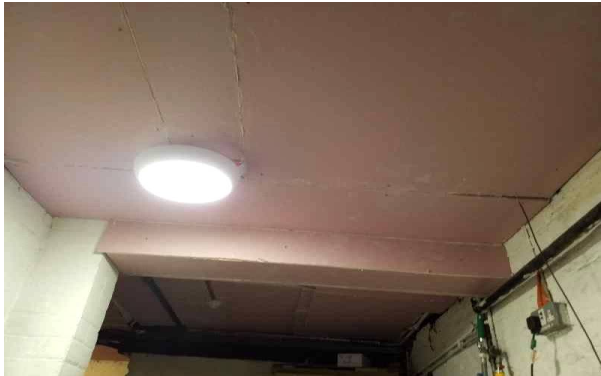
| Comments: | This material was overboarded by Winsulate on 29/05/2020. This area is contaminated and therefore if any works are required in this area, remedial works will be required. On 04/08/2023 ARD Industrial Services enclosed the holes in the suspended ceiling. | | | | |

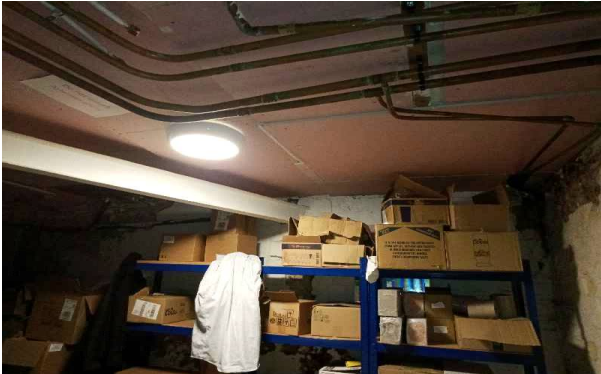
| Comments: | The unsealed areas have been encapsulated by Winsulate on 06/03/2019. This material was overboarded by Winsulate on 29/05/2020. Debris is presumed to be throughout the ceiling void and therefore this area is contaminated and access should be restricted until remedial works have been undertaken. | | | | | |

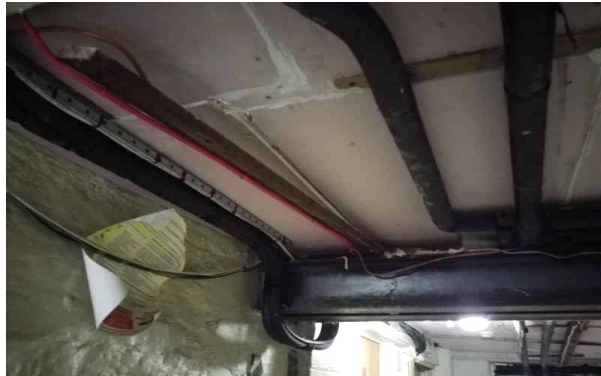
| Comments: | This material was overboarded by Winsulate on 29/05/2020. During the asbestos re-inspection undertaken on 28/07/2023 it was identified that the hole in the ceiling had been over boarded, which is understood to have been completed by IES in July 2022. Debris is presumed to be throughout the ceiling void and therefore this area is contaminated and access should be restricted until remedial works have been undertaken. | | | | |

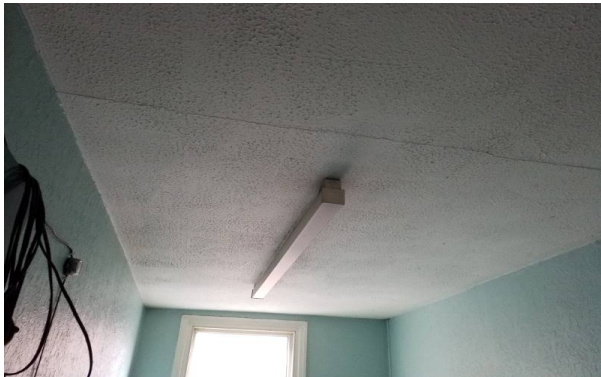
| Item / Inspection Ref: | #31 | Material Assessment | Product type: | 1 | | |

| Comments: | Stipple effect. On 04/08/2023 ARD Industrial Services removed the damaged areas of this material and encapsulated the edges. | | | | | |

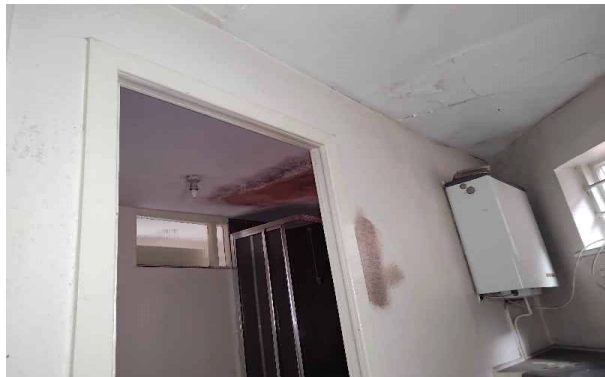
| Item / Inspection Ref: | #32 | Material Assessment | Product type: | 1 | | |

| Comments: | Stipple effect. On 04/08/2023 ARD Industrial Services encapsulated the damaged areas of this material. | | | | | |

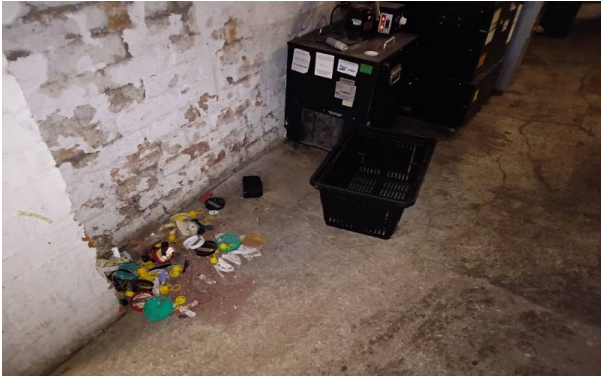
| <b>Item / Inspection Ref:</b> | #36 | <b>Material Assessment</b> | Product type: | 2 | |

| <b>Comments:</b> | During the asbestos re-inspection undertaken on 28/07/2023 it was identified that this material has been removed, which is understood to have been completed by iES in July 2022. | | | | |

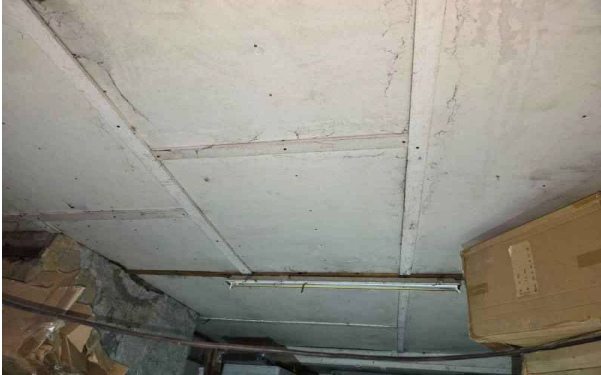
| <b>Item / Inspection Ref:</b> | #67 | <b>Material Assessment</b> | Product type: | | |

| <b>Comments:</b> | No inspection above sampled superlux, insulating board may be present above. | | | | |

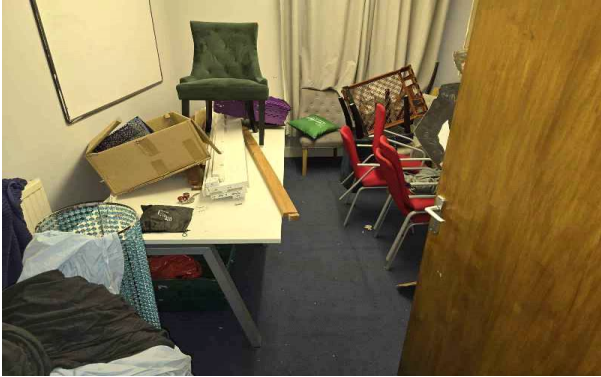
| <b>Item / Inspection Ref:</b> | #72 | <b>Material Assessment</b> | <b>Product type:</b> | | |

| <b>Comments:</b> | Unable to access below floor coverings due to amount of stored items and furniture in room | | | | |
