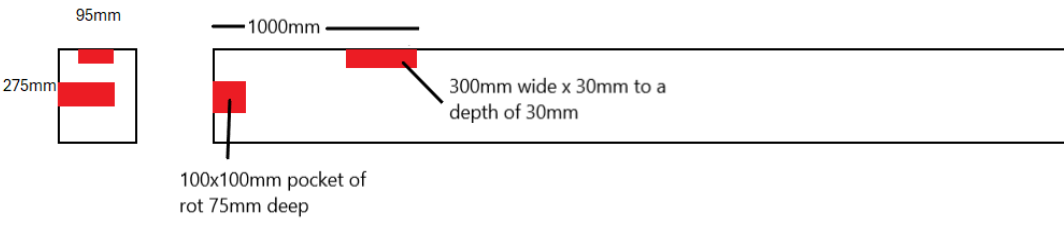
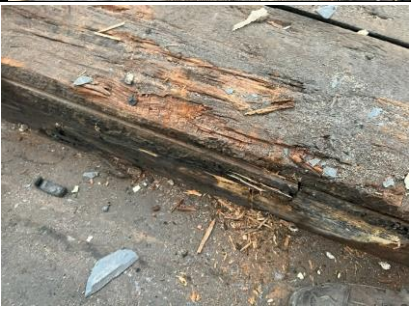
| I/VB/7<br><br>Bearing end opposite VB5 | | <p>Pocket of rot 75mm deep 100x100mm in section</p> <p>Further pocket of rot to top edge 30mm deep 300x30mm in section</p> | | | <div>Recommendations</div> <p>Flitch beam plate repair as per drawings and calculation provided by WMI Consulting</p> <p>Buro Happold Comment</p> <p>Agree with repair to encapsulate both repair location as per email 2-12-2024</p> |

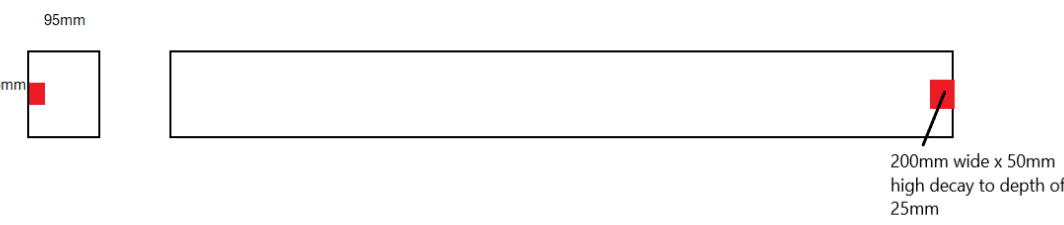
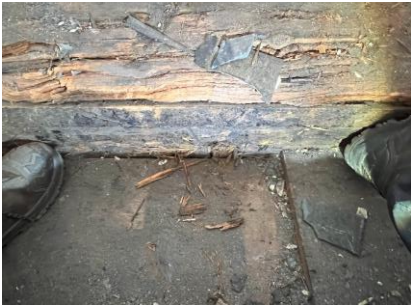
| I/VB/9<br><br>Bearing end opposite VB7 | | | | | <div>Recommendations</div> <p>De-frass the decay back to sound timber and splice a new section wedge shaped glue with Sikadur 31 EF 2 Part Epoxy Structural adhesive</p> <p>Buro Happold Comment</p> <p>Agree with repair as per standard noted as per email dated 2-12-2024</p> |

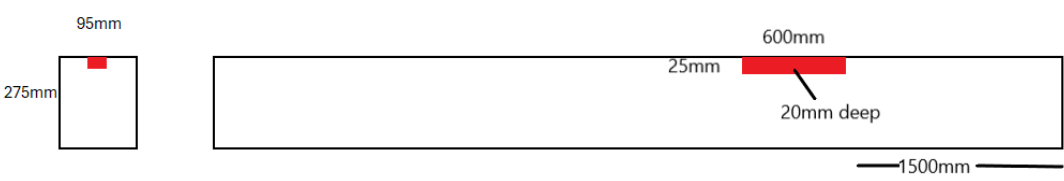
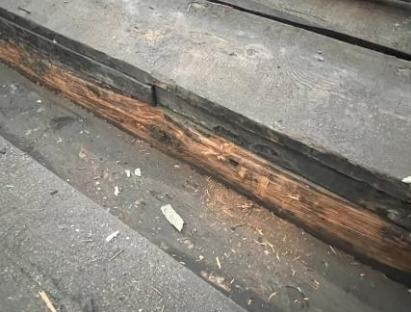
| I/VB/12<br><br>Mid section of the beam | | <p>1500mm from bearing end 600mm wide patch of rot 25mm in height to depth of 20mm</p> | | | <div>Recommendations</div> <p>De-frass the decay back to sound timber and splice a new section wedge shaped glue with Sikadur 31 EF 2 Part Epoxy Structural adhesive</p> <p>Buro Happold Comment</p> <p>Agree with repair as per standard noted as per email dated 2-12-2024</p> |

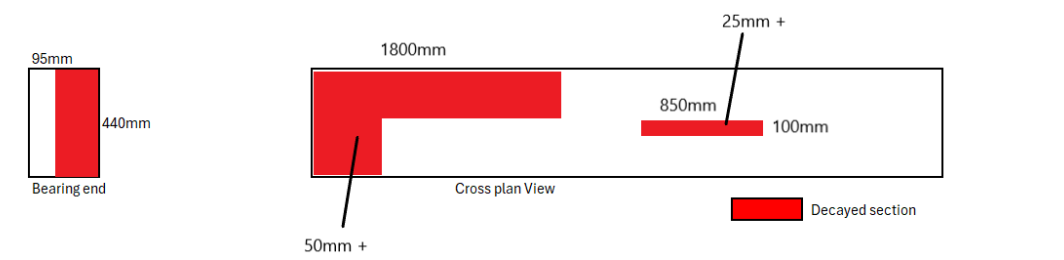
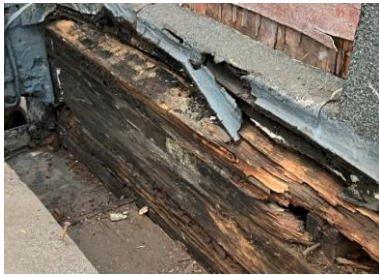
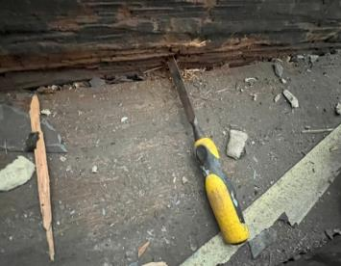
| I/VB/13<br><br>Full length of the beam | | <p>Rot to the inner face to the valley</p> <p>The first 2 metres from the external wall the decay 30 to 50mm to the upper 175mm of exposed beam. Superficial decay to the remaining 3 metres 10 to 15mm deep to upper 175mm of beam</p> | | | <div>Recommendations</div> <p>Fully renew the beam with treated timber in two sections 95x175/265mm C24 Douglas fir timber</p> <p>Buro Happold Comment</p> <p>Agree with replacement to be like for like as per email dated 2-12-2024</p> |

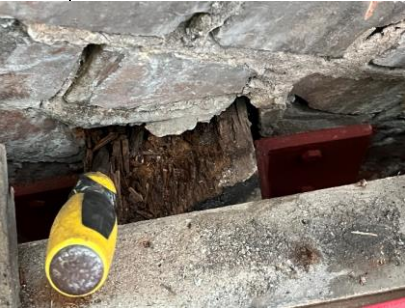
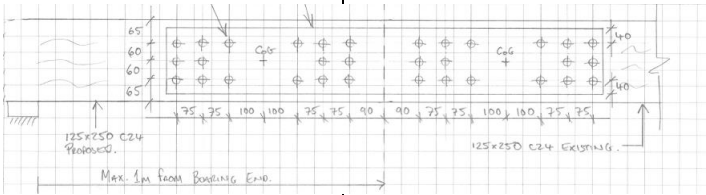
| Purlin end<br><br>Full length of the beam | <p>Decayed purlin end identified in previous reports between Gridlines H and I to elevation facing Power Ro. Confirm decayed to bearing within brickwork.</p> | | <p>WLM Purlin repair</p> | | <div>Recommendations</div> <p>Currently fixed with 2 steel brackets, propose to cut decayed section out of brickwork and support on steel shoe resin bolted to brickwork. No repair required to timber</p> <p>Buro Happold Comment</p> <p>Agree with replacement BH to provide loads . Timber end in the wall to be cut and end Repair to be flitch plate/paated splice as per email dated 2-12-24. RPL designs provided approved in email dated 17-1-2025 from BH</p> |

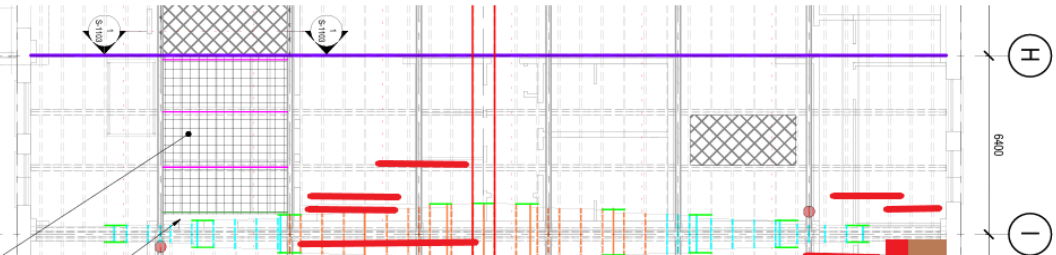
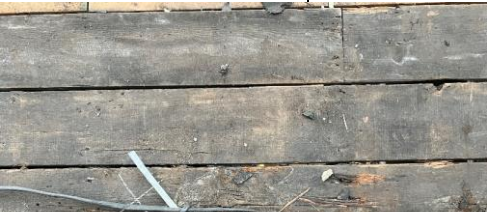
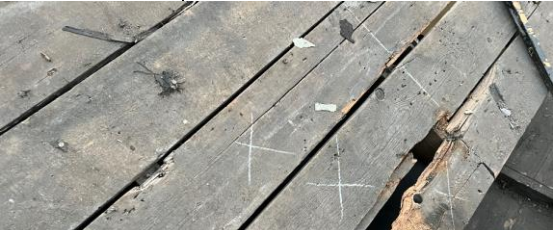
| Sarking board | | | | | <div>Recommendations</div> <p>Renew with Redwood 19x225mm boards</p> |

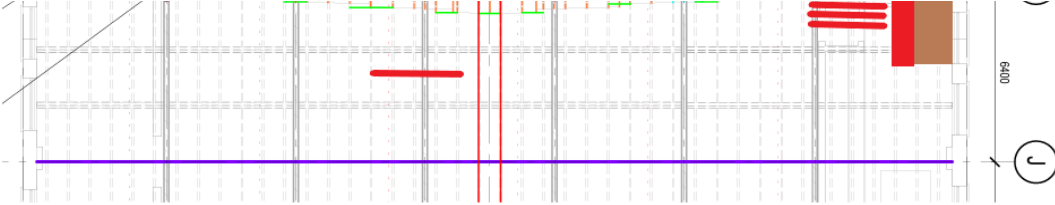
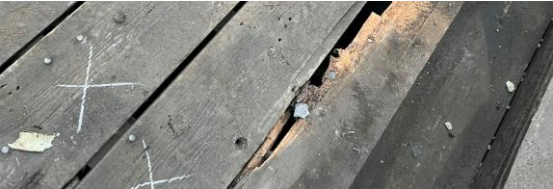
| | <p data-bbox="299 352 839 405">Hatch to be removed by others<br/>Areas of sarking board renewal</p> | <p data-bbox="1320 411 1421 432"><b>BH Comment</b></p> | <p data-bbox="1486 411 2136 432"><u>Robinsons to replace all decayed sarking boards like for like as per email dated 2-12-2024</u></p> |
