## Midland Hotel, Manchester – Fire Damage Repair Work

### METHODOLOGY

To describe a step-by-step process for the removal and replacement of polished granite and overhanging Terracotta damaged by fire in the entranceway to the Hotel restaurant.

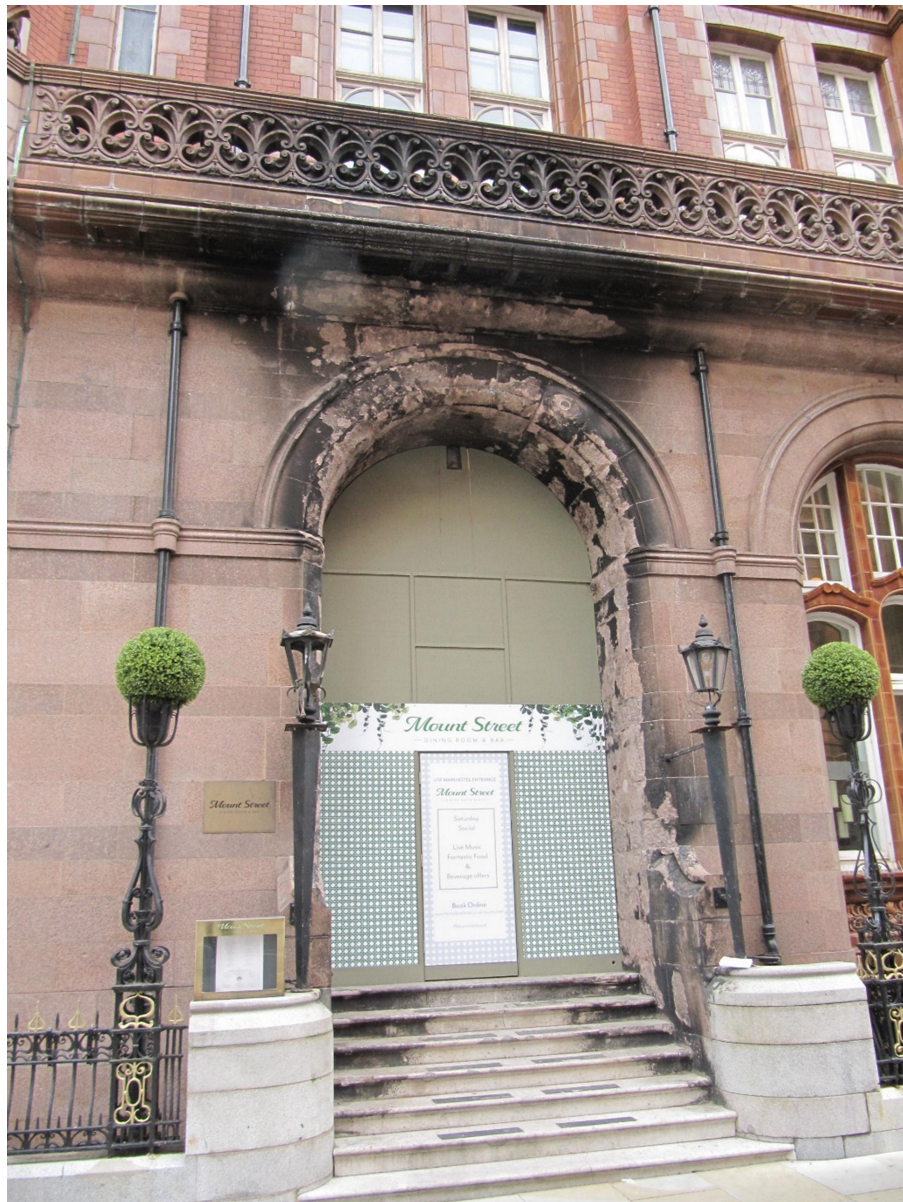
From initial inspection from the ground, the fire has caused damage to much of the granite stonework within the Arched doorway, to the facing granite surrounding the doorway, especially above the Arch and to the face and soffit of the balcony above.
