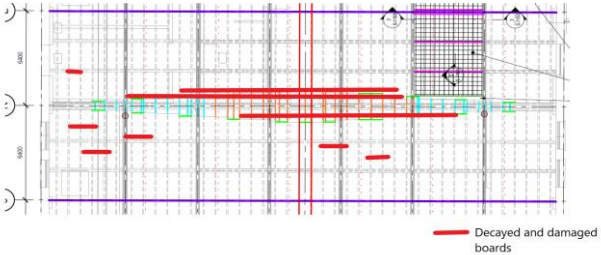
| Location/Beam | Decayed sections | Photographs | | |
|---|---|---|---|---|
| Roof Boardings | | | | <p>Renew boarding with 19x225mm Douglas Fir at per agreed rates</p> <p>95 emtres</p> <p><b>Buro Happold</b></p> <p><b>Replace all decayed boards like for like as per email dated 2-12-2024</b></p> |
