## **Brunswick Mill, Bradford Road, Manchester**

**Paint analysis results and an assessment of the historical paint schemes applied to the structural cast iron columns throughout the mill.**

**January 2025**

**M. WOMERSLEY**  
Historic Building Specialists

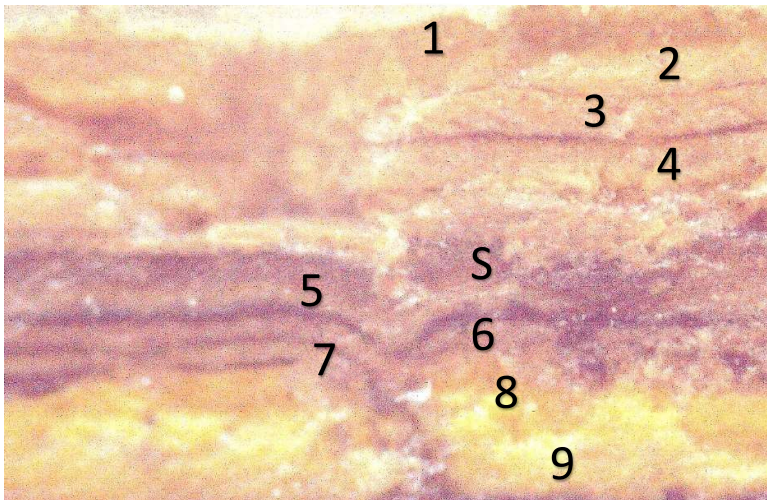
Figure 6. Sixth-floor main canal side spinning mill. Sample 1 at X40.

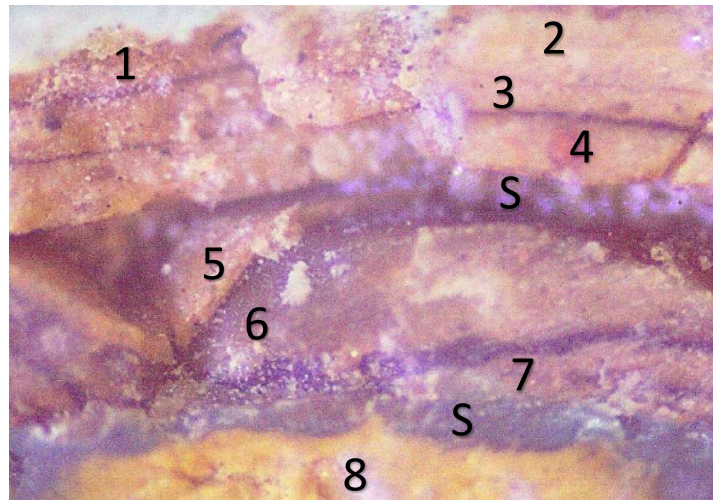
Figure 7. Sample 1 in UV light at X40.

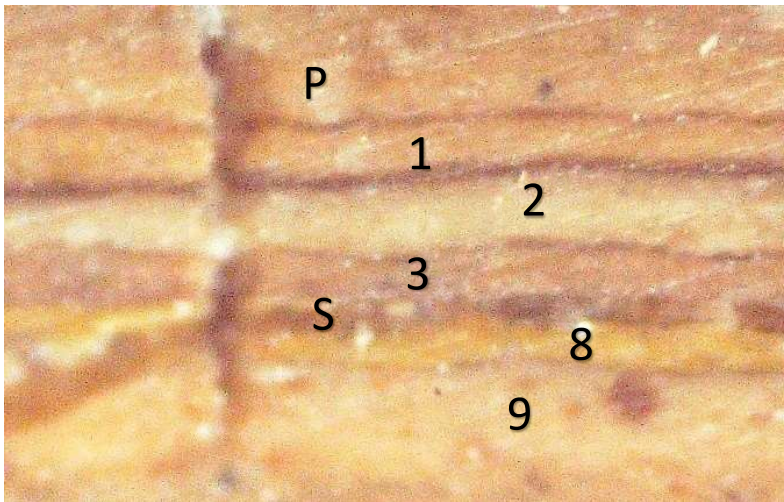
Figure 10. Sixth-floor north wing. Sample 2 at X40.

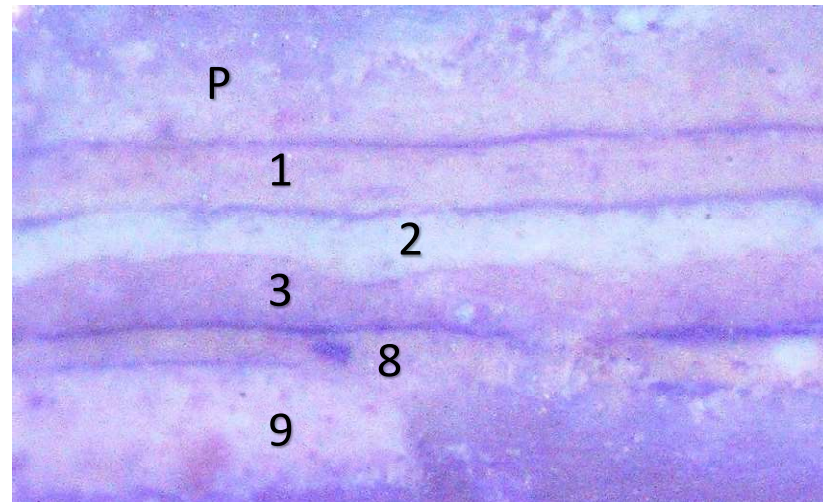
Figure 11. Sample 2 in UV light at X40.

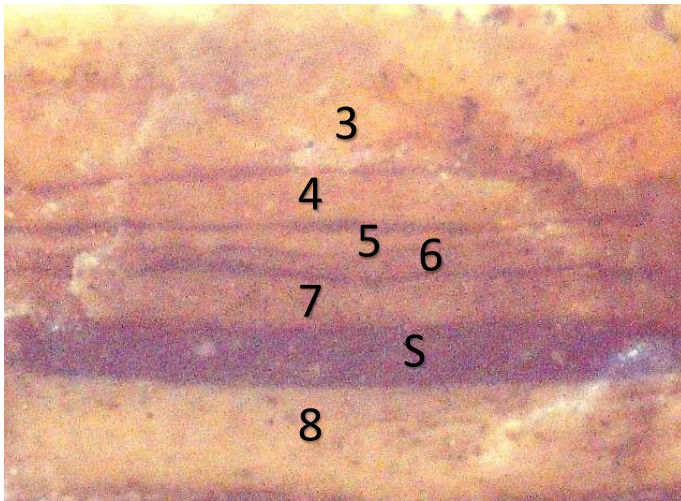
Figure 14. Fifth-floor, south wing. Sample 3 at X40.

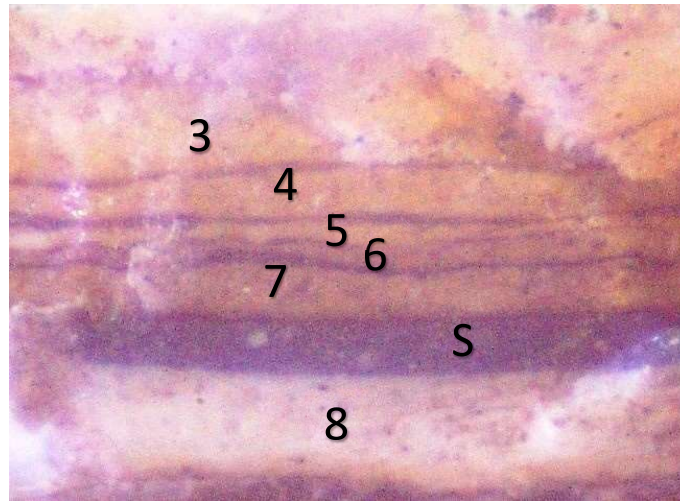
Figure 15. Sample 3 in UV light at X40.

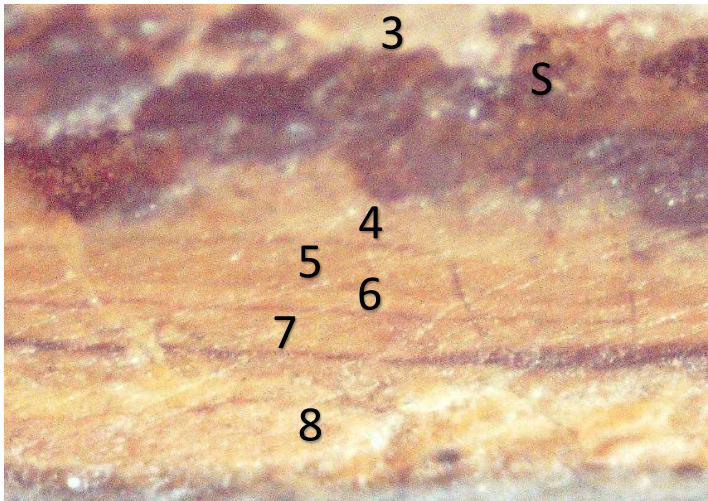
Figure 18. Fifth-floor, main canal side spinning mill. Sample 4 at X40.

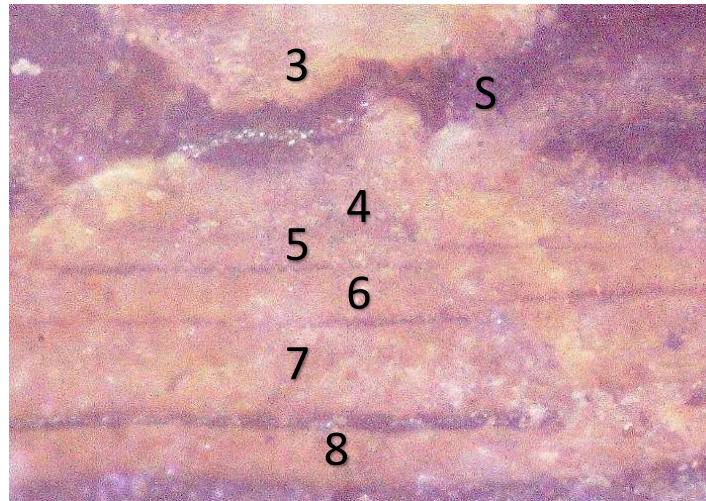
Figure 19. Sample 4 in UV light at X40.

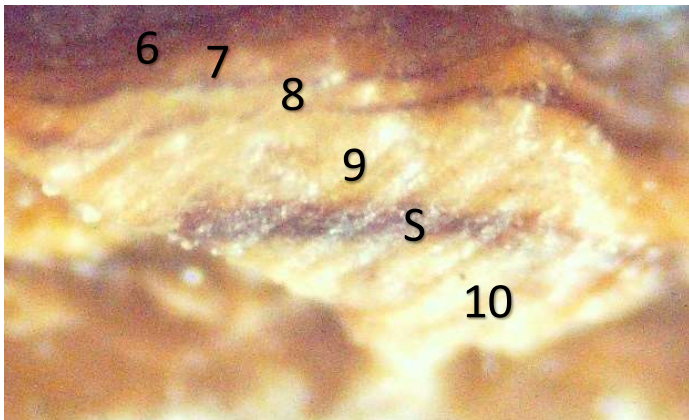
Figures 22. Fourth-floor south wing. Sample 5 at X40

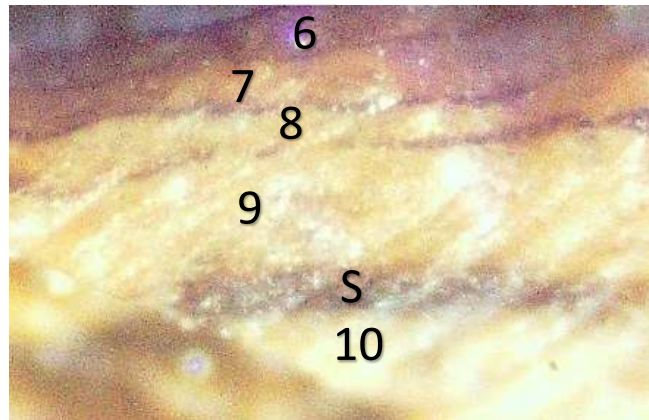
Figure 23. Sample 5 in UV light X40

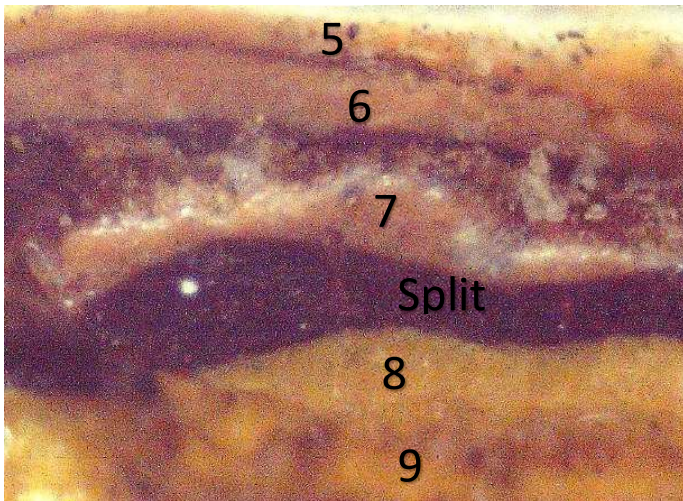
Figure 26. Fourth-floor canal side. Sample 6 at X40.

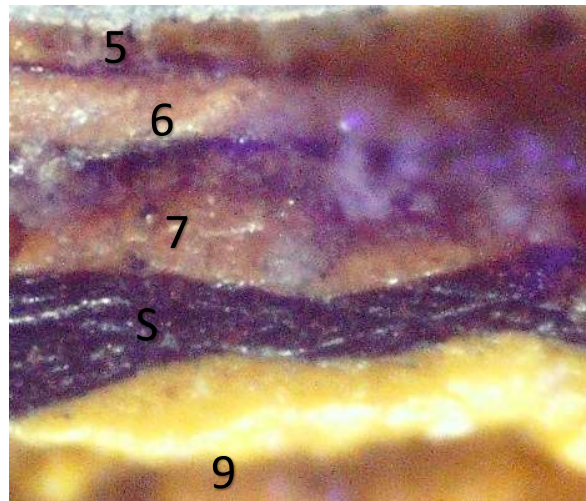
Figure 27. Sample 6 in UV light at X40

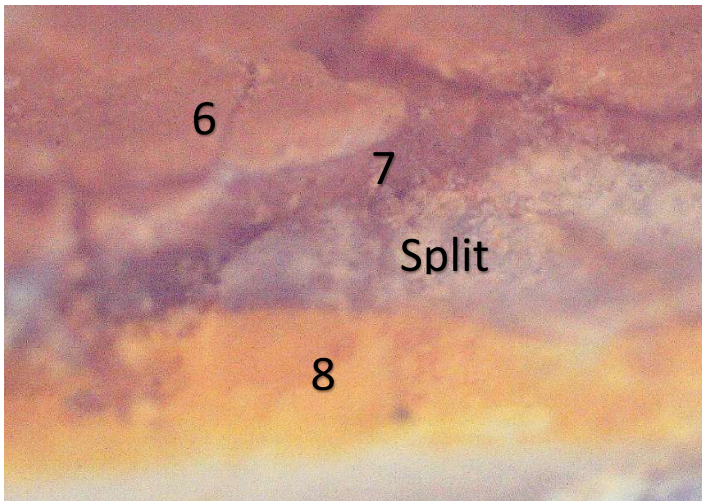
Figure 31. Third-floor main spinning mill canal side. Sample 7 at X40.

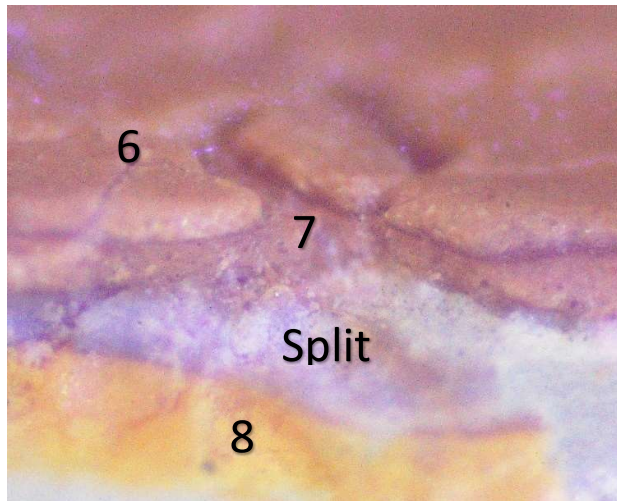
Figure 32. Sample 7 under UV light at X40

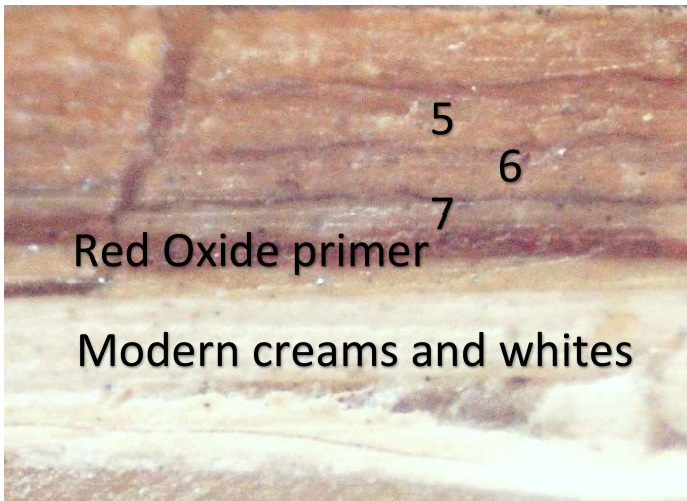
Figure 35. Third-floor south wing. Sample 8 at X40.

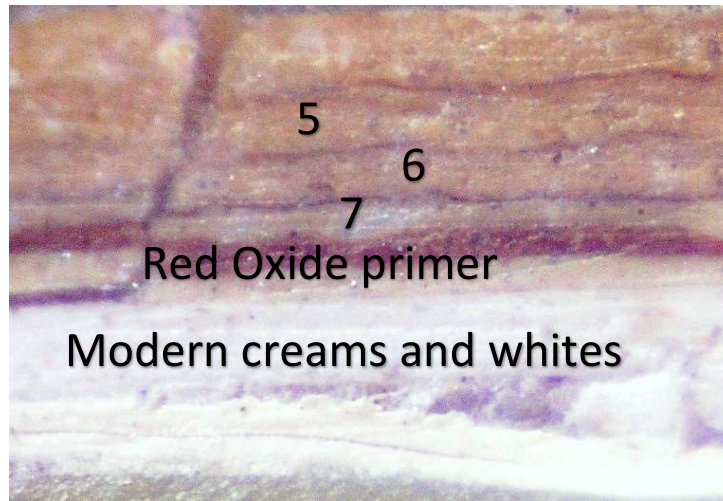
Figure 36. Sample 8 under UV light X40

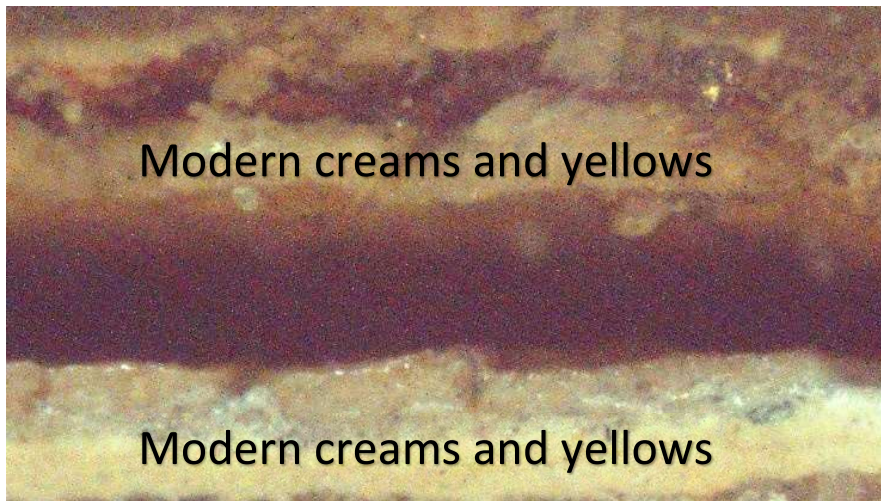
Figure 39. Third-floor Bradford Road extension. Sample 9 at X40

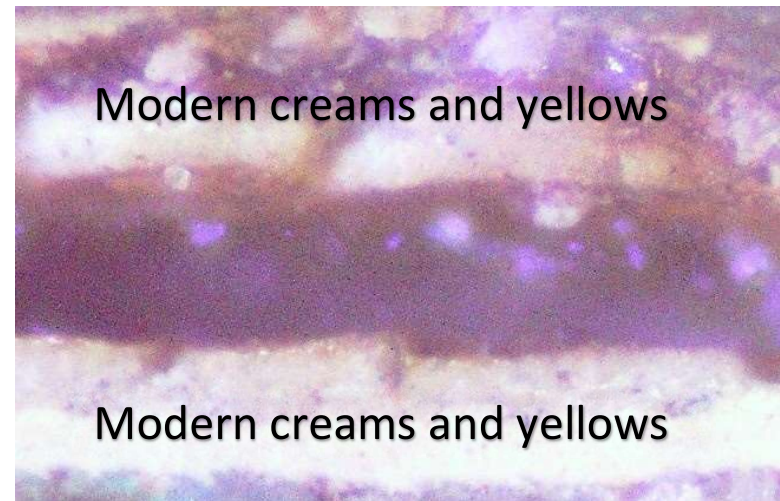
Figure 40. Sample 9 under UV light at X40

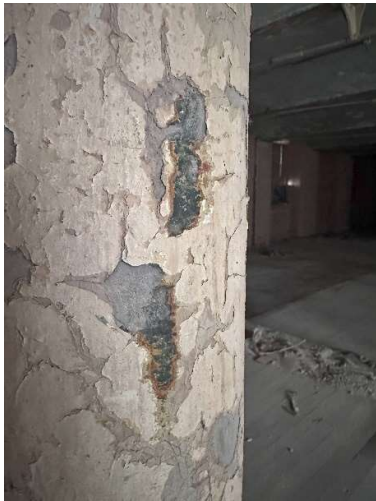
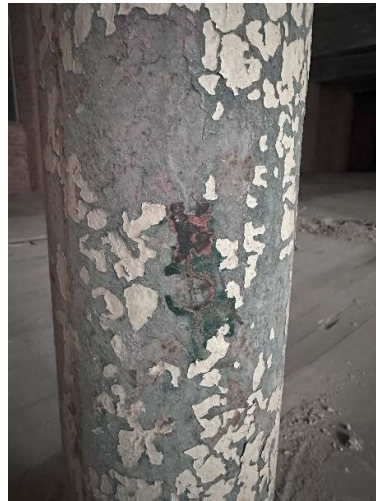
Figures 43 & 44. Sample 10 could not be taken as the earlier paints under the modern layer were badly deteriorated.

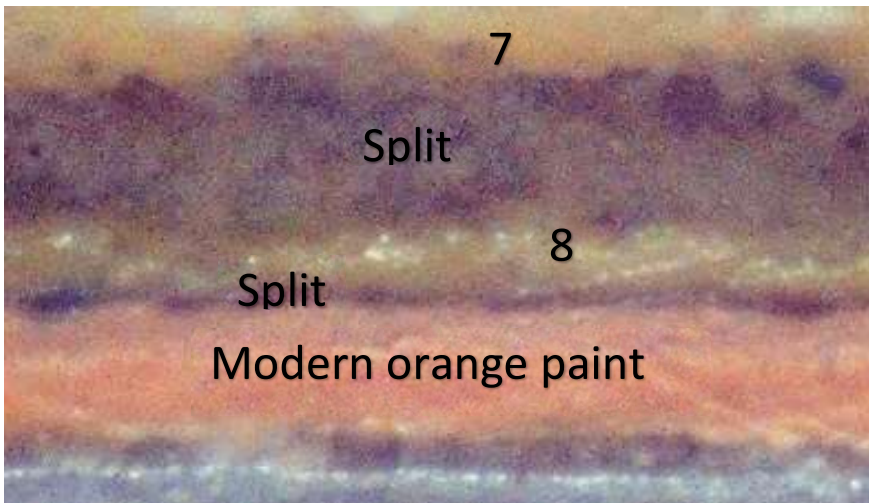
Figure 47. Second-floor, Bradford Road. Sample 11 at X40.

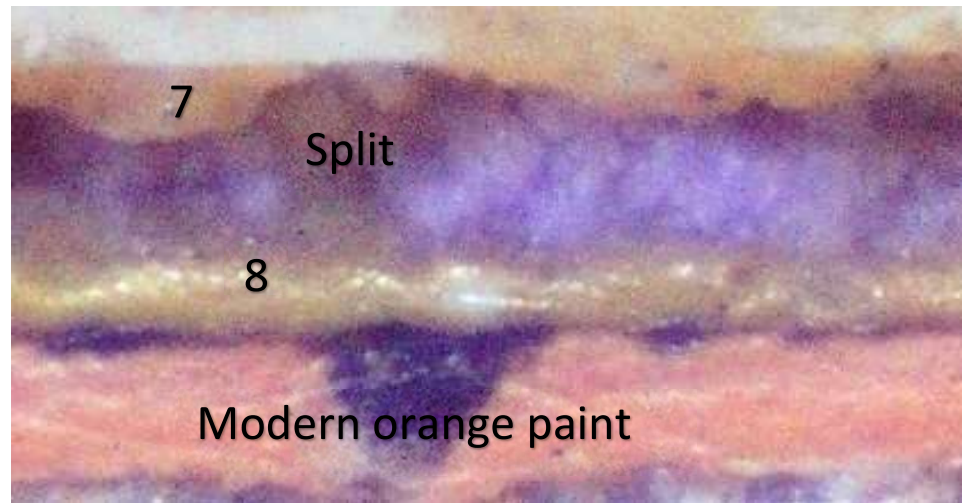
Figure 48. Sample 11 under UV light at X40

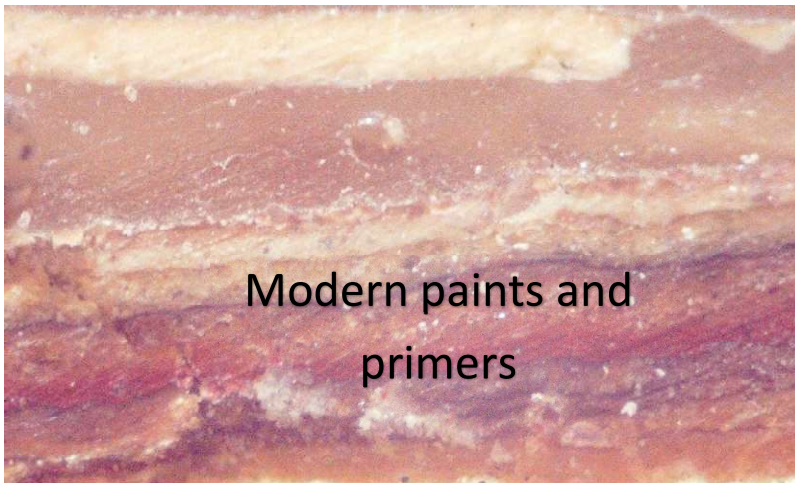
Figure 51. Second-floor, canal side. Sample 12 at X40

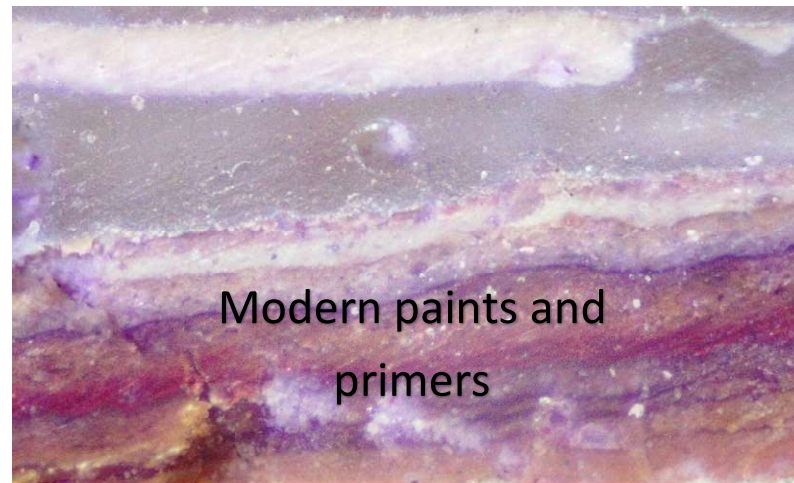
Figure 52. Sample 12 under UV light at X 40.

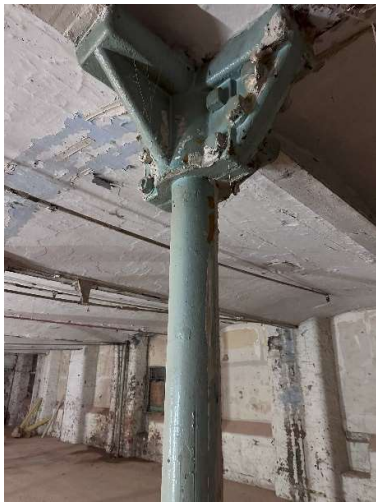
Figure 55. First-floor, south wing. Sample 13 was only modern paints.

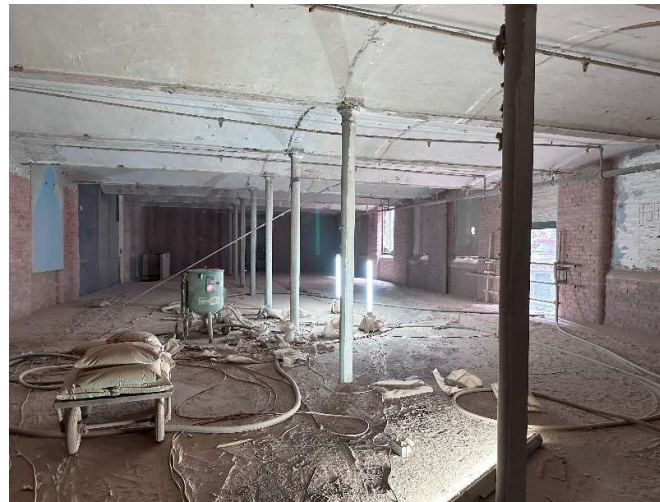
Figure 56. First-floor, Bradford Road. Sample 14 was modern paint.

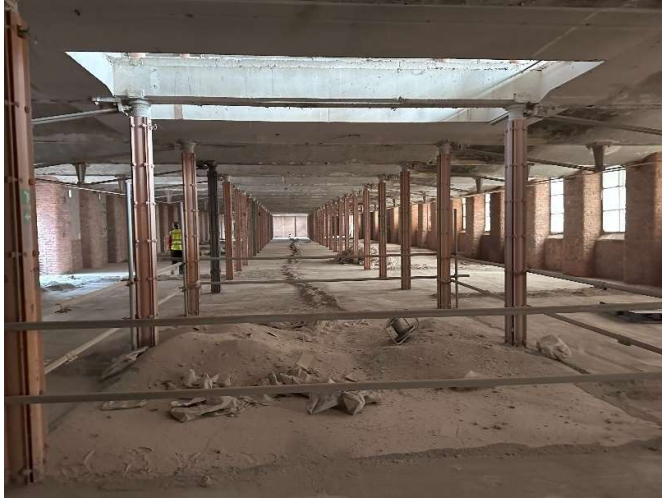
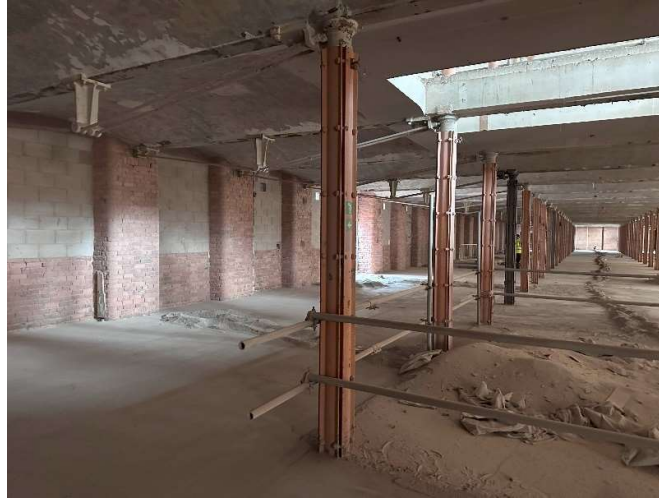
Figures 57 & 58: First-floor, main canal-side mill with columns strengthened and encased with later steel. No sample 15 could be taken.

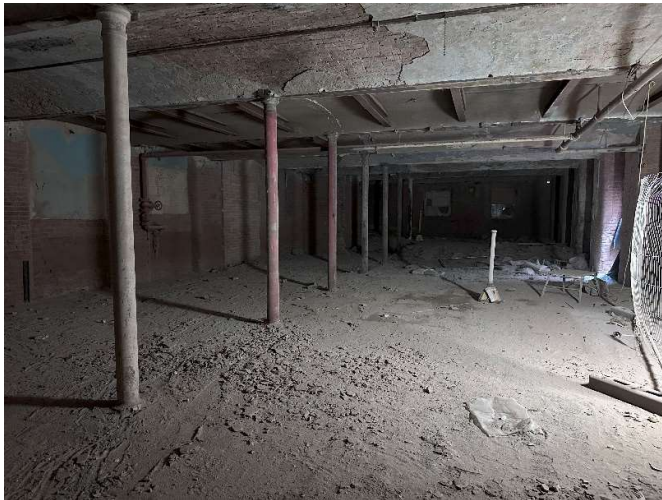
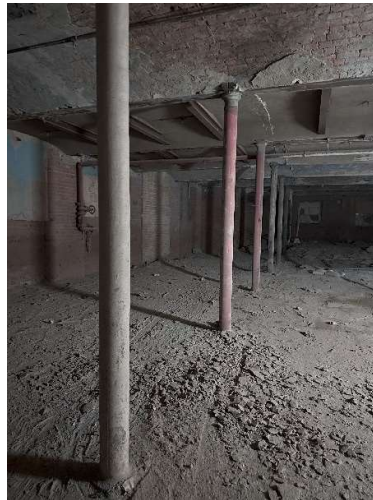
Figures 59 & 60. The ground floor, Bradford Road, previously masonry-encased columns, and paint remnants were just dusted when sample 16 was sought.

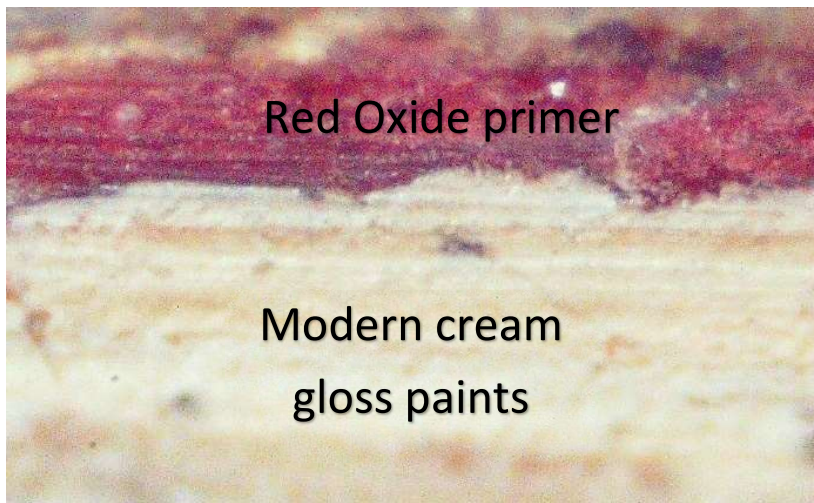
Figure 63. Ground floor, canal side. Sample 17 at X40

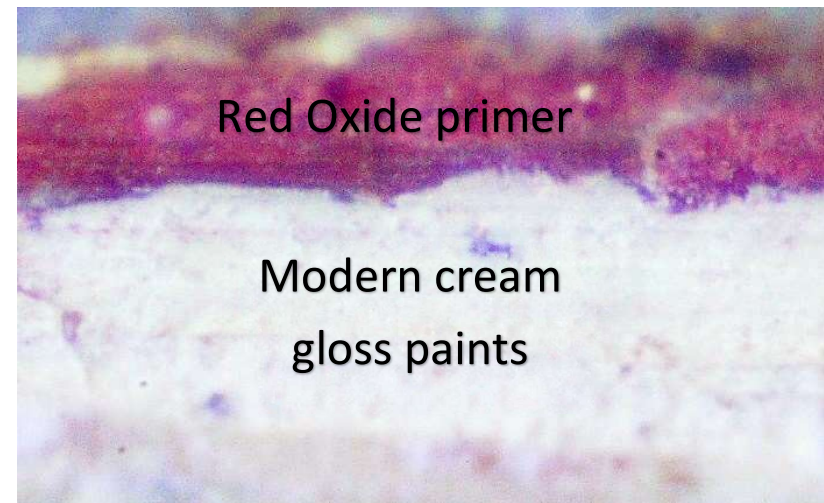
Figure 64. Sample 17 under UV light at X40
