### **Manchester University - Listed Building (office)**

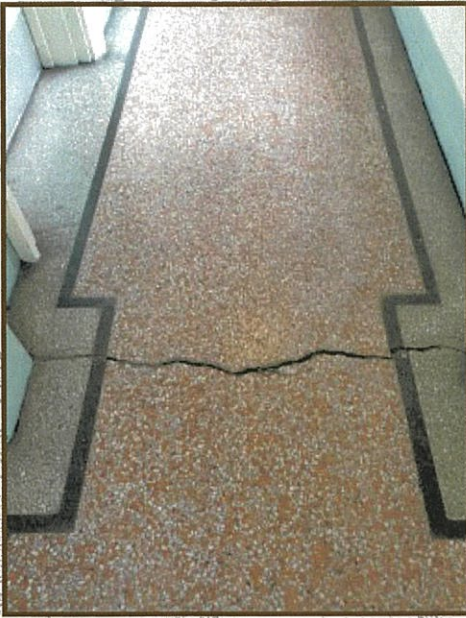
**Before**

Large Crack to Corridor

Rake out crack within corridor and remove loose material.

Bonding agents applied followed by new Bespoke Terrazzo Insitu compound (hand mixed on site) with colour pigmentation to match (as near as possible).

Mechanically ground using coarse/medium/fine heads.

Reseal whole area with a Saturate Solution of Zinc Silicate Flourides.

Diamond resurfaced to complete.
