## STRUCTURAL REPORT ON RETAINED FAÇADE

Red Lion Street  
Northern Quarter  
Manchester

Contract No: 11748  
Dated: February 2025

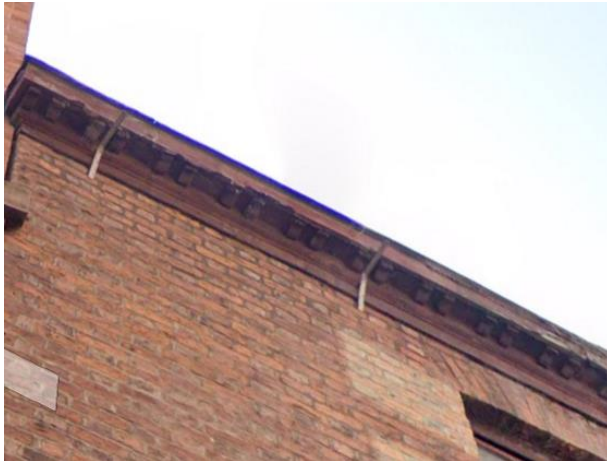
3.4

A view of the front elevation taken from Google Street view shows that there was previously an eaves detail extending at least four courses of brickwork above the brick arch lintel at the northern (lefthand) end

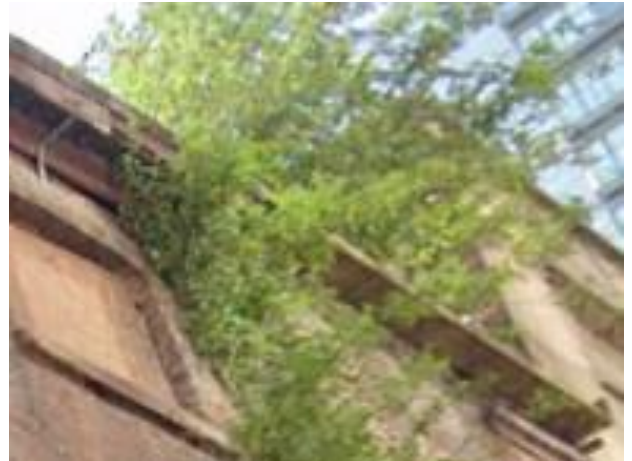
Eaves detail at southern (righthand) end of elevation appears to be stone copings

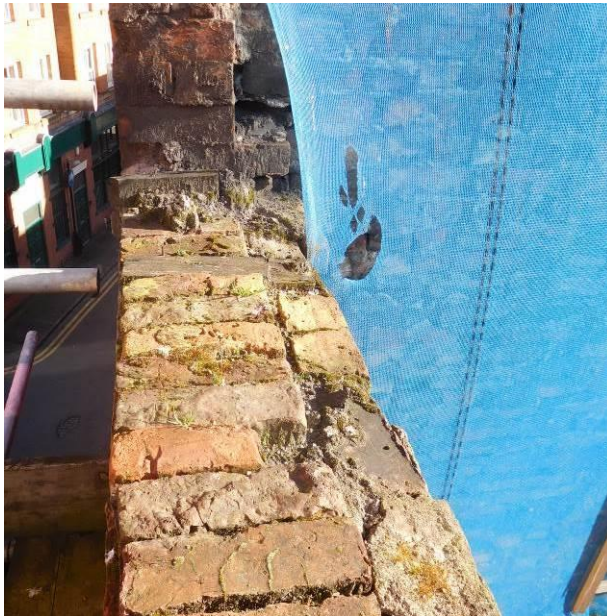
4.7

- 4.5 At the top of the wall it was noted that a “brick on edge” course capped the outer 9” of the wall. It is likely that this was the top course of the wall below a timber eaves detail. The bricks were loose and not well bedded; this was leaving the top of the wall vulnerable to water ingress. A number of the “on edge” bricks were missing leaving those areas of the wall completely unprotected against water ingress.

- 4.6 Notwithstanding the “brick on edge” detail along the top of the wall this, where present, only covered the outer 9” of the wall leaving the inside third of the wall thickness unprotected.

Typical brick on edge detail where present (April 2023)

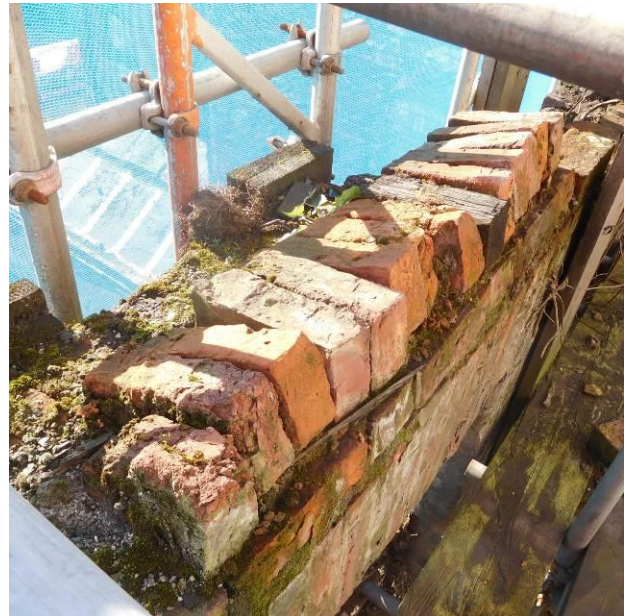
Distorted brick on edge detail over window opening (April 2023)

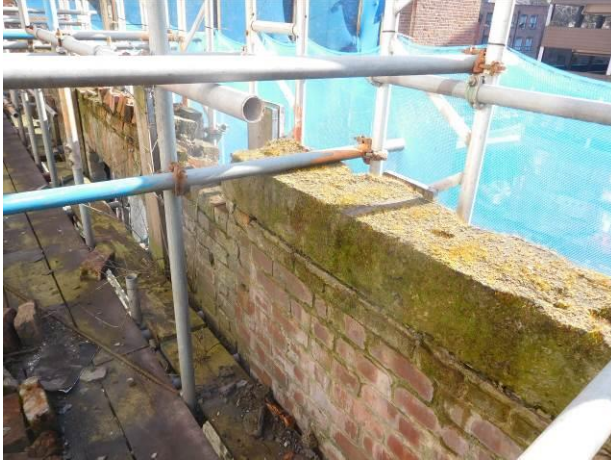
4.10

- 4.8 Towards the righthand end of the wall there was a panel of relatively modern rebuilt/infill brickwork. Over this length the wall was capped with a concrete lintel. It appeared that this did extend over the full thickness of the wall providing protection from water ingress.

Concrete capping lintel to righthand end of wall  
(April 2023)

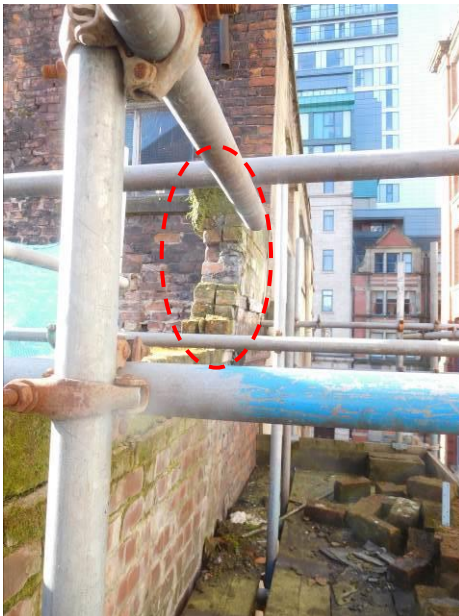
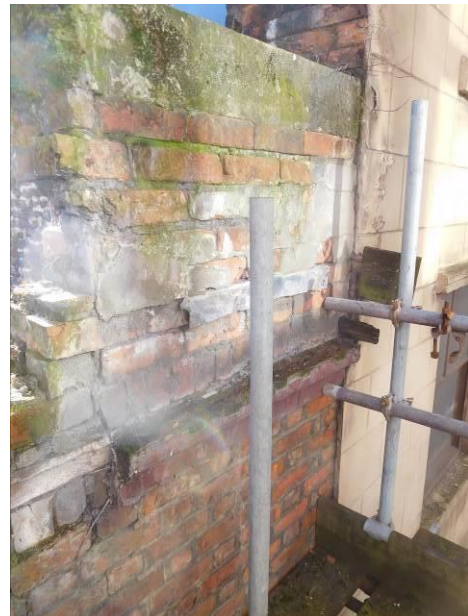
4.11

- 4.9 At the far righthand end of the wall the brickwork extended approximately 1m higher than the concrete lintel noted above. The original configuration of this wall is not known.

High section of wall at righthand end of façade (April 2023)

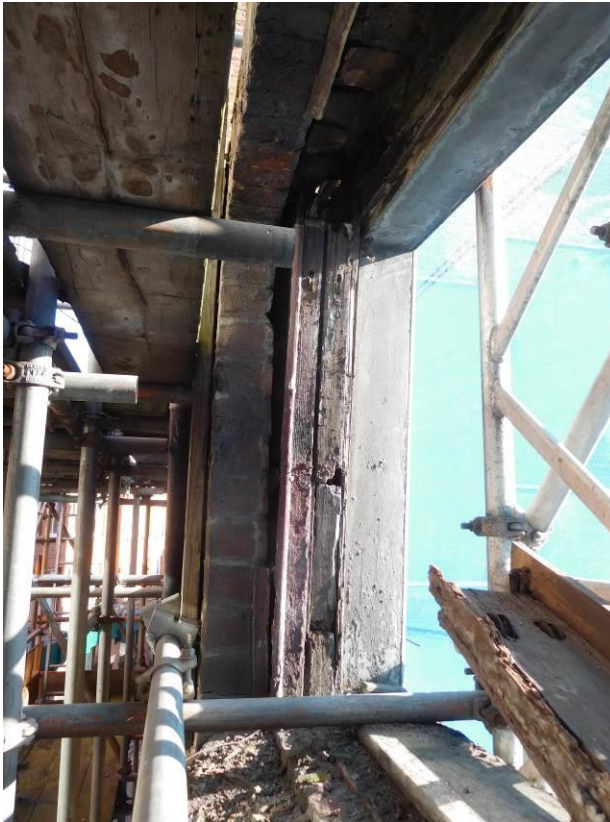
4.14

- 4.13 The stone cill of one window was missing, this did not appear to be causing a significant detriment to the wall as this location was reasonably protected by the scaffold structure. However, the remains of the timber window frame were rotten and collapsing; this was leaving the brickwork above unsupported. It could be seen that the inner and outer leaves of the wall were separating.

Rotting timber frame leaving unsupported brickwork (April 2023)

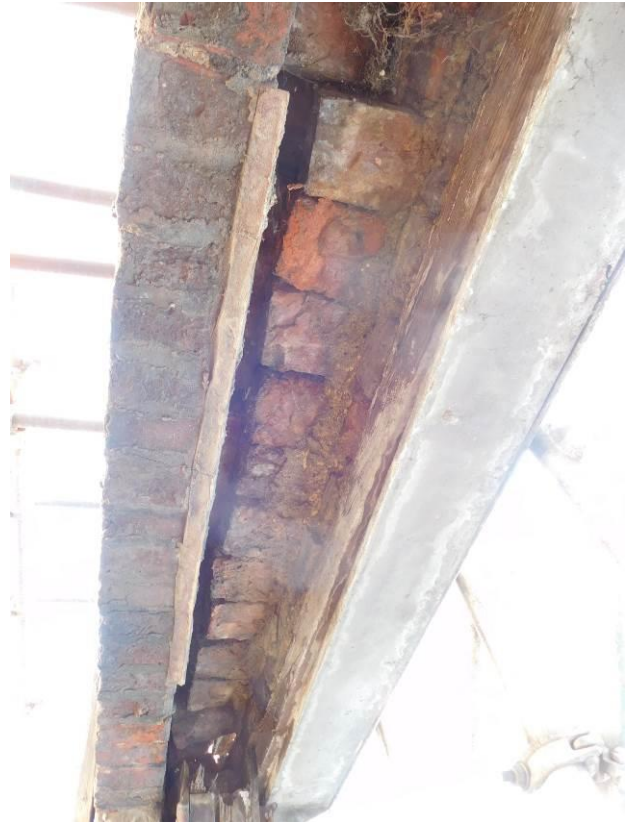
Unsupported window head separating from outer leaf of brickwork (April 2023)

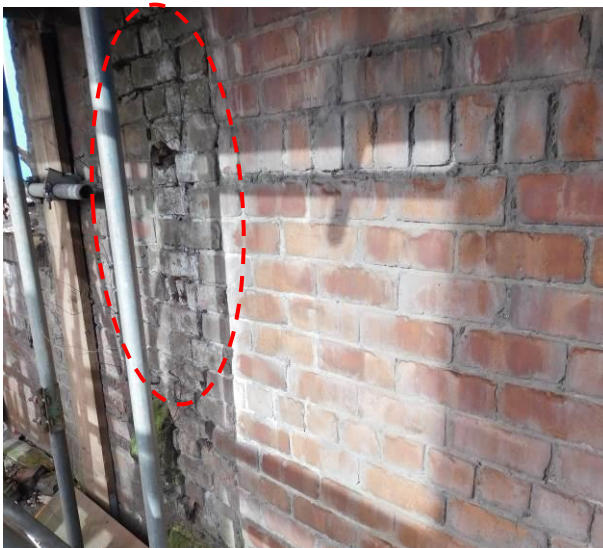
4.16

The panel of brickwork to the left of the infill panel at the righthand side of the elevation was in a poor condition. Extensive washing out of the mortar joints had occurred as the result of a missing rainwater pipe (since at least 2014).

Very poor condition brickwork from missing rainwater pipe (April 2023)

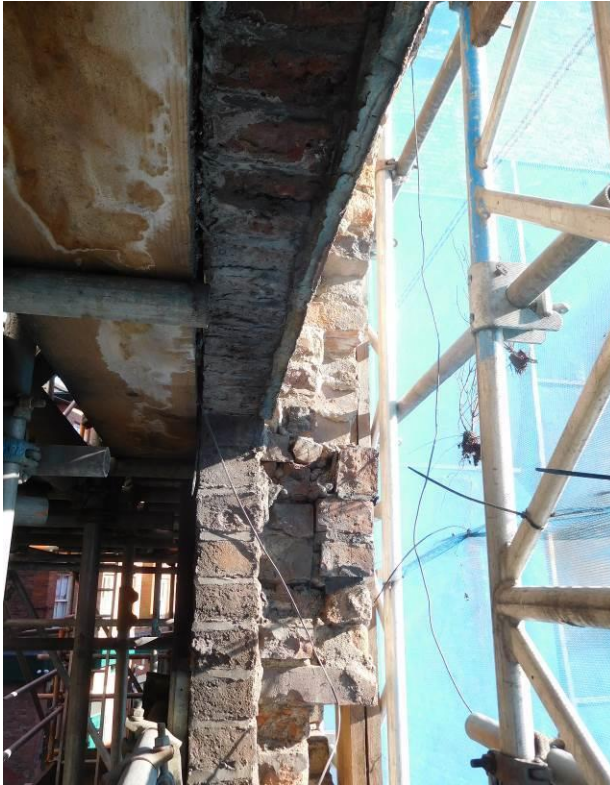
4.18

4.17 Moving down the scaffolding to first floor level severe damage to the inner leaf was apparent where window frames had been removed. Inner lintels were missing leaving the brickwork above unsupported.

Damaged brickwork reveal (April 2023)

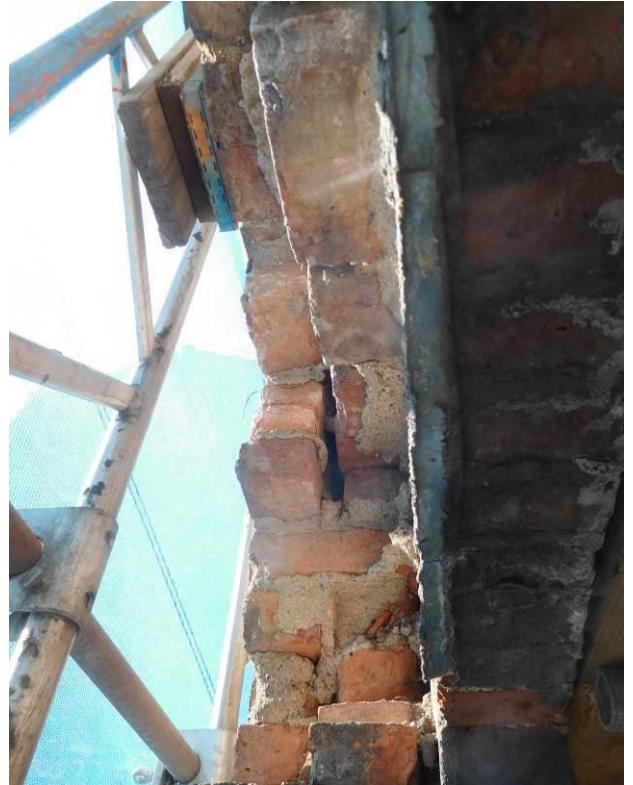
Unsupported brickwork of inner leaf above former window opening (April 2023)

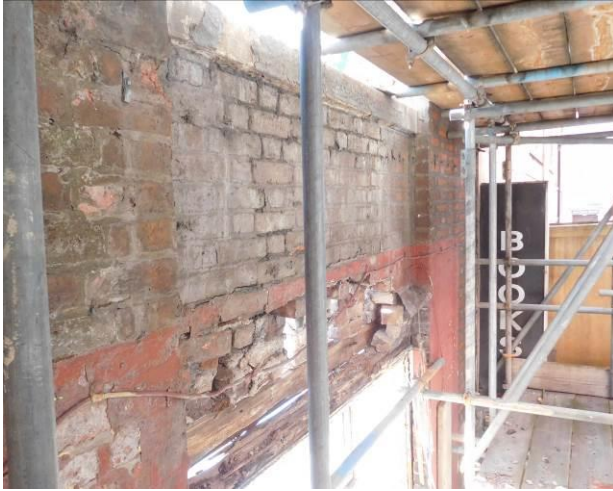
4.20

4.19 A rotten and collapsing timber lintel was noted above one of the ground floor window openings. The brickwork above this was in a poor condition and starting to suffer from localised collapse. It could be seen that the outer leaf of the wall had collapsed due to failure of a timber lintel and that pockets were now visible in the wall which would have served to support timber first floor joists. A single skin of brickwork remained and appeared to be precarious above this opening.

Distressed brickwork above rotten lintel (April 2023)

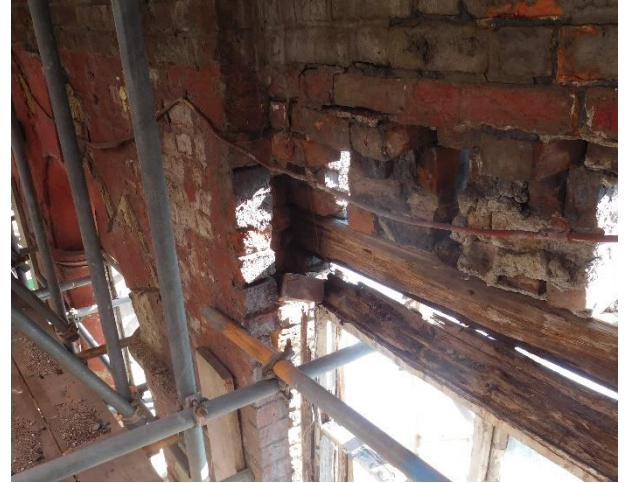
Joist pockets in wall (April 2023)

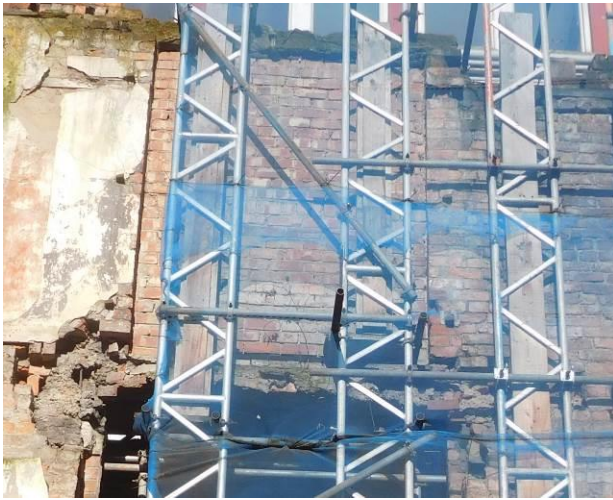
4.25

- 4.24 A panel of relatively recent brickwork was noted at high level at the righthand (southern) end of the elevation. This panel had been noted externally to be an infilled opening. When viewed from inside the building the panel appeared to be supported on what appeared to be a roughly cast insitu concrete lintel. The details of this lintel were not apparent, but there appeared to be brick cast in, or against, the concrete. At the righthand end of the lintel there was an end of a steel beam embedded in the wall; this was roughly encased by concrete and the surrounding brickwork was significantly disturbed.

Brick infill on in situ concrete lintel (April 2023)

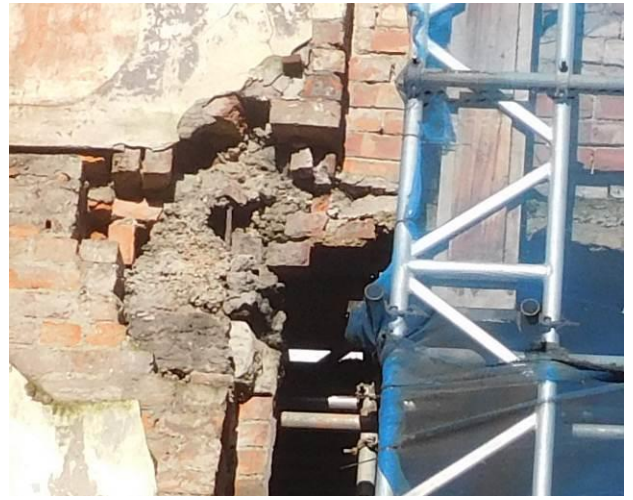
Detail of southern end of lintel (April 223)

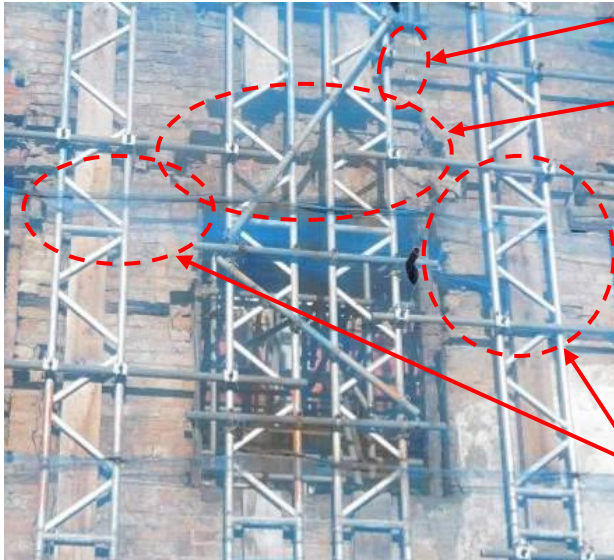
4.27

- 4.26 In the centre of the elevation the former main doorway was evident at ground floor level with a large window opening at first floor level above. The lintel above the first floor window had failed and a section of the inner leaf of the brickwork had fallen. Cracking above the panel of missing brickwork indicated that a further failure is likely to occur when the current restraint measures are released.

Cracking above missing brickwork

Panel of brickwork missing

Significantly disturbed panels of brickwork

First floor window above main entrance door (April 2023)

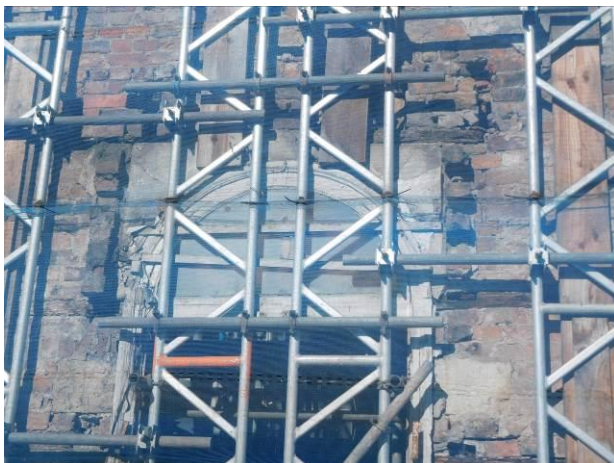
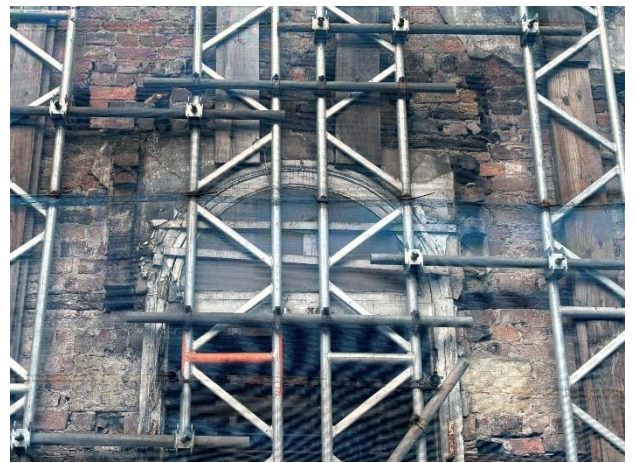
4.30

The brickwork immediately above the main entrance door appeared to be disturbed and the presence of header bricks indicated that there may have been walls bonded into the front elevation prior to the demolition. A timber lintel was noted above the arch of the doorway, the brickwork above this was disturbed. No significant deterioration had occurred since our 2023 inspections.

Brickwork around head of main entrance door (April 2023)

Brickwork around head of main entrance door (January 2025)

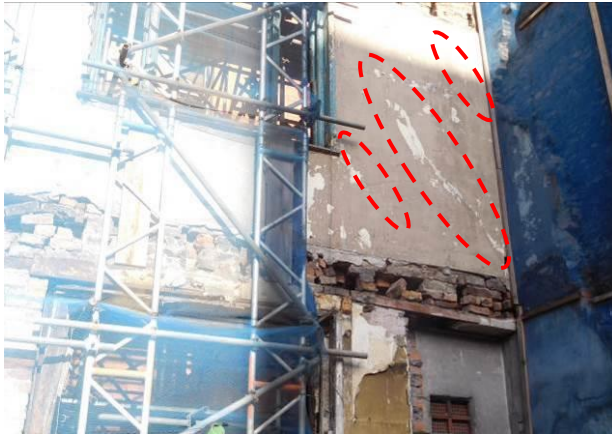
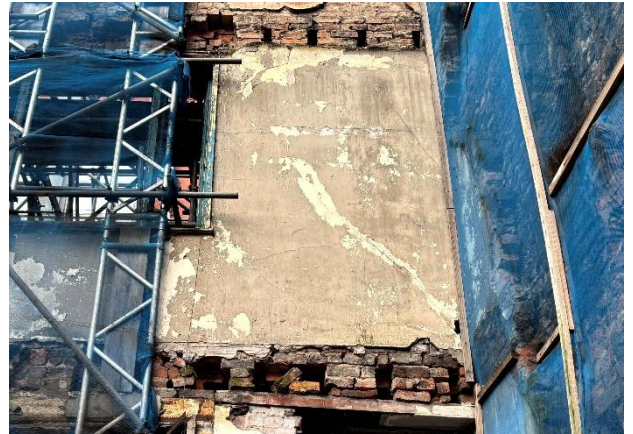
4.33

4.31 At the lefthand (northern) end of the elevation a shallow timber beam spanned over a side entrance doorway. It appeared that this beam had previously formed a bulkhead and supported the inner 9" leaf of the wall. In addition, it could be seen that the beam had also supported the timber joists of the first floor. The timber lintel was deflected in shape and cracking in the plaster of the wall above confirmed that movement was affecting the brickwork behind.

Cracking in panel above side entrance doorway  
(April 2023)

Cracking in panel above side entrance doorway  
(January 2025)

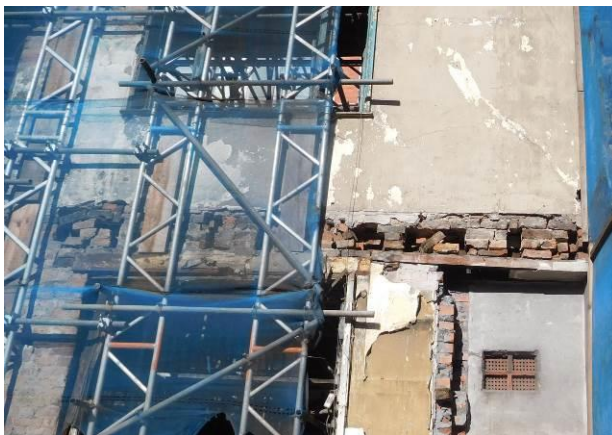
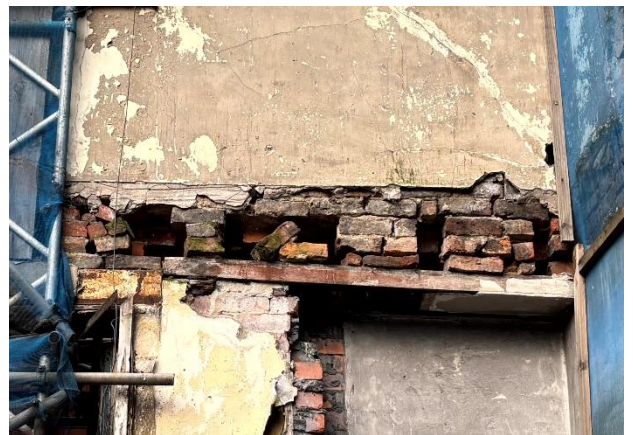
4.34

4.32 A series of joist pockets at first floor level had been left open when the building behind was demolished. It appears that great care was not exercised when the joists were removed which resulted in significant damage to the brickwork around the pockets.

Damaged brickwork around first floor joist pockets (April 2023)

Damaged brickwork around first floor joist pockets  
(January 2025)

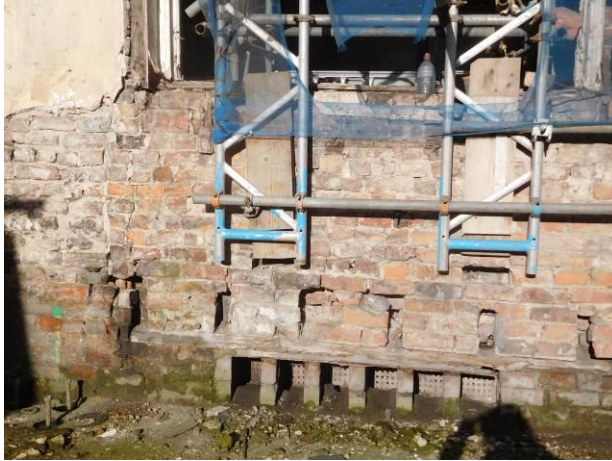
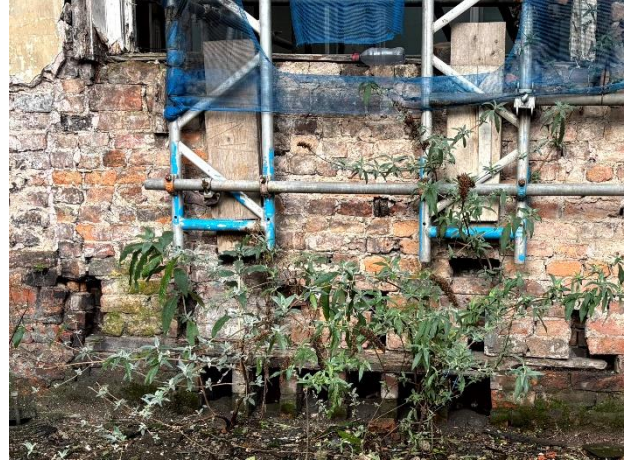
4.36

4.35 Joist pockets were also apparent at ground floor level; these were generally in a better condition than those at first floor level.

Joist pockets at ground floor level (April 2023)

Joist pockets at ground floor level (January 2025)

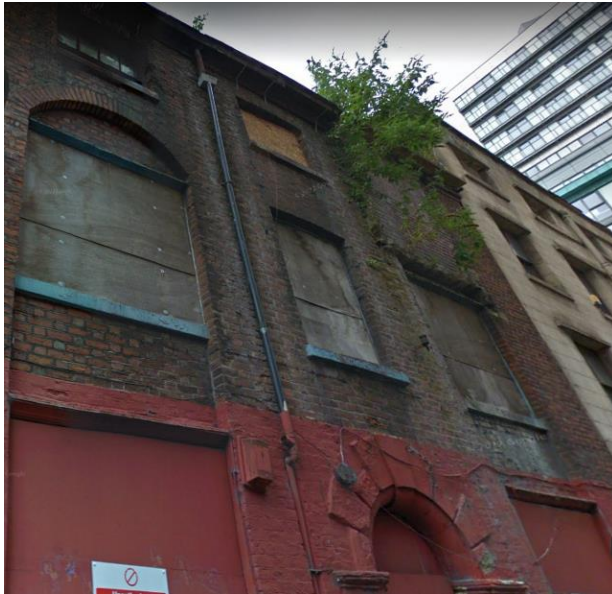
5.4

5.2 Google Street view from 2014 shows significant growth of Buddleia on the front elevation where a rainwater pipe was missing. It could also be seen that the gutters towards the righthand (southern) end of the elevation may have been missing or ineffective, especially over the infilled second floor opening at that end of the elevation. Other areas of the front elevation also showed evidence of significant water damage to have been present in 2014.

5.3 The lack of effective rainwater goods had allowed water to penetrate the wall which, in turn, had exacerbated the vegetation growth on the elevation. The combination of water ingress and root activity will have disrupted the masonry and weakened its effectiveness as a structural unit.

2014 view of building taken from Google Streetview
